## ANN ARBOR HISTORIC DISTRICT COMMISSION

### Staff Report

**ADDRESS:** 200 East Washington Street, Application Number HDC14-060

**DISTRICT:** Main Street Historic District

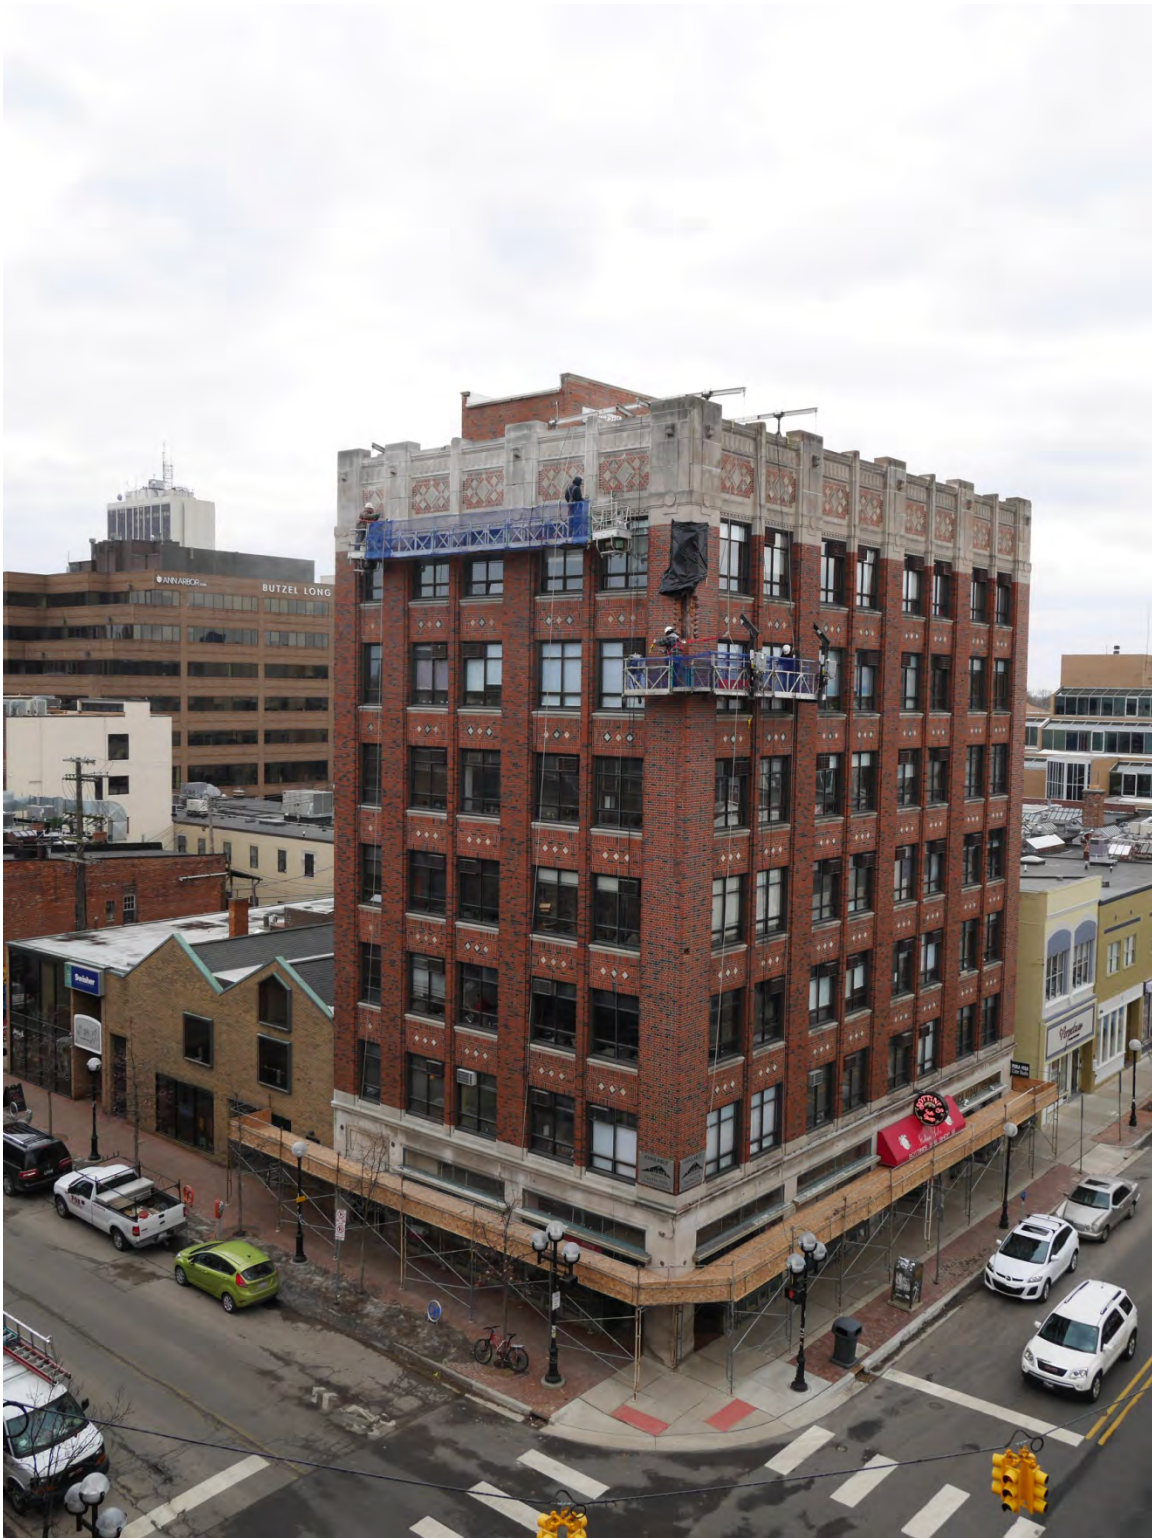
Photo taken by the applicant on March 20, 2014. The brick piers and mullions of the upper stories do not align with the storefront masonry below, and storefront window muntins also do not align with the brick masonry above. Scaffolding obscures a clear view of the storefronts and kickplates.

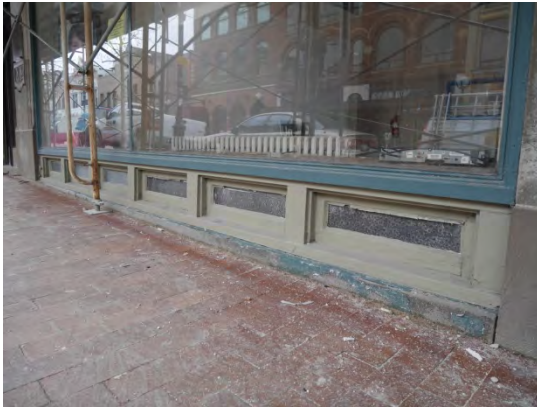
Easternmost storefront on E. Washington has a thinner kickplate than the others, because the sidewalk slopes up from the corner. In the proposed scheme, the stone foundation would be restored, the original number of panels, and the strong sill line are retained.

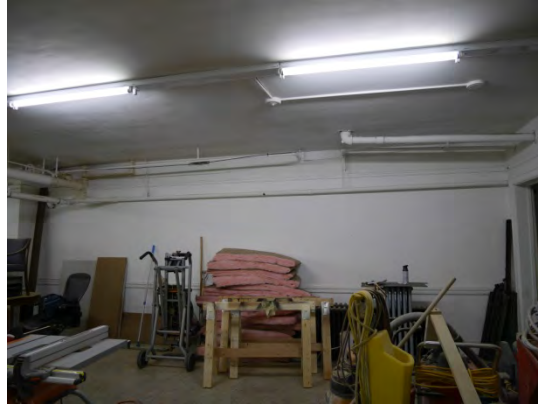
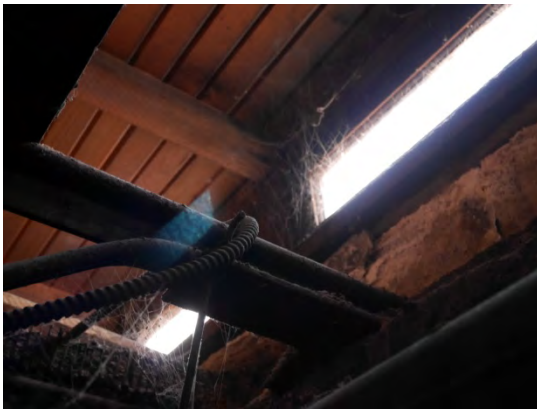
From inside the basement, all of the windows fronting on E. Washington are covered over with drywall, although they can be seen from the utility closet looking behind the drywall.

Although access is difficult, we were able to observe split and eroding foundation stone, creating genuine concern about the structural integrity of the foundation wall under all of the storefronts.

All of the perimeter foundation walls under the kickplate require extensive repairs.

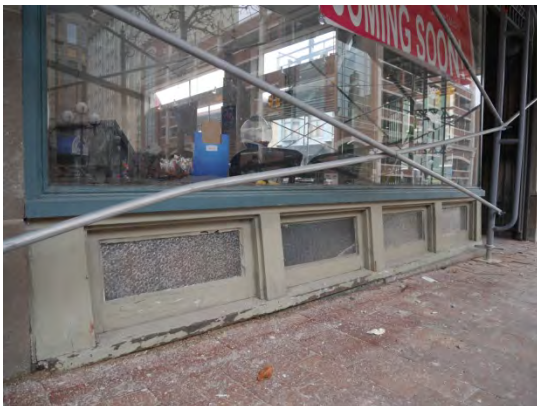
The kickplates that are displaced along E. Washington, caused during recent road re-surfacing, present a threat to the stability of the entire infill panel. The weight of the plate glass, the transom beam, and the transom glass all sit on the lower section, currently framed in wood. While the wood itself is not rotted, it is subject to severe weathering, paint failure, and salt damage, and the wood is mostly newer, having been selectively replaced over time from past changes to the storefronts. It may be possible to salvage the wood kickplates in sections, and to reset them on a repaired foundation, but the wood itself is highly vulnerable to a repeat of deteriorating conditions and difficult to maintain.

Westernmost kickplate on E. Washington does not sit over its foundation. Road work vibration caused the kickplate to “kick” out, destabilizing the storefront glass and transom, all of which bear on this stone foundation.

This section is not visible from the interior.

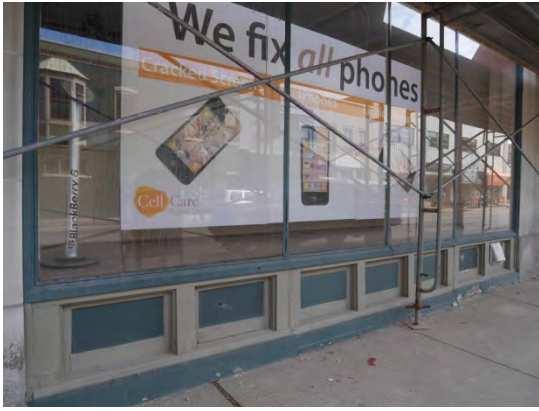
This storefront on S. Fourth has undergone the most changes. The original angled recessed entry has been filled in with newer wood panels, and the plate glass is divided into four pieces. The outer panes align with the original storefront corners, and the infilled section is divided into two panes. This division has nothing to do with the upper brick masonry.

The proposed scheme keeps the same number of lower panels in the kickplate and uses three panes of glass for the storefront. Above the transom, the original seven panes will be restored.

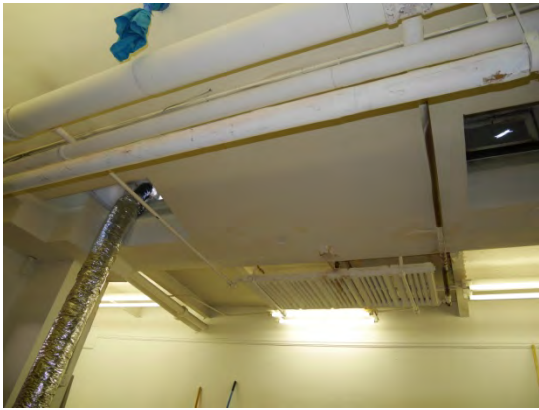
The flat ceiling is under the original recessed storefront. Windows are just visible to either side. These windows are not proposed to be restored.

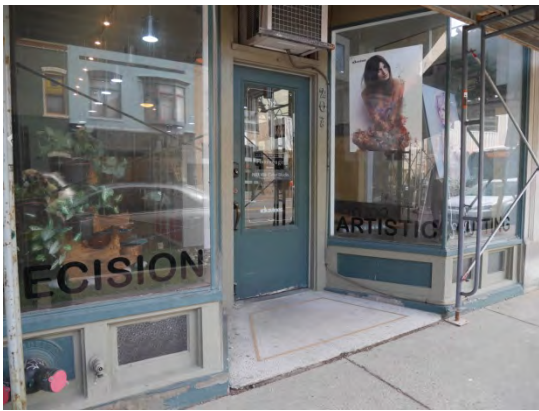
Southernmost storefront shows glazed sash in the kickplate, but these has been altered at the interior.

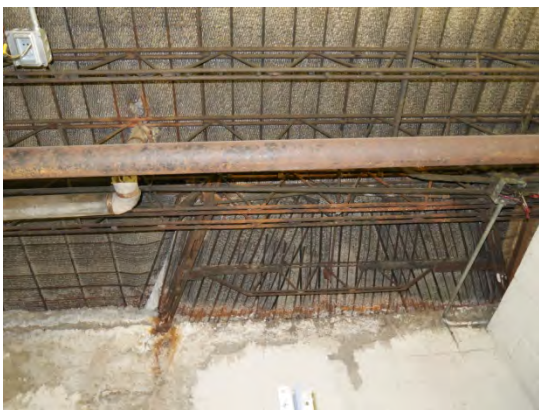
Under Sottini's and the salon the windows have been blocked up and provide no windows into the basement. Along the perimeter foundation, the rebar supporting the recessed entries is badly corroded.

The proposal is to remove the storefronts to fully restore the foundation. The new storefronts will restore the recessed entries

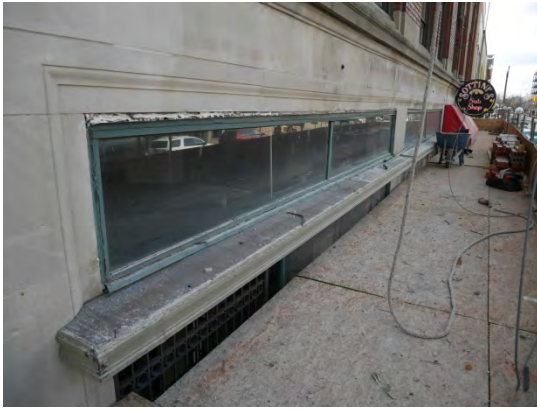
None of the transom glass is original. Photo from circa 1950 clearly shows the smaller panes. Even the steel frame is not original.

The awning cover is in very poor condition.

The proposed scheme restores the original number of panes in each opening. This creates a strong horizontal line inside the limestone surround.

The proposed scheme replaces this with a strong horizontal transom beam in the same material as the rest of the storefront system.

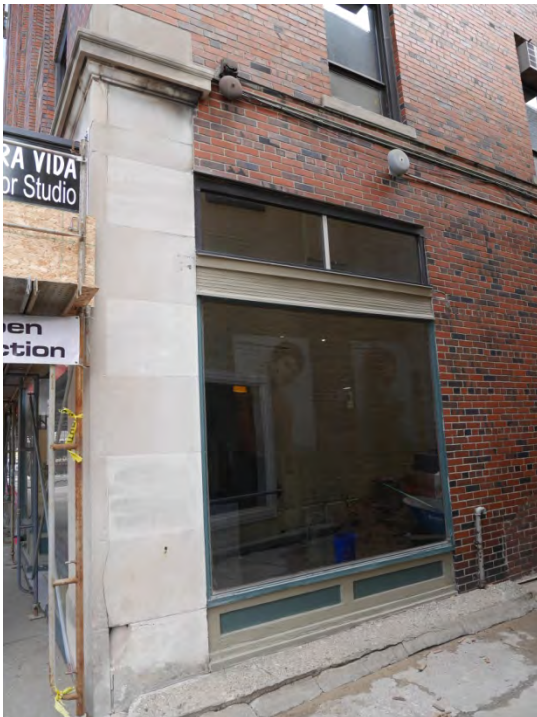
The alley window is also not original material for the glazing, although the kickplate may be old enough to be from the period of significance.

The proposed scheme restores the small panes in the transom, retains a single large pane for the storefront, and replicates the kickplate in aluminum as shown in the attached drawings.
