ADDENDUM No. 3

RFP No. 980

Interim Operation of Ann Arbor Material Recovery Facility (MRF) and Waste Transfer Station

City of Ann Arbor MRF Audit

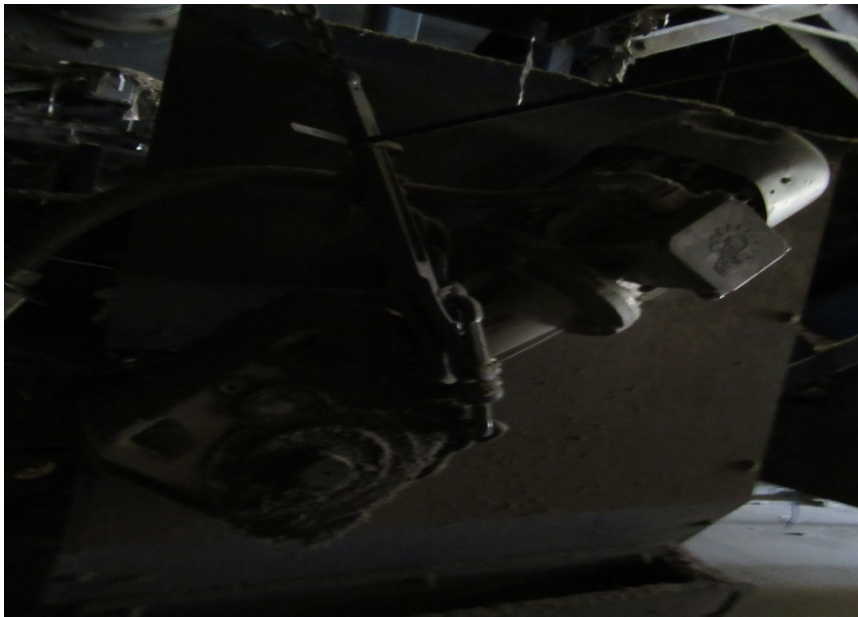
Photo A shows the gear motor supported by a chain. We recommend replacing the torque arm bracket and mounting the gear motor properly to prevent damage to the pulley or gear motor.
