## City of Ann Arbor

### HISTORIC DISTRICT COMMISSION

Re: 903 W Huron new submission

**ADDRESS:** 903 West Huron Street, Application Number HDC24-0089

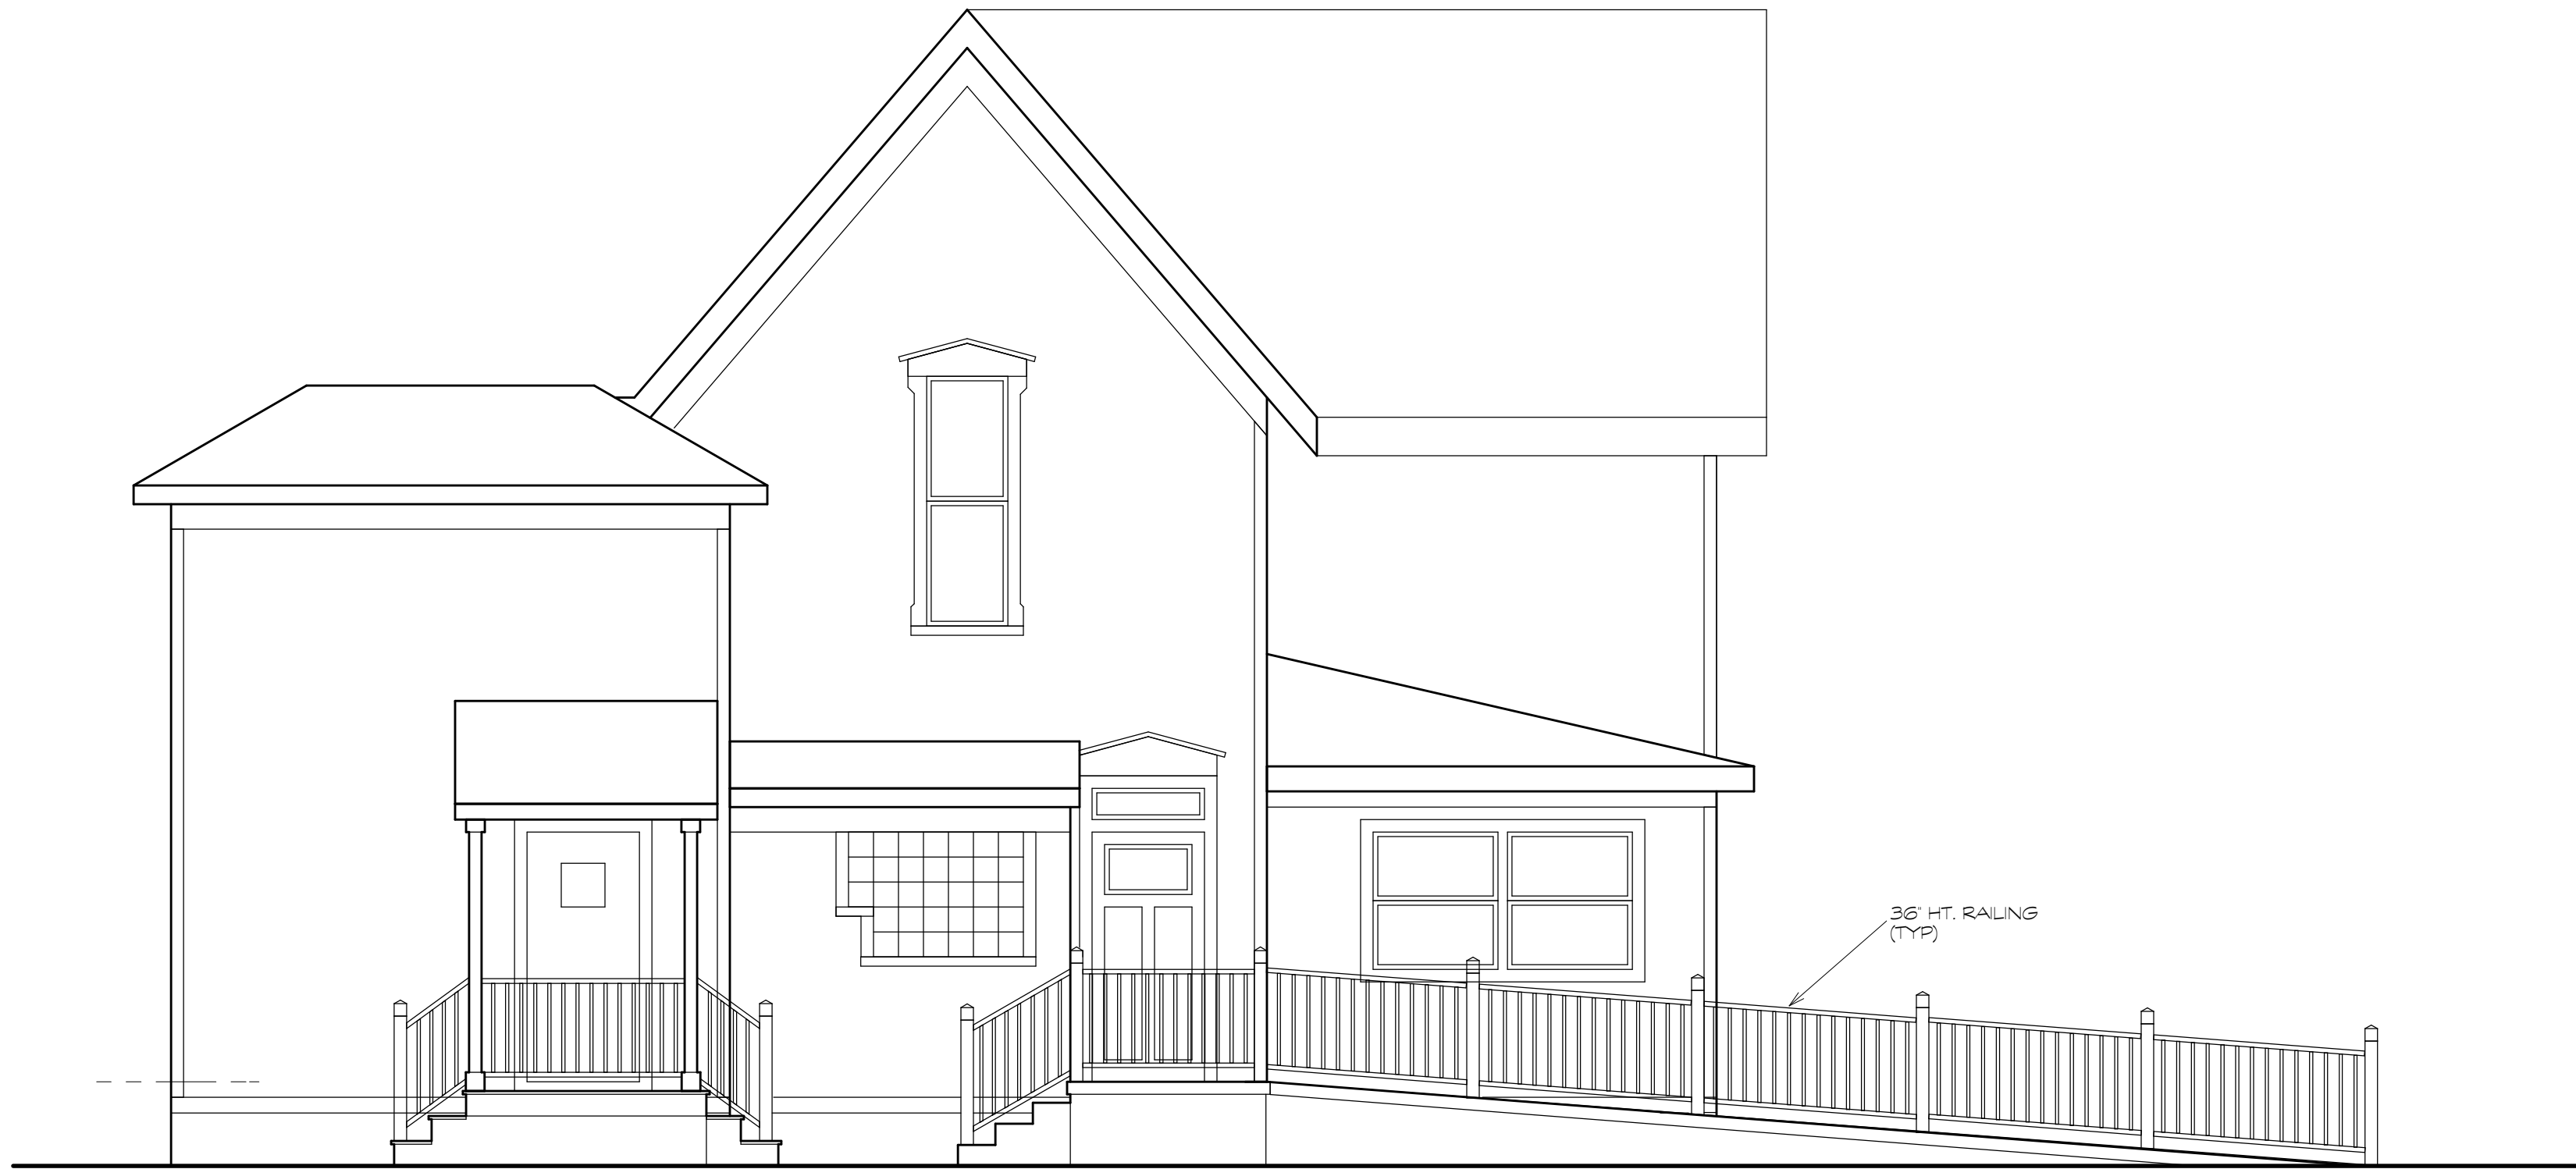
## SOUTH ELEVATION

At the June 13, 2024 HDC meeting, part of the application at 903 W Huron was postponed to allow the applicant to adjust and complete the proposal to replace the rear window with a door and add a new stoop and ramp. The attached revised drawings show a paneled door in the location of the former window, but there is no further information regarding materiality or appearance of the door. The drawings show a new concrete landing, steps, and ramp that run parallel to the existing rear wall of the house. The ramp extends roughly 15 ft east beyond the southeast corner of the house. The ramp is approximately 4 ft wide and is surrounded to the north and south by new planting areas. The ramp will have a simple guardrail that appears to meet the design guidelines, but no material information was provided. A new concrete walk will connect the steps and ramp to the existing driveway. According to the drawings, the same guardrail design will also be installed at the existing covered porch west of the new door and ramp.

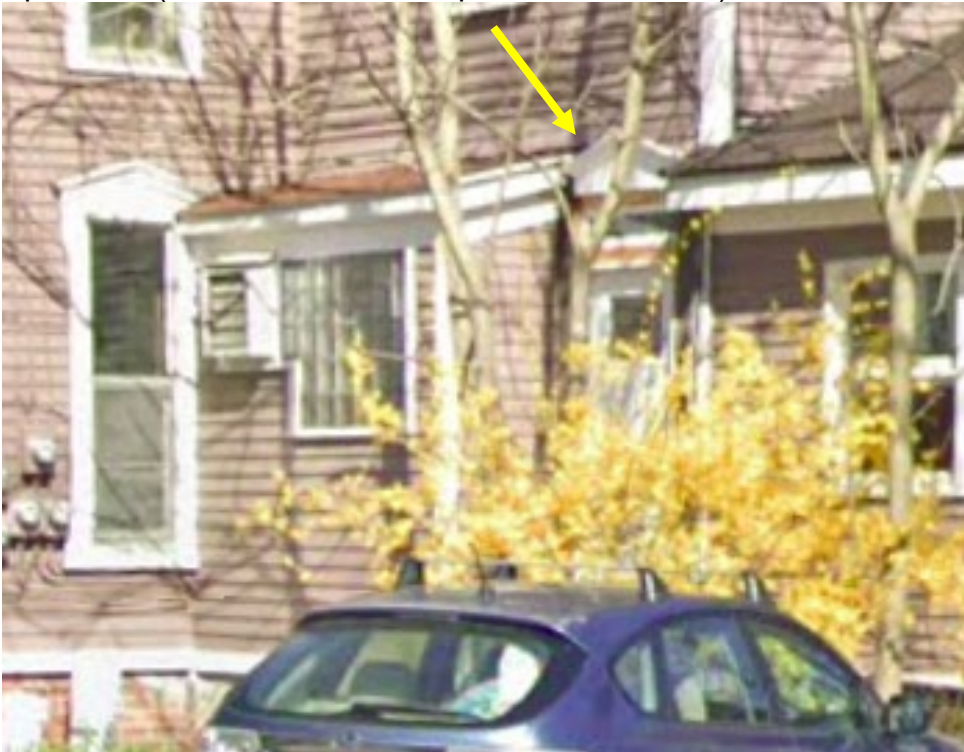
3. On the south elevation of the house, visible from the public right-of-way, work was begun to replace a window with a door. The only historic material remaining after this work is the former window's pedimented crown. The trim that enframed the window on the sides has been removed. The window opening was made larger to accommodate a steel door and a narrow, disproportionate transom window. The door and transom are framed by underlayment or tar paper. The intended design or method to finish this trim is unknown.

April 2024 (Window has been replaced with a door)

I move that because this work was done without permission of the Commission and does not qualify for a certificate of appropriateness, the property owner is ordered to restore the (front porch) (window on the south elevation) to (its) (their) prior condition. The restoration work must be completed by September 13, 2024.

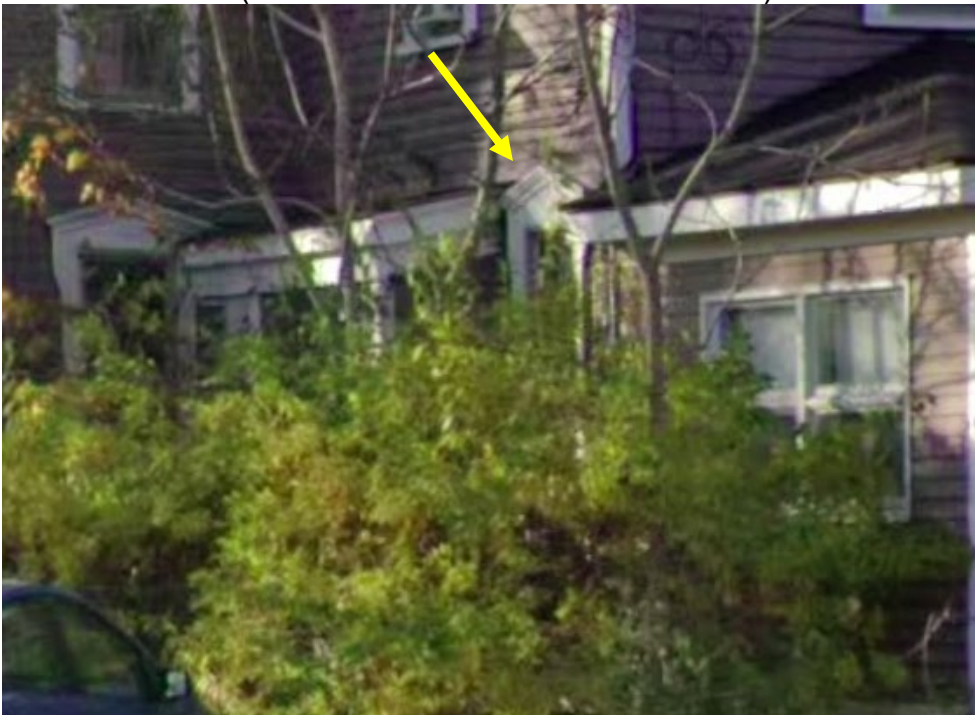
November 2020 (Window before conversion to a door)

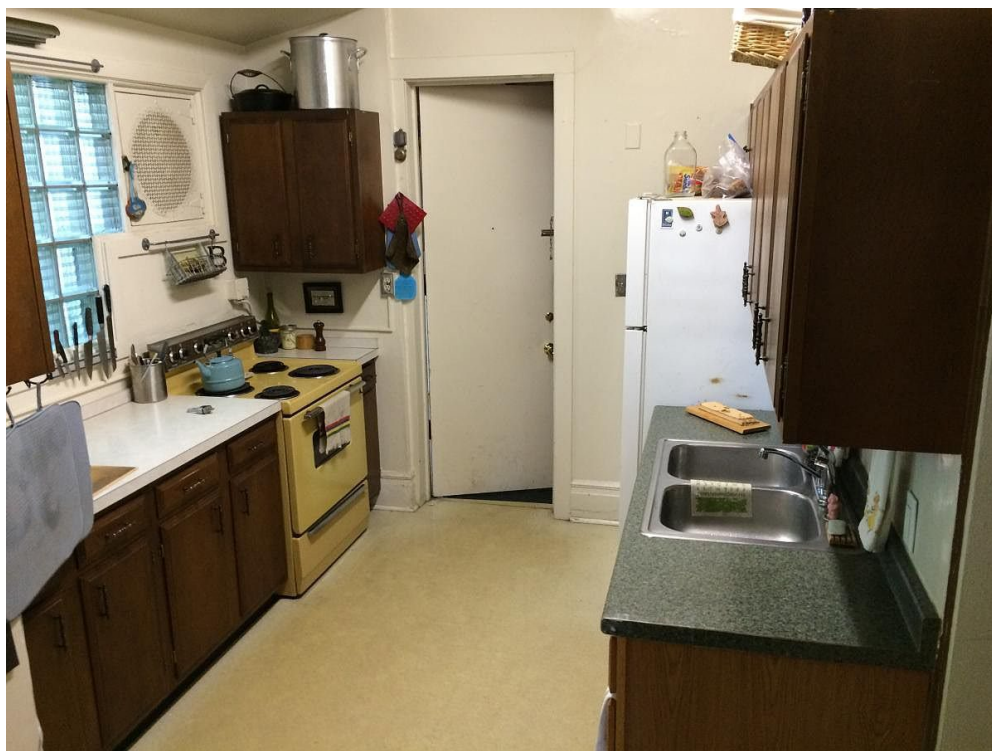
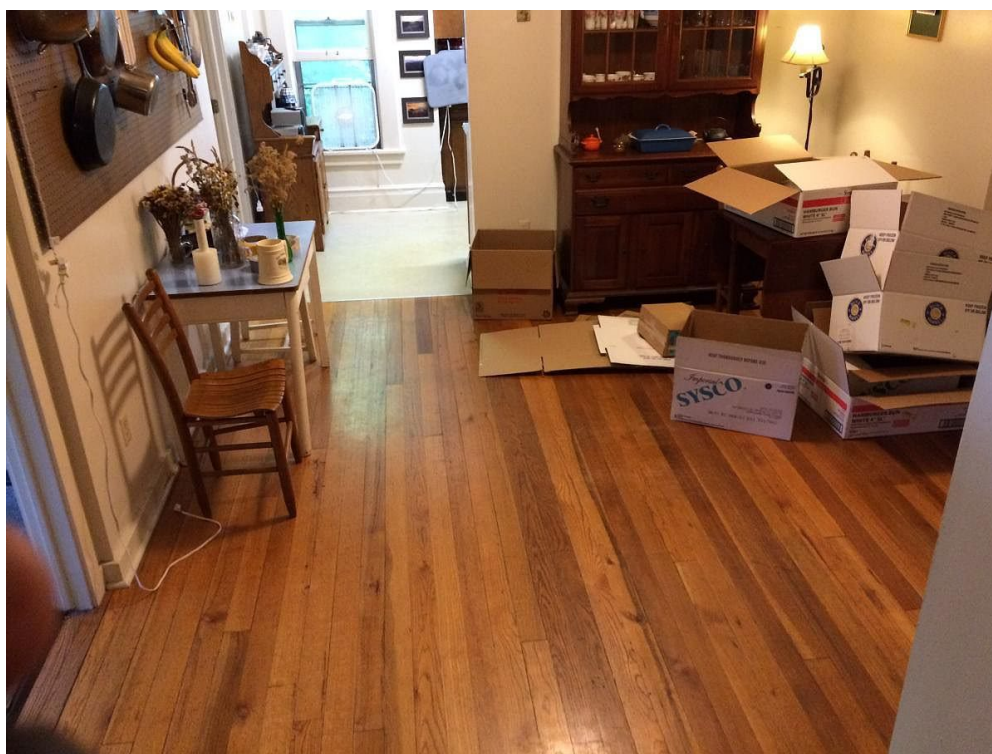
Undated interior photos from Zillow of 903 W Huron #1 (Note the glass block kitchen window that faces the rear parking lot, and the grey chair cushions (?) hanging from a cupboard in both photos. The window with the box fan is the one that was converted into a door.)
