Andrew Palms  
718 Lawrence St.  
Ann Arbor, MI 48104  
(734)433-0500  
andy@palms.name

October 24, 2022

Subject: Windows at 718 Lawrence St.

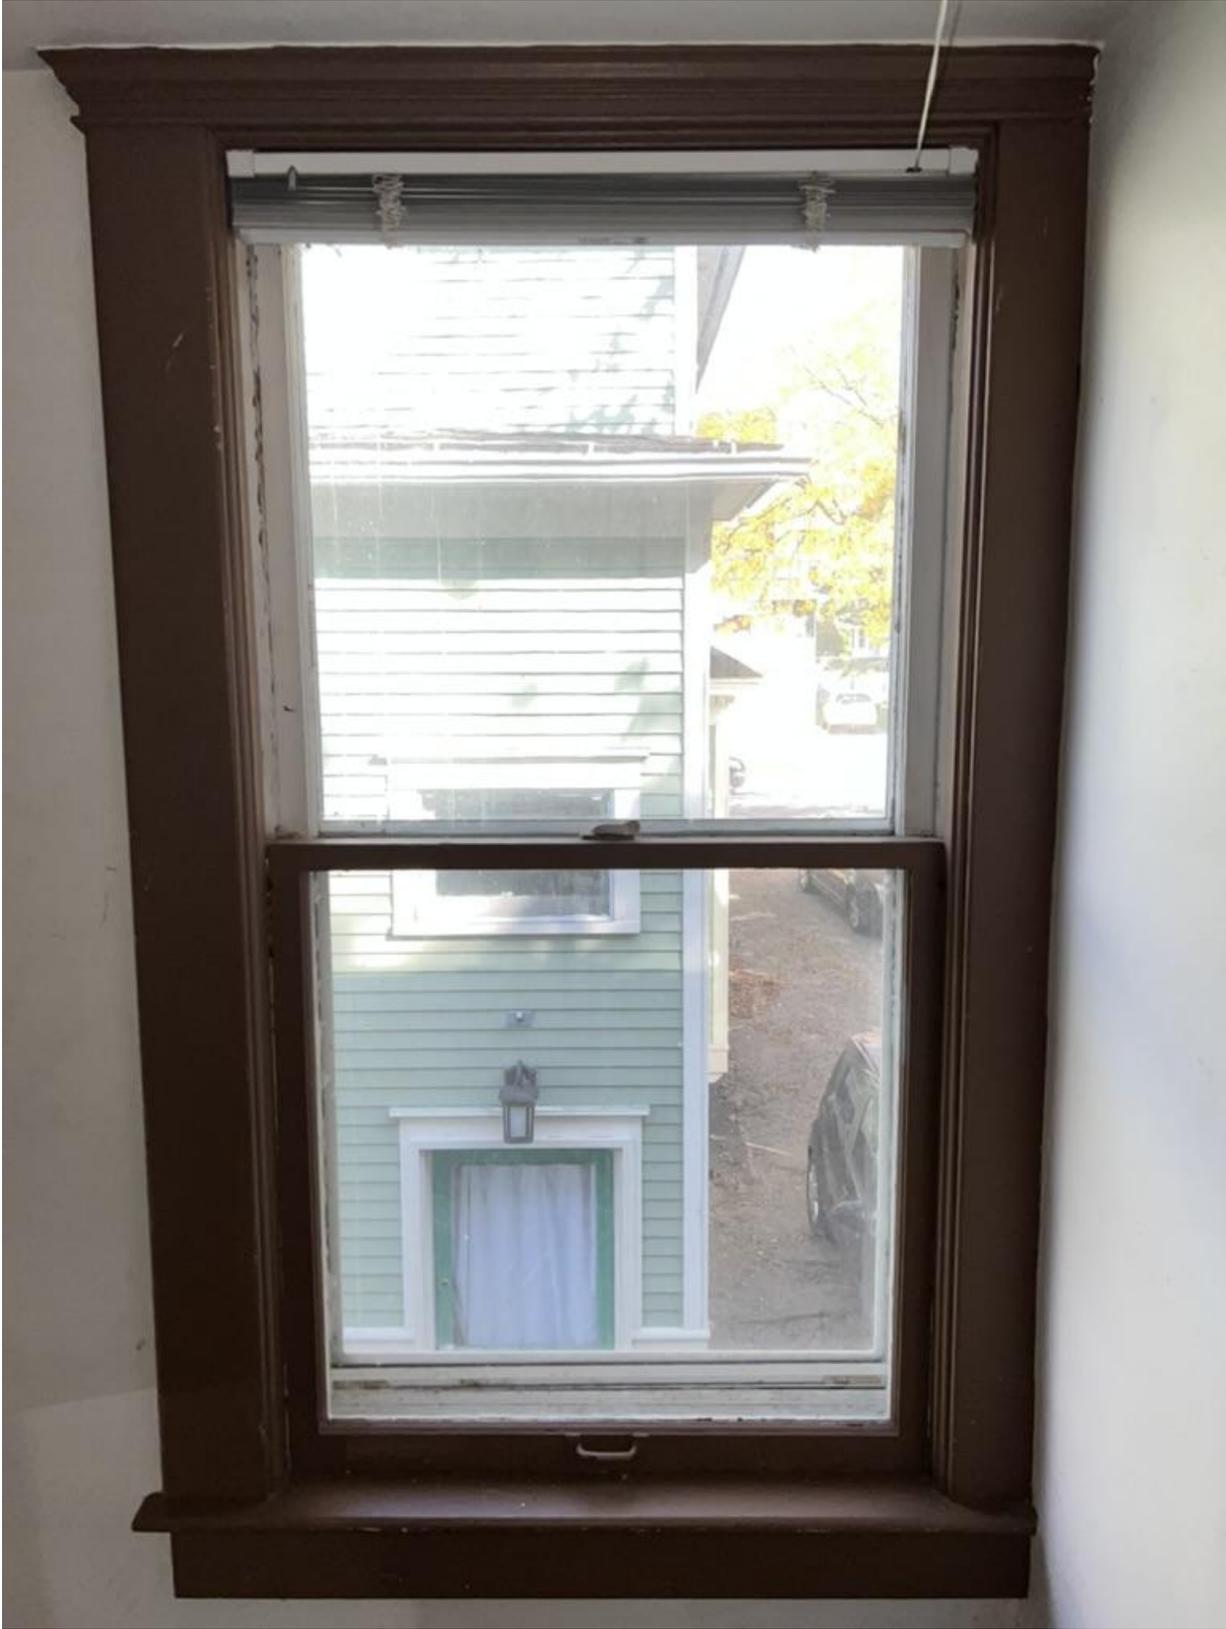
had wooden glass storms installed and were probably not opened/closed frequently and some were protected by an overhang. See attachments 1 & 2. These 1901 windows remain in place.

**Attachment 1 - 1901 Original Window in the Home Today - Interior Trim Painted Brown**

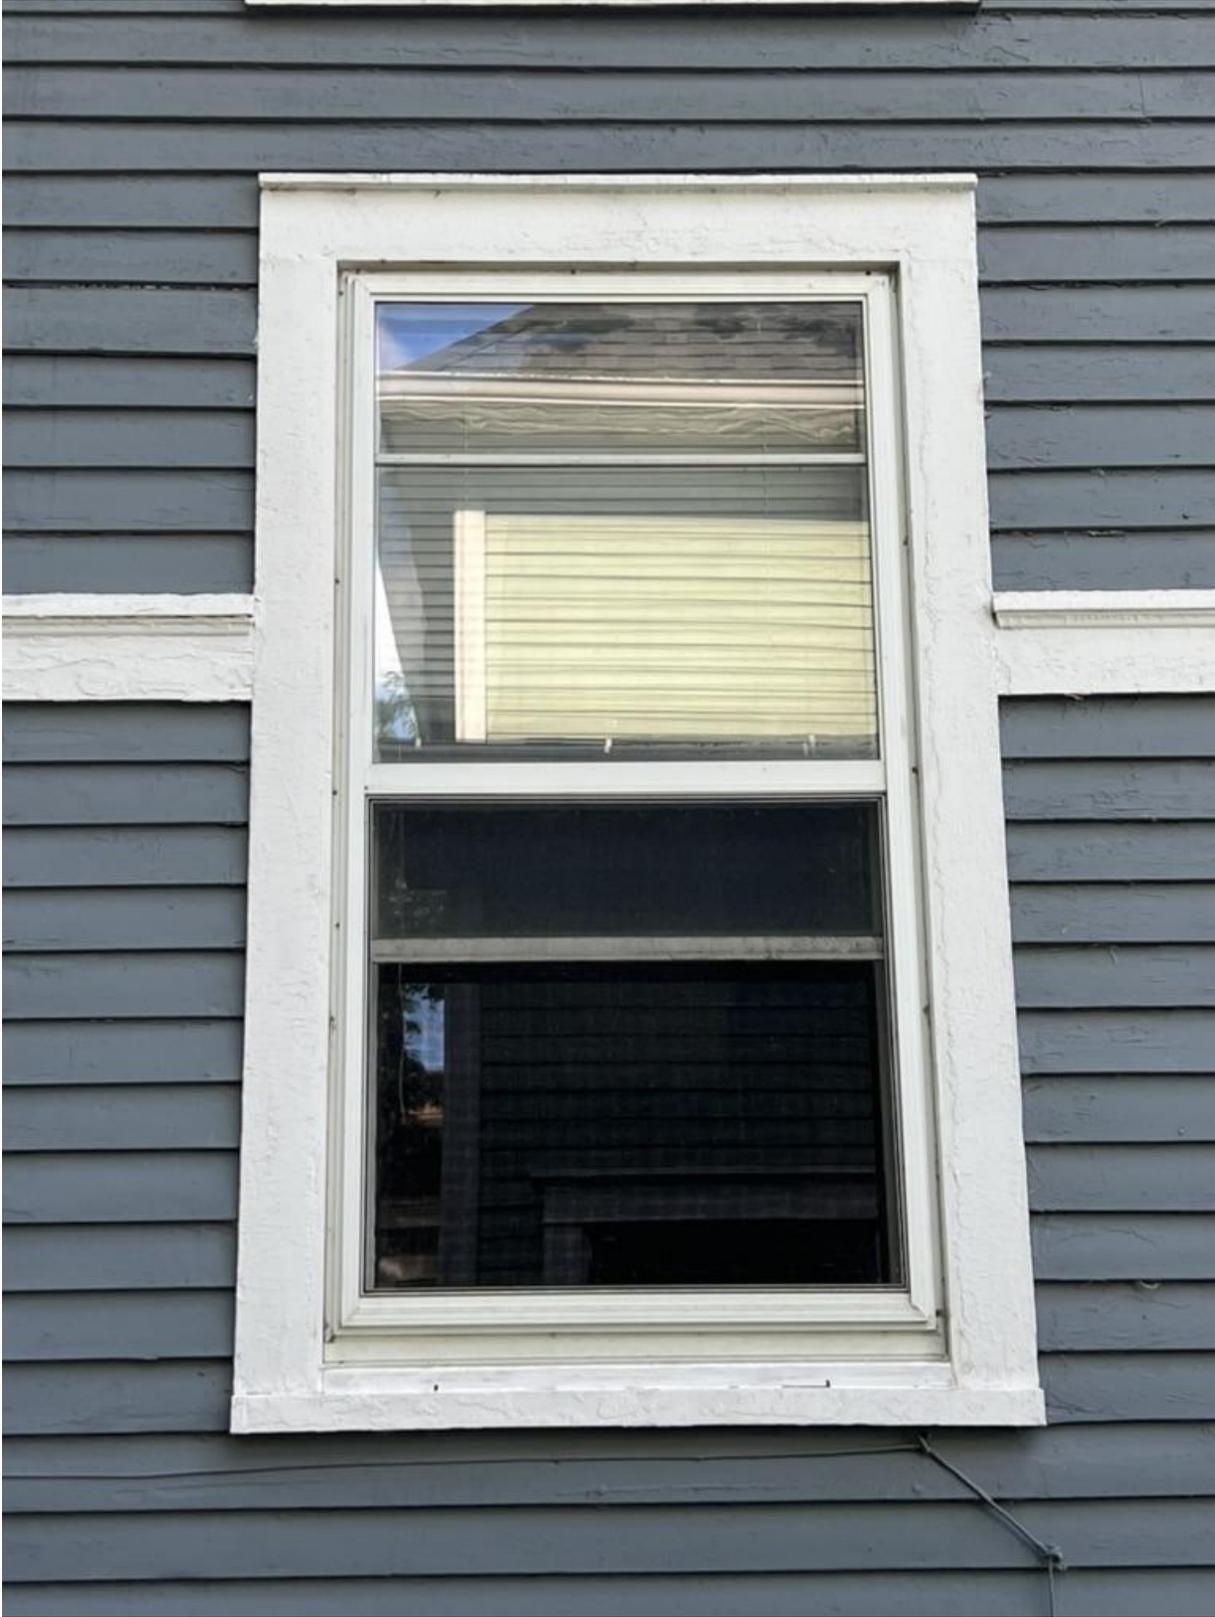
**Attachment 2 - 1901 Original Window in the Home Today - Exterior with Aluminum Storm**

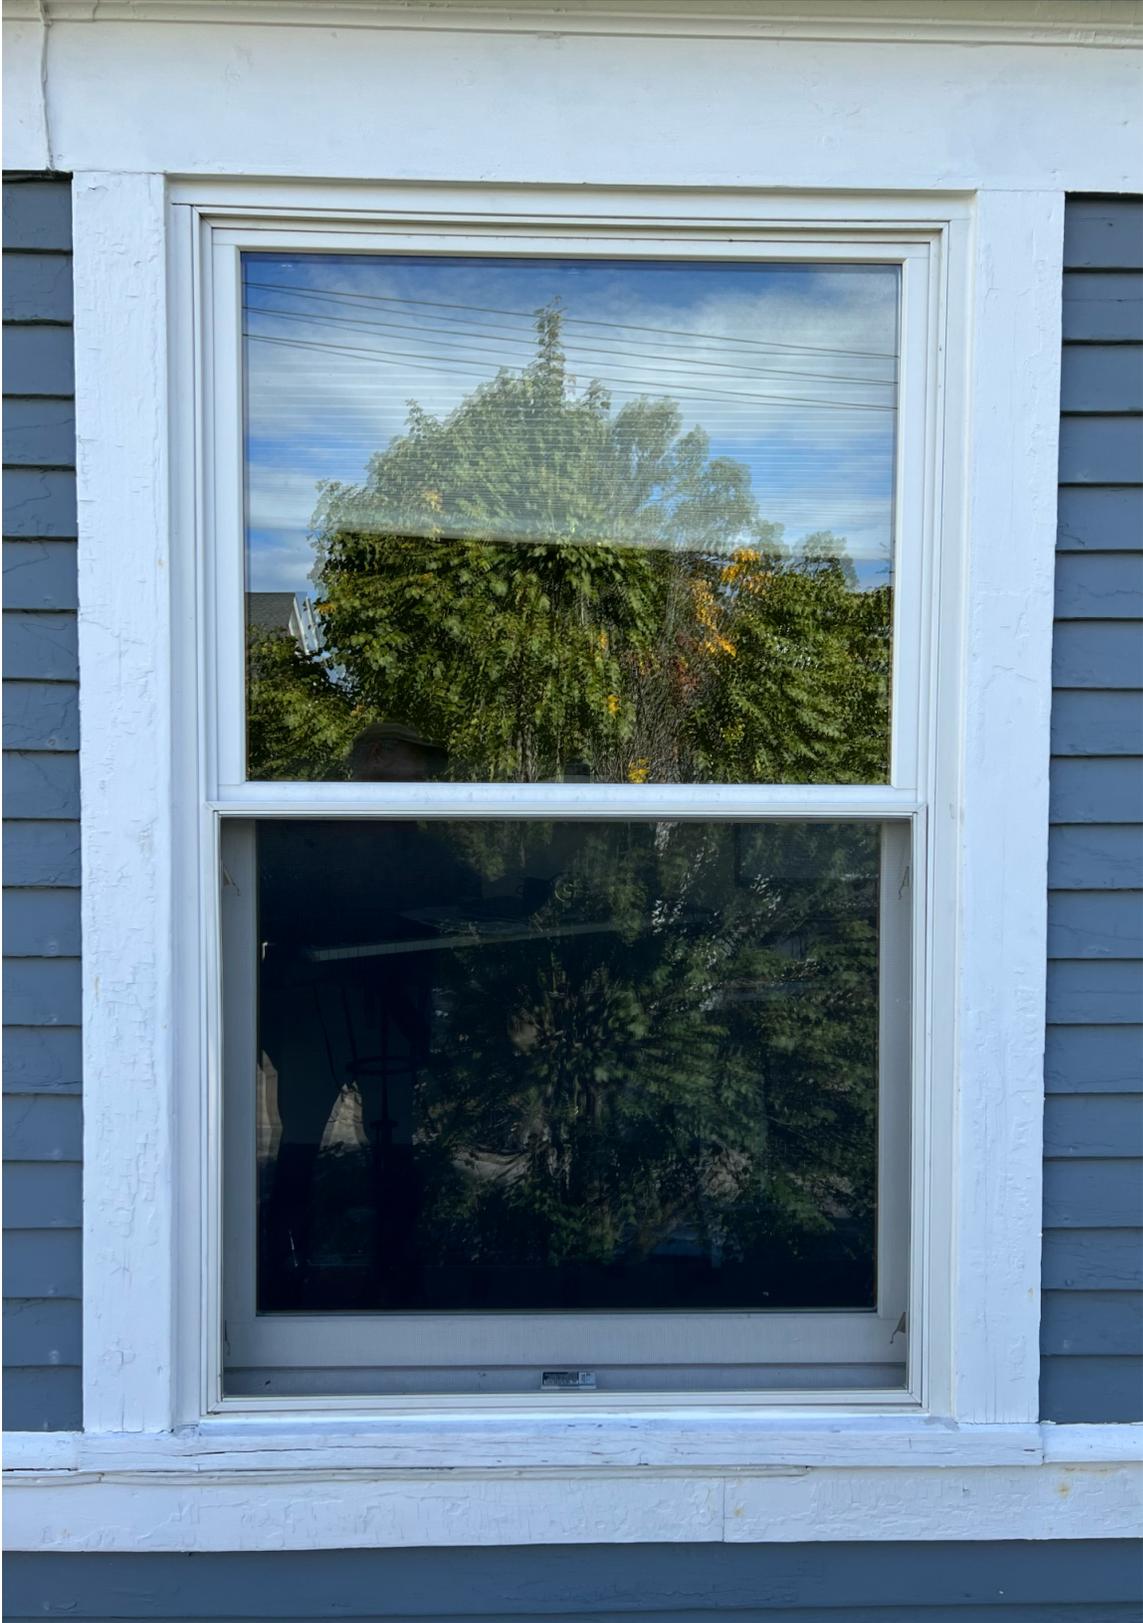
Attachment 5 presents a photo of the house with a standard Anderson installation. It has a seam in it that I find telling that it is not wood. Attachment 6 presents a photo of one window that has the standard installation with supplementary wood trim I fabricated that covers this line. If it would please the Commission this trim could be added to all 2015 windows. Attachment 7 presents an interior photo of an Anderson window on the first floor.

**Attachment 5 - New 2015 Window - Exterior with Half Screen**

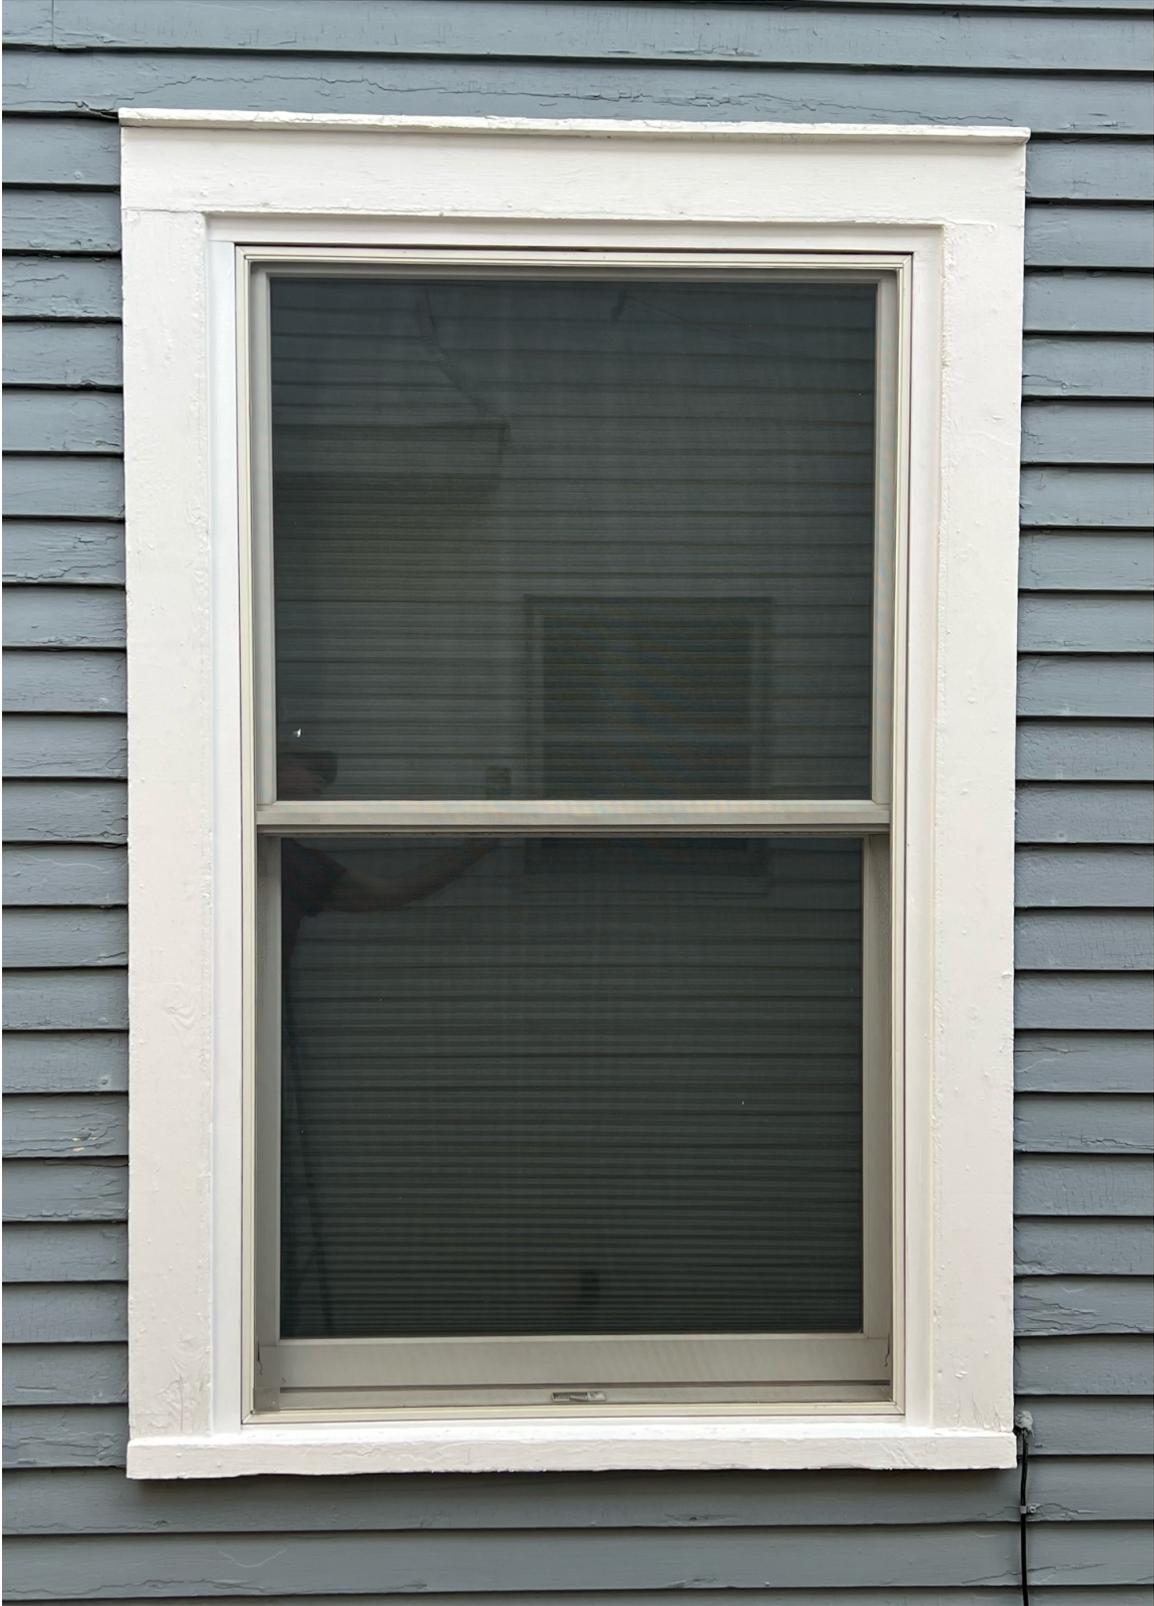
**Attachment 6 - New 2015 Window - Exterior with Full Screen & Supplementary Trim**

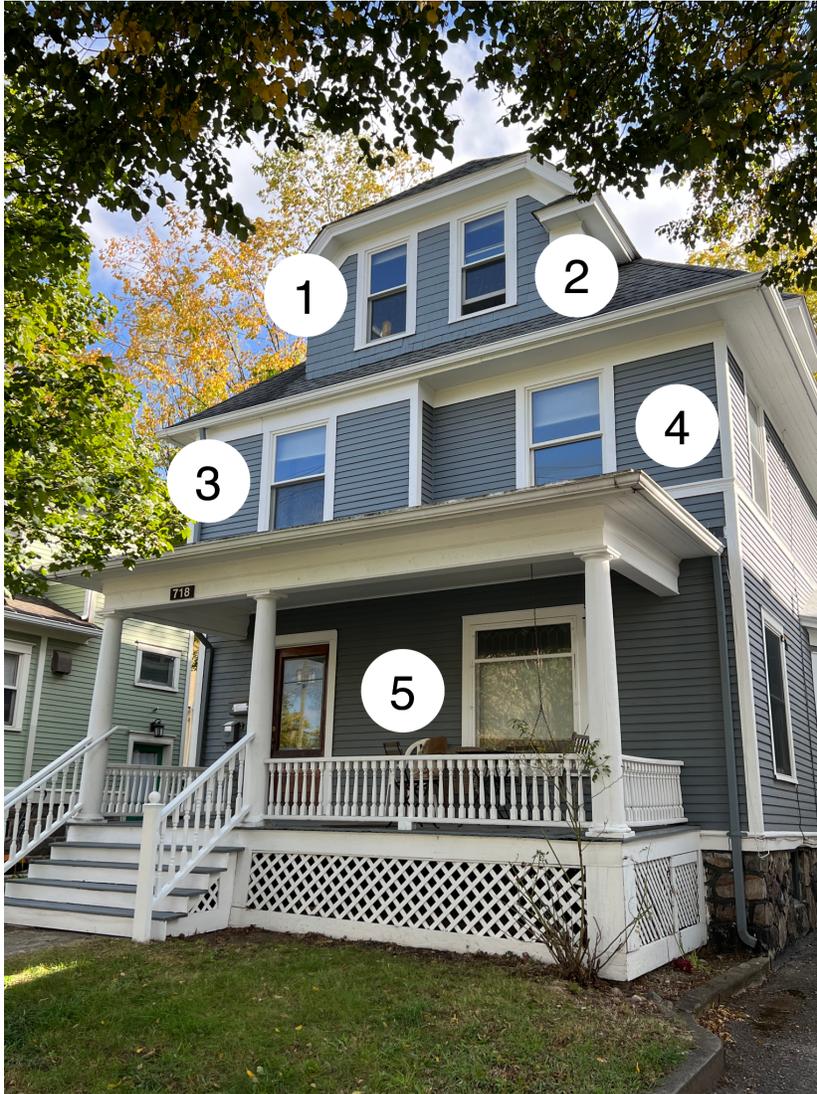
Attachment Front - Front (North) Photo and Window Information

Window	Dimension	Existing Window Description	Comments
1 & 2 - Bedroom	29 ½" x 57 ¾"	<ul style="list-style-type: none"> <li>• Andersen 400 Series Woodwright installed 2015</li> <li>• Double hung</li> </ul>	<ul style="list-style-type: none"> <li>• Excellent condition</li> <li>• Custom sized</li> </ul>
3 & 4 - Bedroom	39 ⅝" x 61 ¾"	<ul style="list-style-type: none"> <li>• Andersen 400 Series Woodwright installed 2015</li> <li>• Double hung</li> </ul>	<ul style="list-style-type: none"> <li>• Excellent condition</li> <li>• Custom sized</li> </ul>
5 - Living Room	n/a	<ul style="list-style-type: none"> <li>• Original 1901 window</li> <li>• Double hung style</li> <li>• Upper sash leaded glass</li> <li>• Wood storm window</li> </ul>	<ul style="list-style-type: none"> <li>• Window is in excellent condition but does not open.</li> <li>• Interior window and trim paint stripped &amp; refinished.</li> <li>• Storm window is functional</li> </ul>

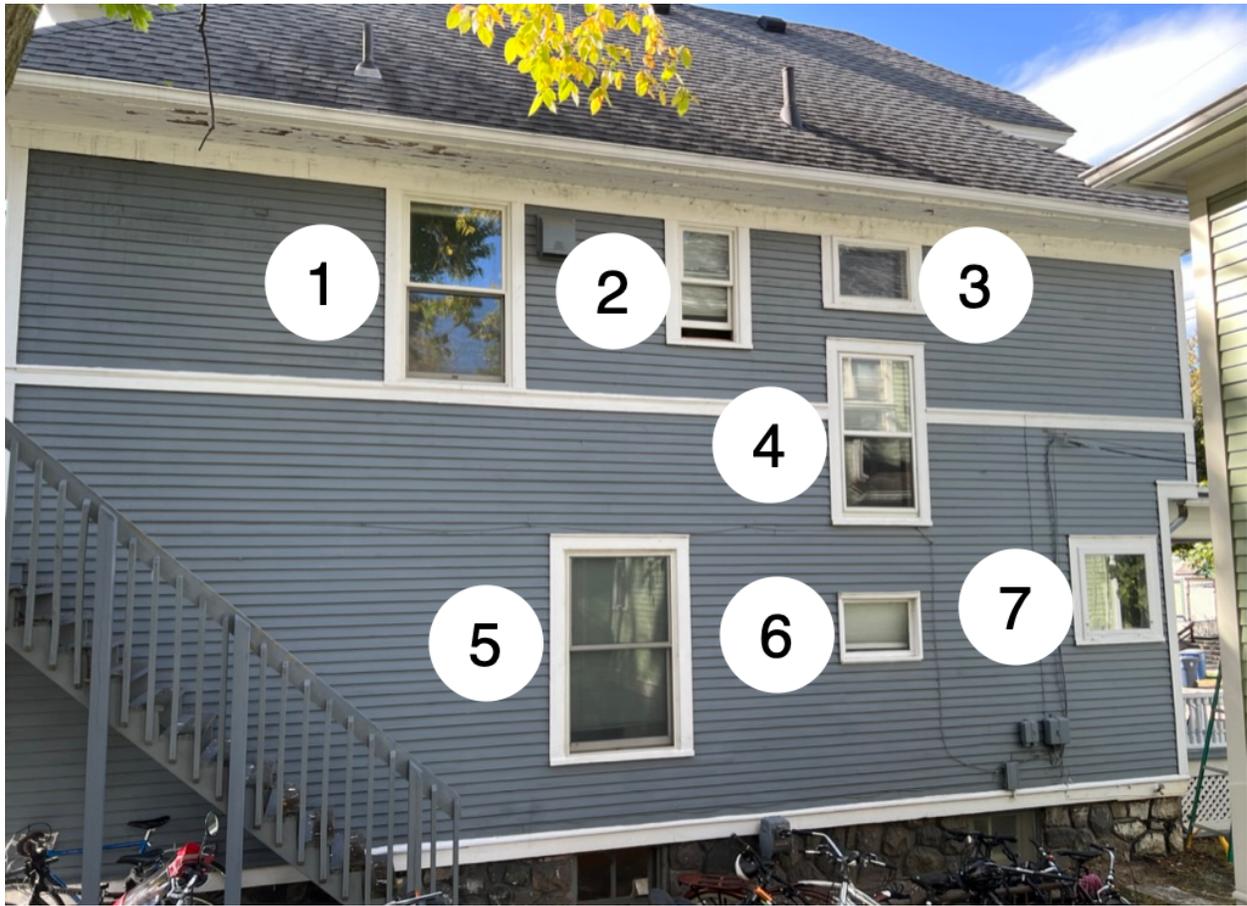
Attachment East - East Side Photo and Window Information

Window	Dimension	Existing Window Description	Comments
1 - Kitchen	35 <sup>5</sup> / <sub>8</sub> " x 63 <sup>3</sup> / <sub>4</sub> "	<ul style="list-style-type: none"> <li>• Andersen 400 Series Woodwright installed 2015</li> <li>• Double hung</li> </ul>	<ul style="list-style-type: none"> <li>• Excellent condition</li> <li>• Custom sized</li> </ul>
2 - Bathroom	23 <sup>5</sup> / <sub>8</sub> " x 41 <sup>3</sup> / <sub>4</sub> "	<ul style="list-style-type: none"> <li>• Andersen 400 Series Woodwright installed 2015</li> <li>• Double hung</li> </ul>	<ul style="list-style-type: none"> <li>• Excellent condition</li> <li>• Custom sized</li> </ul>
3 - Stairway	n/a	<ul style="list-style-type: none"> <li>• Original 1901 window</li> <li>• Fixed</li> <li>• Wood storm window</li> </ul>	<ul style="list-style-type: none"> <li>• Very good condition</li> <li>• Storm in good condition</li> </ul>
4 - Stairway	n/a	<ul style="list-style-type: none"> <li>• Original 1901 window</li> <li>• Double hung</li> <li>• Aluminum storm window</li> </ul>	<ul style="list-style-type: none"> <li>• All wood in very good condition</li> <li>• Painted trim and window</li> <li>• Sash ropes broken</li> <li>• Storm in good condition</li> </ul>

5 - Bedroom	39 <sup>5</sup> / <sub>8</sub> " x 66 <sup>3</sup> / <sub>8</sub> "	<ul style="list-style-type: none"> <li>• Andersen 400 Series Woodwright installed 2015</li> <li>• Double hung</li> </ul>	<ul style="list-style-type: none"> <li>• Excellent condition</li> <li>• Custom sized</li> <li>• Interior trim paint stripped &amp; refinished</li> </ul>
6 - Bathroom	n/a	<ul style="list-style-type: none"> <li>• Awning Window</li> <li>• Mid 1970s?</li> </ul>	<ul style="list-style-type: none"> <li>• Good condition</li> </ul>
7 - Vestibule	n/a	<ul style="list-style-type: none"> <li>• Original 1901 window</li> <li>• Fixed</li> <li>• Wood storm</li> </ul>	<ul style="list-style-type: none"> <li>• Very good condition</li> <li>• Storm in good condition</li> </ul>

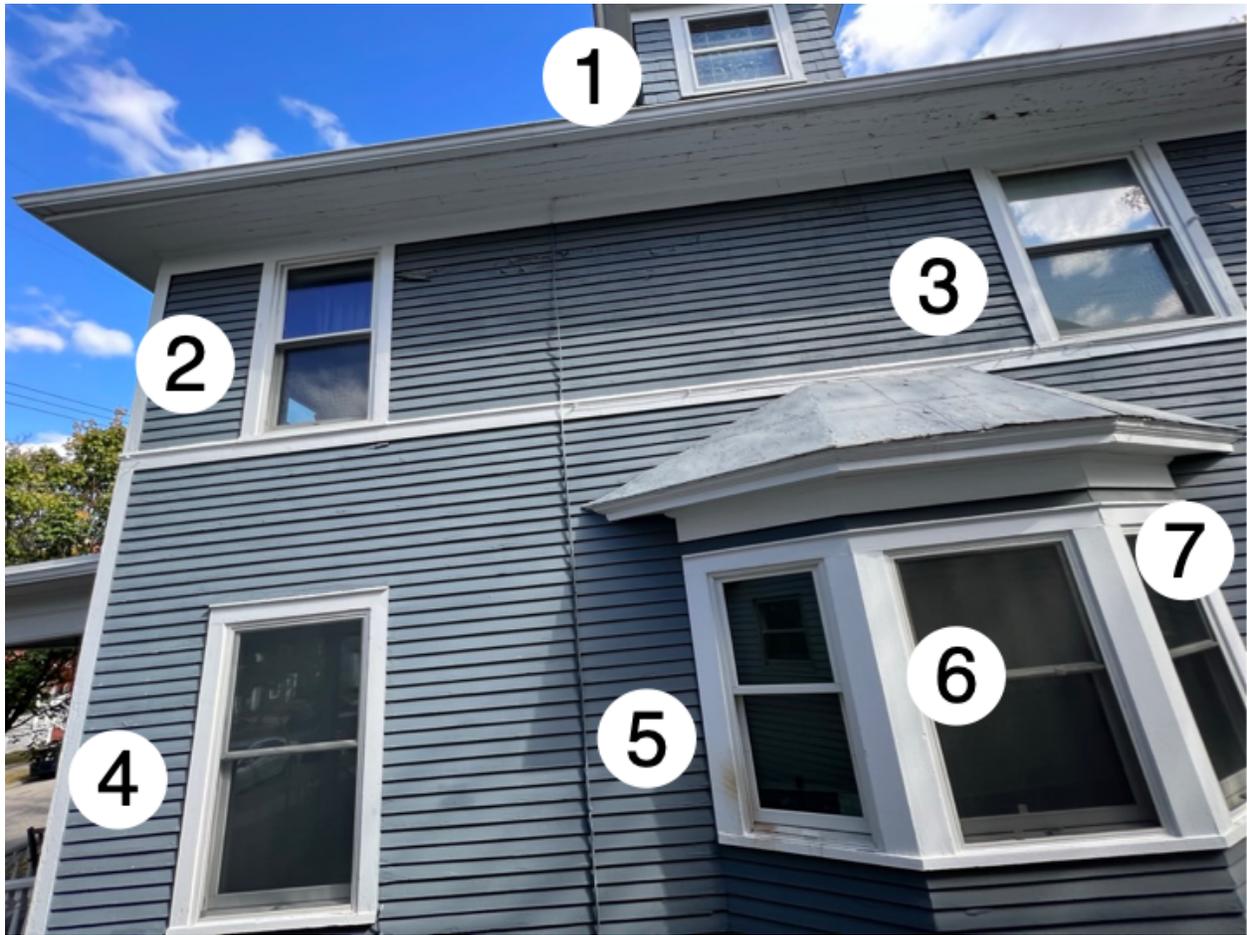
Attachment West - West Side Photo and Window Information

Window	Dimension	Existing Window Description	Comments
1 - Bathroom	n/a	<ul style="list-style-type: none"> <li>• Glass block installed 1980s</li> <li>• Aluminum storm</li> </ul>	Good condition
2 - Bedroom	39 <sup>5</sup> / <sub>8</sub> " x 61 <sup>3</sup> / <sub>4</sub> "	<ul style="list-style-type: none"> <li>• Andersen 400 Series Woodwright installed 2015</li> <li>• Double hung</li> </ul>	<ul style="list-style-type: none"> <li>• Excellent condition</li> <li>• Custom sized</li> </ul>
3 - Bedroom	45 <sup>5</sup> / <sub>8</sub> " x 61 <sup>3</sup> / <sub>4</sub> "	<ul style="list-style-type: none"> <li>• Andersen 400 Series Woodwright installed 2015</li> <li>• Double hung</li> </ul>	<ul style="list-style-type: none"> <li>• Excellent condition</li> <li>• Custom sized</li> </ul>
4 - Living Room	39 <sup>5</sup> / <sub>8</sub> " x 56 <sup>3</sup> / <sub>8</sub> "	<ul style="list-style-type: none"> <li>• Andersen 400 Series Woodwright installed 2015</li> <li>• Double hung</li> </ul>	<ul style="list-style-type: none"> <li>• Excellent condition</li> <li>• Custom sized</li> <li>• Interior trim paint stripped &amp; refinished</li> </ul>

5 & 7 - Living Room	27 <sup>5</sup> / <sub>8</sub> " x 56 <sup>3</sup> / <sub>8</sub> "	<ul style="list-style-type: none"> <li>• Andersen 400 Series Woodwright installed 2015</li> <li>• Double hung</li> </ul>	<ul style="list-style-type: none"> <li>• Excellent condition</li> <li>• Custom sized</li> <li>• Interior trim paint stripped off and refinished</li> </ul>
6 - Living Room	39 <sup>5</sup> / <sub>8</sub> " x 56 <sup>3</sup> / <sub>8</sub> "	<ul style="list-style-type: none"> <li>• Andersen 400 Series Woodwright installed 2015</li> <li>• Double hung</li> </ul>	<ul style="list-style-type: none"> <li>• Excellent condition</li> <li>• Custom sized</li> <li>• Interior trim paint stripped &amp; refinished</li> </ul>

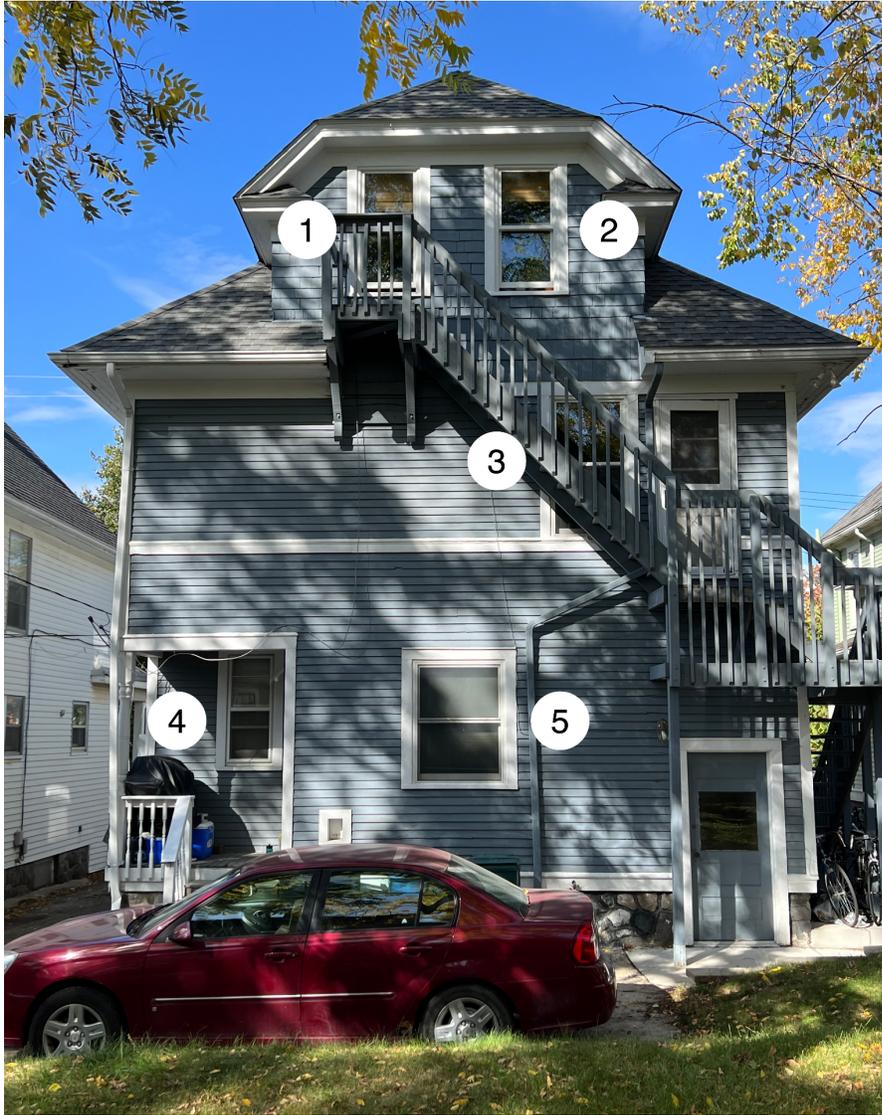
**Attachment Back - Back (South) Photo and Window Information**

Window	Dimension	Existing Window Description	Comments
1 & 2 - Bedroom	27 <sup>3</sup> / <sub>8</sub> " x 57 <sup>3</sup> / <sub>4</sub> "	<ul style="list-style-type: none"> <li>• Andersen 400 Series Woodwright installed 2015</li> <li>• Double hung</li> </ul>	<ul style="list-style-type: none"> <li>• Excellent condition</li> <li>• Custom sized</li> </ul>
3 - Kitchen	35 <sup>5</sup> / <sub>8</sub> " x 61 <sup>3</sup> / <sub>4</sub> "	<ul style="list-style-type: none"> <li>• Andersen 400 Series Woodwright installed 2015</li> <li>• Double hung</li> </ul>	<ul style="list-style-type: none"> <li>• Excellent condition</li> <li>• Custom sized</li> </ul>
4 - Pantry	n/a	<ul style="list-style-type: none"> <li>• Original 1901 window</li> <li>• Double hung</li> <li>• Aluminum storm window</li> </ul>	<ul style="list-style-type: none"> <li>• Window is in excellent condition</li> <li>• Interior trim and window paint stripped &amp; refinished.</li> <li>• Storm window in good condition</li> </ul>

5 - Kitchen	39 <sup>5</sup> / <sub>8</sub> " x 52 <sup>3</sup> / <sub>8</sub> "	<ul style="list-style-type: none"> <li>• Andersen 400 Series Woodwright installed 2015</li> <li>• Double hung</li> </ul>	<ul style="list-style-type: none"> <li>• Excellent condition</li> <li>• Custom sized</li> <li>• Interior trim paint stripped &amp; refinished</li> </ul>
