ANN ARBOR HISTORIC DISTRICT COMMISSION

Staff Report

ADDRESS: 203-205 North Ingalls, Application Number HDC19-108

DISTRICT: Old Fourth Ward Historic District

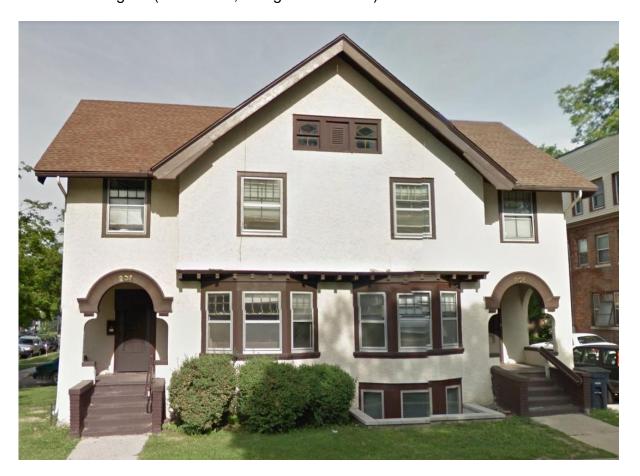
203-205 N Ingalls, south elevation (August 2017, Google Streetview)

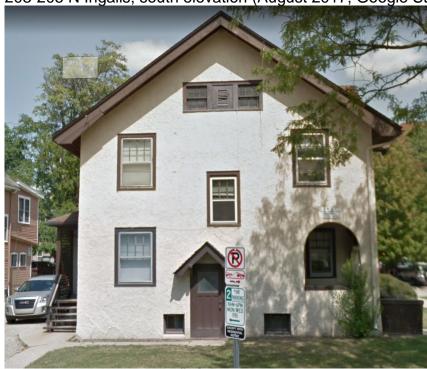
203-205 N Ingalls, west elevation (August 2017, Google Streetview)

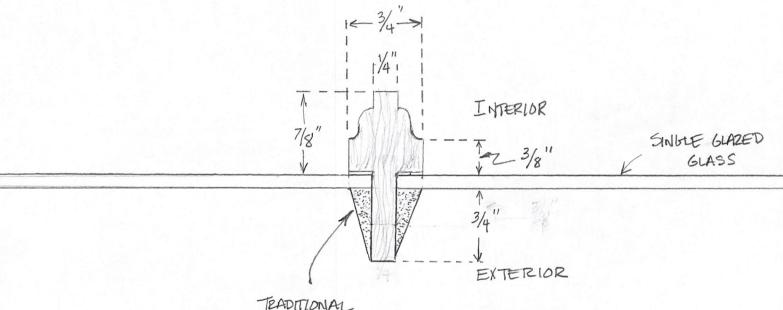
MUNTIN CROSS SECTION

(HISTORICAL WINDOW)

BASED ON SITE MEASURE OF
205 DR WINDOW (ORIG)

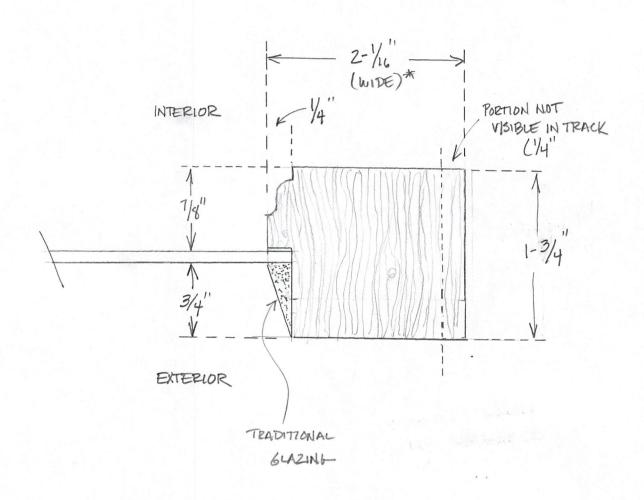
UPPER SASH STILE AND BAIL

RAIL: AND STILE WIDTHS

* TOP PAIL = 1-1/6"

* BOTTOM RAIL = 3-1/8"

* STILES: 1-3/4"
