# West Park Project Update

# Remaining Items to Address Swirl Concentrator Failures

# Remaining Items to Address Swirl Concentrator Information

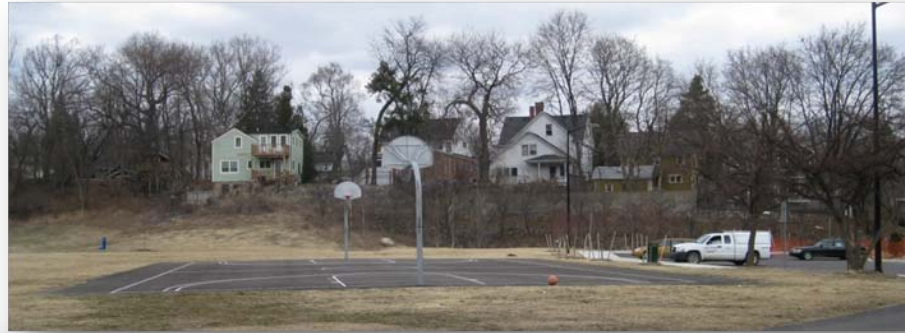
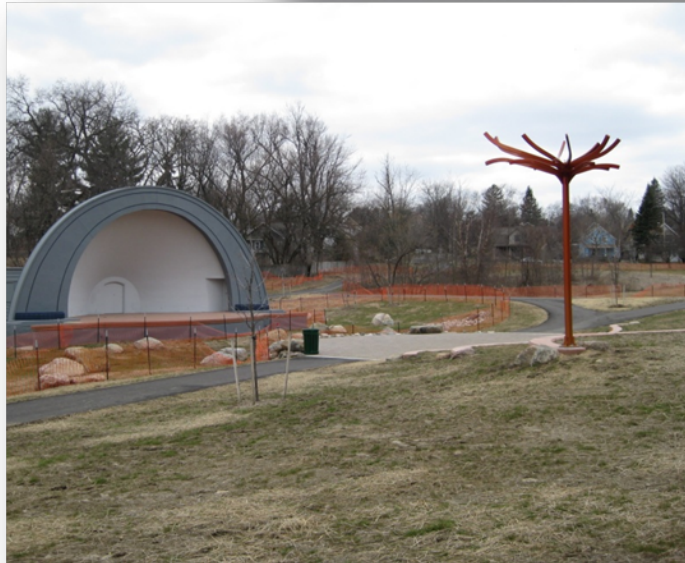
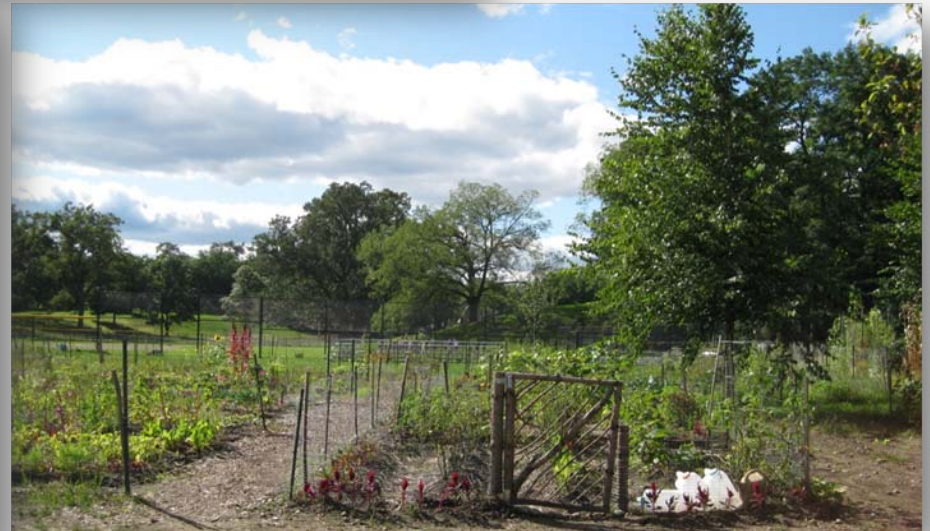
# Overview of Work Completed

Surface  
Stormwater  
Treatment  
System

North Branch  
Treatment  
Structures

South Branch  
Treatment  
Structures

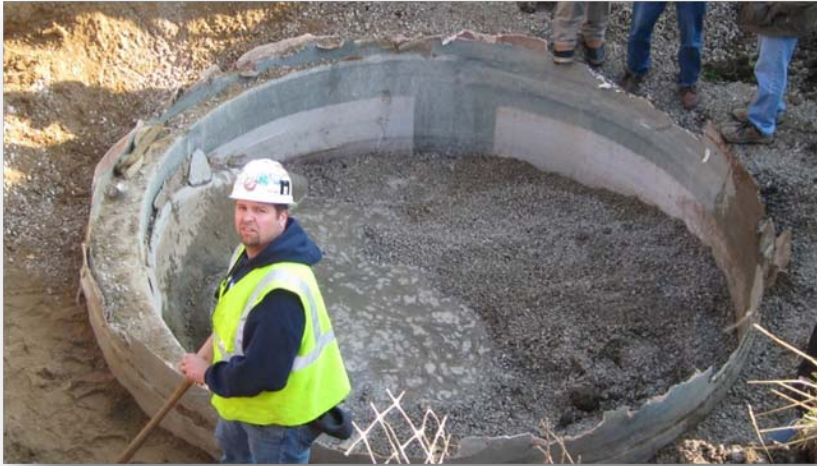
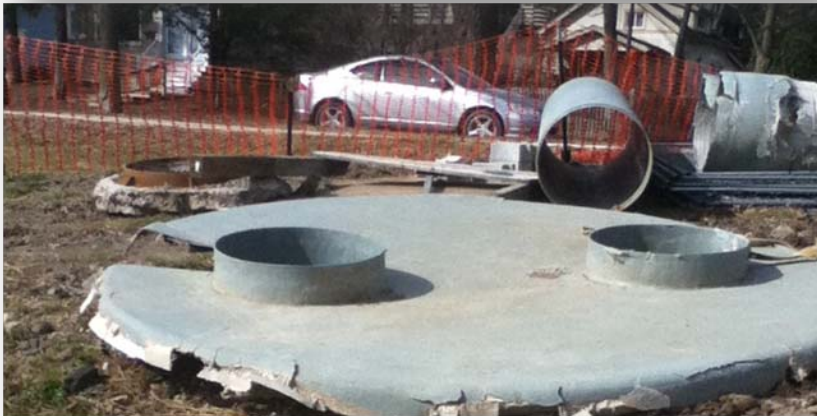
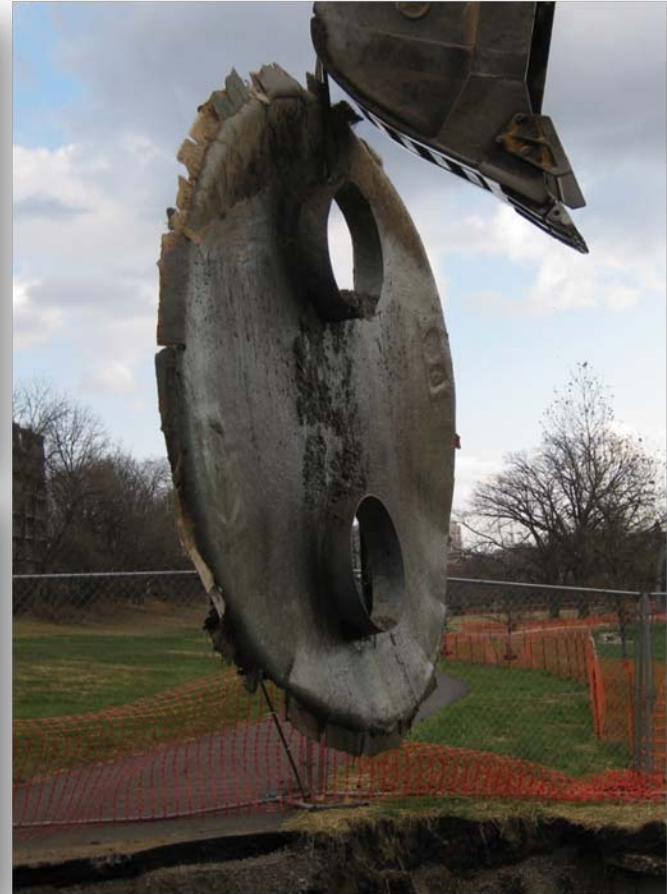
- 8 AquaSwirl units installed
  - 4 on north branch
  - 4 on south branch
  - Individual cost per installed unit: \$66,000
  - Installation: June 2010
  - N. Seventh Street Stormwater Separation: August 2010
  - Failure on N. Branch: November 2010
  - Treatment Units Taken Offline:
    - S. Branch: late August 2010 (not operating properly)
    - N. Branch: November 2010 (upon failure)

- AquaShield repair of swirl concentrator units
  - ▣ May/June 2012
- City to Replace Weir Walls
  - ▣ Based on refined design by OHM
  - ▣ Following repair of AquaSwirl Units

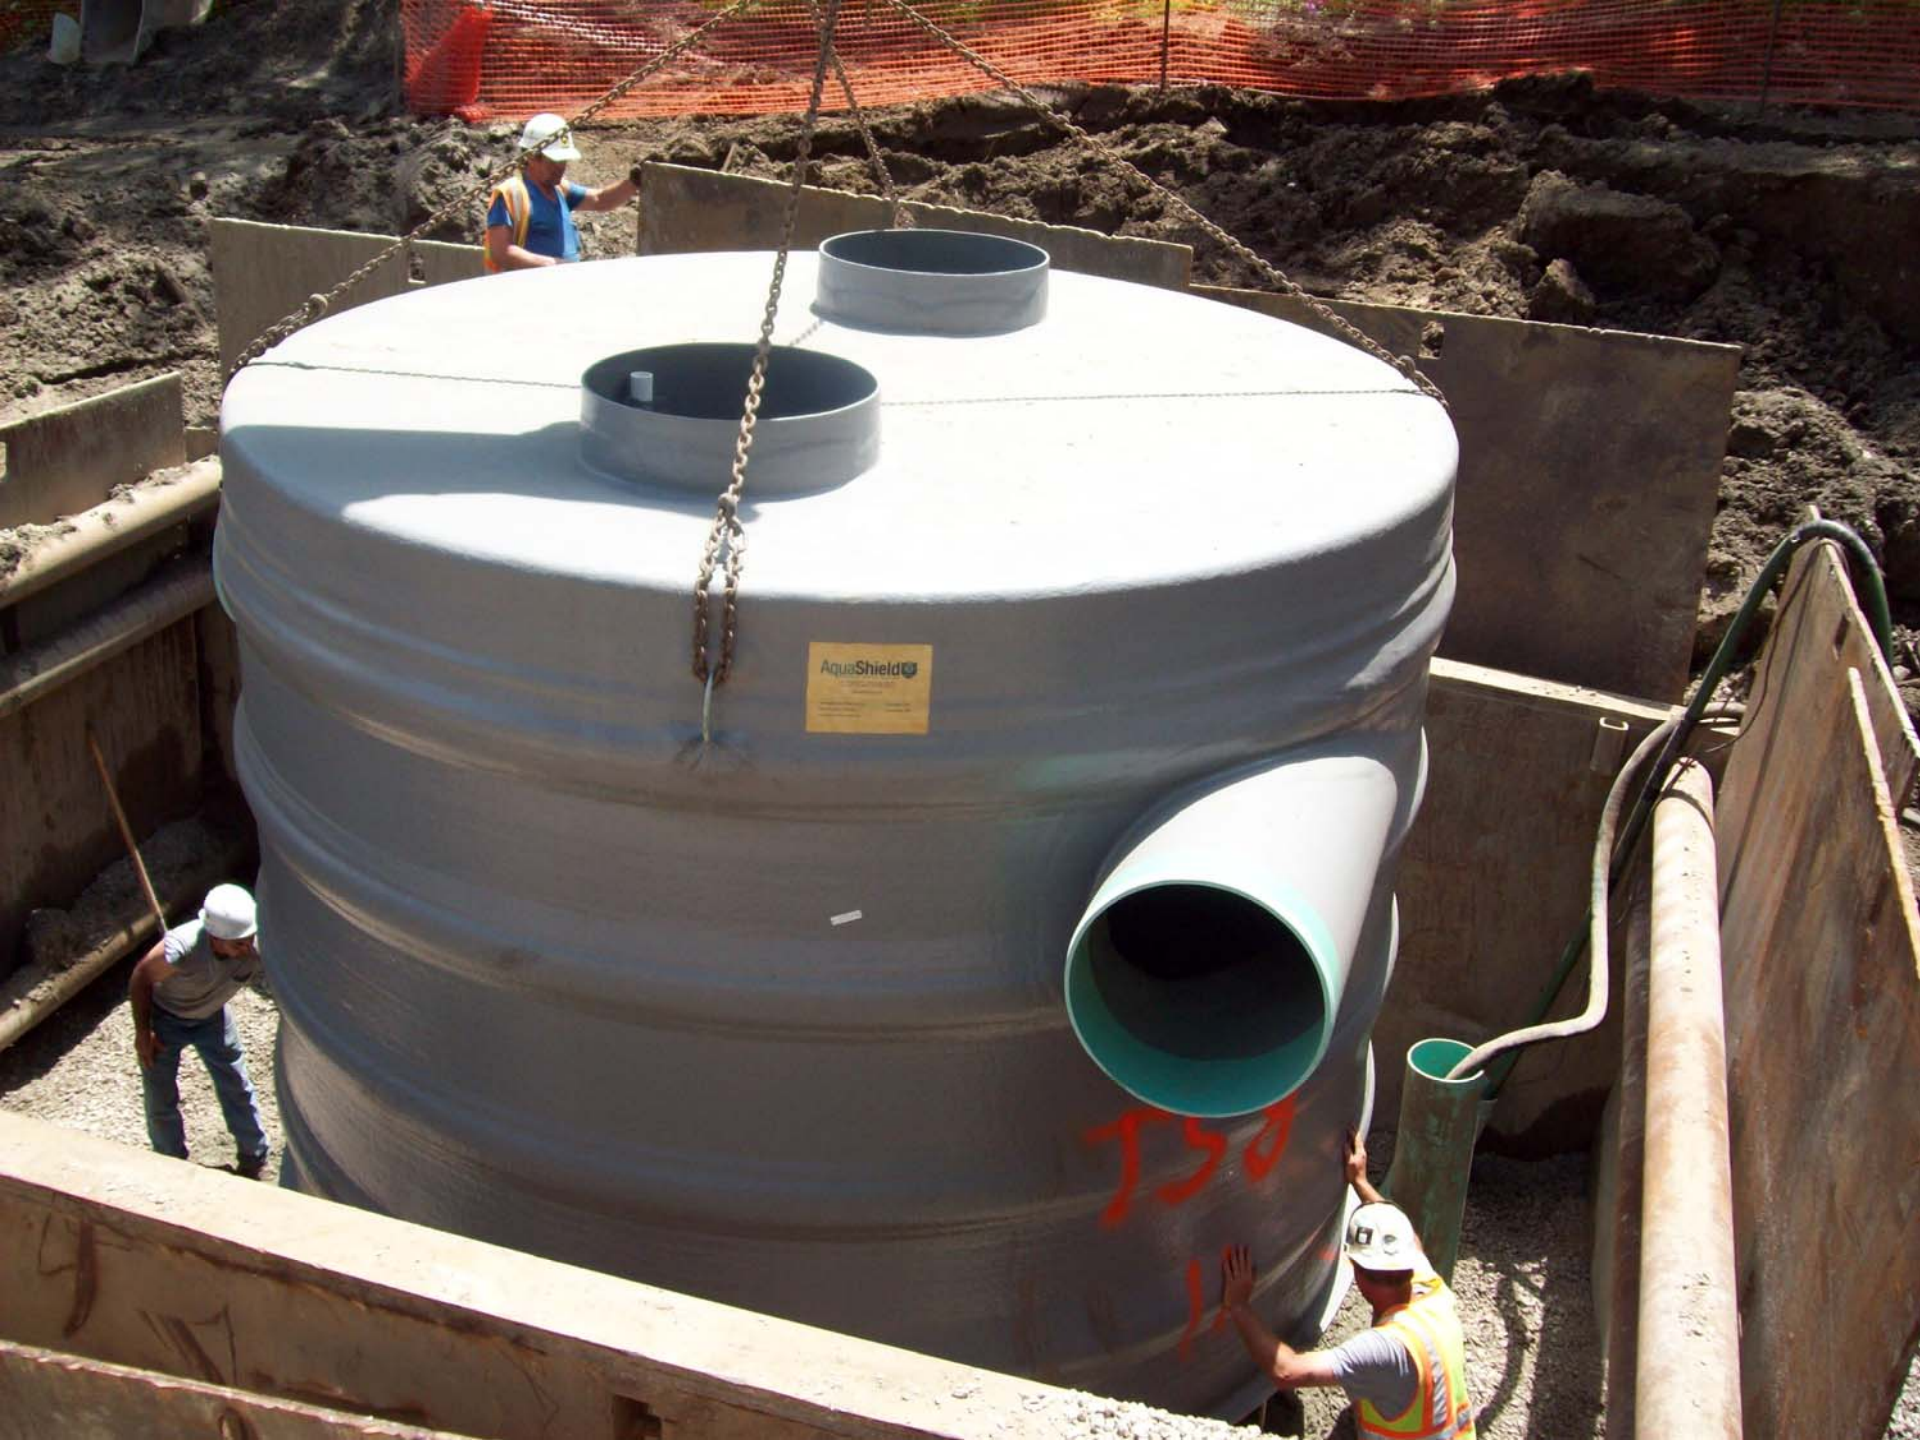
AquaShield
