Pedestrian Crossing Improvements

Project Management Services Unit

City Council Work Session

December 12, 2011

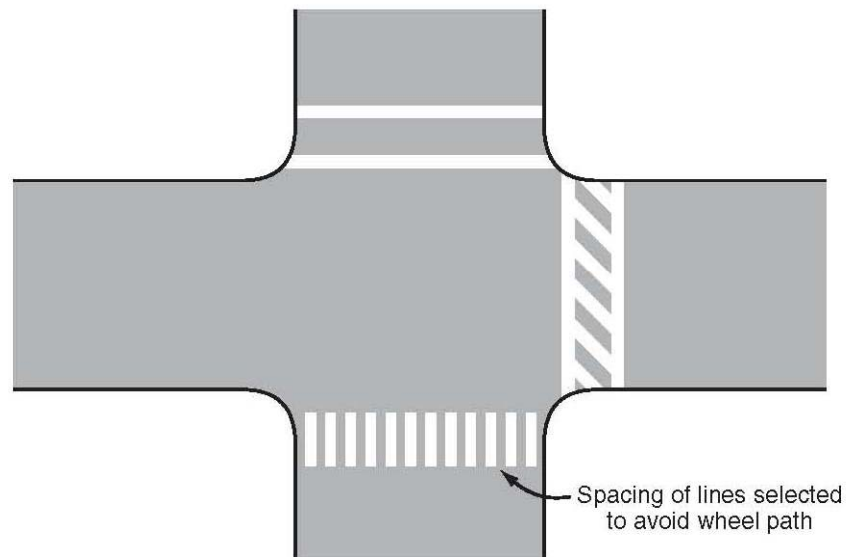
Figure 3B-16. Examples of Crosswalk Markings

- Unmarked
- Traditional
- Special Emphasis

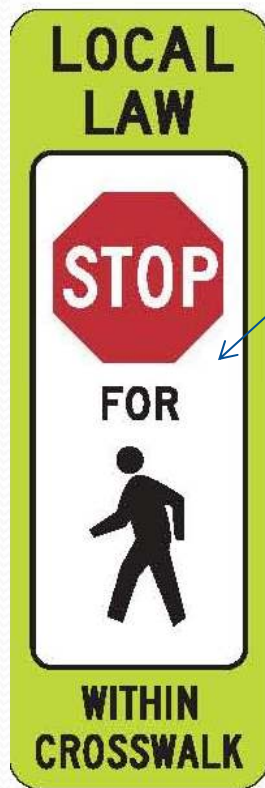
In Road signs

No state law for uncontrolled crosswalks

Stop for peds primary message

Sign is MMUTCD sign

- Size for in road only
- Uniform look for all
- Within Crosswalk standard language

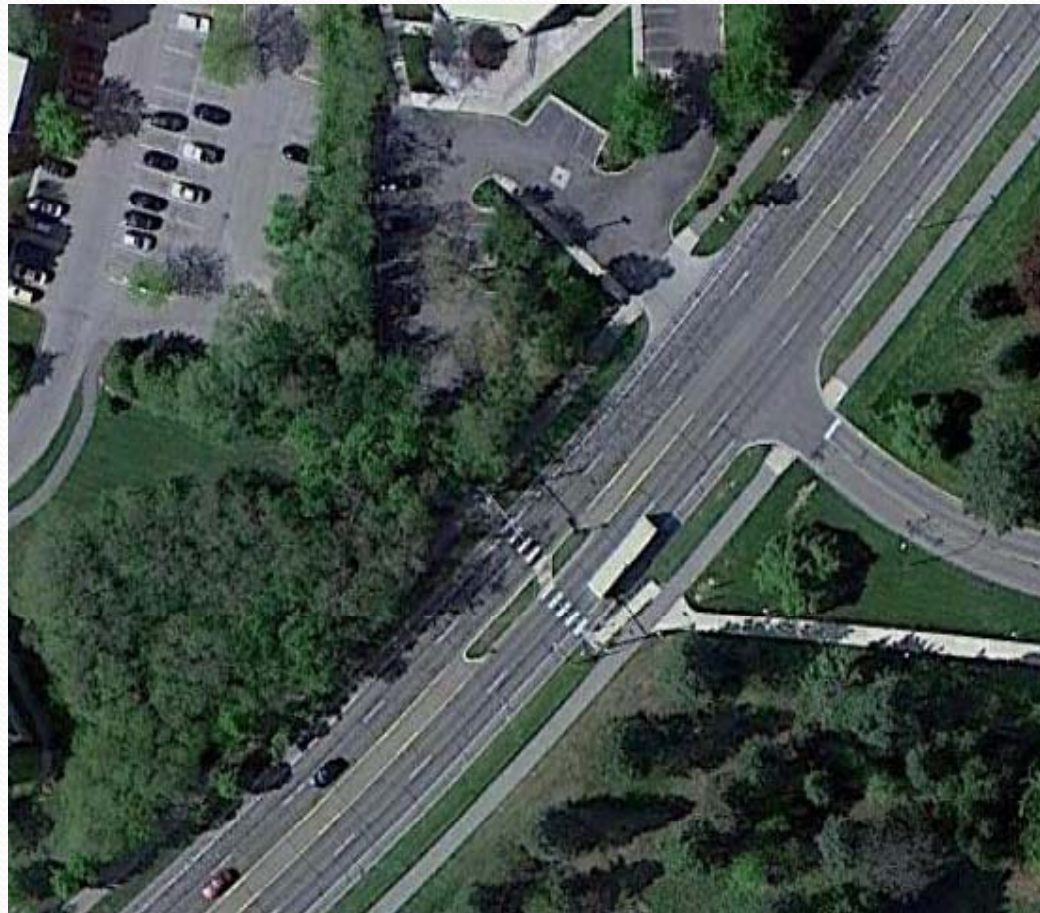
Plymouth near Beal

- 22,000 vpd
- Speed Limit 35
- 5 lane cross section with ped crossing island
- No recent crash history
- Site of 2 Ped fatalities in 2003

- Installation of RRFBs at all four (4) Plymouth island locations
 - Lower cost and complements existing infrastructure
 - High yielding rates
 - Consistent treatment along the corridor
- Washtenaw Ave near Tappan under study by MDOT
 - Pedestrian volumes likely not warranting HAWK

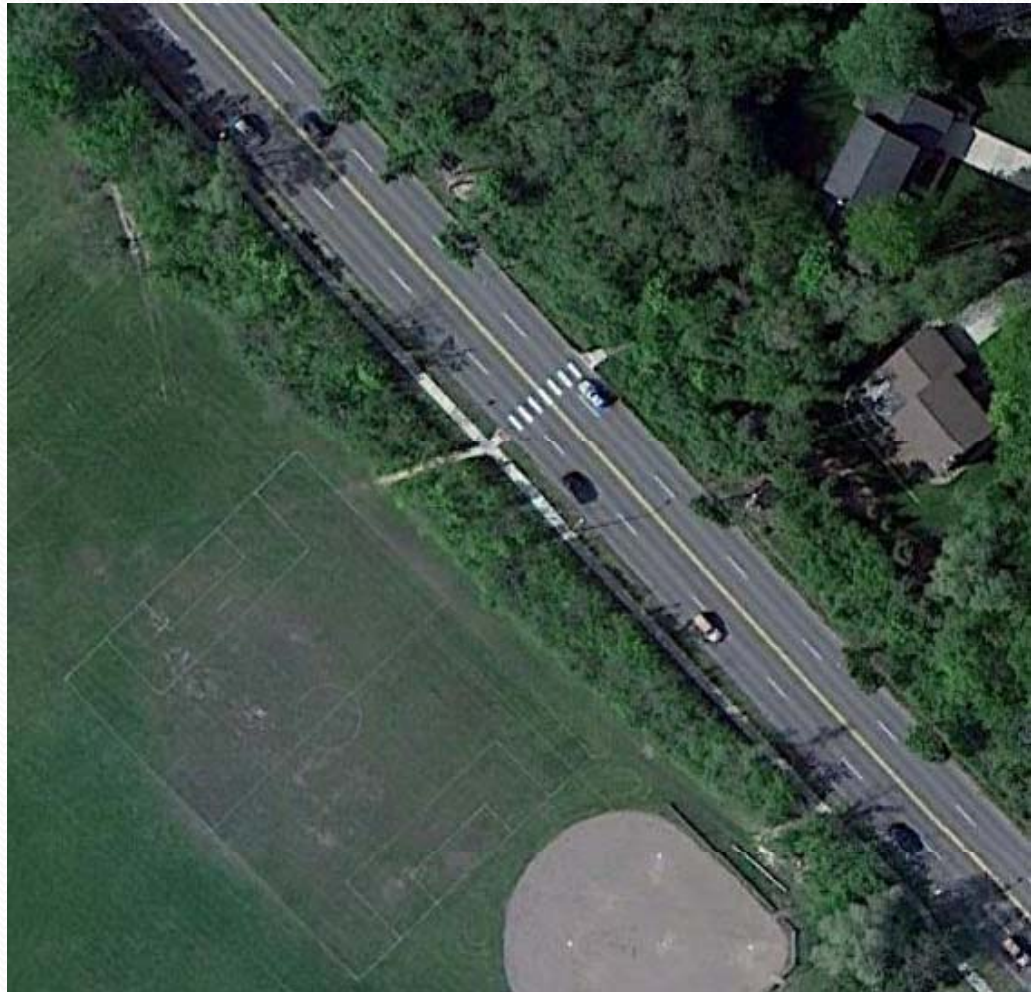
Washtenaw near Tappan M.S.

- State trunkline hwy (BL-94)
- ADT of 19,500
- Speed Limit 45 mph / school zone 30 mph
- 4 lane cross section
- No crash history

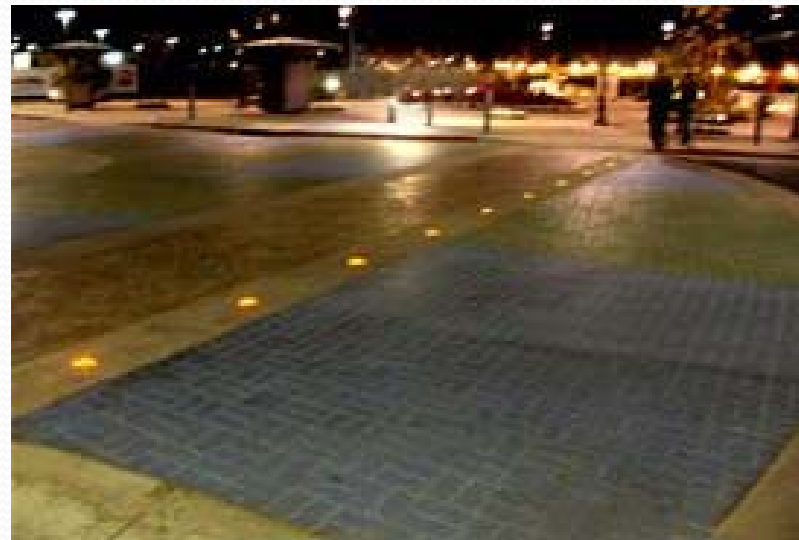
- In pavement lights
- LED airport strobes
- Reported **% yielding
- MUTCD complaint
- Costly to install
(requires trenching)
- Possible maintenance
issues

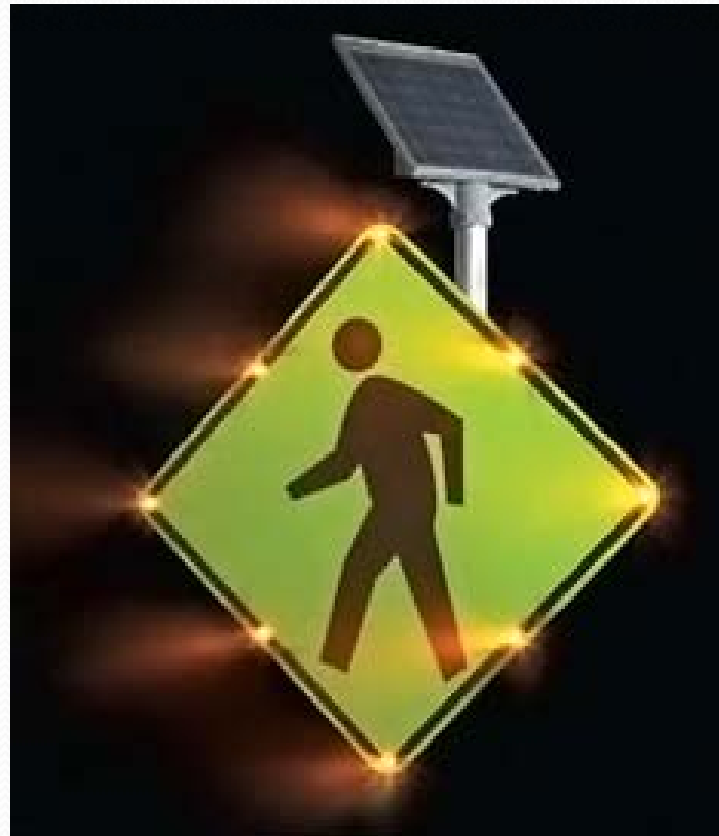
- Blinker Sign
- LEDs in border
- Claimed 80% yielding
- Not MUTCD complaint ?
- Low cost and solar power

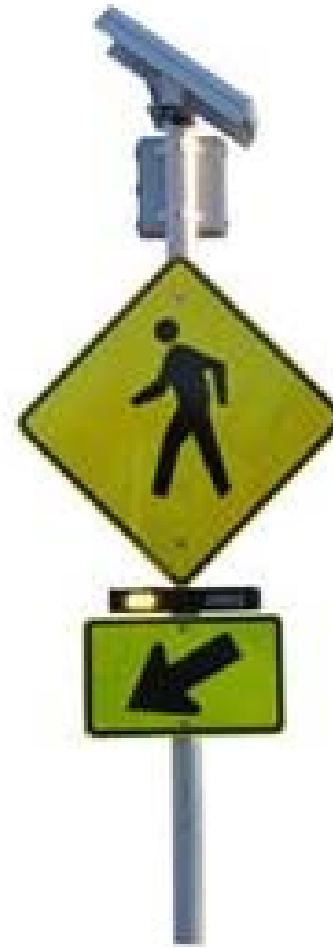
- Rectangular Rapid Flashing Beacon (RRFB)
- LEDs strobe in stutter flash
- Pedestrian actuated
- High 80% yielding rate
- MUTCD compliant
- No warranting volumes set
- Low cost and solar power

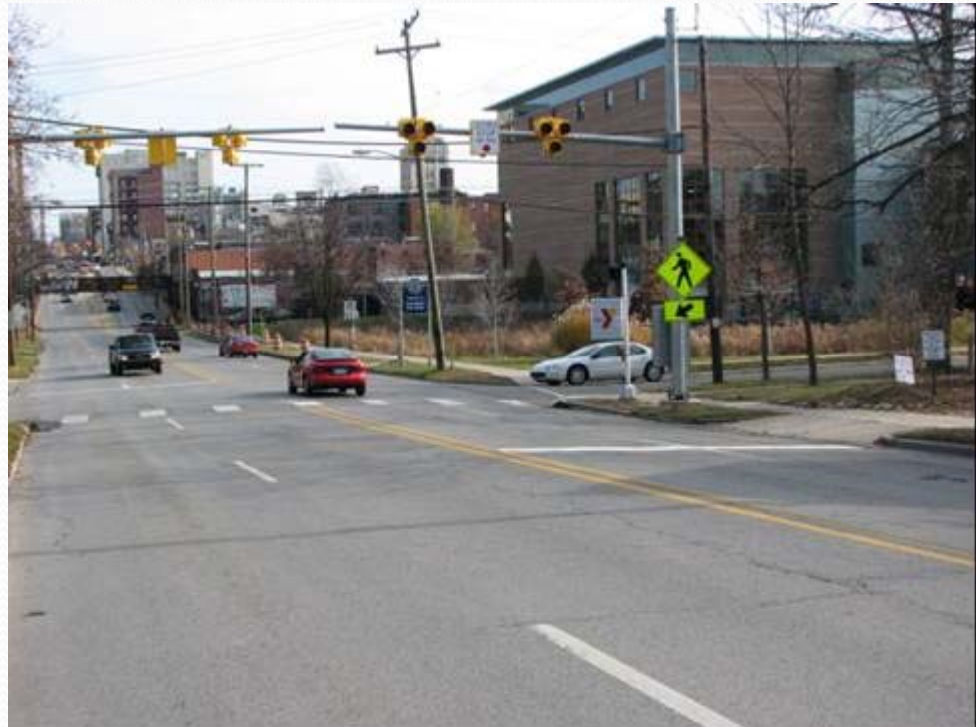
- Pedestrian Hybrid Beacon or HAWK
- Red / Yellow signal
- Ped actuated
- 90% yielding rate
- MUTCD complaint – warrant required
- High cost and requires power
