Task 1 History and Architectural Significance

Task 3 Structure Condition Assessment: Site Features

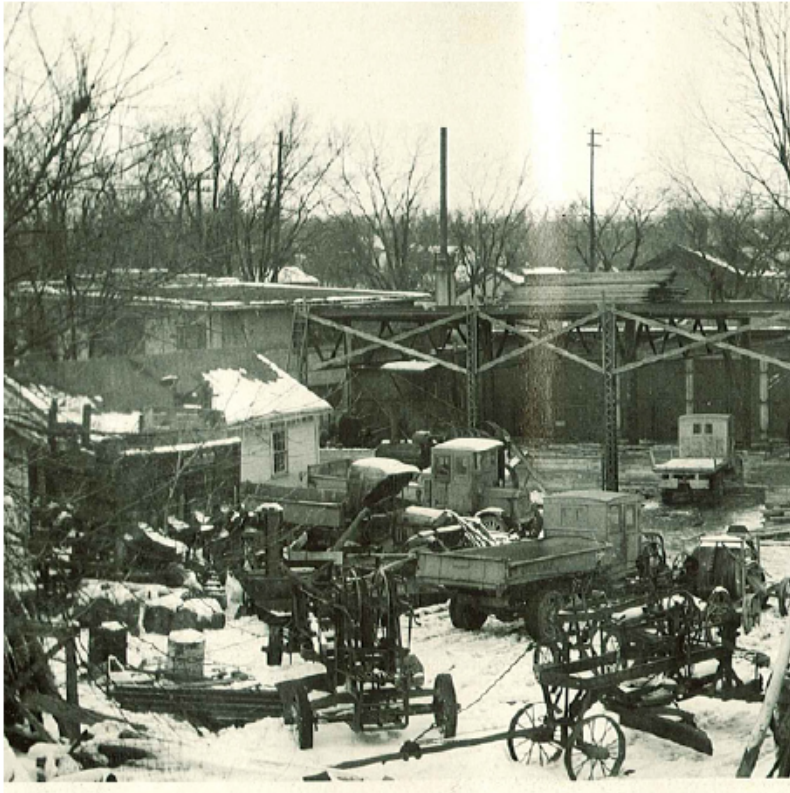
Photo showing construction of the steel framed high bay space

The high bay steel framed space is a good example of early Warren trusses built of riveted steel angles and web connectors of plate steel. The roof deck is board-formed reinforced concrete. The trusses are supported by steel lattice columns at each truss end and are encased in concrete for corrosion and fire protection. These columns, some on the interior but mostly on the exterior, are showing corrosion related concrete spalling. We will need to evaluate how much corrosion has reduced the cross section of the column's small steel sections and how to arrest further corrosion and what the best techniques for repair will be. Some destructive testing for visual inspection may be required.

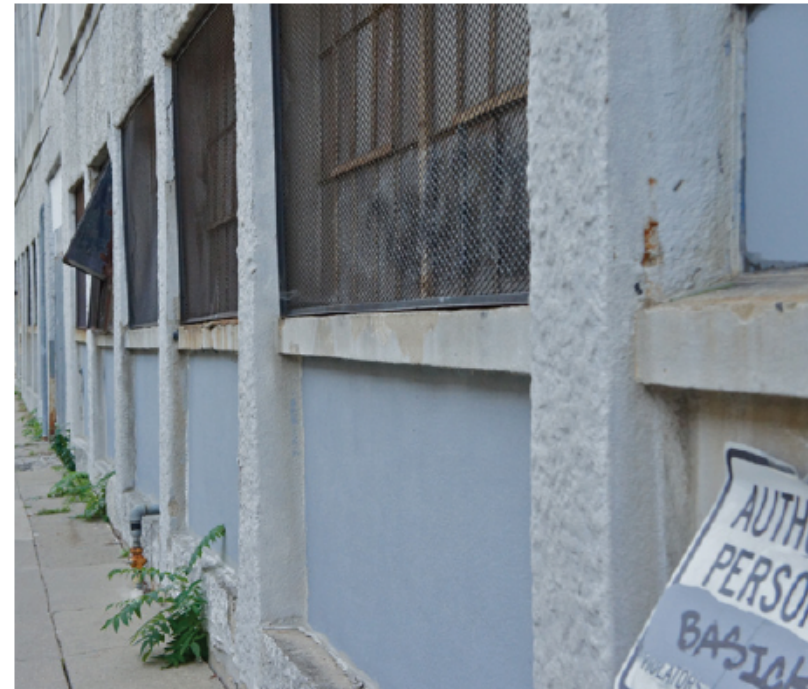
The earliest phases of the building complex have had over eighty-five years to settle. By sighting along the window sills fronting Washington Street, it is obvious that there is some differential settlement. There is also some visible cracking between bays that extends up to the parapet. It is not known what the soils conditions are along Washington Street where foundation damage is most noticeable. Soil investigations are not a part of this study. It is possible to tell what size the foundations for the steel high bay space are from historic photographs. Other documentation may exist which could help determine what foundation conditions are below grade. We will document obvious areas where some failure is occurring and make recommendations for either further monitoring or for remediation.

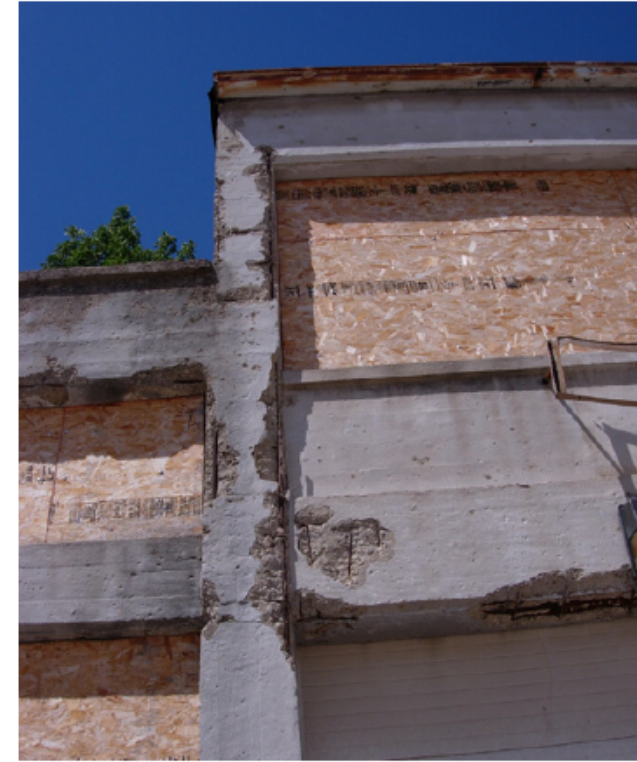
Concrete spalling on west concrete frame

The exterior frame has many obvious surface weathering problems, most of them related to the shallow embedment of reinforcing steel and its subsequent corrosion. This structural type's exterior building envelope will need to be more closely analyzed than the other three types. Areas of deterioration will be documented and techniques for stabilization and repair will be proposed.
