ANN ARBOR HISTORIC DISTRICT COMMISSION

Staff Report

ADDRESS: 403 West Mosley, Application Number HDC17-044

APPLICATION: The applicant seeks HDC approval to replace two double-hung windows with casement windows to meet egress requirements in two bedrooms.

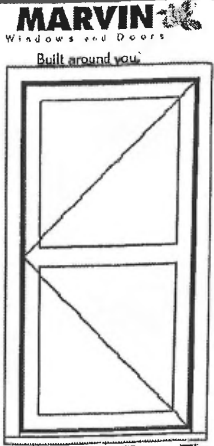
Line #1	Mark Unit:			
Qty: 1

<p>As Viewed From The Exterior</p> <p>Entered As: FS FS 22" X 47" RO 23" X 47 1/2" Egress Information Width: 14 57/64" Height: 39 21/32" Net Clear Opening: 4.10 SqFt</p>		<p>Bare Pine Exterior Bare Pine Interior Wood Ultimate Casement - Left Hand Frame Size w/ Subsill 22" X 47" Rough Opening w/ Subsill 23" X 47 1/2" Bare Pine Sash Exterior Bare Pine Sash Interior IG - 3/4 in Low E2 w/Argon Stainless Perimeter and Spacer Bar 2 13/32" SDL - With Spacer Bar - Stainless Checkrail - Special Cut 1W1H 2 Rect Lites Bare Pine Ext - Bare Pine Int Ogee Interior Glazing Profile Standard Bottom Rail Beige Weather Strip Satin Taupe Folding Handle Satin Taupe Multi - Point Lock Aluminum Screen Charcoal Fiberglass Mesh Satin Taupe Surround 4 9/16" Jambs Bare Pine BMC Bare Pine Standard Subsill No Installation Method</p> <p>Other: Qty 1: TOTAL INSTALLED PRICE ** NON-TAXABLE ITEM</p>

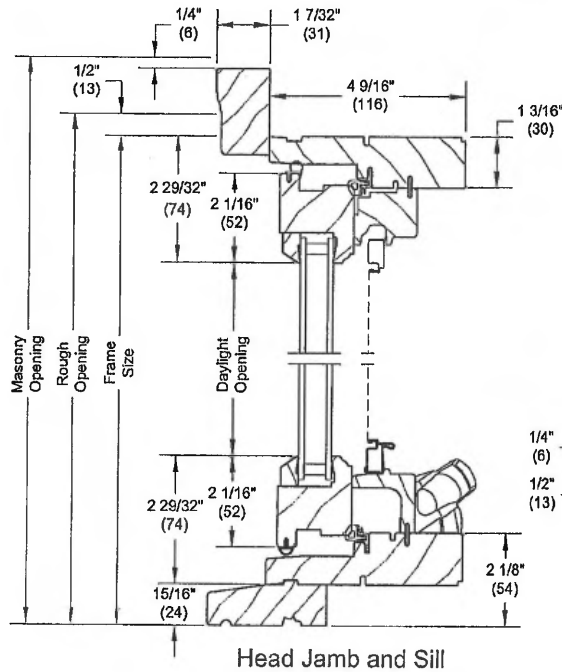
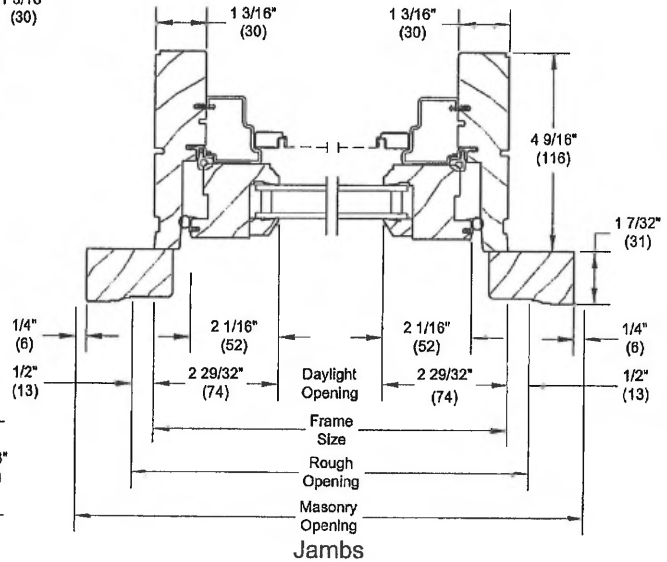
Wood Ultimate Casement, Awning and Picture

Section Details: Operating and Stationary / Picture - 3/4" (19) IG

Scale: 3" = 1' 0"

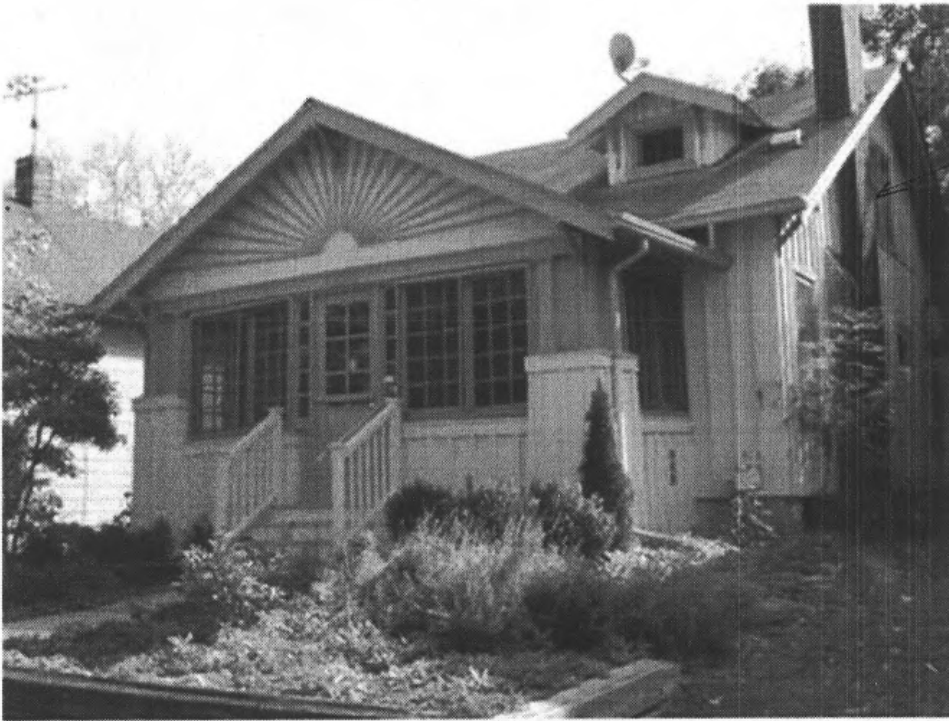
SIDEWALK / STREET VIEW

WINDOW CLOSEST TO
CHIMNEY TO BE
REPLACED

4. Attach any additional information that will further explain or clarify the proposal, and indicate these attachments here.
IN THE LARGER UPSTAIRS ROOM THERE ARE TWO WINDOWS SIDE BY SIDE. ONLY THE LEFT WINDOW (WHEN LOOKING FROM OUTSIDE) WILL BE REPLAZED. THIS WINDOW IS CLOSE TO THE CHIMNEY AND BARELY SEEN FROM THE OUTSIDE ROAD / SIDEWALK.

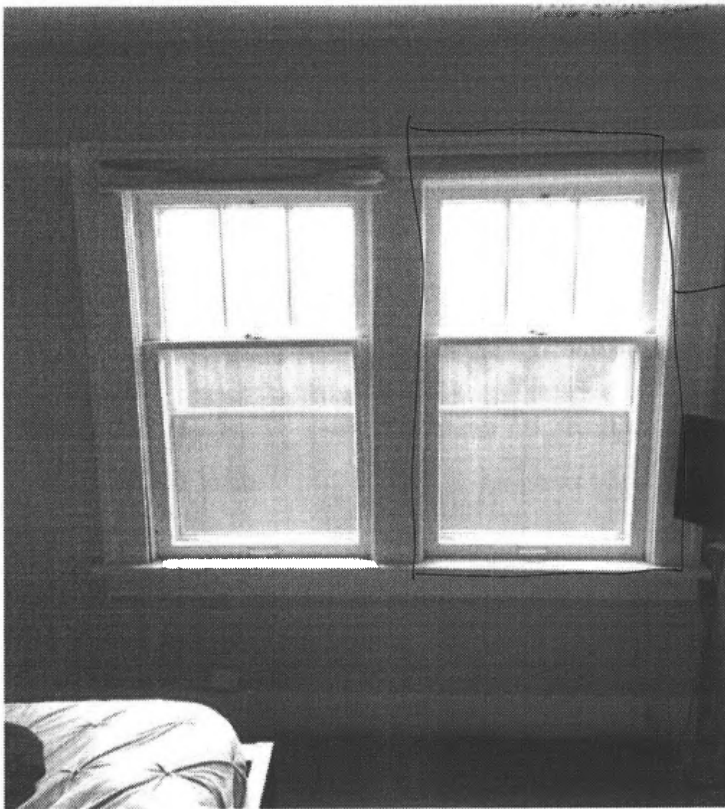
MARVIN BASEMENT WINDOW
IN 3 OVER 1 STYLE.

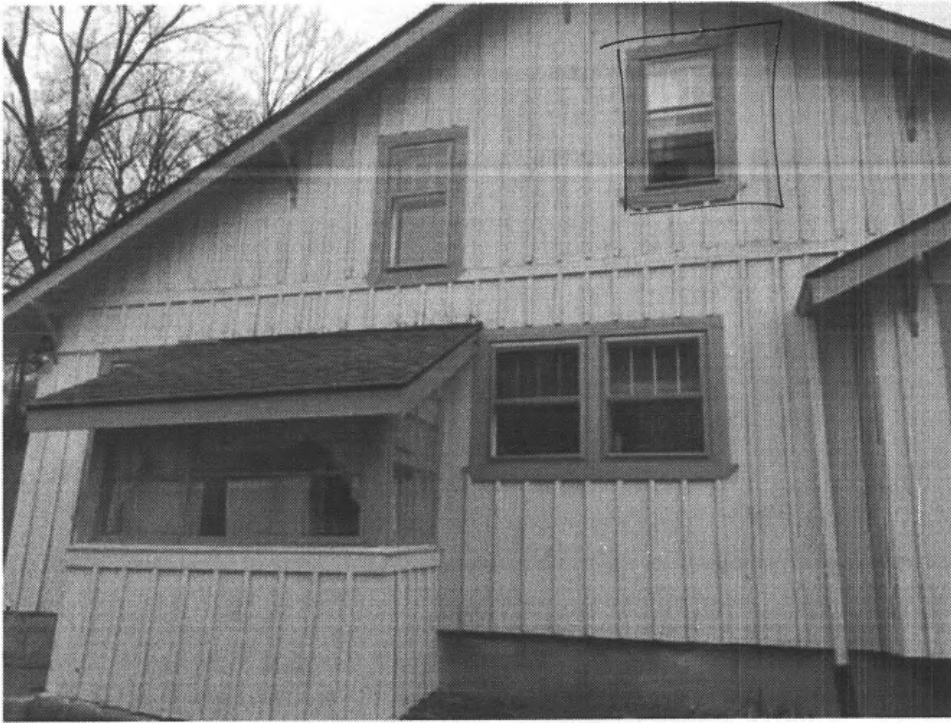
DRIVEWAY SIDE VIEW

1. The windows proposed to be replaced are on the two side elevations of the house on the second floor. The house has not been previously certified as a rental, and two means of egress are required per housing code. The windows have an inadequate opening size, probably contributed by the fact that the windows have unequally-sized sash. That is, the top sash is smaller than the bottom, so the bottom sash cannot be raised as high as on a window with sashes of equal sizes. The east window is the most visible, along the driveway. The west window is sandwiched between the chimney and a matching three-over-one window, and is harder to see from the sidewalk.
2. The replacement casement windows are wood Pella with applied muntins and internal spacer bars to simulate a divided-lite window.
3. Staff is working with the Building Official to clarify under what circumstances historic

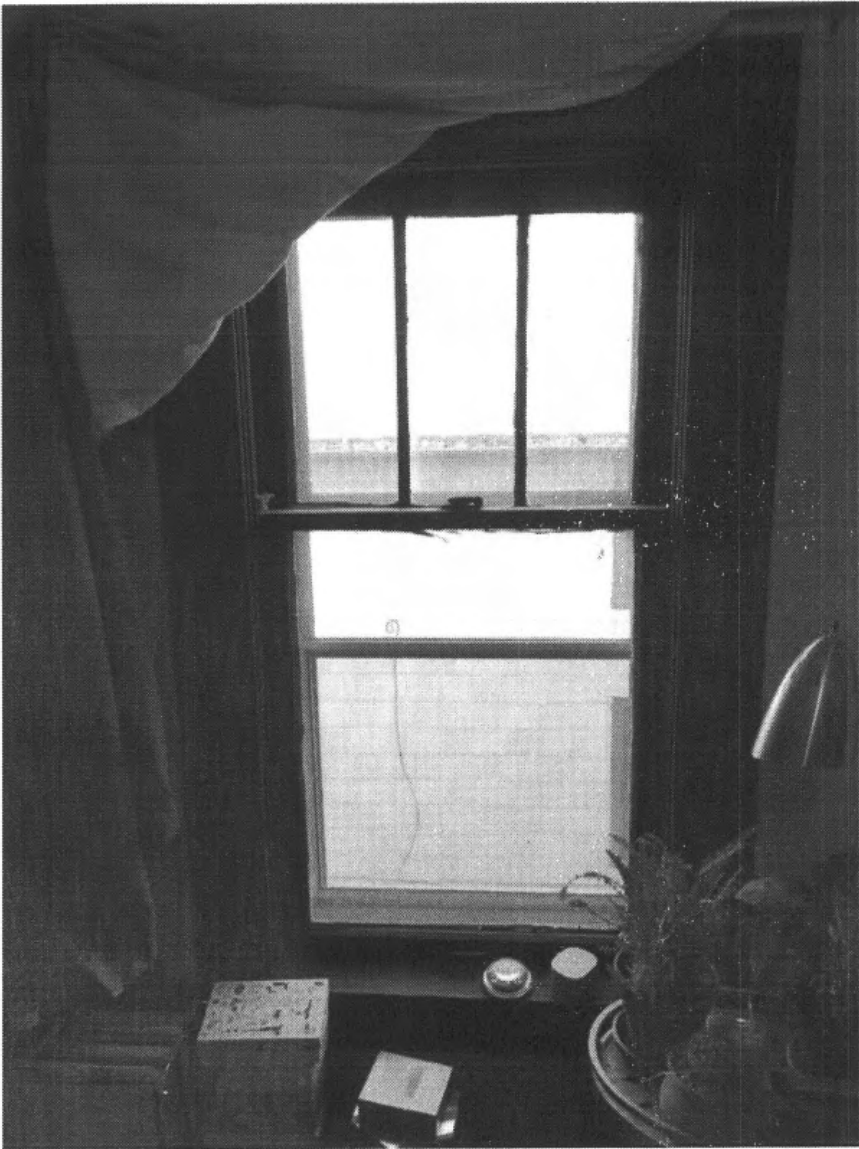
DRIVEWAY SIDE INSIDE

2. Provide a description of existing conditions. THE CURRENT WINDOWS ARE IN WORKING CONDITION BUT CURRENTLY NEED REPAIRING OF ROPING MECHANISMS & WEIGHTS. ADDITIONALLY, THE CURRENT WINDOWS DO NOT MEET EGRESS.
