## ANN ARBOR HISTORIC DISTRICT COMMISSION

### Staff Report

**ADDRESS:** 208 South Main Street, Application Number HDC12-138

**DISTRICT:** Main Street Historic District

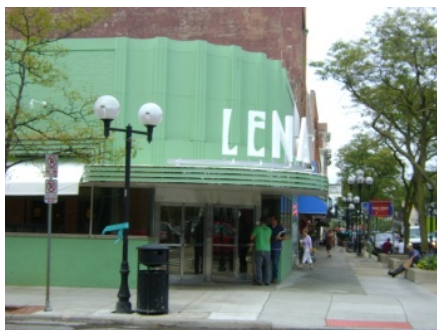
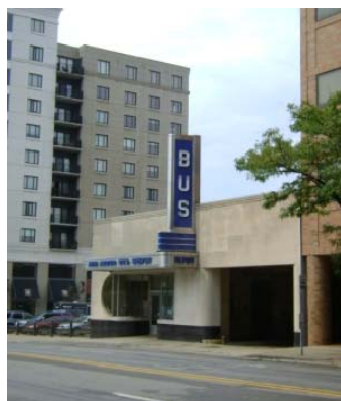
Three that are original (Cunningham's Drugs/Parthenon/Lena at 226 South Main, and the Greyhound Bus Depot, both in the art moderne style) or reproductions of the original (Marchese Building at 319-325 South Main, left in photo);

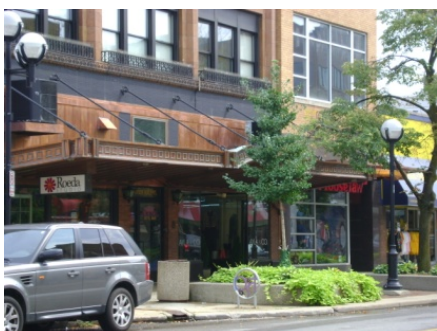
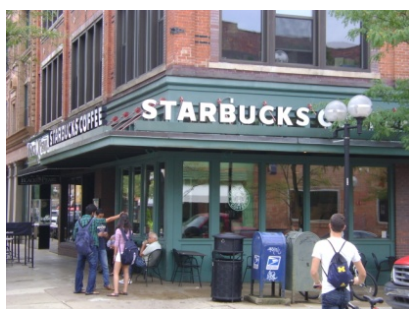
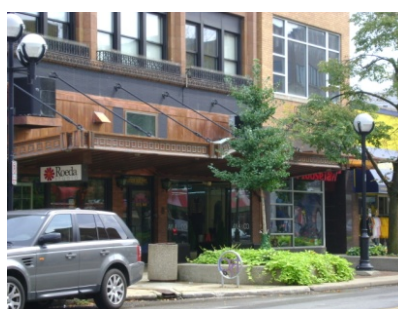
Two that are relatively new (Starbucks on the southwest corner of West Liberty and South Main was approved by the HDC in 2005, and Moosejaw at 327 South Main, right in photo, was approved by the HDC in 1995 on a non-contributing building);

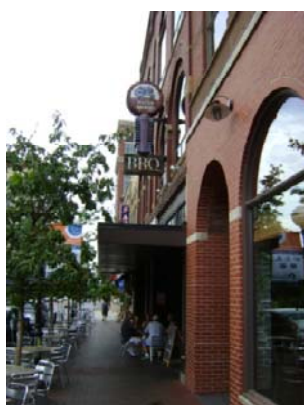
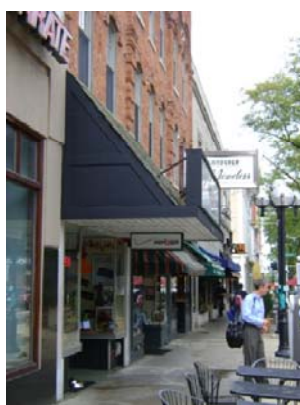
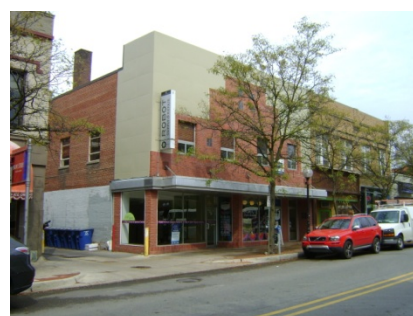
Three that are older but not from the period of significance for the district (Sudworth Building at 205-207 West Washington, 212 South Main, and 113-115 East Liberty, a non-contributing building).

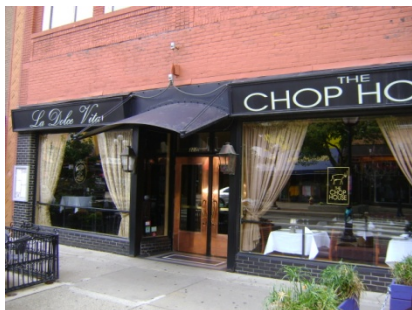
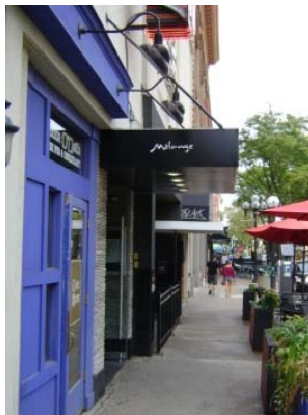
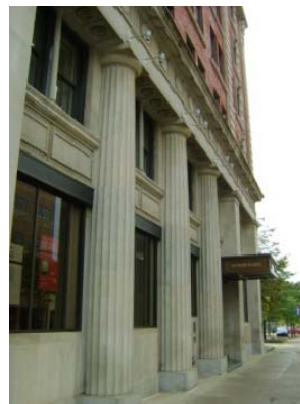
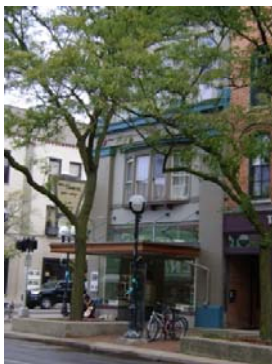
Several buildings have fixed canopies covering only the front door, not the storefront (a steel one on the Chop House at 322 South Main, and canvas over Melange at 312 South Main and Rush Street at 314 South Main), as well as side doors on the Glazier Building (Key Bank, 100 South Main) and others.

The canopy on 301 South Main (Selo Sheval) dates back to at least 1973, but whether it dates to the period of significance is unknown.

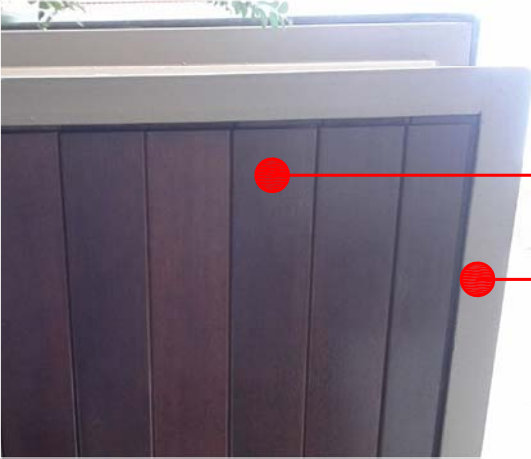
—ST<sub>1</sub>- BLACK HONED GRANITE

—WD<sub>1</sub>- TONGUE & GROOVE CEDAR, STAINED TO MATCH DESIGNERS SAMPLE

—MTL<sub>1</sub>- PAINTED STRUCTURAL STEEL AWNING FRAME

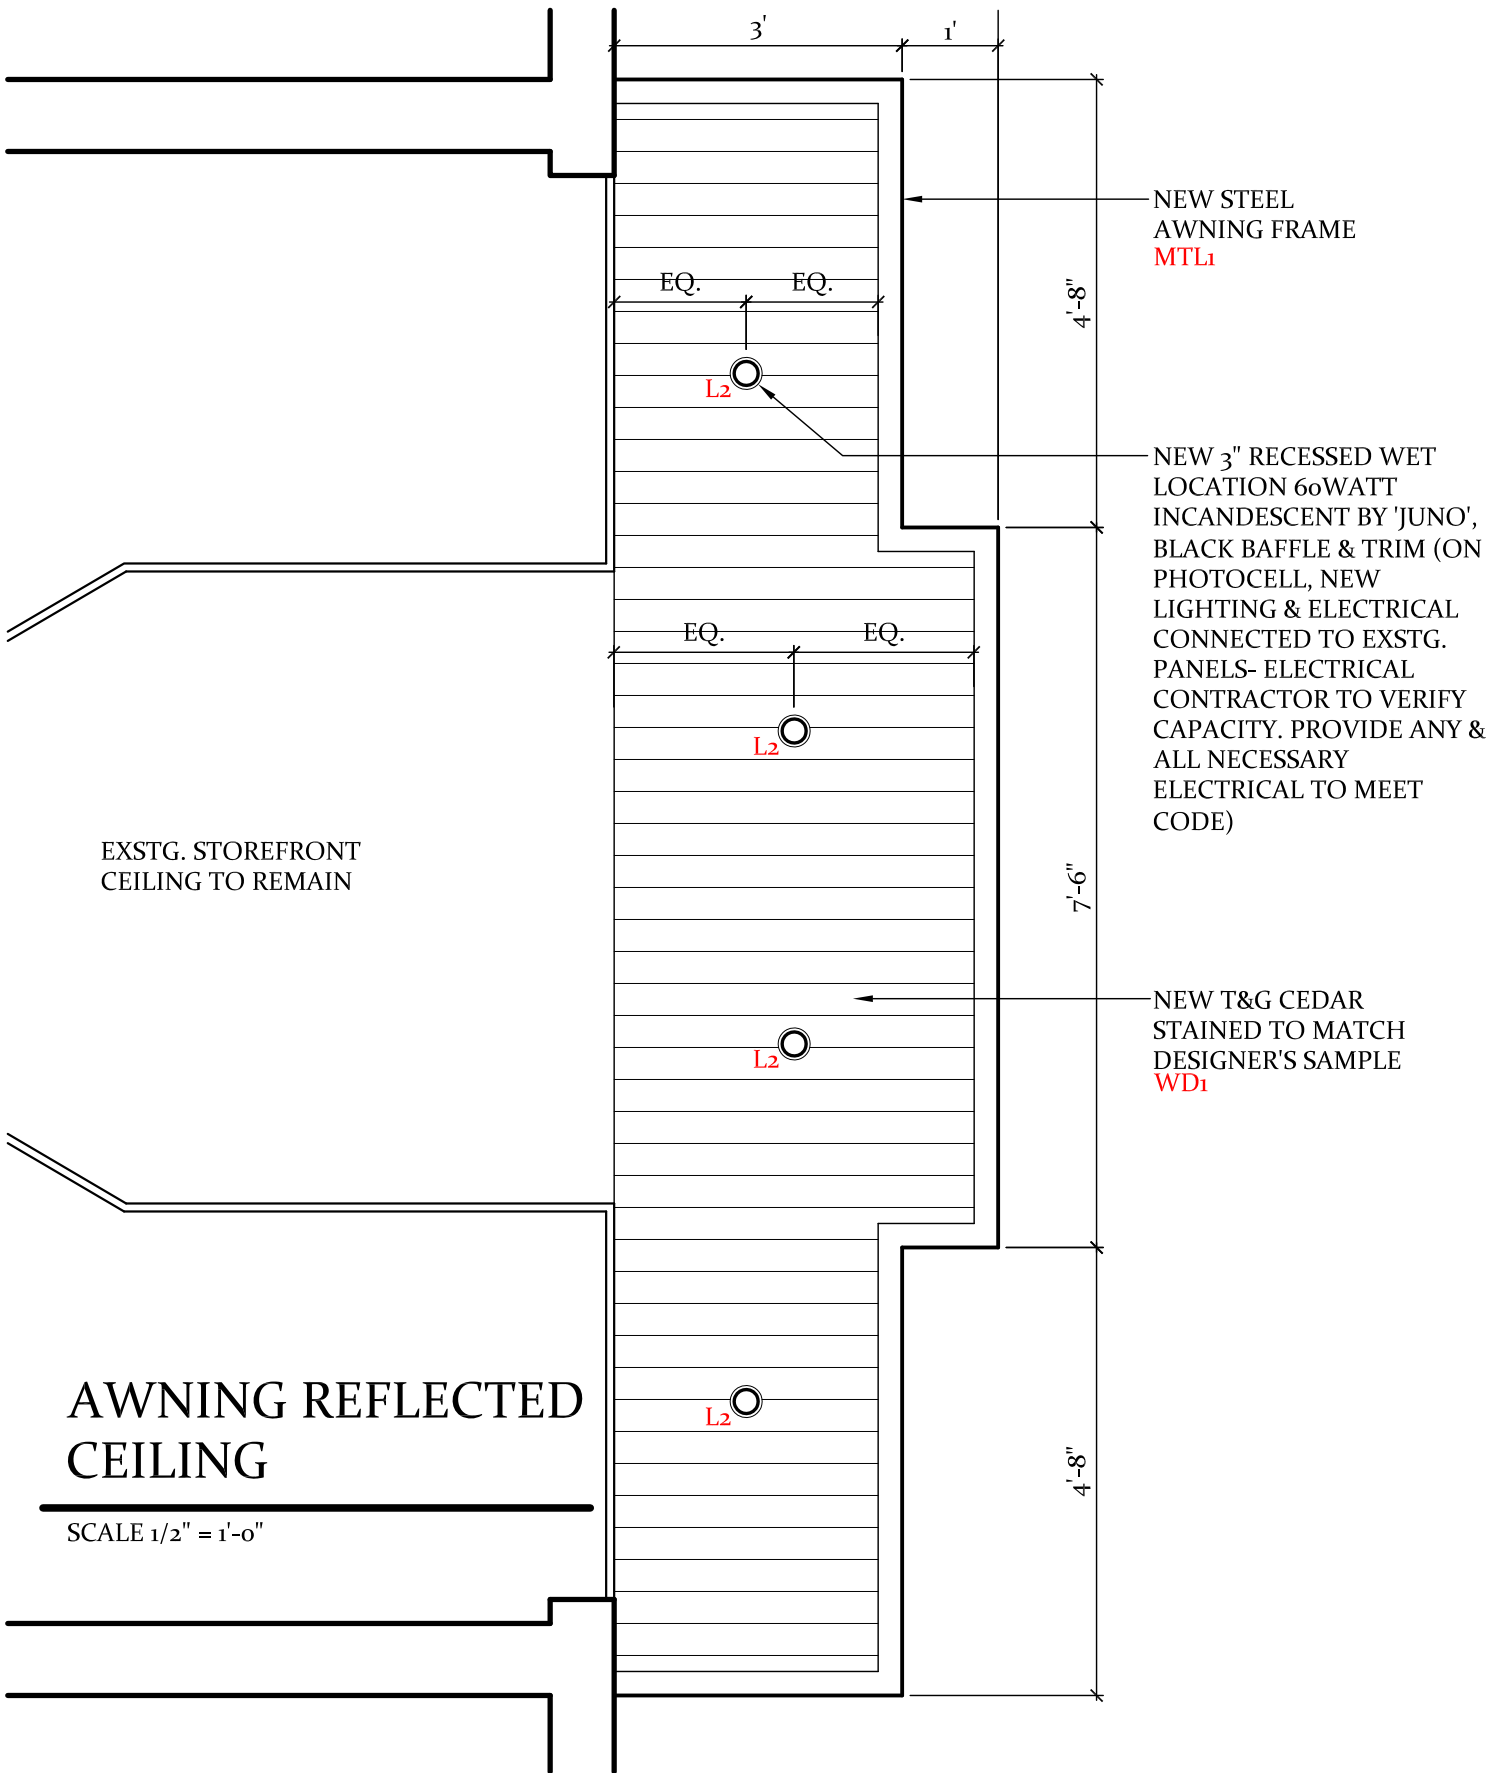
## AWNING REFLECTED CEILING

EXSTG. STOREFRONT  
CEILING TO REMAIN

NEW STEEL  
AWNING FRAME  
MTL1

NEW 3" RECESSED WET  
LOCATION 60WATT  
INCANDESCENT BY 'JUNO',  
BLACK BAFFLE & TRIM (ON  
PHOTOCELL, NEW  
LIGHTING & ELECTRICAL  
CONNECTED TO EXSTG.  
PANELS- ELECTRICAL  
CONTRACTOR TO VERIFY  
CAPACITY. PROVIDE ANY &  
ALL NECESSARY  
ELECTRICAL TO MEET  
CODE)

NEW T&G CEDAR  
STAINED TO MATCH  
DESIGNER'S SAMPLE  
WD1

5. The proposed canopy has a stained wood "ceiling" with four recessed lights. The wood ceiling will be tongue and groove cedar stained a dark brown color. The "roof" of the canopy will have one small spotlight to illuminate the proposed wall sign located on the façade above the canopy. Based on the provided mock ups, the entire canopy will be painted beige and will have copper flashing on the raised portion along the front edge. The existing canvas awning is much more typical of a small downtown storefront than the proposed canopy. The historic documentation (photos) that staff was able to find all showed canvas awnings on this and neighboring storefronts.

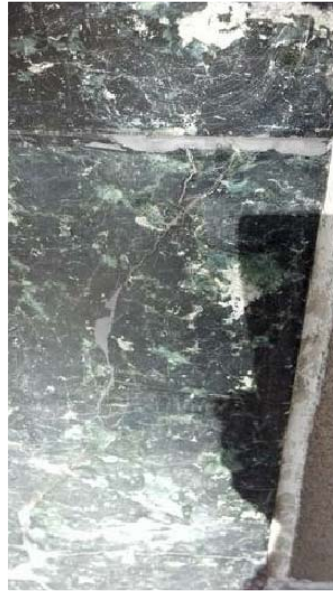
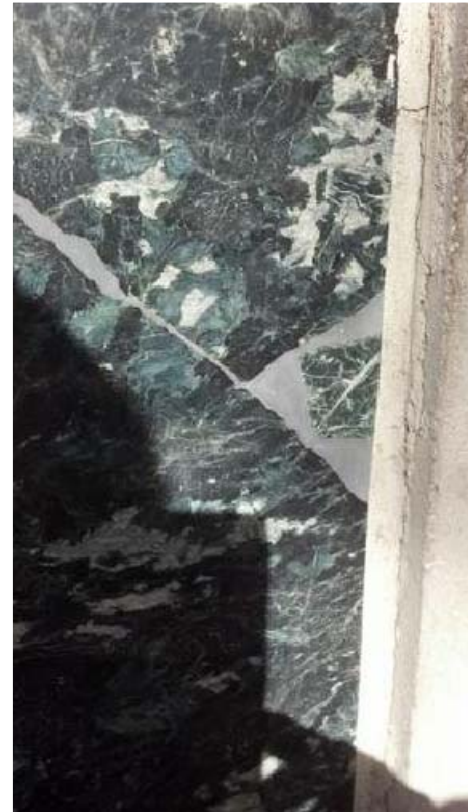
**PHOTOS OF DAMAGED STONE**

After reviewing the condition of the existing façade stone in question at 208 S. Main Street (Schlanderer's & Sons), my professional recommendation is replacement. The existing stone damage has created and perpetuated water damage to the sub structure. To fix the sub structure, the façade stone would need to be removed. In doing so, the stone would be damaged beyond reasonable repair. The existing stone is cracked and patched in multiple locations. This makes saving the stone for replacement not an option.

The removal of the existing stone will allow us to make necessary repairs to the sub structure. Once the sub structure is repaired the new stone will be applied in a way to ensure any future water damage.
