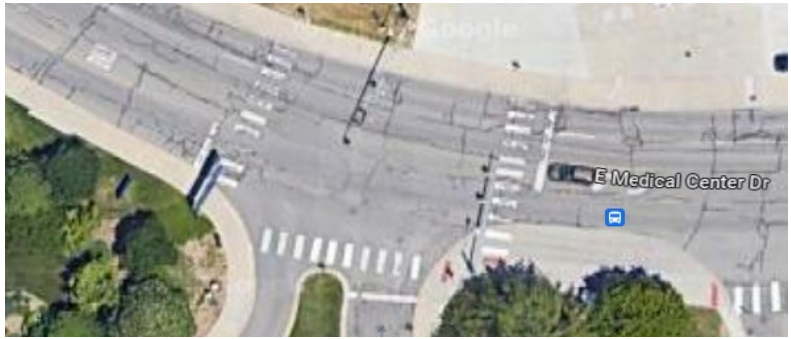
Location: E. Medical Center Drive at Cancer Center Entrance (Private)

TCO No. 2507401
 Date: 2/10/2022
 Time: 7:18
 Crash Type: Pedestrian
 No. K 0
 No. A 1
 No. B 0
 No. C 0
 No. O 1

Contributing Factors:
 Traffic Signal, Dawn, Surface was Slush

Focus Area:
 Failure to Yield

Narrative
 Unit 1 stated she saw the pedestrian as she was turning but a vehicle drove passed in front of her she turned to avoid the other car and when she finished the turn she struck the pedestrian. Wooten, the pedestrian stated that she was crossing the street at the Cancer Center, she saw the bus waiting to turn left and thought the bus driver saw her, she started crossing the street and then she saw the bus coming toward her. She stated she tried to run, but the bus hit her.

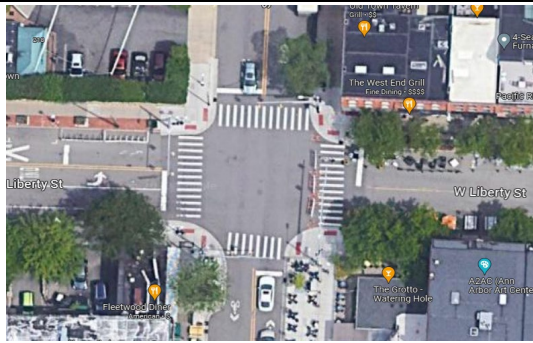
Location: Ashley St. at Liberty St.

TCO No. 2599782
Date: 5/25/2022
Time: 12:30
Crash Type: Pedestrian
No. K 0
No. A 1
No. B 0
No. C 0
No. O 1

Contributing Factors:
 Signal, cloudy, daylight, dry surface

Focus Area:
 Failure to yield

Narrative
 V1 WAS TRAVELING EAST ON W LIBERTY ST APPROACHING S. ASHLEY ST. HE STATED HE OBSERVED THE LIGHT TURN YELLOW AND PROCEEDED TO GO THROUGH AND TURN LEFT ON TO S. ASHLEY ST. HE THEN OBSERVED THE PEDESTRIAN IN THE CROSSWALK AND WAS UNABLE TO STOP. V1 THEN COLLIDED WITH THE PEDESTRIAN WITH THE FRONT MIDDLE OF THE VAN, CAUSING THE PEDESTRIAN TO GO UP ONTO THE HOOD AND THEN FALL TO THE GROUND. IN THE PEDESTRIAN WAS TRANSPORTED TO U OF M BY HVA FOR UNKNOWN INJURIES. SHE WAS UNRESPONSIVE AT THE TIME SHE WAS BEING TRANSPORTED TO THE HOSPITAL. WHEN SHE GOT TO THE HOSPITAL SHE APPEARED TO BE STABLE WITH INJURIES TO HER HEAD. IN WITNESSES DID NOT OBSERVE THE INITIAL CRASH. THE FIRST WITNESS HEARD THE CRASH AND LOOKED AND OBSERVED THE PEDESTRIAN GOING UP ON THE HOOD OF THE VAN. IN THERE IS VIDEO OF THE INCIDENT FROM A LOCAL BUSINESS THAT WAS ABLE TO BE VIEWED BY OTHER OFFICERS. IN A POLICE REPORT HAS ALSO BEEN WRITTEN.

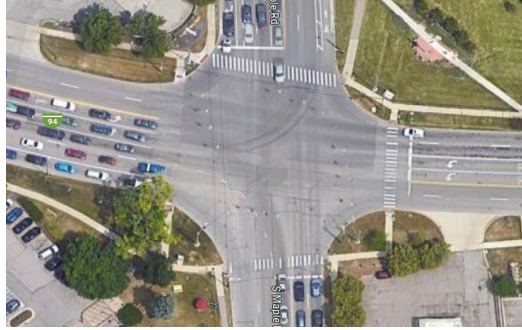
Location: Jackson Ave. at Maple Road, west approach

TCO No. 2603043
Date: 5/26/2022
Time: 15:04
Crash Type: Pedestrian
No. K 0
No. A 1
No. B 0
No. C 0
No. O 1

Contributing Factors:
 Signal, rain, daylight, wet surface

Focus Area:
 Failure to yield

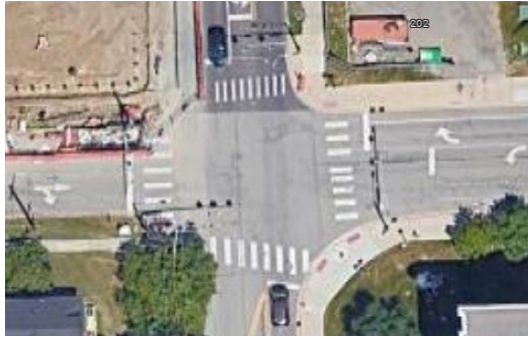
Location: Ann St. at Glen Ave.

TCO No. 2618185
Date: 6/17/2022
Time: 23:06
Crash Type: Pedestrian
No. K 0
No. A 1
No. B 1
No. C 0
No. O 1

Contributing Factors:
 Signal, clear, dark-lighted, dry

Focus Area:
 Failure to yield

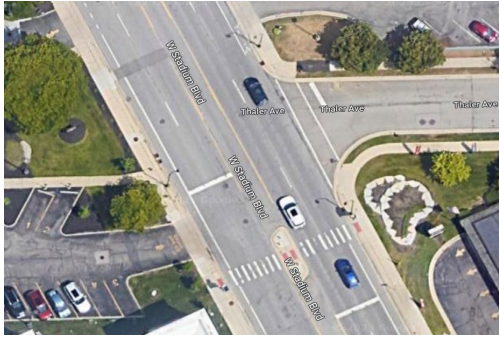
Location: Stadium Blvd. at Thayer Ave.

TCO No. 2635331
Date: 3/30/2023
Time: 4:09
Crash Type: Bicycle
No. K 1
No. A 0
No. B 0
No. C 0
No. O 1

Contributing Factors:
 No control on Stadium Blvd., rain, dark-lighted, wet

Focus Area:
 Failure to yield

Narrative
 UNIT 1: HAYES STATED HE WAS TRAVELING SOUTHBOUND ON STADIUM BLVD. WHEN THE BICYCLIST CROSSED THE STADIUM BLVD FROM THE EAST TO THE WEST SIDE OF THE ROADWAY. HAYES STATED WHEN HE NOTICED THE BICYCLIST HE WAS UNABLE TO STOP AND STRUCK THE BICYCLIST WITH THE FRONT OF HIS VEHICLE. IN UNIT 2: DUE TO THE INJURIES SUSTAINED TO THE BICYCLIST WE WERE UNABLE TO GET A STATEMENT FROM HIM UPON OUR ARRIVAL. IN AN ACCIDENT RECONSTRUCTION WAS COMPLETED (AAPD CASE #22-12009). UNIT 2 WAS FOUND AT FAULT DUE TO CROSSING THE ROADWAY OUTSIDE OF A DESIGNATED CROSSING. FURTHERMORE, UNIT 2 WAS RIDING THE BICYCLE IN THE ROADWAY AND NOT OBEY TRAFFIC LAWS AS REQUIRED.

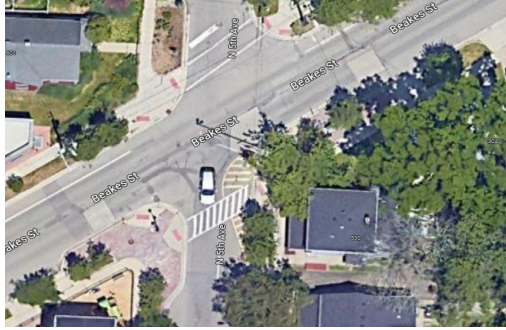
Location: Beakes St. at Fifth Ave.

TCO No. 2659002
Date: 8/12/2022
Time: 18:30
Crash Type: Pedestrian
No. K 0
No. A 1
No. B 0
No. C 0
No. O 2

Contributing Factors:
 No control on Beakes, clear, daylight, dry surface

Focus Area:
 Failure to yield

Narrative
 UNIT 1 AND 2 WERE TRAVELING SW ON BEAKES ST. UNIT 2 WAS IN THE LEFT LANE AND UNIT 1 WAS IN THE RIGHT LANE. UNIT 1 BEGAN MERGING INTO THE LEFT LANE AND STRUCK UNIT 2. UNIT 2 LOST CONTROL AND WENT UP ONTO THE CURB, STRIKING A PEDESTRIAN. \NMINOR DAMAGE TO BOTH VEHICLES. NO INJURIES TO EITHER DRIVER. \NNTHE PEDESTRIAN SUSTAINED FIVE BROKEN RIBS (LEFT SIDE), BROKEN CLAVICLE, BROKEN SCAPULA (LEFT), AND RUPTURED SPLEEN.

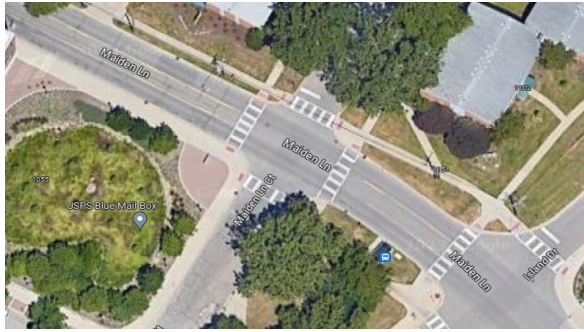
Location: Maiden Lane at Maiden Lane Ct.

TCO No. 2703677
Date: 9/28/2022
Time: 15:25
Crash Type: Pedestrian
No. K 0
No. A 1
No. B 0
No. C 0
No. O 1

Contributing Factors:
 Stop, clear, daylight, dry surface
Focus Area:
 Failure to yield

Narrative
 UNIT 1: THE DRIVER OF UNIT 1 ADVISED SHE TURNED RIGHT ONTO WALL ST FROM MAIDEN LANE CT. SHE ADVISED SHE DID NOT SEE UNIT 2. AFTER SHE COMPLETED HER RIGHT TURN, SHE STRUCK UNIT 2 CAUSING INJURY. \NINUNIT 2: UNIT 2 SAID SHE THINKS THE CRASH IS HER FAULT BECAUSE SHE WALKED OUT INTO THE ROADWAY. SHE SAID SHE WAS WALKING ACROSS THE STREET AND UNIT 1 STRUCK HER. UNIT 2 WAS TRANSPORTED BY HVA TO U OF M HOSPITAL FOR AN APPARENT BROKEN ANKLE. \NINUNIT 2 WAS CROSSING AT THE INTERSECTION. HOWEVER, THERE WAS NO MARKED CROSSWALK. \NINWITNESSES: A WITNESS PROVIDED A GOOGLE DRIVE DASH CAMERA FOOTAGE OF THE INCIDENT WHICH IS AVAILABLE, IF NEEDED.

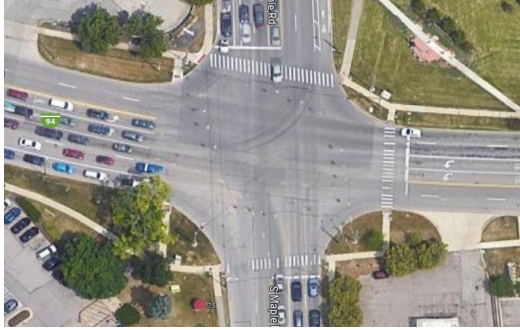
Location: Maple Rd. at Jackson Ave.

TCO No. 2729673
Date: 10/25/2022
Time: 15:26
Crash Type: Rear End Straight
No. K 0
No. A 1
No. B 0
No. C 0
No. O 1

Contributing Factors:
 Signal, clear, daylight, dry
Focus Area:
 Failure to yield

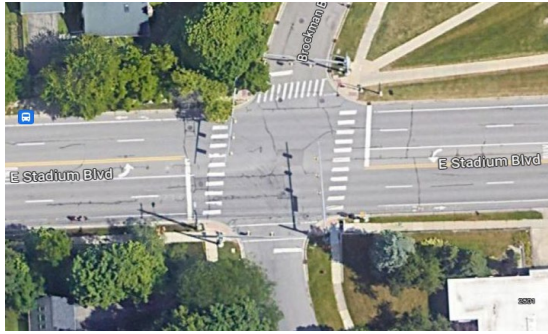
Location: Stadium Blvd. at Brockman Blvd.

TCO No. 2739967
Date: 11/2/2022
Time: 19:05
Crash Type: Bicycle
No. K 0
No. A 1
No. B 0
No. C 0
No. O 1

Contributing Factors:
 Signal, clear, dark-lighted, dry

Focus Area:
 Failure to yield

Narrative
 THE DRIVER OF UNIT 1 SAID HE WAS TURNING LEFT FROM GOING WESTBOUND ON E STADIUM AVE TO SOUTHBOUND ON BROCKMAN BLVD. HE HAD A FLASHING YELLOW TRAFFIC SIGNAL, THERE WAS NO ONCOMING TRAFFIC, AND HE DID NOT SEE ANYONE IN THE CROSSWALK. THE EAST/WEST CROSSWALK DID HAVE A WALK SIGNAL. AS HE TURNED SOUTH HE SAID HE SAW A BICYCLE APPROACHING FROM HIS LEFT AND HE STOPPED HIS VEHICLE. THE DRIVER SAID HE THEN SAW THE CYCLIST TUMBLE TO THE GROUND IN FRONT OF HIM. NEW DAMAGE NEAR THE FRONT LEFT WHEEL SHOWED WHERE THE BIKE HIT THE SIDE OF THE CAR. THE CYCLIST SAID THE CAR WAS STILL IN MOTION WHEN SHE STRUCK IT. THE BIKE, A BLACK DIAMONDBACK ROAD BIKE WITH NO LIGHTS, SEEMED TO HAVE SCRATCHES BUT NO SIGNIFICANT DAMAGE. THE CYCLIST WAS TRANSPORTED TO U OF M HOSPITAL BY HVA FOR INJURIES TO HER FACE. THE CYCLIST SAID SHE THOUGHT HER FACE STRUCK THE PAVEMENT AFTER GOING ACROSS THE HOOD OF THE CAR. I OBSERVED MINOR SCRATCHES ON HER HELMET.

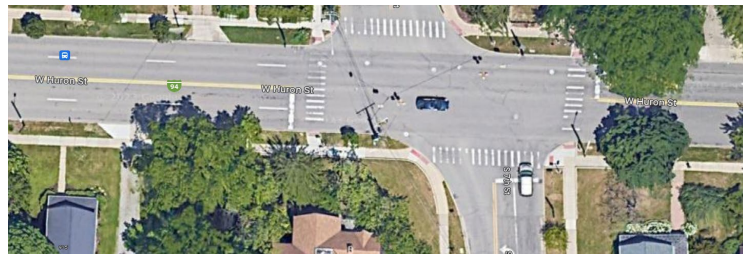
Location: Stadium Blvd. at Brockman Blvd.

TCO No. 2741213
Date: 10/23/2022
Time: 18:25
Crash Type: Misc. Single Vehicle
No. K 0
No. A 1
No. B 0
No. C 0
No. O 0

Contributing Factors:
 Signal, clear, daylight, dry
Focus Area:
 None

Narrative
 THE DRIVER OF VEHICLE #1, WAS TRAVLING WEST BOUND ON W. HURON ST, COMING TO THE INTERSECTION OF S. SEVENTH. WHEN THE DRIVER WHO IS DISABLED (POWER WHEEL CHAIR BOUND). ADVISED HE GOT HIS PRIMARY HAND WRAPPED IN THE SEAT BELT CAUSING HIM TO DRIFT OFF THE ROAD INTO A POLE JUST EAST OF THE INTERSECTION. \NIN THE DRIVER SUFFERED MINOR, BUT SIGNIFIGANT SMALL CUTS TO THE FACE AND ARM. THE VEHICLE SUSTAINED LITTLE TO NO DAMAGE.\NIN THE VEHICLE WAS TOWED AND THE DRIVER WAS TAKEN TO THE HOSPITAL FOR MEDICAL FOLLOW UP.

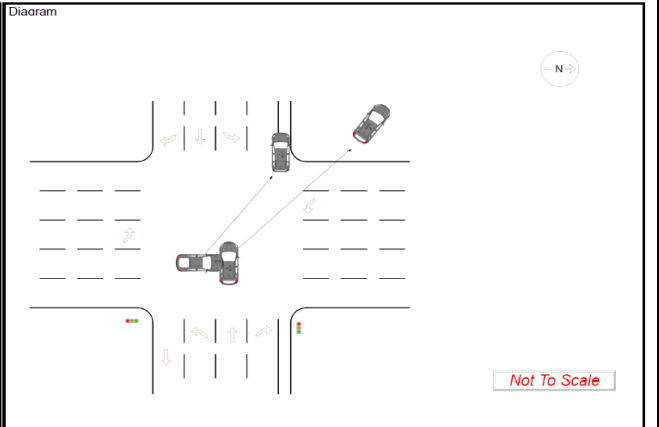
Location: Maple Rd. at Dexter Ave.

Contributing Factors:
 Signal, clear, dark-lighted, dry surface

Narrative
 VEHICLE 2 WAS TRAVELLING WEST ON DEXTER AVE. VEHICLE 1 WAS TRAVELLING NORTH ON NORTH MAPLE ROAD. AS VEHICLE 2 ENTERED THE INTERSECTION OF DEXTER AND MAPLE, WITH A GREEN TRAFFIC LIGHT BEING DISPLAYED, VEHICLE 1 COLLIDED WITH VEHICLE 2. VEHICLE 2 WAS STRUCK WITH SUCH FORCE THAT IT ENDED UP COMING TO A STOP ON THE GREEN AREA TO THE NORTH WEST OF THE INTERSECTION. IN THE DRIVER OF VEHICLE 2 WAS TRAPPED IN THE CAR AND HAD TO BE CUT OUT OF THE VEHICLE BY FIRE DEPT. HE WAS TRANSPORTED TO UNIVERSITY OF MICHIGAN HOSPITAL WITH NON LIFE THREATENING INJURIES. IN THE DRIVER OF VEHICLE 1 WHICH WAS A STOLEN VEHICLE FLED THE SCENE AND WAS NOT LOCATED.
