ANN ARBOR HISTORIC DISTRICT COMMISSION

Staff Report

ADDRESS: 216 N State Street, Application Number HDC21-035

DISTRICT: Old Fourth Ward Historic District

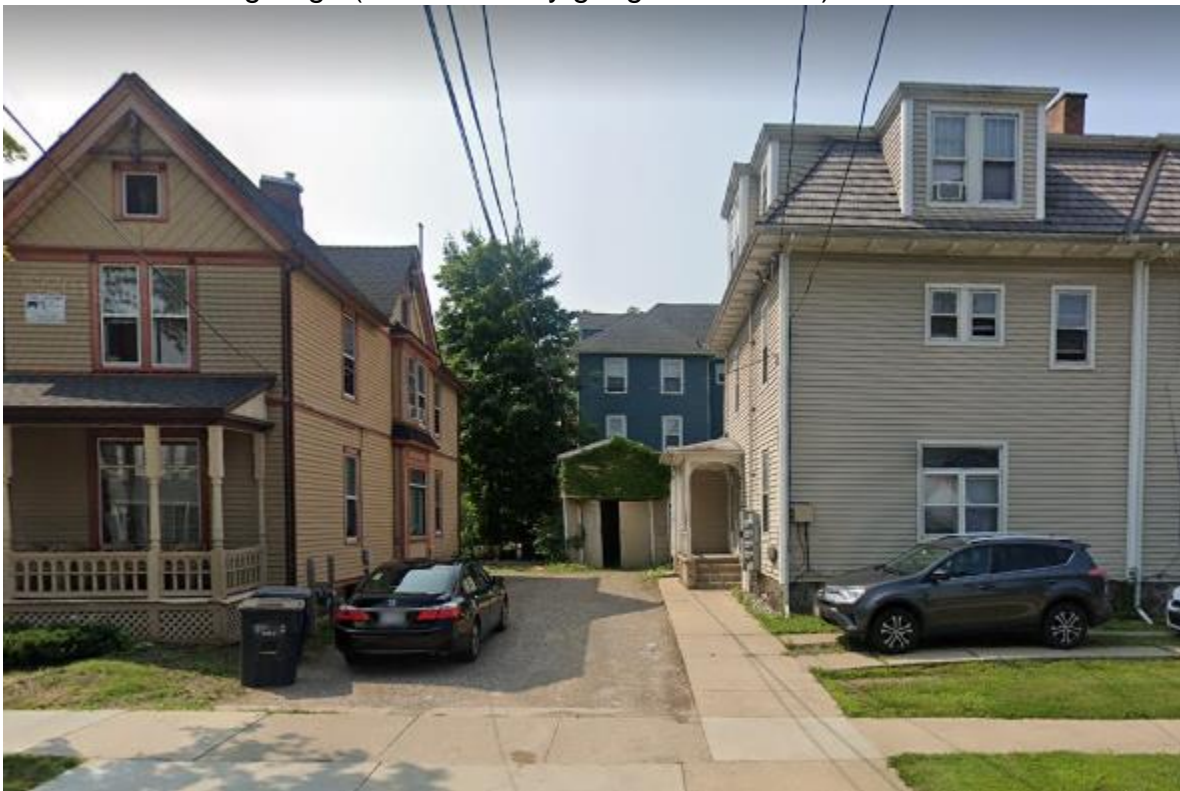
216 N State and garage (2019 courtesy google streetview)

4. Visible exterior materials and forms of the garage believed to be from the period of significance (pre-1945) include:
 - The original footprint, four walls, and two stories
 - Narrow lap siding with corner boards
 - A slight overhang that protects the double leaf doors
 - Two single-sash window openings on the west elevation and one on the east that are boarded but retain their trim and sills.
 - Exposed rafter tails

Visible exterior non-historic (post-1944) materials and forms include:

- Wood double leaf doors that appear to be modern replacements

- The siding has been replaced with slightly wider siding in the second floor of the front elevation and on the lower four courses of the south elevation

In addition, there is a large concrete trough pushed up against the west elevation. Its age and purpose are unknown.

5. The post-1944 changes to the garage are minimal. The doors, if they are modern as they appear to be in the application photos, are in keeping with the style and period of the existing garage and use the historic opening size. Staff believes that this building was present during the period of significance and possesses historic integrity. It adds to the historic architectural quality of property and the Old Fourth Ward Historic District.
6. The HDC must determine whether or not the garage is a contributing structure, and if it is, whether or not it is deteriorated beyond repair and if replacement with a replica is appropriate. Three motions are suggested below.
