**Report No. CMEC 16-018
Test Evaluation of Tree Anchor Bolts**

**Nelson Treehouse and Supply
PO box 1135
Fall City, WA 98024**

**Composite Materials and Engineering Center
Washington State University
14 December, 2016**

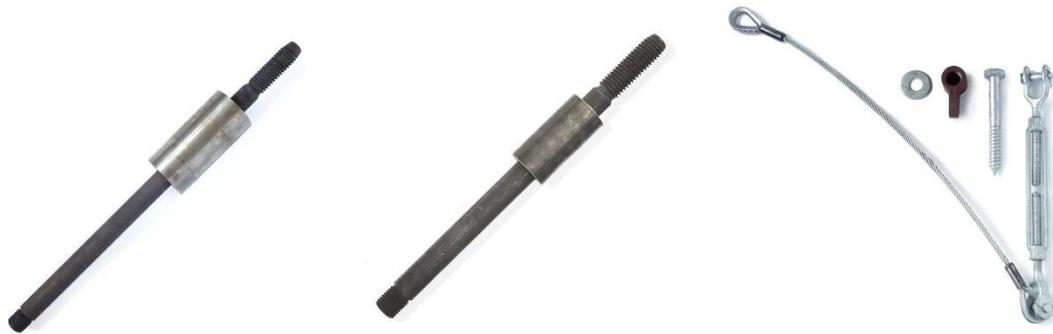
Figure 1. Nelson Treehouse products

Standard limb TAB
(1¼-in diameter)

Heavy Limb TAB
(1¾-in diameter)

Cable backup
(3/8-in diameter)

Standard and heavy treehouse attachment bolts and cable backup systems were provided by Nelson Treehouse and Supply for testing. These products were tested in both Western Red Cedar and Douglas Fir logs that were harvested within the state of Washington. The dimensions of all specimens were measured and recorded prior to testing. Moisture content of the logs near the location where the bolt was inserted for testing was determined after the testing was complete for each log.

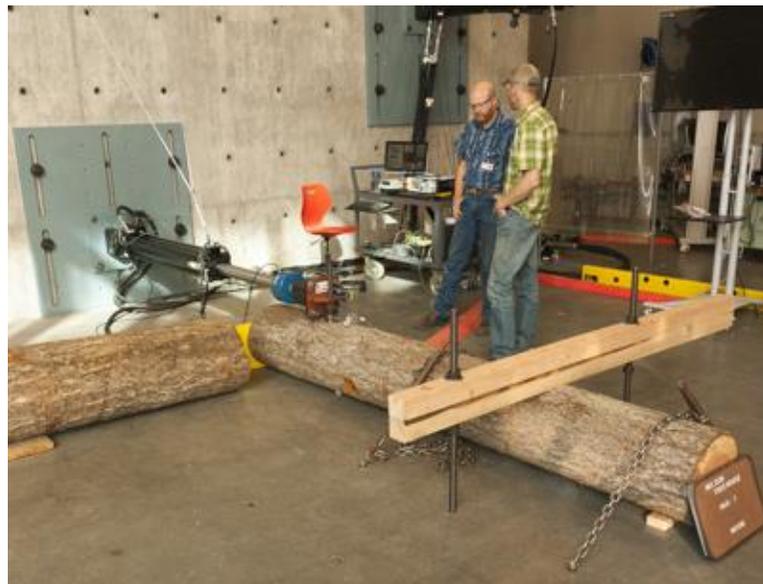
Figure 2. Typical parallel to grain test setup.

The two TAB sizes were tested in three distinct directions relative to the grain direction in a log: Parallel to the longitudinal axis/grain direction of the tree, perpendicular to the longitudinal axis/grain direction of the log (tangential to the curvature of the log), and parallel to the short axis/radial direction of the log (withdrawal). The parallel to grain direction test (longitudinal) was selected to simulate the in-service occupancy load of the treehouse due to gravity. The perpendicular to grain direction (tangential) was selected to simulate wind and or seismic loading of the treehouse. The withdrawal test was selected to also simulate wind or seismic loading of the treehouse. A typical setup for a longitudinal TAB test (parallel to the grain) is shown in Figure 2. A typical setup for a tangential TAB test (perpendicular to the grain) is shown in Figure 3. A typical setup for a withdrawal TAB test is shown in Figure 4.

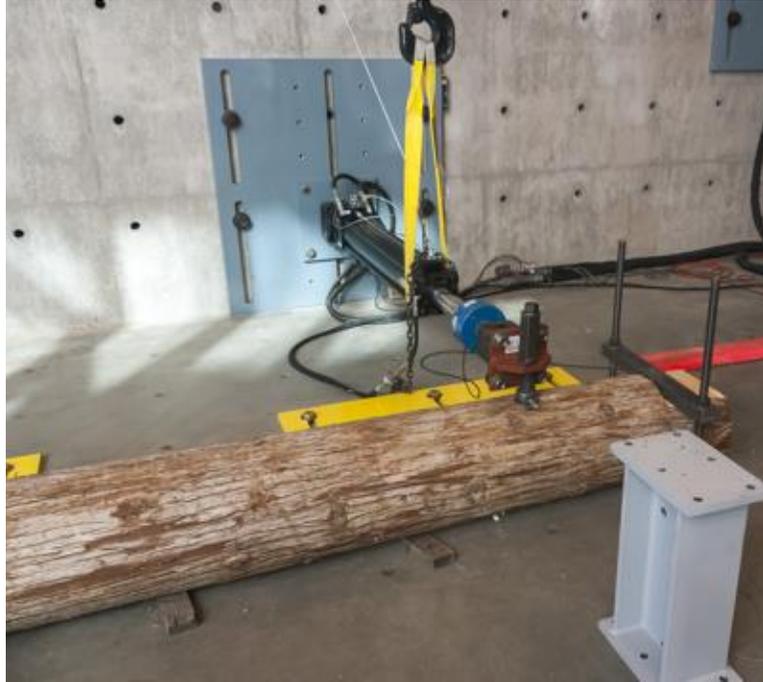
Figure 3. Typical perpendicular to grain test setup

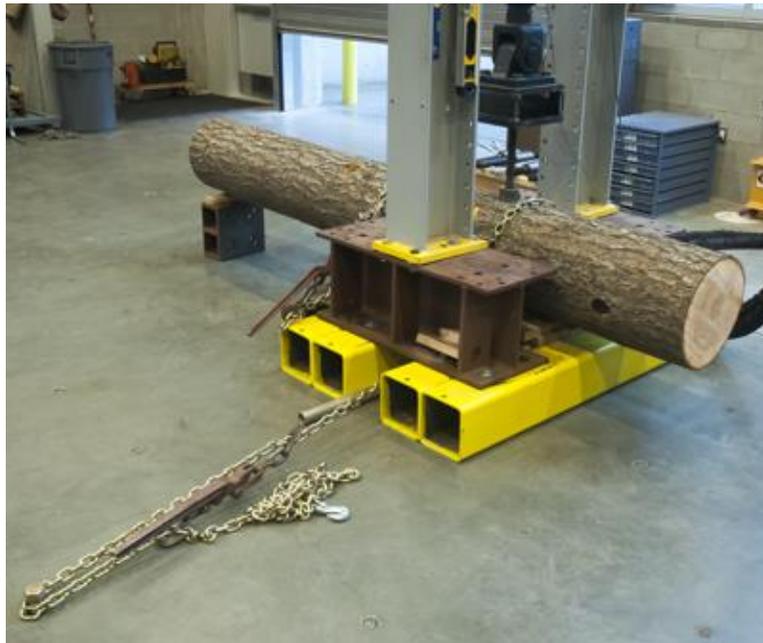
Figure 4. Typical withdrawal test setup

The withdrawal testing was conducted at a constant rate throughout the test. The rate was initially set at 0.15 inches per minute, but was increased to 0.25 inches per minute after the first test due to the failure occurring in almost 20 minutes for the first specimen. The increase resulted in a time to failure of about 10 minutes.

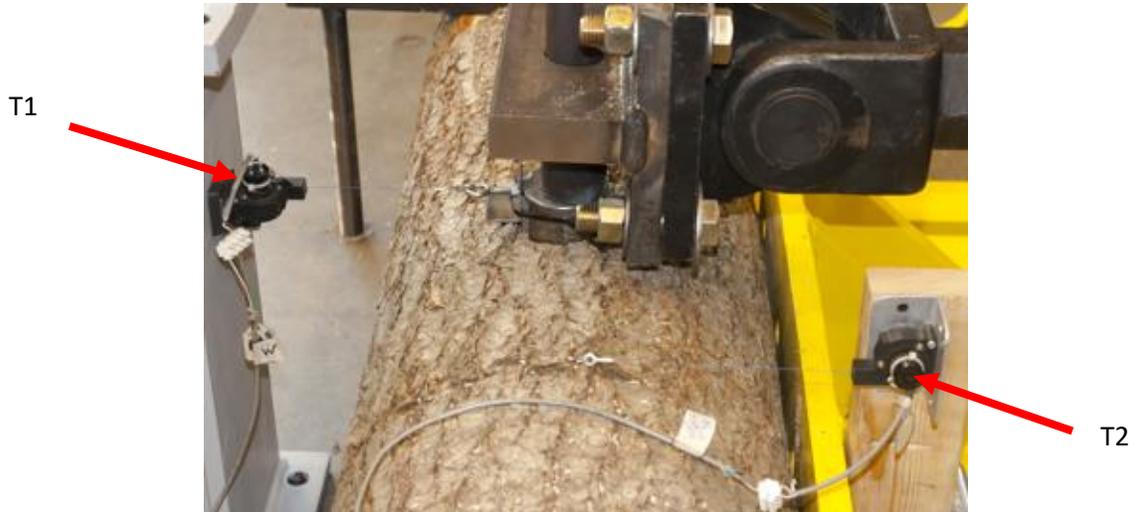
method was use the movement of the actuator as the movement of the TAB. Figure 6 shows the typical location of two displacement transducers used to measure movement during a perpendicular to grain test. Transducer T1 was used to measure movement of the boss portion of the TAB (and the log). Transducer T2 was used to measure movement (roll) of the log. During analysis of the data, the rigid body movement of the log was removed from the movement of the TAB and the log, to provide the relative movement of the TAB.

Figure 6. Displacement transducer locations-perpendicular test setup

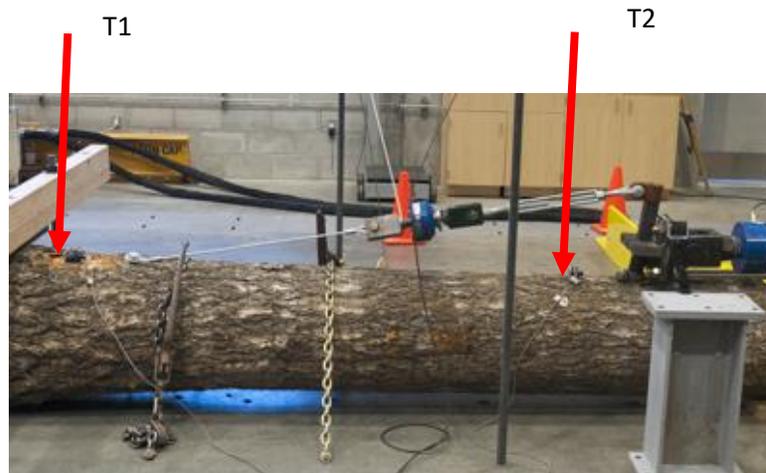
The typical setup for a parallel to grain test with a backup cable attached and two distance transducers being used to measure movement of different components is shown in Figure 7. Transducer T1 was used to measure movement of either boss around the backup lag screw or the lag screw directly. Transducer T2 was used to measure movement of the boss portion of the TAB. When the cable backup was not tested only transducer T2 was used.

Figure 7. Displacement transducer locations-parallel to grain test setup

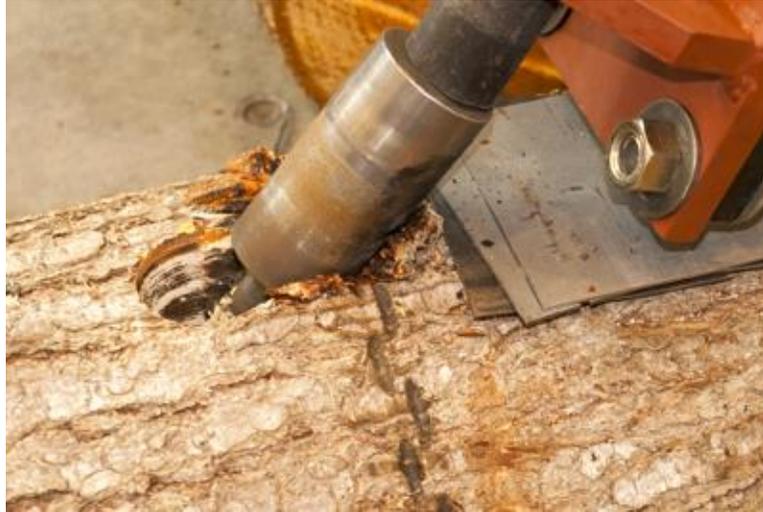
Figure A1. Parallel to grain (long axis) failure in Douglas Fir

Failure was considered when the TAB, or the system, could no longer sustain an increase in load. This typically resulted in a withdrawal of the TAB from the log. When testing was perpendicular to the grain (long axis) the failure was most often seen with splitting of the log. This may not happen in a tree due to the ability of the tree to move freely (i.e. twist) when under the increased stresses imposed during testing as well as the increased length of the tree relative to the tested logs. When a backup cable was installed the failure was either fracture of the cable or yielding of the steel in the TAB. Pictures of typical failures are shown in Appendix A.

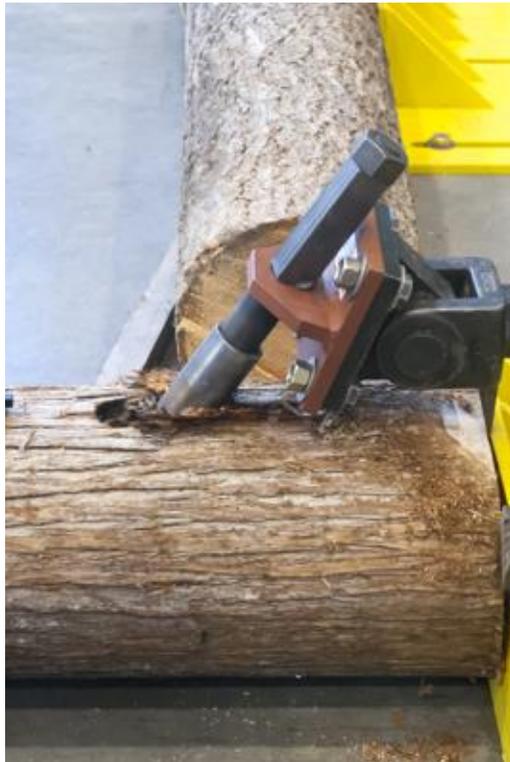
Figure A2. Parallel to grain (long axis) failure in Western Red Cedar

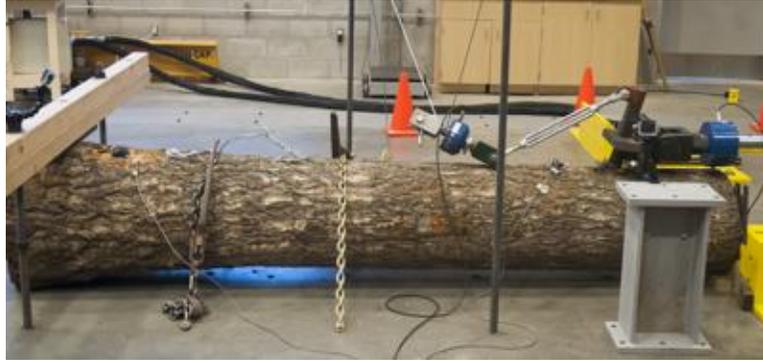
Figure A3. Parallel to grain (long) axis failure in Douglas Fir with cable backup

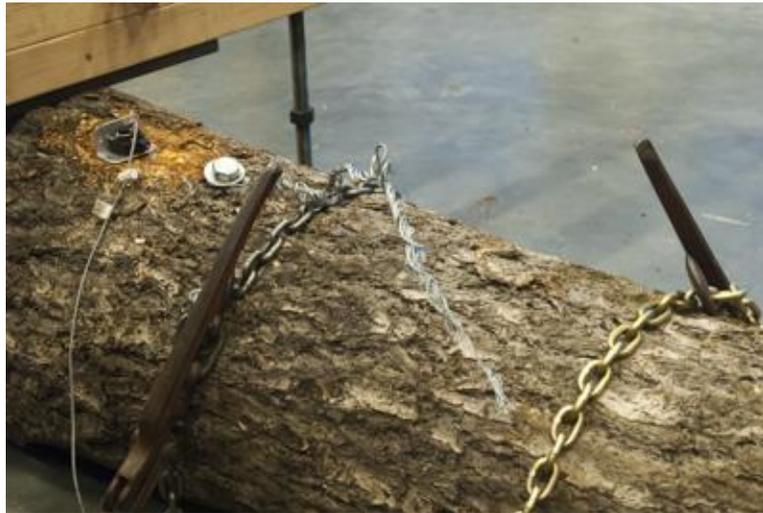
Figure A4. Parallel to grain (long axis) failure in Douglas Fir with cable backup

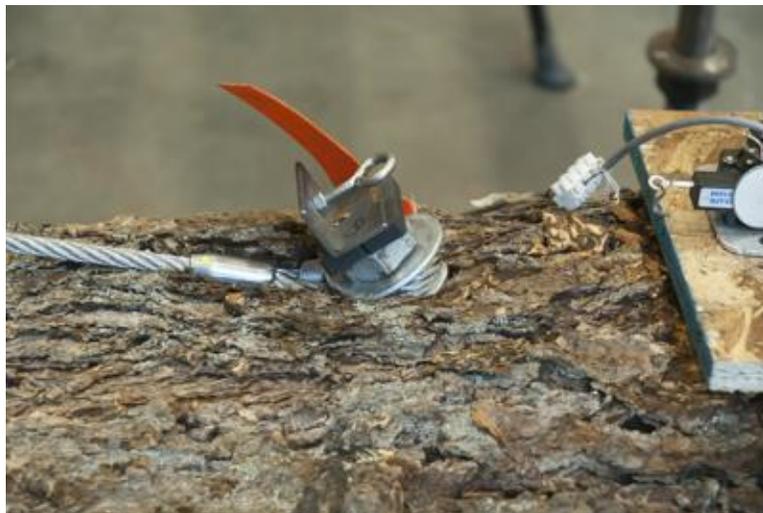
Figure A5. Parallel to grain (long axis) failure in Douglas Fir with cable backup

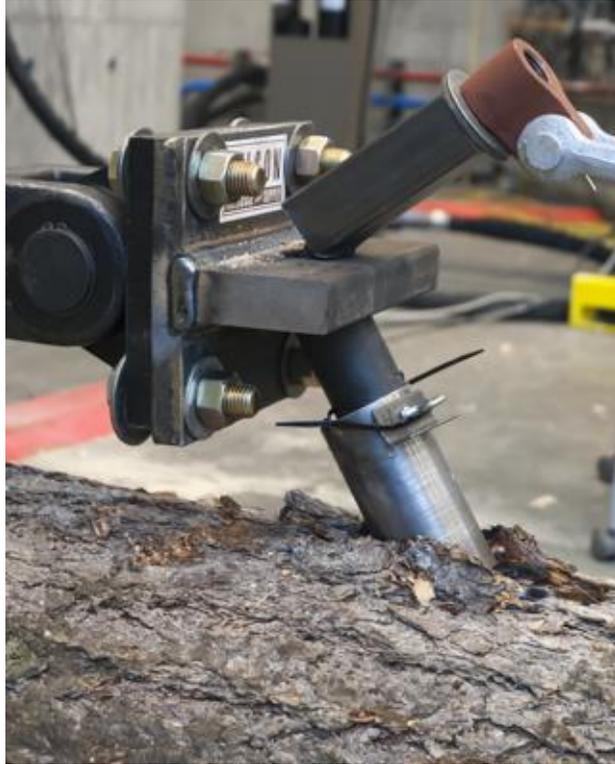
Figure A6. Parallel to grain (long axis) failure in Douglas Fir with cable backup

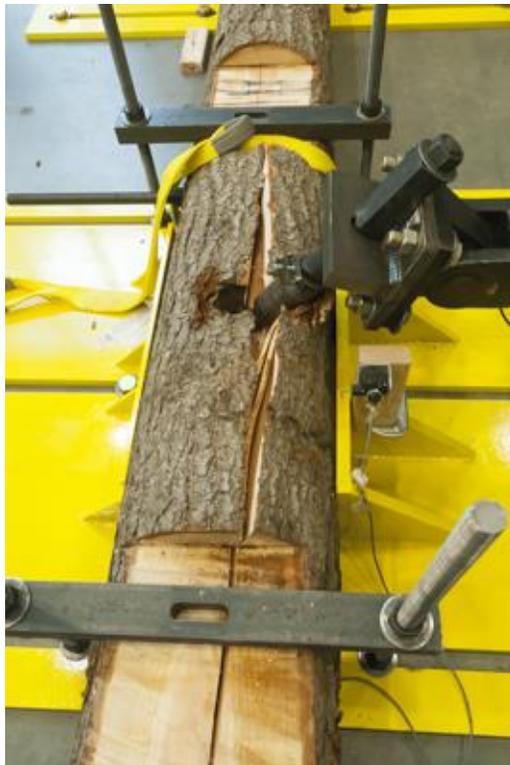
Figure A7. Perpendicular to grain (long axis) failure in Douglas Fir

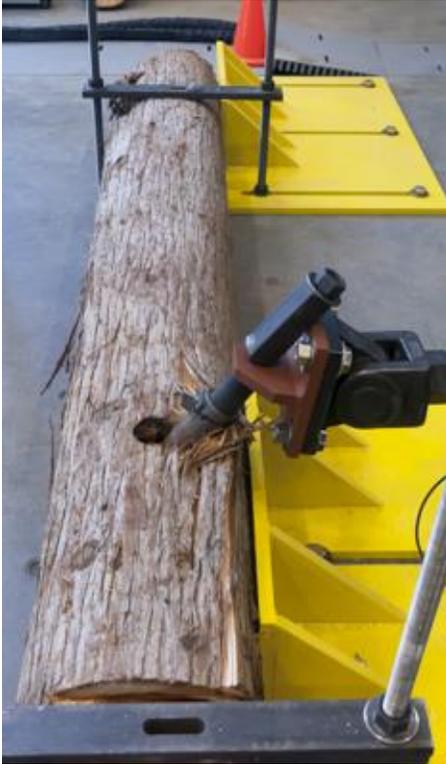
Figure A8. Perpendicular to grain (long axis) failure in Western Red Cedar

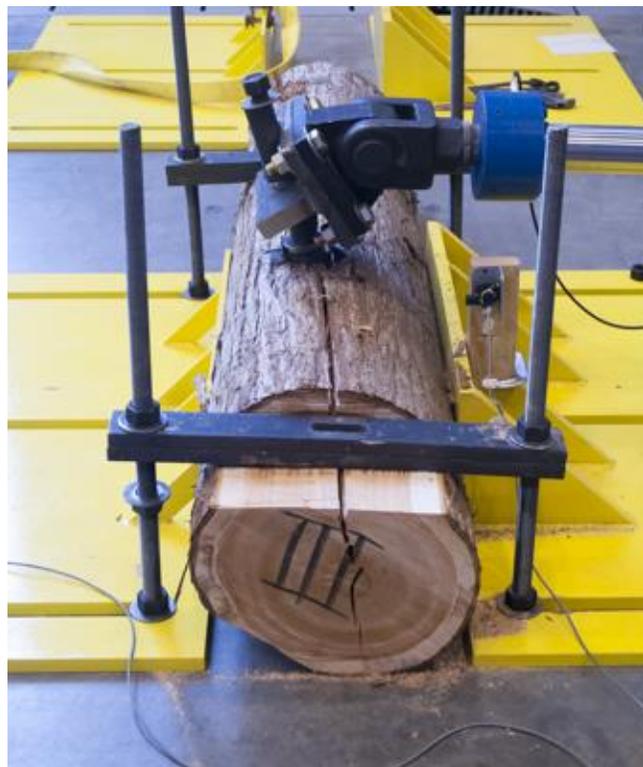
Figure A9. Perpendicular to grain (long axis) failure in Western Red Cedar after cyclic testing

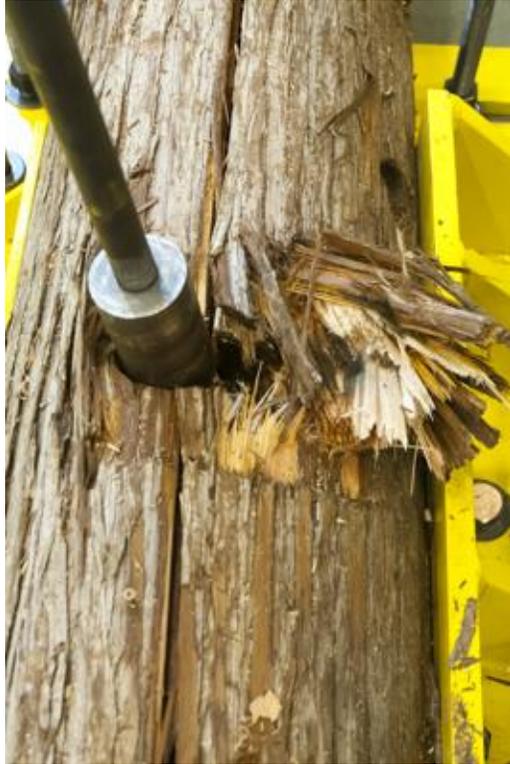
Figure A10. Perpendicular to grain (long axis) failure in Western Red Cedar after cyclic testing

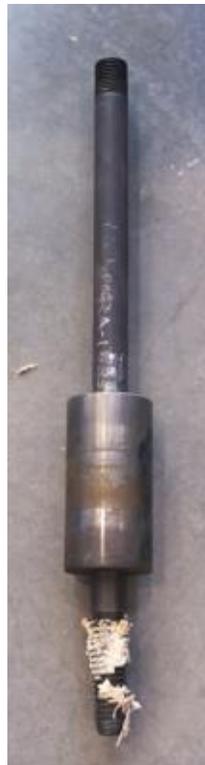
Figure A11. TAB with minimal damage after testing

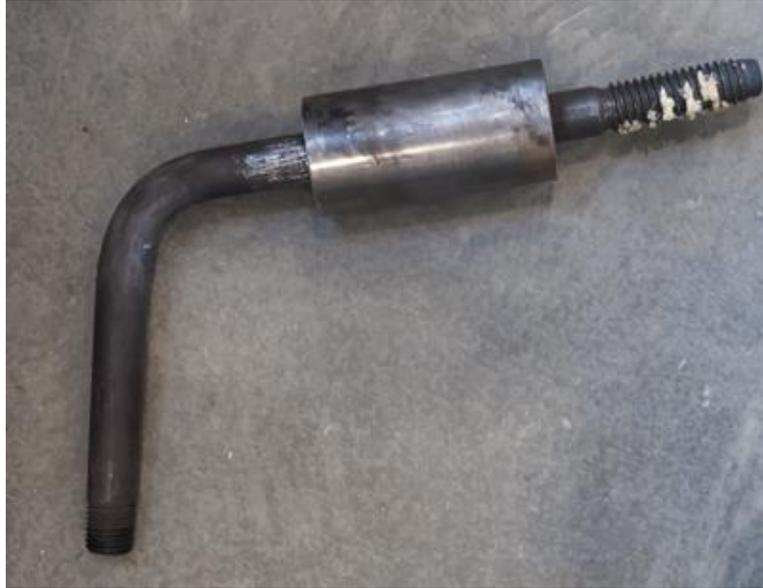
Figure A12. TAB with heavy damage after testing
