WASHTENAW COUNTY BROWNFIELD REDEVELOPMENT AUTHORITY (WCBRA)

BROWNFIELD PLAN FOR:

Arbor South Redevelopment, Ann Arbor, Michigan

2800 E. BOARDWALK; 2845, 2991 S. STATE STREET ANN ARBOR, MICHIGAN 48108

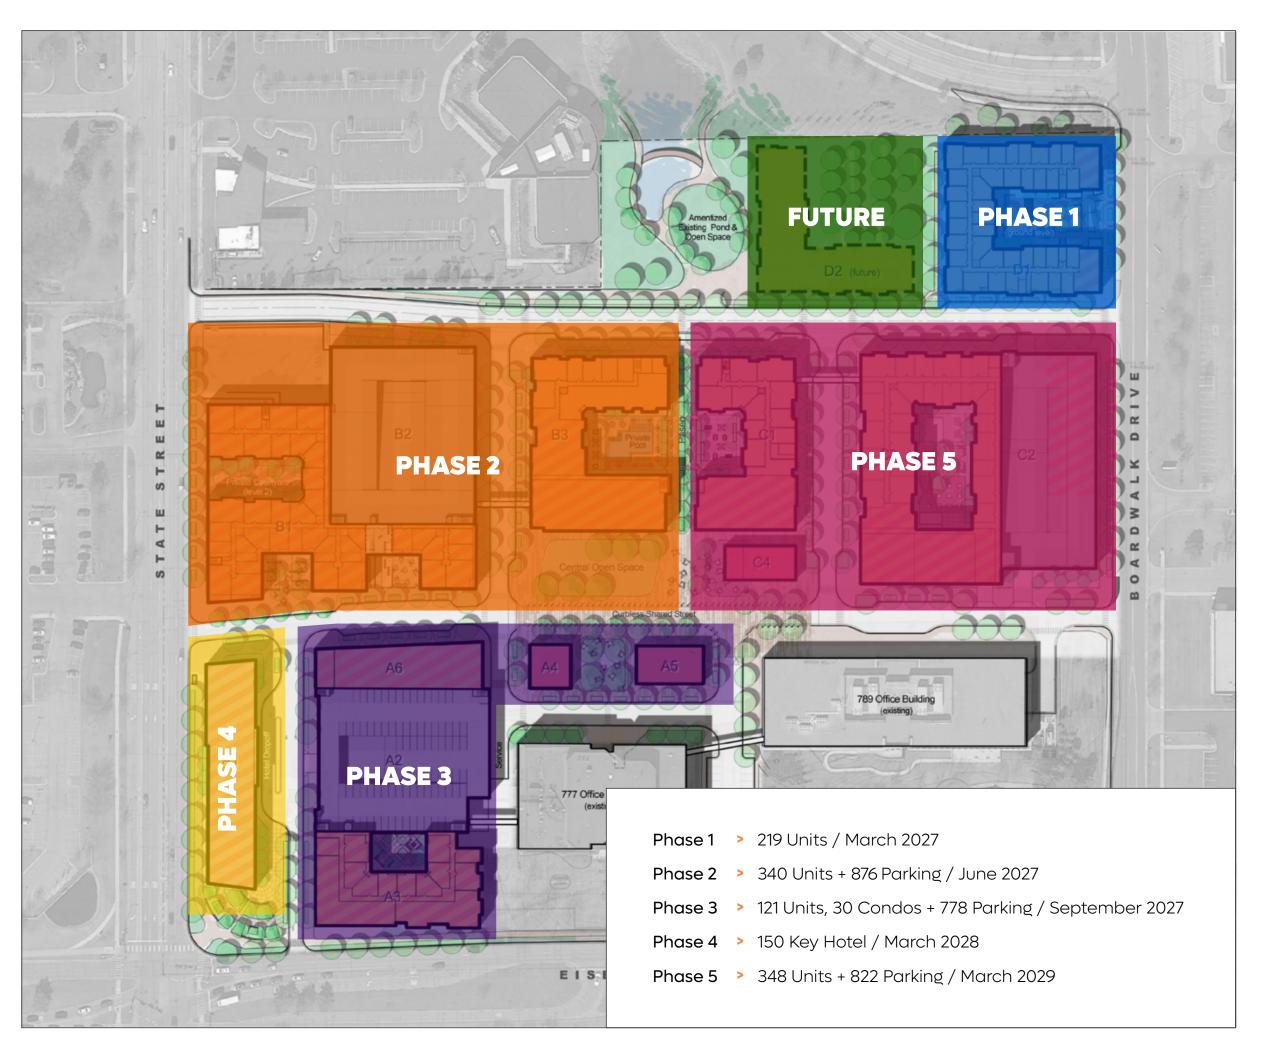
ATTACHMENT D PROJECT SITE PLAN

Site Concept Plan Arbor South
