ANN ARBOR HISTORIC DISTRICT COMMISSION**Staff Report**

ADDRESS: 530 N Division Street

DISTRICT: Old Fourth Ward Historic District

PETITION FOR THE RE-CLASSIFICATION OF THE STRUCTURE AT 530-532 NORTH DIVISION AS A NON-CONTRIBUTING RESOURCE

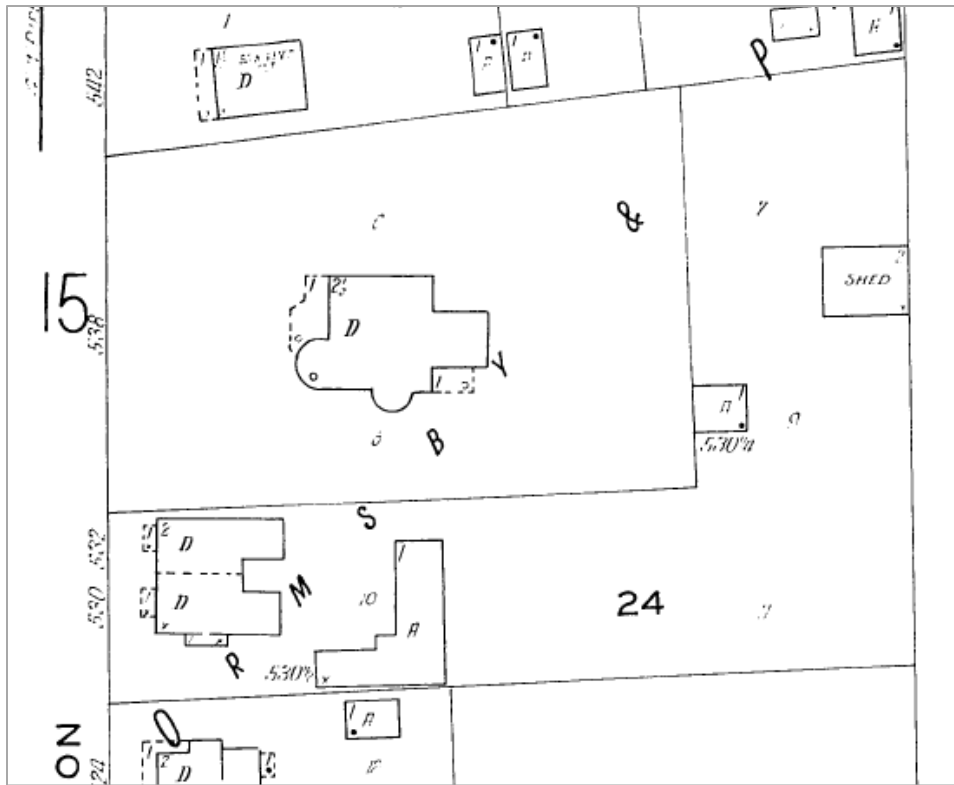
- The footprint of the building appears the same as shown on the 1931 Sanborn Fire Insurance Map.
- The massing of the building appears unaltered from when it was constructed in 1929.
- A 1947 aerial photo shows the same roof form that exists today.
- The building retains a bumpout on the south side that appears on the 1931 Sanborn.
- Evidence of wood clapboard siding is present under several layers of siding, including vinyl and asphalt brick.

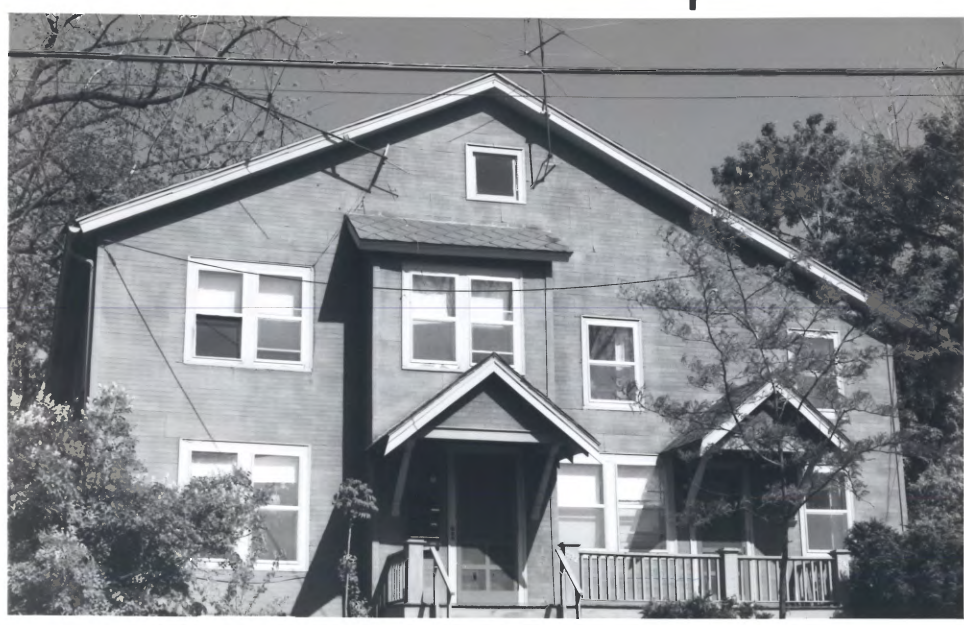
STRUCTURAL CONDITION	GOOD <input checked="" type="checkbox"/>	FAIR <input type="checkbox"/>	POOR <input type="checkbox"/>	10
MAINTENANCE QUALITY	GOOD <input checked="" type="checkbox"/>	FAIR <input type="checkbox"/>	POOR <input type="checkbox"/>	10

ALTERATIONS	NONE or MINOR <input checked="" type="checkbox"/>	MODERATE <input type="checkbox"/>	EXTENSIVE <input type="checkbox"/>	15
	APPROPRIATE <input checked="" type="checkbox"/>	INAPPROPRIATE <input type="checkbox"/>

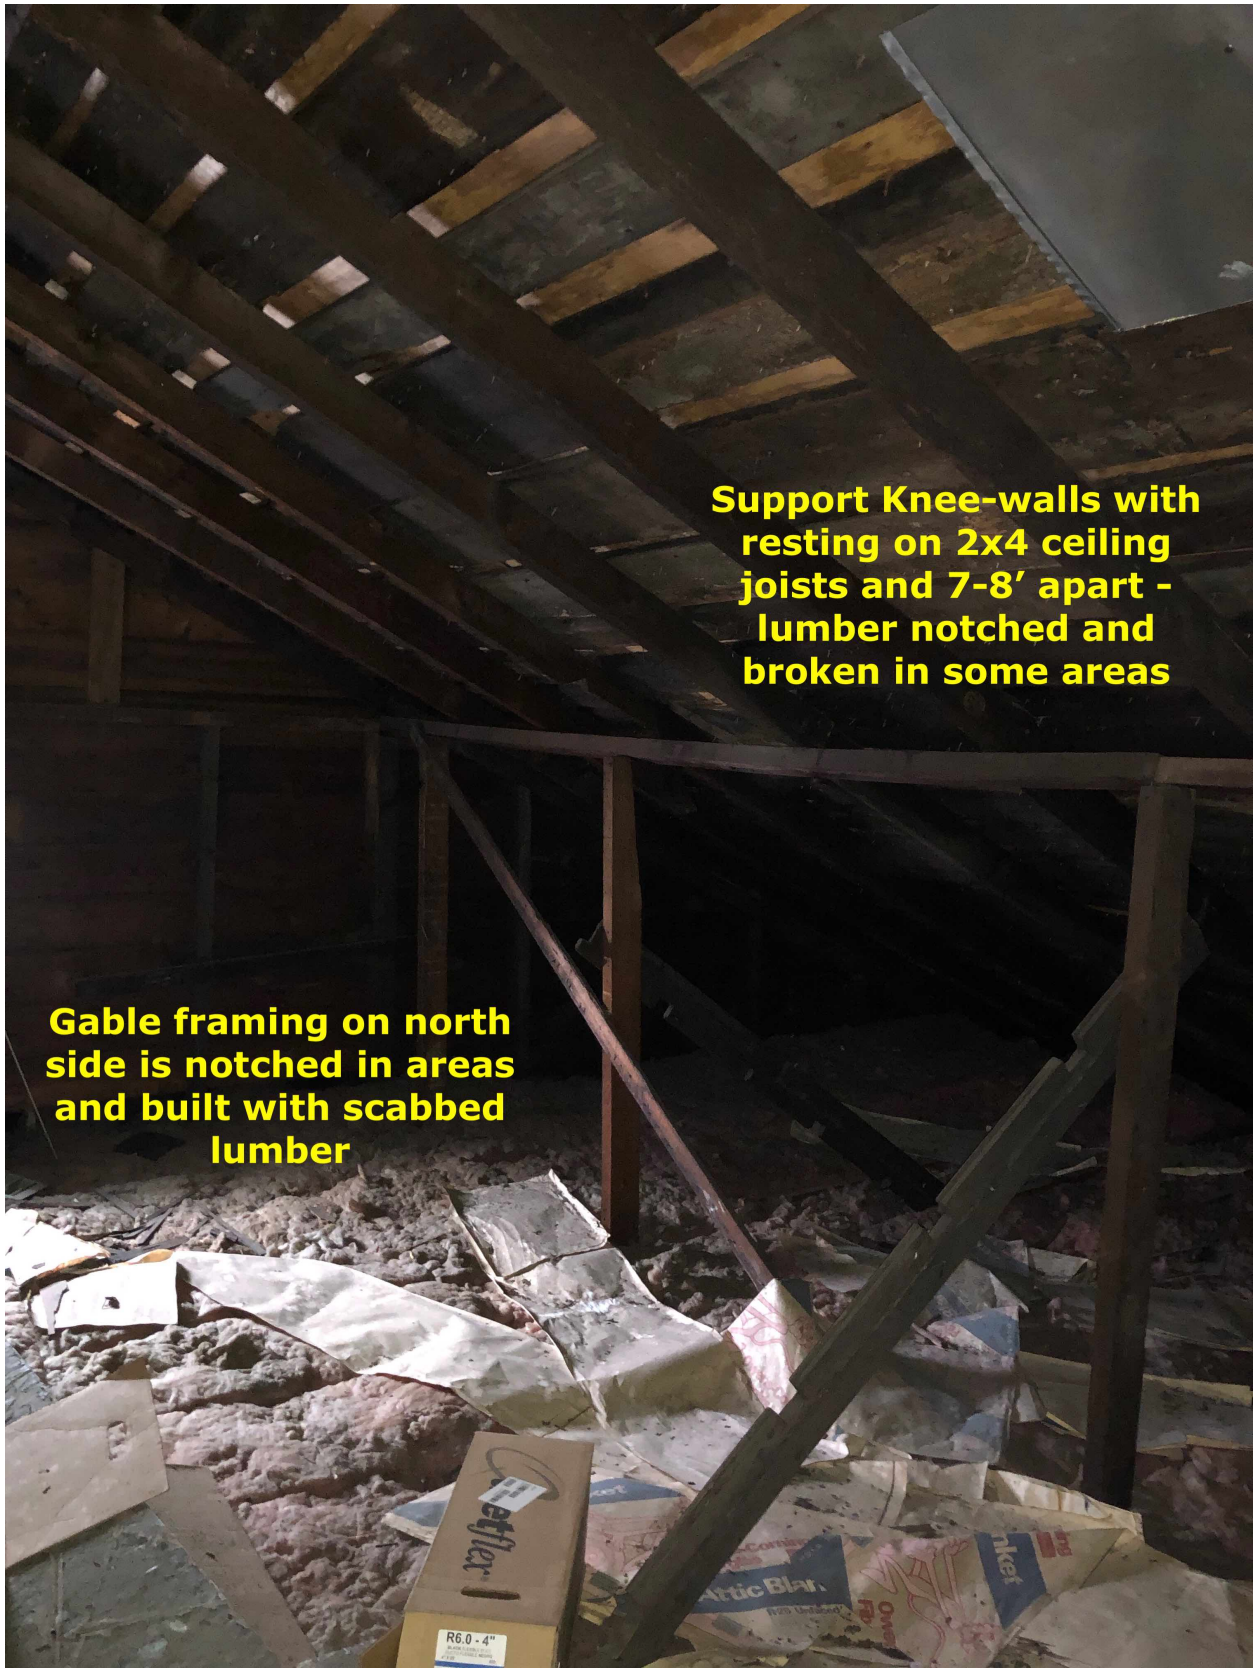
Support Knee-walls with resting on 2x4 ceiling joists and 7-8' apart - lumber notched and broken in some areas

It is my recommendation that the rafters should be entirely replaced with properly sized lumber that does not need knee-walls for support unless the second-floor ceiling joists are also completely replaced with lumber adequate to support those loads.
