ROAD SAFETY AUDIT

GLEN AVENUE & CATHERINE STREET; GLEN AVENUE & ANN STREET; ANN STREET & ZINA PITCHER PLACE

ANN ARBOR, MI

DATE: JULY 2025

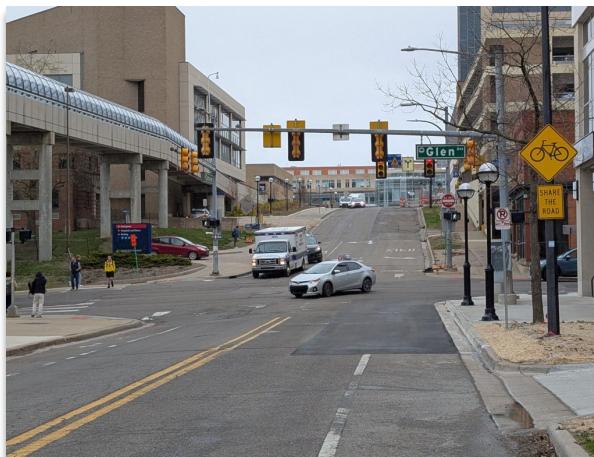
*Glen Avenue and Catherine Street Signal –
Eastbound Approach*

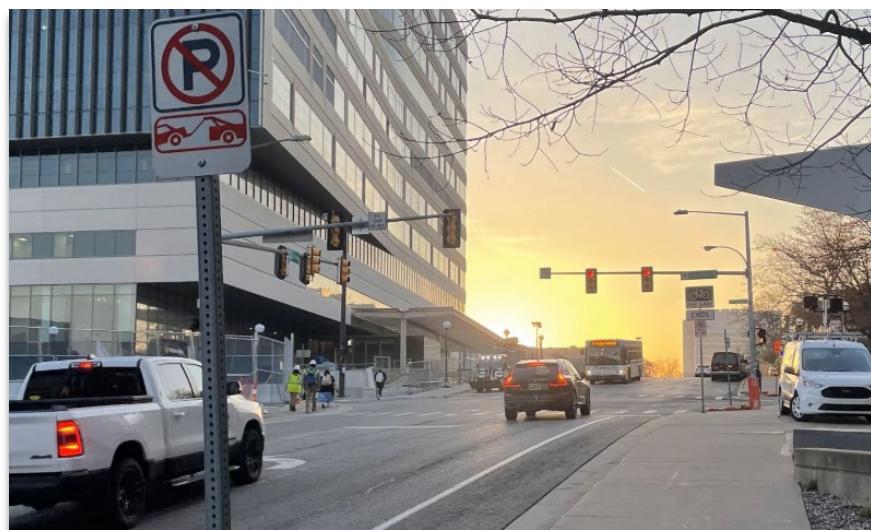
Ann Street and Zina Pitcher Place Signal – Eastbound Approach

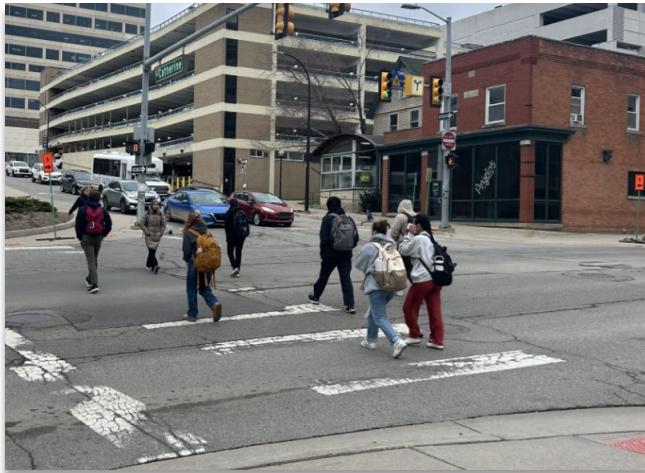
Pedestrians Crossing the North Leg at Glen Avenue and Catherine Street

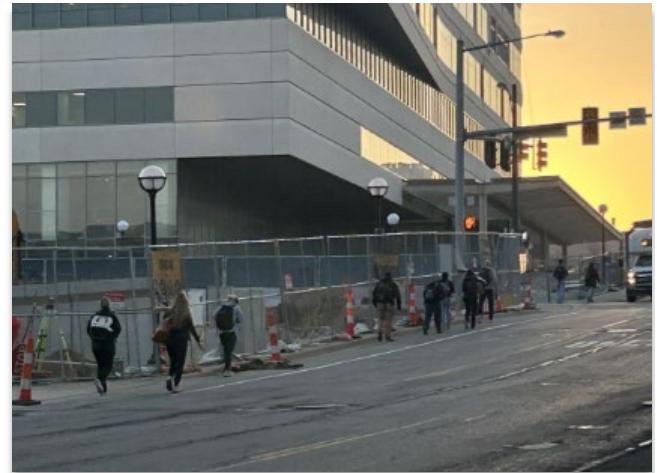
Pedestrians Walking in the Road Along the Closed Sidewalk on Ann Street

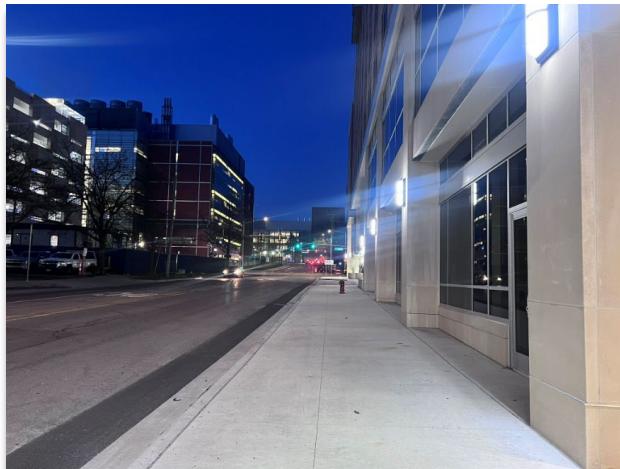
Pedestrian-scale Lighting

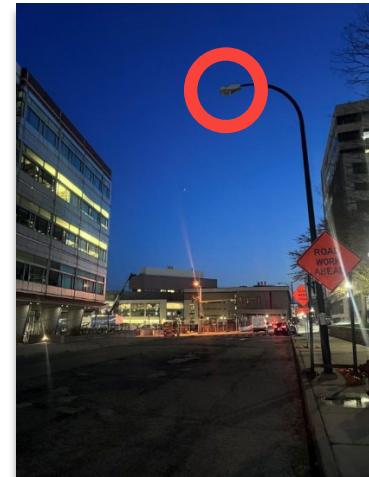
Non-working Light Fixture at Ann Street and Zina Pitcher Place

Fix the Non-functional Light Fixtures

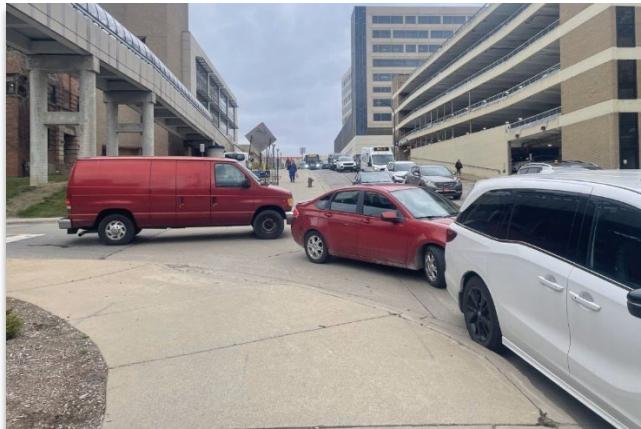
Traffic Congestion Turning from W Medical Center Drive

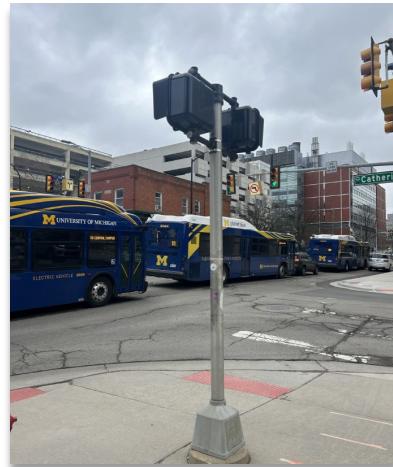
Traffic Congestion Traveling Southbound along Glen Avenue from Catherine Street to Ann Street

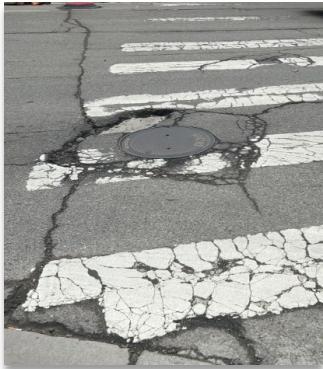
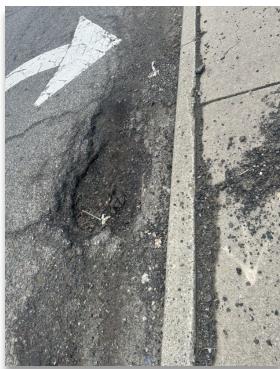
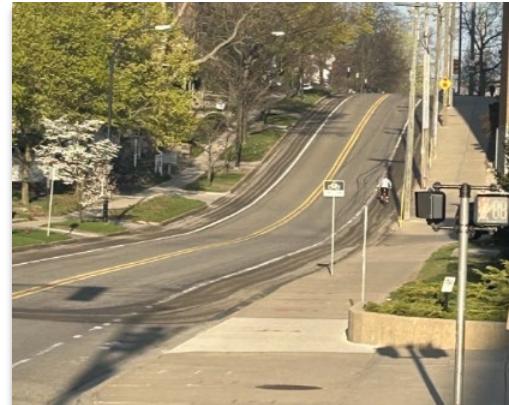
Cracked Pavement Throughout the Study Area

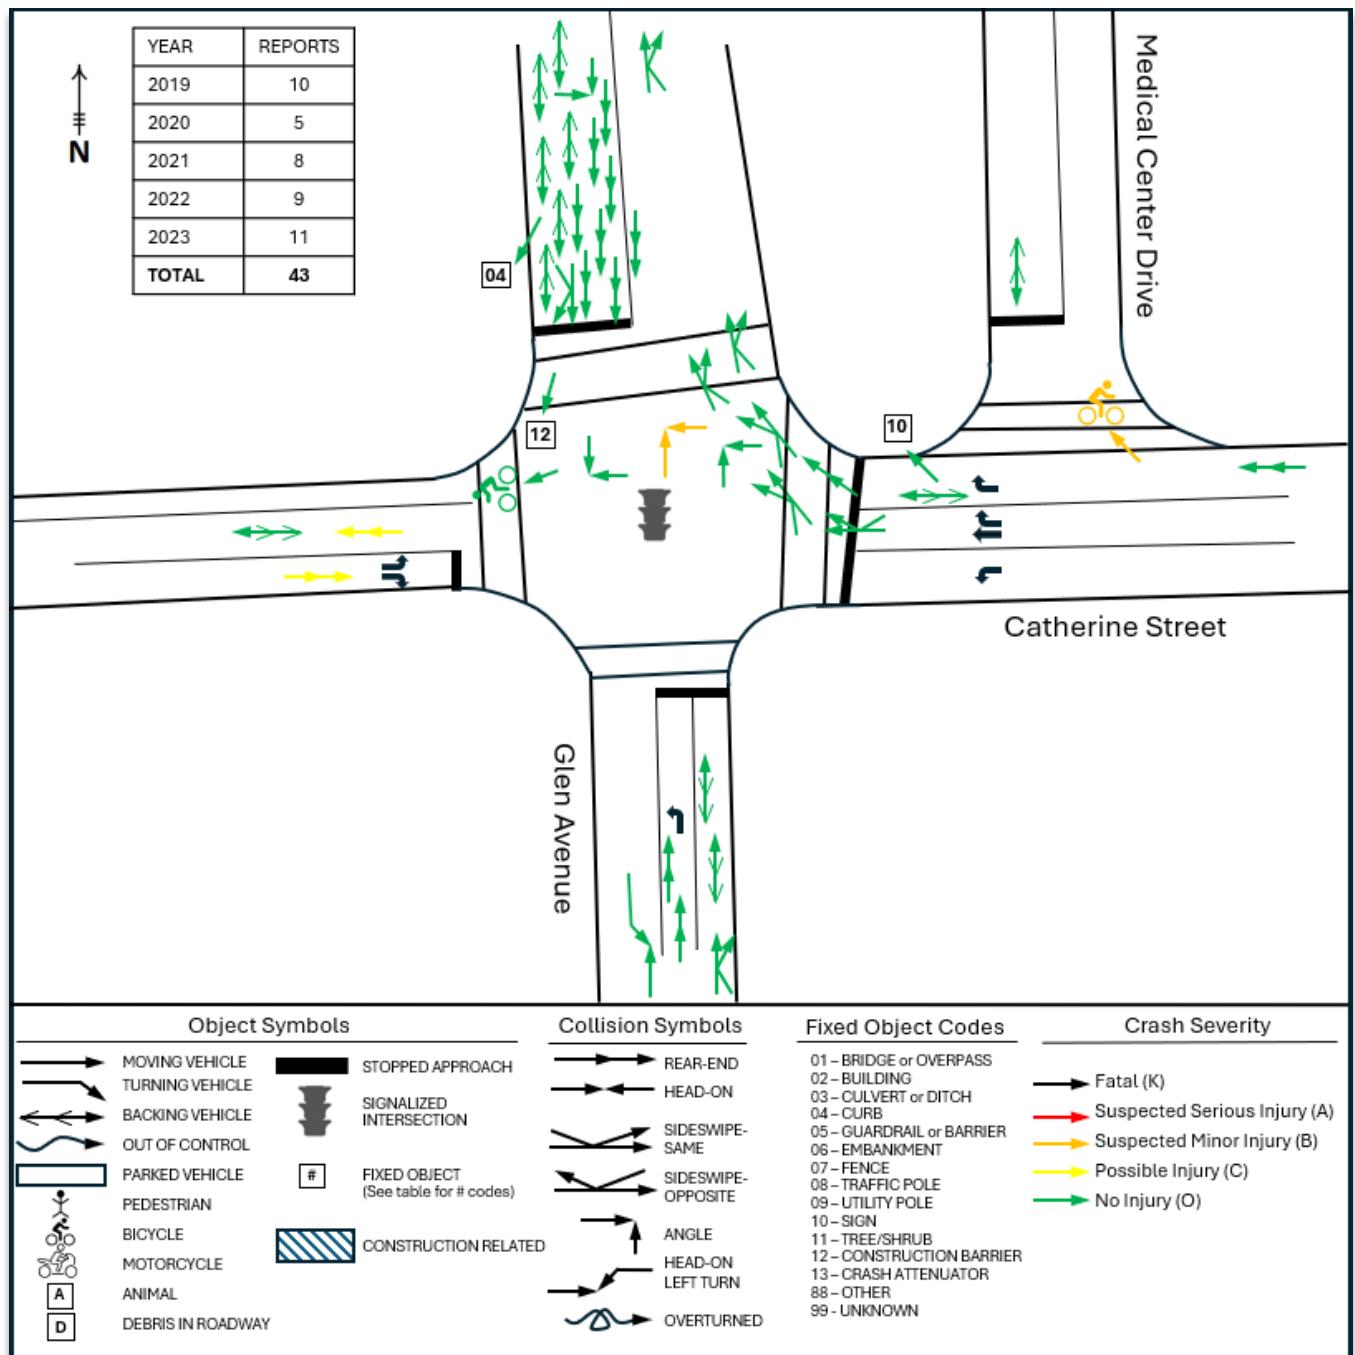
Figure 6 - Spatial Distribution of Crashes at Glen Avenue and Catherine Street from 2019-2023 (Source: MTCF)

- Rear-end crashes
 - Fourteen rear-end crashes occurred throughout the intersection. The majority of rear-end crashes (8 crashes) occurred along the north leg of Glen Ave. Two rear-end crashes that occurred along the west leg of Catherine St resulted in a possible injury while the remaining rear-end crashes resulted in property damage only.

- Backing crashes
 - Eleven backing crashes occurred throughout the intersection. The majority of backing crashes (6 crashes) occurred along the north leg of Glen Ave. The presence of a vertical slope along the north leg was noted as a contributing factor for many of the backing crash types. All of the backing crashes resulted in property damage only.

- Sideswipe-same direction crashes
 - Eight sideswipe-same direction crashes occurred at the intersection. Five of the crashes resulted from improper lane use or turning too tight when making the right turn onto northbound Glen Ave from westbound Catherine St. All of the crashes resulted in property damage only.

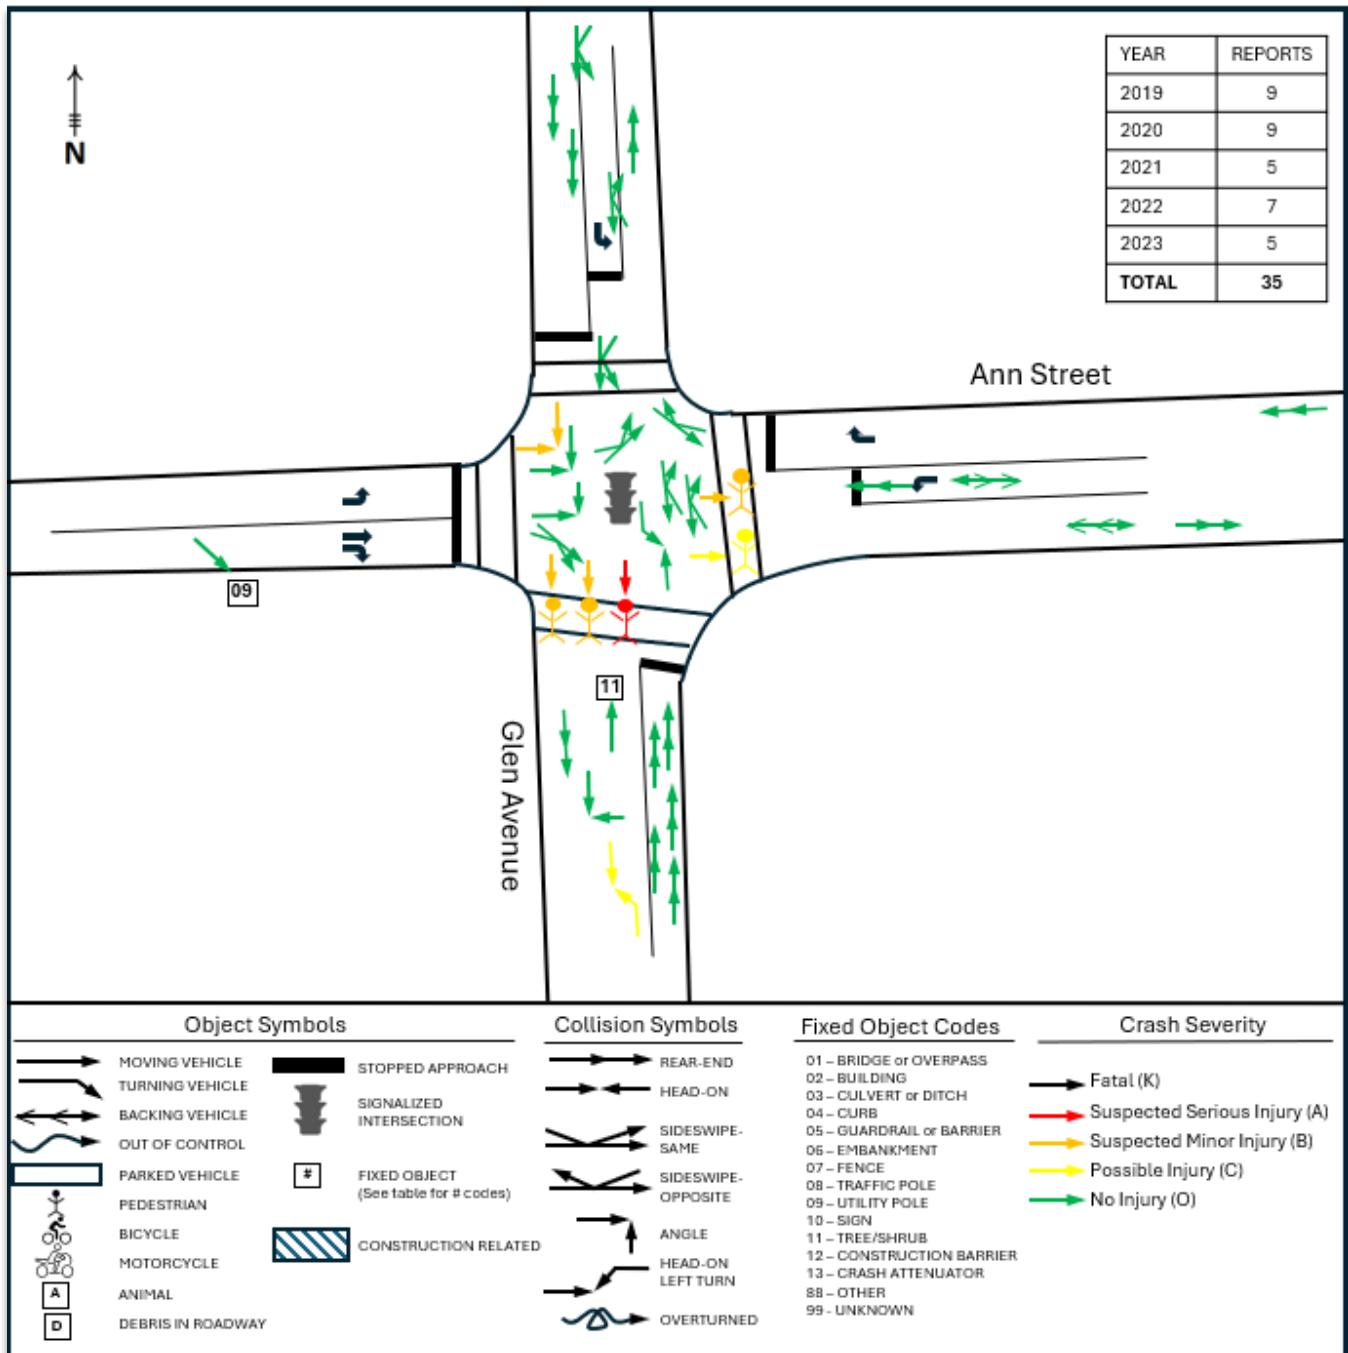
Figure 7 - Spatial Distribution of Crashes at Glen Avenue and Ann Street from 2019-2023 (Source: MTCF)

- Rear-end crashes
 - Twelve rear-end crashes occurred throughout the intersection. The most rear-end crashes (5 crashes) occurred along the south leg of Glen Ave. All of the rear-end crashes resulted in property damage only.
- Backing crashes
 - Two backing crashes occurred on the east leg of the intersection, of which all resulted in property damage only.
- Fixed object crashes
 - Two fixed object crashes occurred at the intersection.
 - One fixed object crash resulted from a driver traveling the wrong way along the west leg of Ann St, which is a one-way street. Once the driver realized they were traveling the wrong way, they attempted to make a U-turn and struck a utility pole. The crash resulted in property damage only.
 - One fixed object crash occurred when a large tree branch fell from a tree onto a vehicle traveling along Glen Ave. The crash resulted in property damage only.

- Sideswipe-same direction crashes
 - Four sideswipe-same direction crashes occurred at the intersection. Two of the crashes involved striking a university bus. Narrow lane widths were noted as contributing factors for many of the sideswipe crashes. All of the crashes resulted in property damage only.

- Sideswipe-opposite direction crashes
 - Four sideswipe-opposite direction crashes occurred at the intersection. Three of the crashes involved striking a university bus. Narrow lane widths were noted as contributing factors for many of the sideswipe crashes. All of the crashes resulted in property damage only.

- Angle crashes
 - Four angle crashes occurred at the intersection. Three of the crashes resulted in a collision between an eastbound vehicle along Ann St and a southbound vehicle on Glen Ave. The remaining angle crash resulted along the south leg of the intersection when a vehicle was attempting to make a left turn into a private drive. One angle crash resulted in a suspected minor injury and the remaining crashes resulted in property damage only.

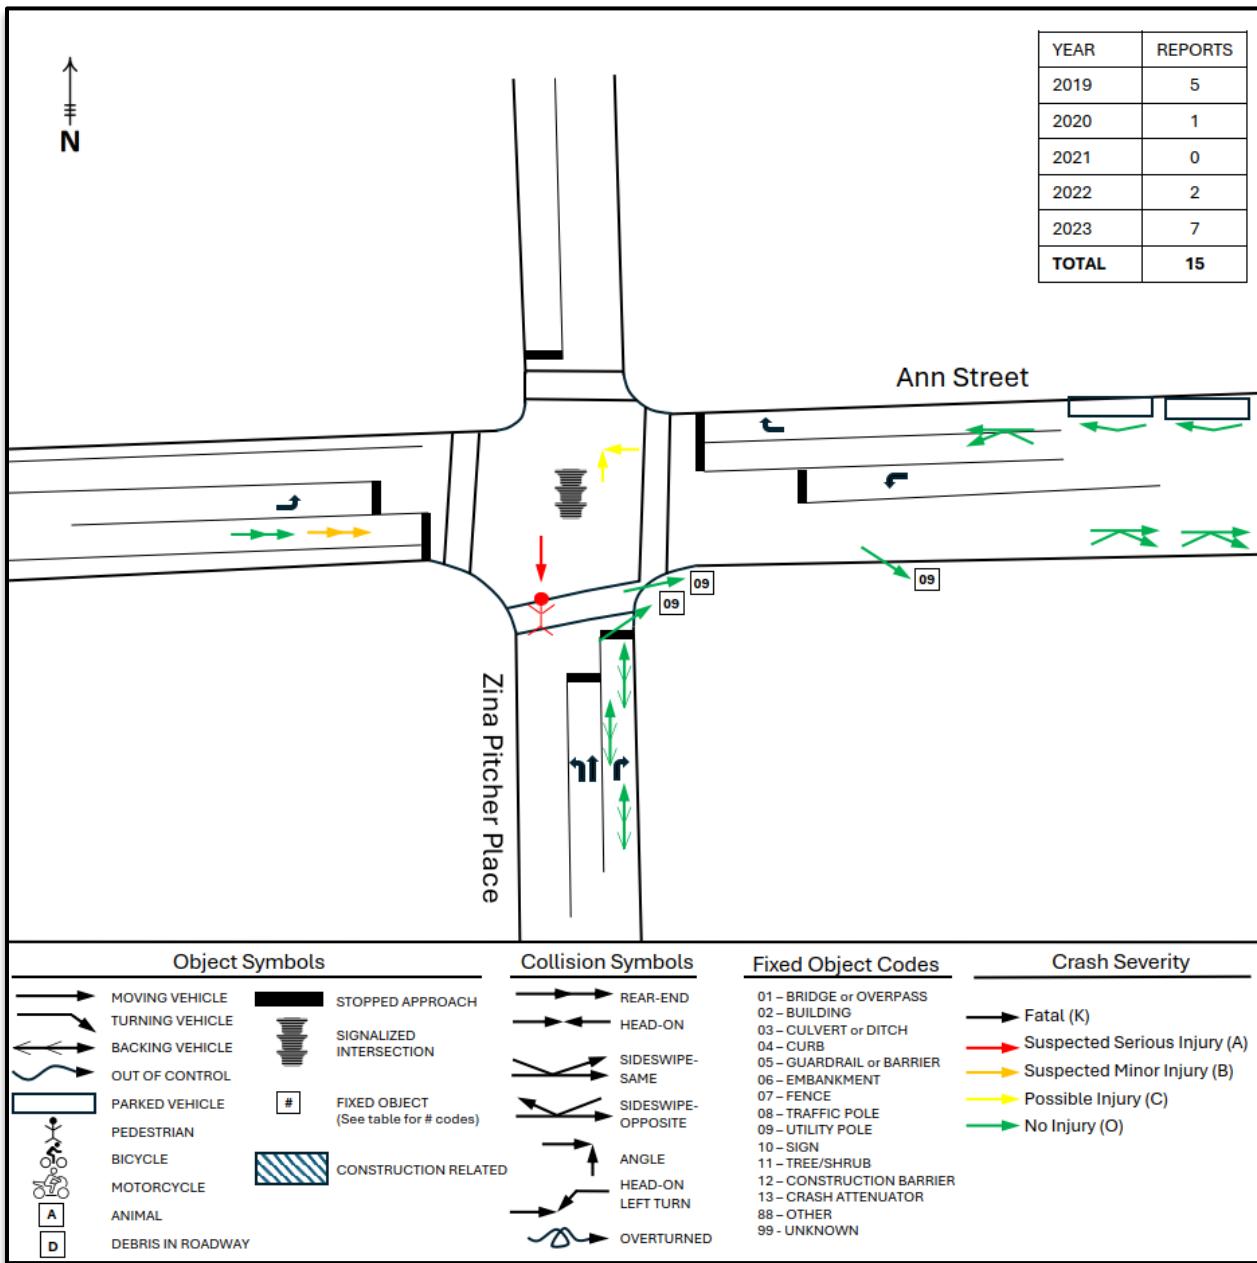
Figure 8- Spatial Distribution of Crashes at Ann Street and Zina Pitcher Place from 2019-2023 (Source: MTCF)

- Rear-end crashes
 - Two rear-end crashes occurred on the west leg of the intersection, of which one resulted in a non-incapacitating injury crash severity.
- Backing crashes
 - Three backing crashes occurred on the south leg of the intersection, of which all resulted in property damage only.
 - One crash was caused by a driver backing up to not block a crosswalk, one crash was caused by a driver backing up to get out of snow, and one crash was caused by a driver backing up to allow room for a truck to turn.

- Fixed object crashes
 - Three fixed object crashes occurred at the intersection. Two resulted from a bus attempting to turn right from Zana Pitcher Pl onto Ann St and striking a utility pole located in the southeast corner of the intersection. The other crash occurred from a bus traveling eastbound along Ann St and striking a utility pole. All crashes resulted in property damage only.

- Sideswipe-same direction crashes
 - Five sideswipe-same direction crashes occurred along Ann St on the east leg of the intersection. Two were the result of a vehicle striking a legally parked vehicle along Ann St. The three remaining crashes involved a vehicle striking a university bus while attempting to maneuver around it. All crashes resulted in property damage only.

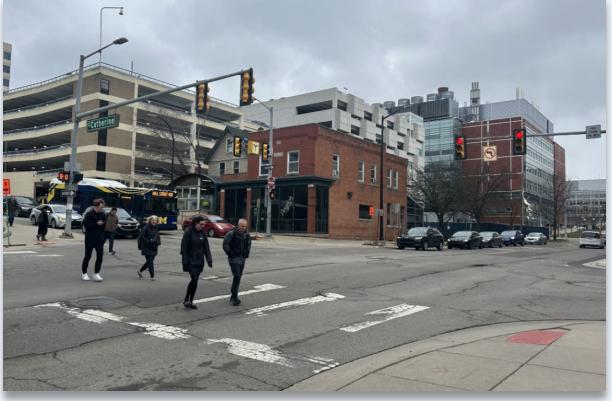
Existing Safety Measures	
Modern Features at the Intersections	
<p>The study intersections are modernized with box span signal configurations, backplates, continental high visibility crosswalks, detectable warning pads, countdown pedestrian signals (with the exception of Ann Street and Zina Pitcher Place), and leading pedestrian intervals (LPIs). Countdown timers, high visibility markings, and leading pedestrian intervals help improve non-motorized user safety. Box span layouts align traffic signal heads with approaching vehicles and improve signal conspicuity. Backplates help delineate the signal heads against background visuals as well as low angle sun positioning for east/west approaches.</p>

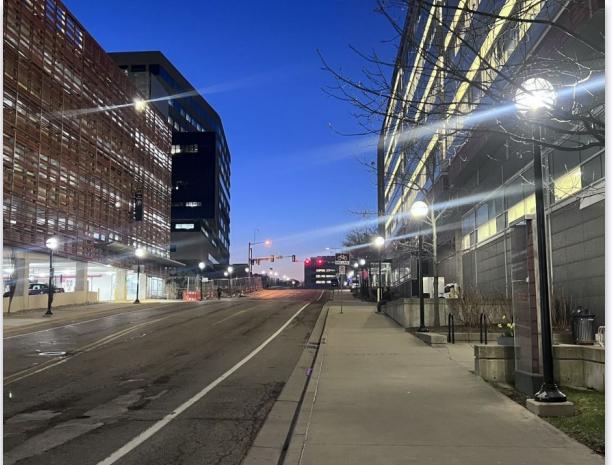
Intersection and Pedestrian-scale Lighting <p>Overhead lighting is present throughout the study area as well as pedestrian scale lighting located along a few places within the study area. Intersection lighting improves visibility for drivers and pedestrians. Furthermore, pedestrian-scale lighting illuminates sidewalks and crosswalks, making it easier for pedestrians to navigate safely and improving their conspicuity to drivers, especially at night.</p>

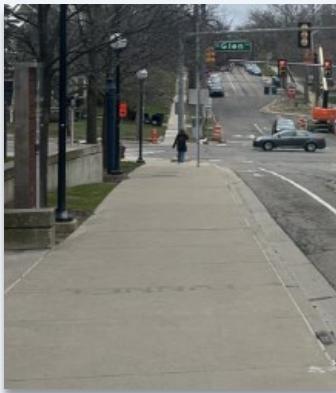
<p>Sidewalk Connectivity</p> <p>Sidewalks are located throughout the study area, excluding temporary construction areas, and were observed to be sufficiently wide and in good condition with minimal cracks.</p>

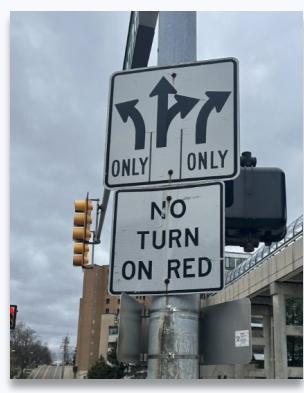
<p>No Turn on Red Restrictions</p> <p>Right turn on red restrictions are present throughout Glen Avenue and Catherine Street as well as for some movements at the other study intersection. The restriction helps to eliminate conflicts between right-turning vehicles and pedestrians and bicyclists traveling through the intersection.</p>

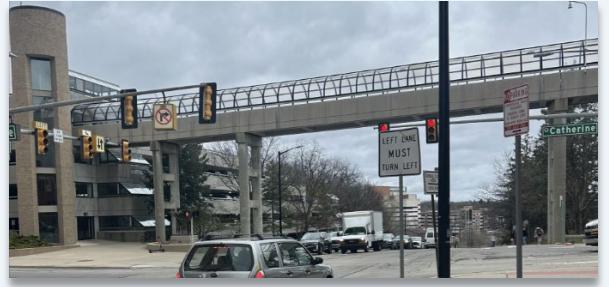
<p>Pedestrian Skywalk</p> <p>The pedestrian skywalk located above the north leg of Glen Avenue and Catherine Street reduces pedestrian-vehicular conflicts for pedestrians moving from the Glen Avenue parking structure towards the hospital.</p>

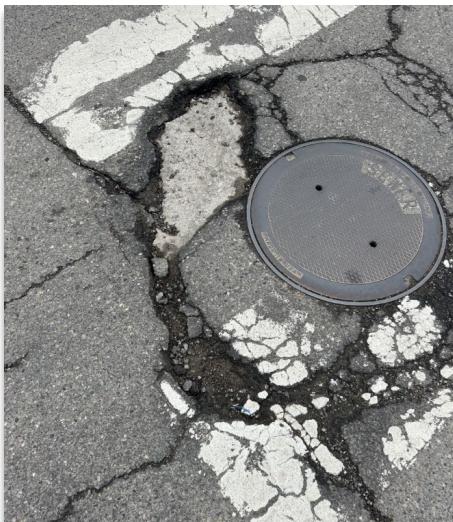
During the field review, the RSA team observed pedestrian obstacles such as broken pavement in the crosswalks at the study intersections and faded pavement markings. Figure 17 depicts the pedestrian obstacles identified during the field review. Broken pavement can create tripping hazards, making it difficult for pedestrians to navigate the crosswalks safely and leading to deviations outside of marked crossings. This is particularly concerning for individuals with mobility impairments, who may struggle to maintain balance on uneven surfaces. Faded pavement markings can reduce the visibility of crosswalks and stop bars for all users, leading to confusion among pedestrians and increasing the risk of pedestrian-vehicle collisions. Without clear markings, pedestrians may not be aware of designated crossing areas, further compromising their safety. Additionally, motorists might not see a faded stop bar marking and may encroach on the crosswalk, increasing the risk of a crash involving a pedestrian.

Broken Pavement in the Crosswalk

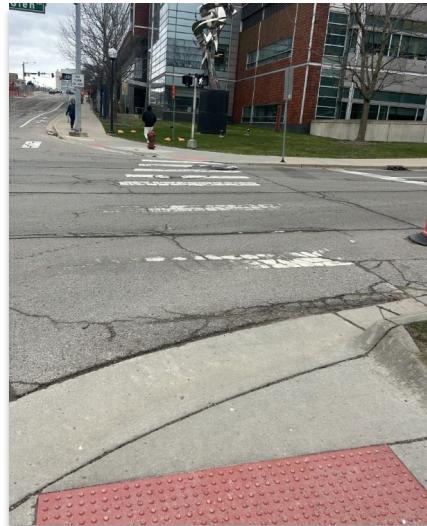
Faded Crosswalk Markings

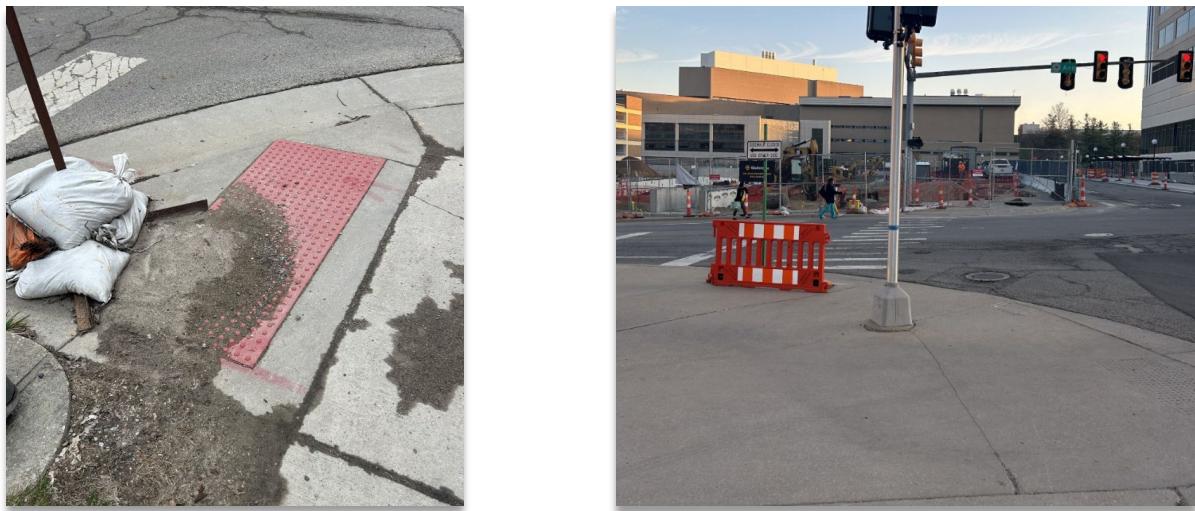
Furthermore, it was observed that some study intersection corners may not be ADA compliant. Specifically, some intersection corners lack detectable warning pads, while others have pads that are obstructed by debris and construction equipment, hindering the tactile cues necessary for visually impaired pedestrians to navigate safely. Additionally, some corners were identified to not provide the adequate amount of space needed for pedestrians, particularly those with mobility impairments, to maneuver comfortably. Figure 18 shows these compliance issues at intersection corners. These conditions pose significant obstacles for pedestrians and compromise the accessibility and safety of the intersections.

Figure 18 - ADA Compliance Issues at Intersection Corners

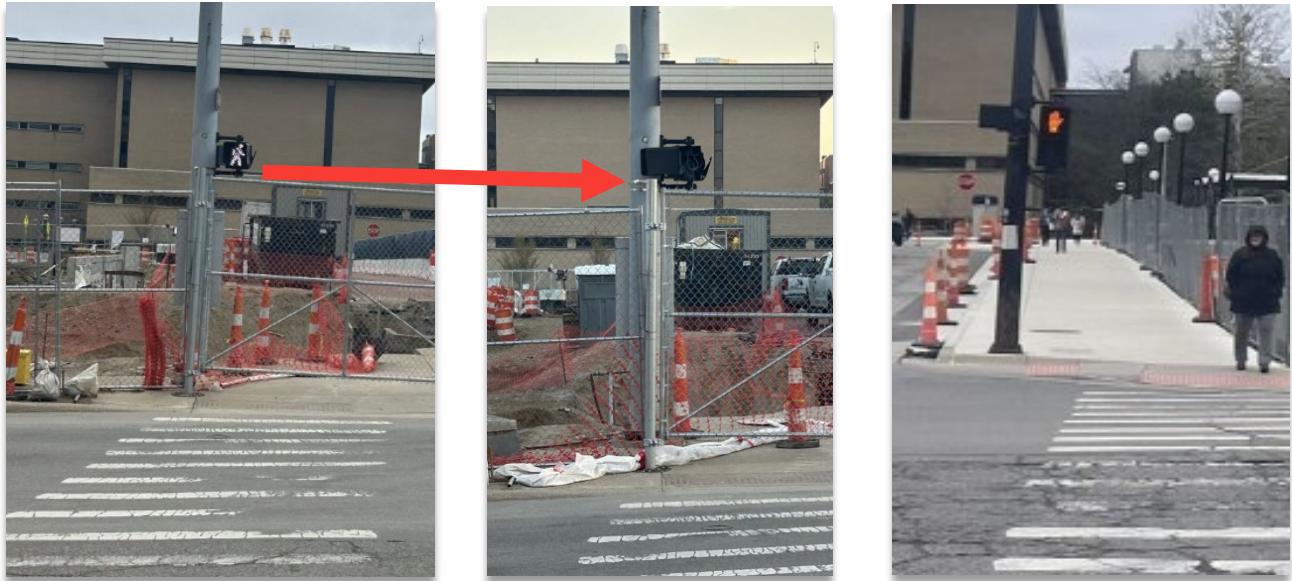
At the study intersection of Ann Street and Zina Pitcher Place, it was observed that countdown pedestrian timers were not present, with the exception of the southwest corner. The pedestrian signals present at the intersection can be seen in Figure 19. Additionally, during the second day of field reviews, it was observed that the pedestrian signal in the northwest corner was broken, as shown in Figure 19. Without countdown timers, pedestrians do not have a clear indication of how much time they have left to cross the street, leading to uncertainty and potentially risky crossing decisions. This can result in pedestrians being caught in the intersection when the signal changes, increasing the risk of pedestrian-vehicle collisions. Countdown timers provide valuable information that help pedestrians make informed decisions about when to start crossing, thereby enhancing overall pedestrian safety.

Broken Pedestrian Signal Head, Northwest Corner

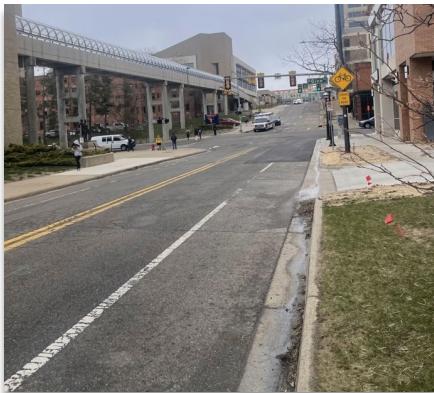
Bicycle facilities and bicyclist safety were also observed during the field review. The RSA team observed that bicycle facilities at Catherine Street and Ann Street drop at the intersections, as shown in Figure 20. This poses significant safety concerns for cyclists, as they are forced to merge with motor vehicle traffic, increasing the risk of collisions. Additionally, the sudden disappearance of dedicated bike lanes can lead to confusion and unpredictability for both cyclists and drivers, making it difficult for cyclists to navigate safely through the study area. Furthermore, the lack of continuous bike lanes can discourage cycling as a mode of transportation, reducing the overall connectivity and accessibility of the area for cyclists and contributing to observed behaviors like biking on the sidewalk.

Catherine Street at Glen Avenue

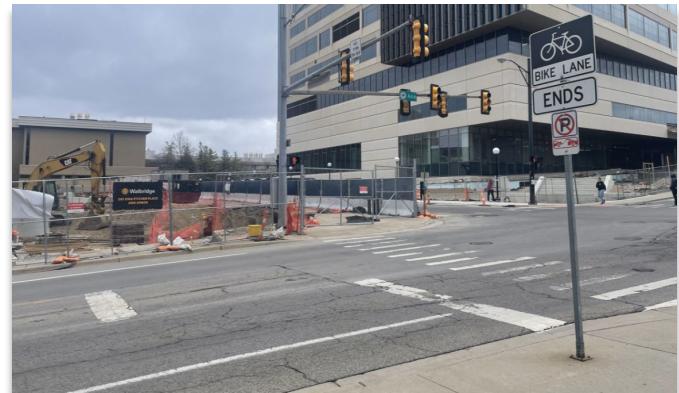
Ann Street at Zina Pitcher Place

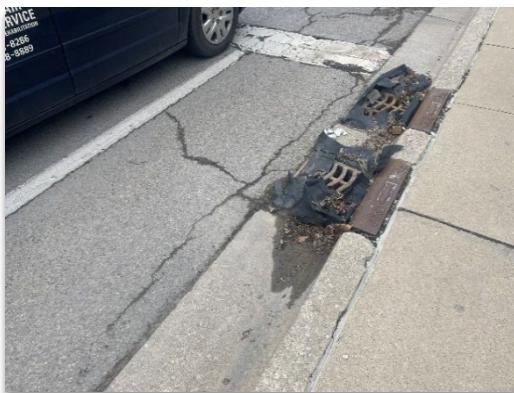
During field review, it was observed that the drainage grates within the bike lanes on Ann Street were aligned incorrectly. Currently, the drainage grates are aligned parallel to the roadway, as shown in Figure 21, when they should be aligned perpendicular. This misalignment poses significant safety concerns for cyclists. When the grates are parallel to the roadway, there is a risk that bicycle tires can get caught in the gaps of the grate, as demonstrated in Figure 21, causing the bicyclist to lose control and potentially fall into the roadway.

Drainage Grate Alignment on Ann Street

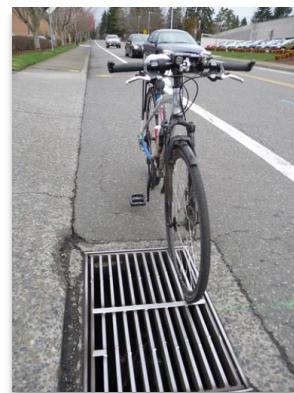
Figure 21 - Incorrect Drainage Grate Alignment

Bicycle Hazard Example³

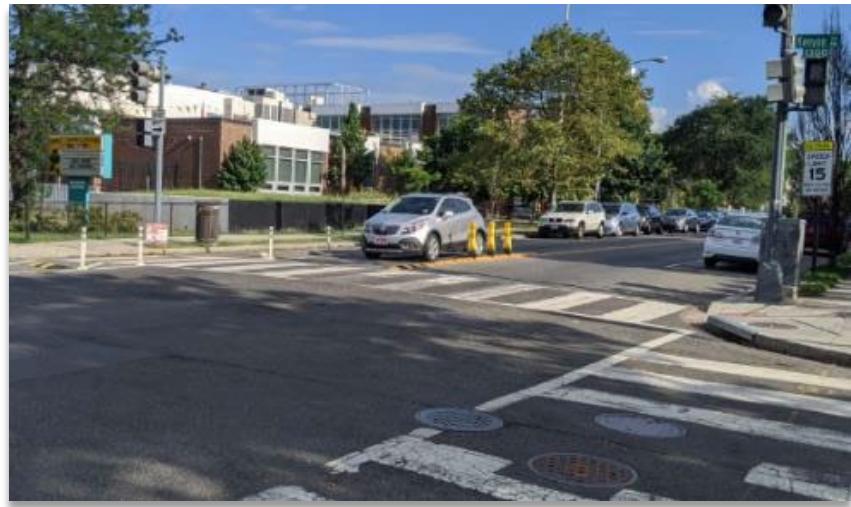
Figure 22 - Centerline Hardening Technique⁴

A crash pattern of left-turning motorists hitting pedestrians in the east and south leg crosswalks of Ann Street and Glen Avenue during the permissive left-turn phase was noted during crash review. To reduce the risk and severity of these crashes, it is recommended to install hardened centerlines along the south and east legs of the intersection. The centerline hardening technique encourages left-turning motorists to turn at safe speeds and angles to improve their visibility of pedestrians crossing in the crosswalk. The technique involves adding physical barriers, such as flexible posts, curbs, or other objects along the centerline of the road to discourage motorists from taking shallow turns, which reduces the visibility of other users. Figure 22 depicts this technique. Additionally, it is important to design the hardened centerlines to ensure emergency vehicles, such as firetrucks needing to respond to calls at the hospital, are still able to complete the left turn maneuvers. To accommodate emergency vehicles, mountable rubber curbs should be used near the crosswalk, followed by flexible posts outside of the turning radius.

To further enhance safety, extra flexible delineators should be strategically placed along the east leg of the intersection through the first entrance to the Ann Street parking structure. By positioning these delineators far enough back, vehicles will be discouraged from making improper turns into the parking garage, a behavior that was observed during field reviews. This improper left turn maneuver into the parking garage is depicted in Figure 23. Figure 24 illustrates the recommended placement of the flexible delineators along both the east and south legs of the intersection. This configuration aims to guide vehicles more effectively, reducing the risk of collisions with non-motorized road users.

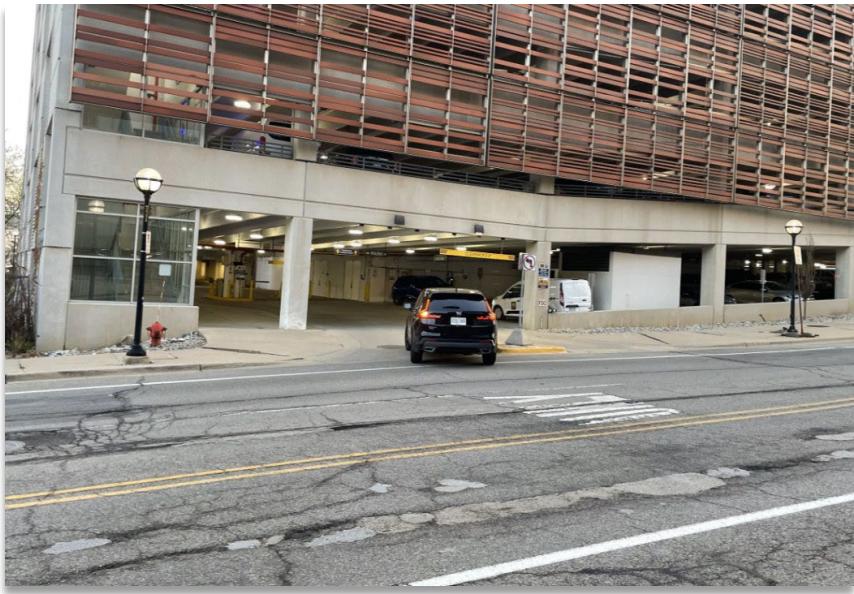
Figure 23 - Improper Left Turn into Ann Street Parking Garage

Figure 24 - Recommended Placement of Centerline Hardening at Ann Street and Glen Avenue

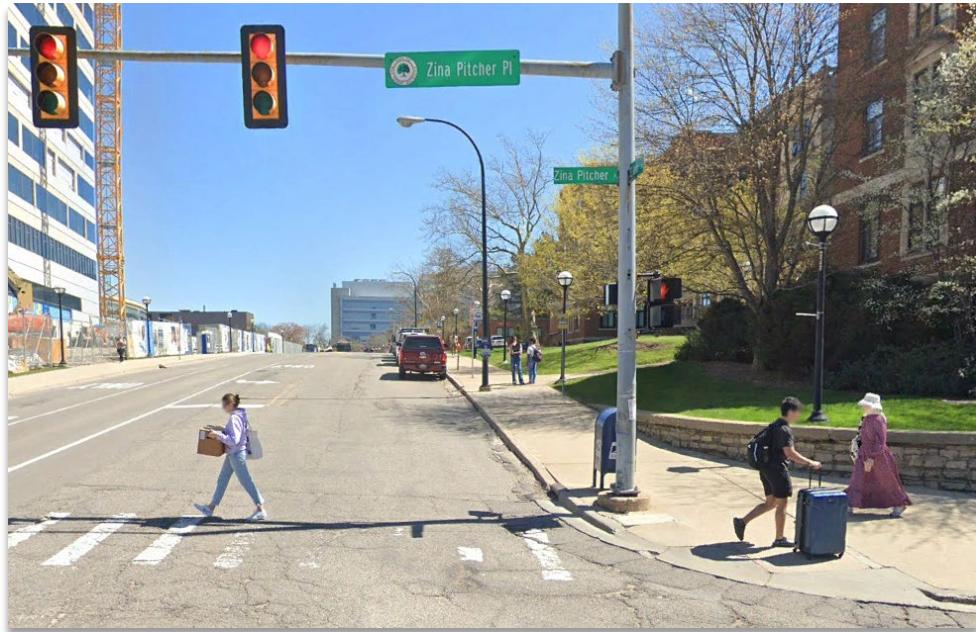
Furthermore, at Ann Street and Zina Pitcher Place, there was a fatal pedestrian crash in 2014 involving a pedestrian being struck by a bus. Although this crash occurred outside the time period for the crash analysis, it is known that the crash took place during nighttime flash operations for the signal.

Figure 28 - Signal Mast Arm Located in the Southeast Quadrant of Ann St and Zina Pitcher Pl

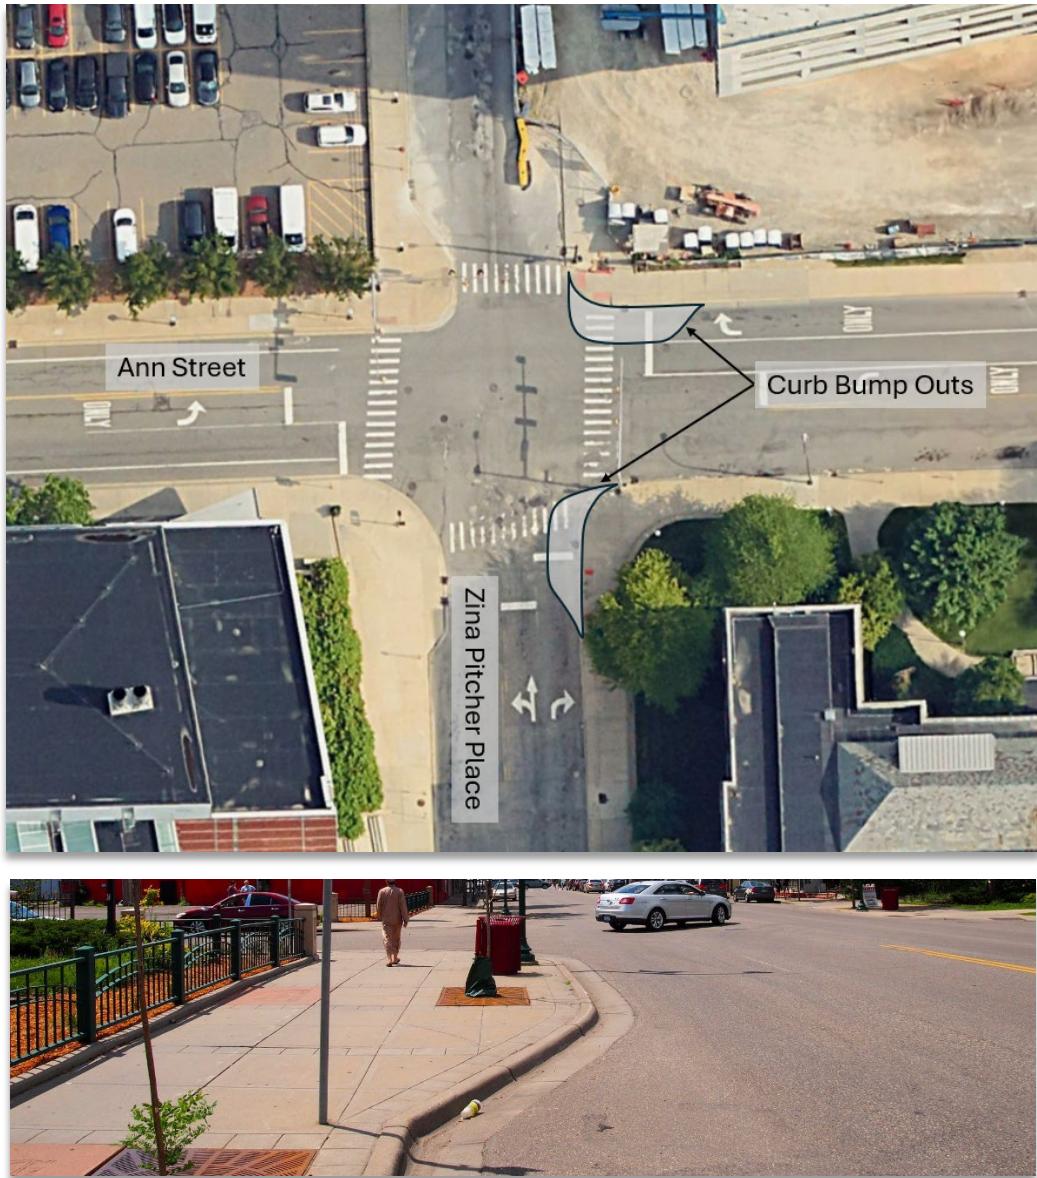
Figure 29 - Curb Bump Outs at Ann Street and Zina Pitcher Place ⁷

Dedicated right turn lanes are present along the westbound and northbound approaches at the intersection. From field reviews, it was observed that the intersection may have excess capacity. With that, it is recommended to assess repurposing the dedicated right turn lanes along the westbound and northbound approaches if excess capacity is present in future conditions. By doing so, the turning radius along those approaches will be increased and buffer between buses and objects like signal poles, reducing the likelihood of non-motorized and fixed object crashes involving buses.

By repurposing the right turn lanes, there would be an opportunity to provide curb bump outs. Curb bump outs are a traffic calming measure that involves extending the sidewalk or curb into the roadway at intersections. This design effectively narrows the crossing distance for pedestrians and improves their visibility to motorists. By reducing the pedestrian crossing distance and increasing visibility, the risk of a pedestrian-vehicle collision is reduced. This is particularly effective in areas with a high presence of pedestrians and bus traffic, such as the intersection of Ann Street and Zina Pitcher Place. Figure 29 depicts the recommended configuration of the intersection.

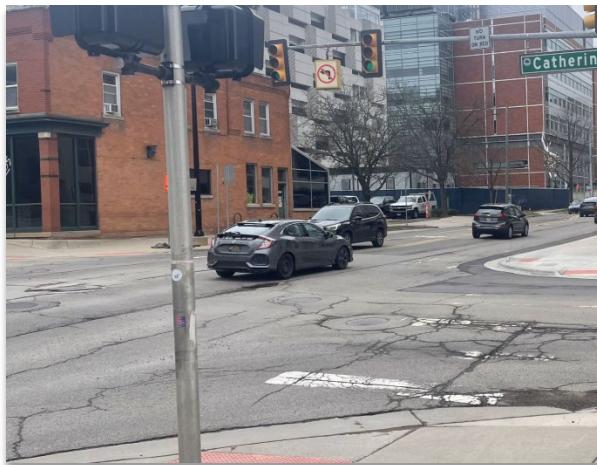
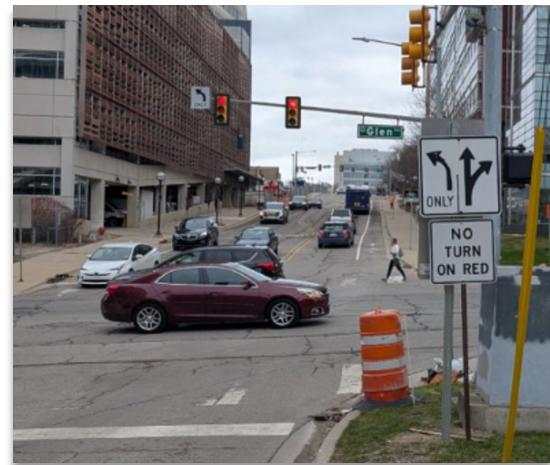
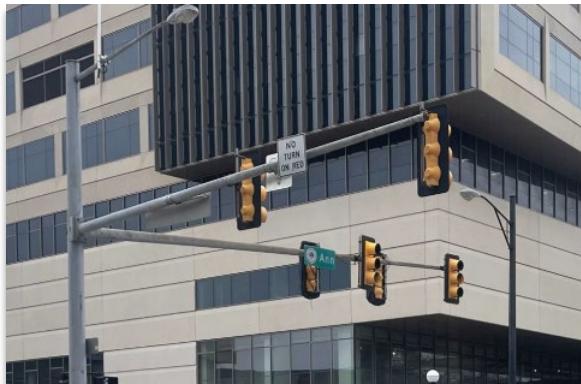
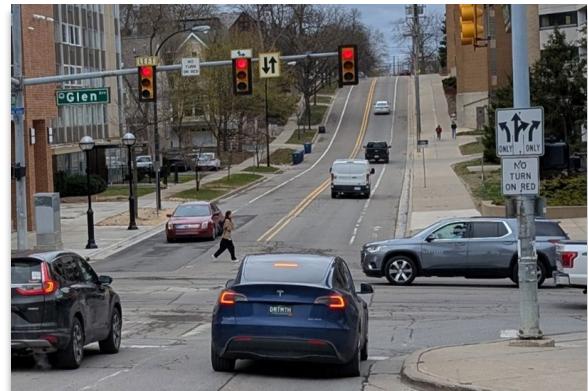
From the field observations conducted by the RSA team, it was noted that there is inconsistent sign placement as well as Manual on Uniform Traffic Control Devices (MUTCD) non-compliant signs located throughout the study area. For example, at the study intersections, “No Turn on Red” signs were located at different placements at approaches. For some approaches, the sign would be located on the mast arm pole near the roadway, while for other approaches, it would be located on the mast arm near the signal heads or mounted on signposts. Furthermore, for some approaches, signs were placed in multiple locations. Inconsistent sign placement can lead to confusion and disruptions to traffic flow which increases the likelihood of a crash. Figure 30 shows the different placements of “No Turn on Red” signs throughout the intersections.

Southbound Approach at Glen Avenue and Catherine Street

Eastbound Approach at Glen Avenue and Ann Street

Eastbound Approach at Ann Street and Zina Pitcher Place

Westbound Approach at Glen Avenue and Catherine Street

Currently, there are signs present at the study intersections that are not compliant with the MUTCD. It is recommended that these signs be replaced with MUTCD compliant signs to ensure consistency and uniformity across the roadway network. This standardization will help drivers recognize and understand the signs easier as they are driving. Signs that were non-compliant with the MUTCD include the “No Turn on Red” signs and “Left Turns Must Yield to Pedestrians” signs. Figure 34 depicts the signs that are compliant with the MUTCD.

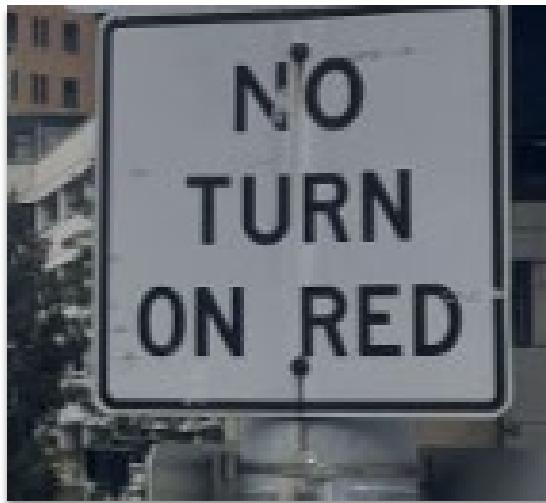
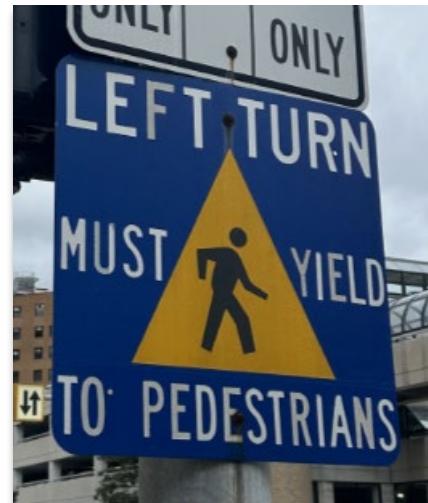
Additionally, signs such as “No Turn on Red” and “Vehicles Must Yield to Pedestrians” signs were noted to no longer be compliant with the Manual on Uniform Traffic Control Devices (MUTCD). This non-compliance can result in confusion for drivers as drivers might not understand the signage. Figure 31 depicts the MUTCD non-compliant signs present at the study intersections.

“No Turn on Red” Sign

“Left Turn Must Yield to Pedestrians” Sign

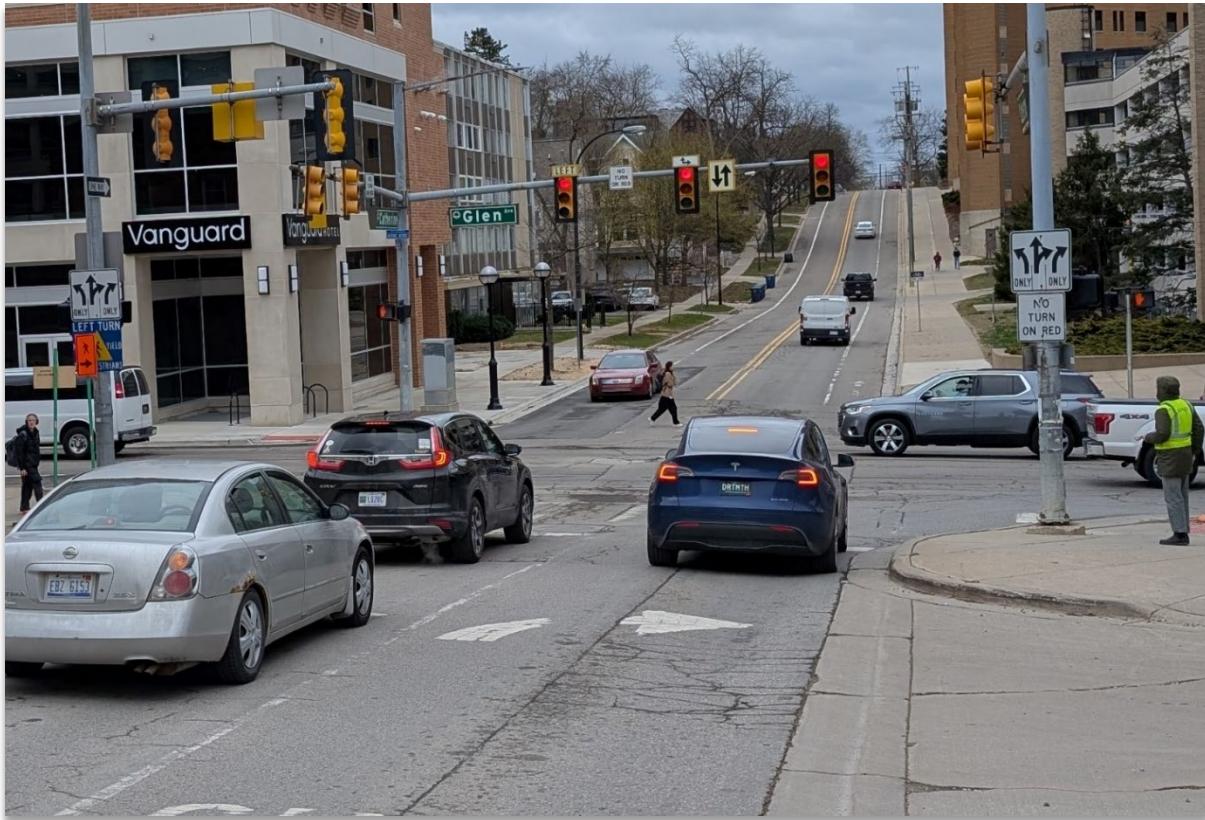
At the intersection of Glen Avenue and Catherine Street, there is an abundance of signage that may lead drivers to become overwhelmed and overloaded with information while traversing the intersection. This may lead to crashes as the driver may become confused with what maneuvers are allowed at the intersection. Signs such as “No Turn on Red”, “Left Turns Must Yield to Pedestrians”, and lane use signage are duplicated along the approaches of the intersection. Figure 32 depicts the westbound approach of the intersection. From the figure, it can be seen that there is duplicate signage for “No Turn on Red” with one sign located on the mast arm pole near the roadway and another sign on the mast arm near the signal heads. Additionally, there are two lane use signs on the mast arm poles along both the left and right sides of the road, as well as case signs designating legal turning maneuvers. Furthermore, the case signs interchange between symbols and words, making them inconsistent.

Figure 32 - Driver messaging overload at Glen Avenue and Catherine Street

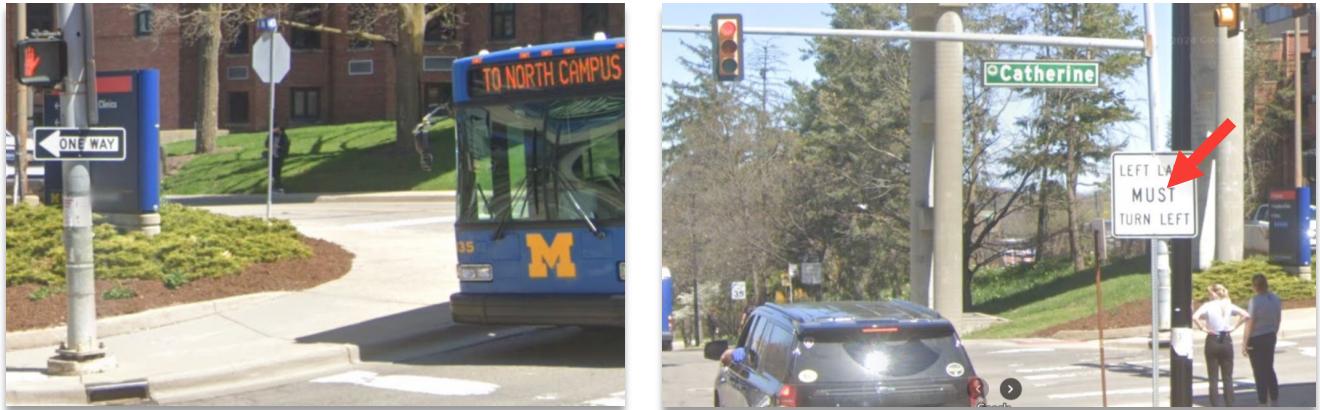
Additionally, the one-way sign, designating Catherine Street as one-way westbound at Glen Avenue, located on the mast arm pole in the northeast quadrant, was observed to be blocked occasionally by buses and by other signs at the intersection. Additionally, the “Do Not Enter” sign located on the mast arm pole in the southeast quadrant was also observed to be obstructed at some angles by other signs. Both scenarios are illustrated in Figure 33. Limited visibility of these signs can lead to drivers missing critical information, resulting in wrong-way movements and increased risk of collisions.

Bus is Taller Than the One-way Sign
