ROAD SAFETY AUDIT

GLEN AVENUE & CATHERINE STREET; GLEN AVENUE & ANN STREET; ANN STREET & ZINA PITCHER PLACE

ANN ARBOR, MI

DATE: JULY 2025

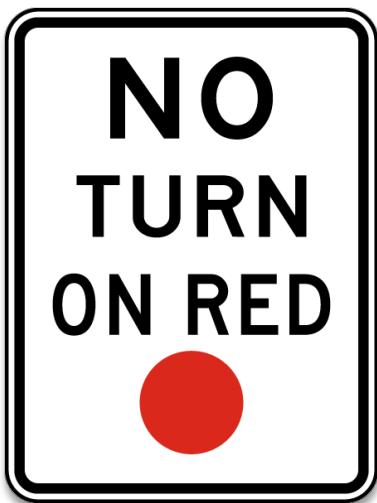
No Turn on Red Sign (R10-11)

Currently, there are signs present at the study intersections that are not compliant with the MUTCD. It is recommended that these signs be replaced with MUTCD compliant signs to ensure consistency and uniformity across the roadway network. This standardization will help drivers recognize and understand the signs easier as they are driving. Signs that were non-compliant with the MUTCD include the “No Turn on Red” signs and “Left Turns Must Yield to Pedestrians” signs. Figure 34 depicts the signs that are compliant with the MUTCD.

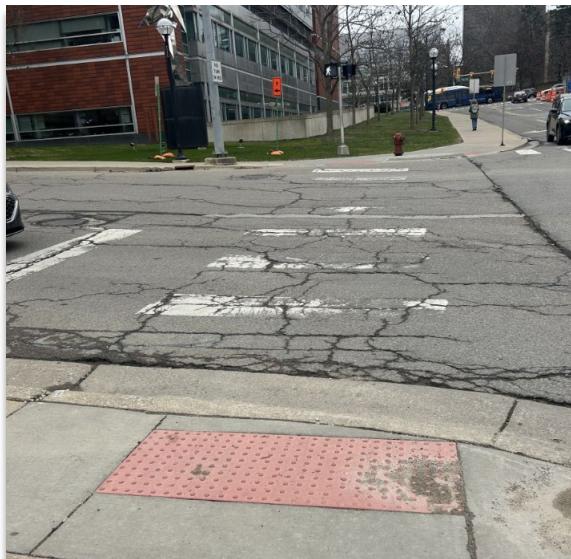
During the field review completed by the RSA team, faded pavement markings of stop bars, crosswalks, and lane markings were noticed throughout the study intersections. When pavement markings are not clearly visible, drivers may have difficulty identifying stop bars, pedestrian crossings, and lane lines, especially during low light conditions. This can lead to confusion and increase the likelihood of crashes, as drivers may inadvertently encroach into other lanes leading to sideswipe crashes or failure to yield to pedestrians resulting in non-motorized crashes. Additionally, faded markings can reduce the effectiveness of traffic signals, as drivers rely on these markings to guide their movements. Figure 35 shows faded markings present at the intersections.

Glen Ave and Ann St East Leg Stop Bar and Crosswalk

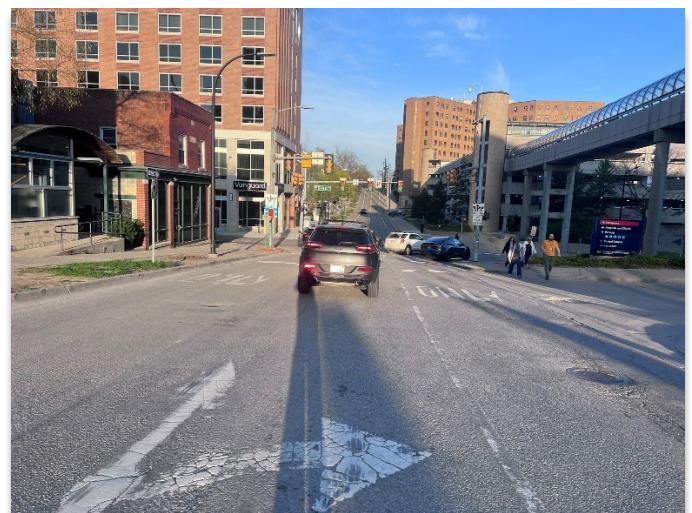
Westbound Catherine St Lane Markings

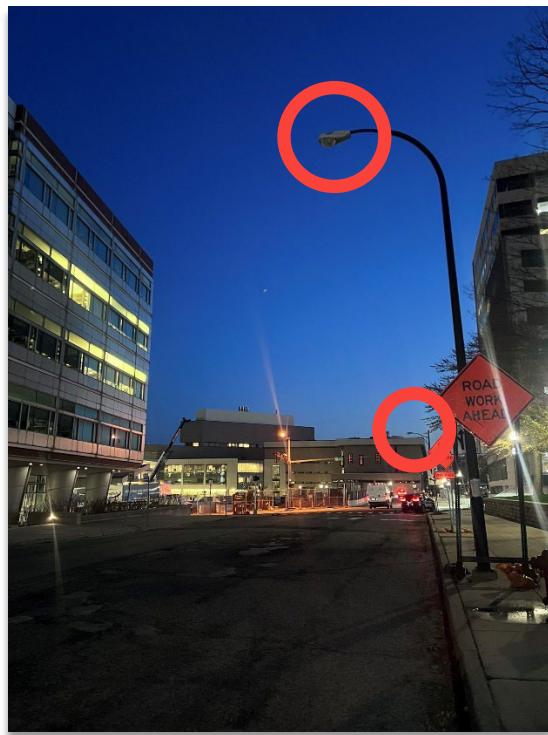
Figure 36 - Non-functional light fixtures at Ann Street and Zina Pitcher Place

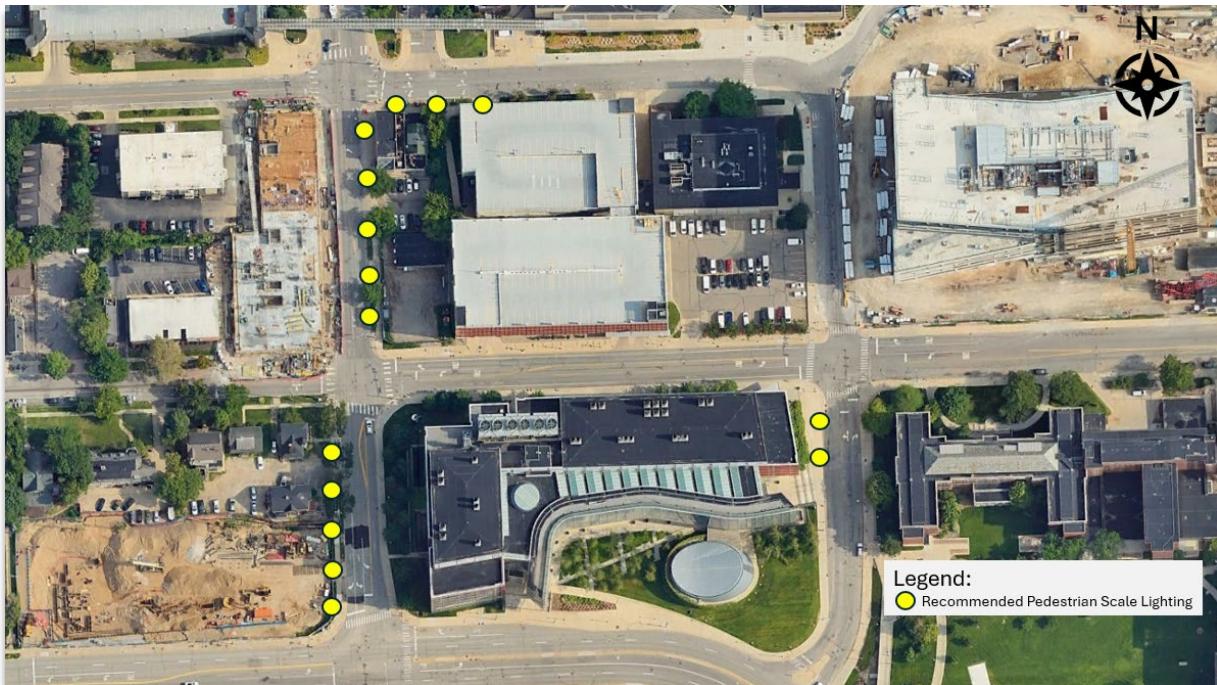
Figure 38 - Recommended Pedestrian Scale Lighting

Currently there is pedestrian-scale lighting located within and around the study area; however, the lighting is not present throughout the entire study area. Areas in which there are gaps in pedestrian scale lighting include the east side of Glen Avenue between Catherine Street and Ann Street, the west side of Glen Avenue south of Ann Street, the south side of Catherine Street near Glen Avenue, and the west side of Zina Pitcher Place south of Ann Street. It is recommended to provide pedestrian scale lighting in the places shown in Figure 38 so that it is present throughout the study area to enhance pedestrian comfort and safety by providing adequate illumination, making it easier to see potential hazards and navigate the area safely.

Additionally, low-level pedestrian-scale lighting creates a more intimate and calming atmosphere, as the light sources are positioned closer to the ground and nearer to pedestrians, rather than high above. Furthermore, low-level lighting can be decorative and visually appealing, adding aesthetic value to the sidewalk and enhancing the overall ambiance of the area.

Based on the review of upcoming projects, it was understood that pedestrian-scale lighting is expected to be constructed along the sidewalks where the new parking structure is being constructed in the northwest quadrant of Ann Street and Zina Pitcher Place.

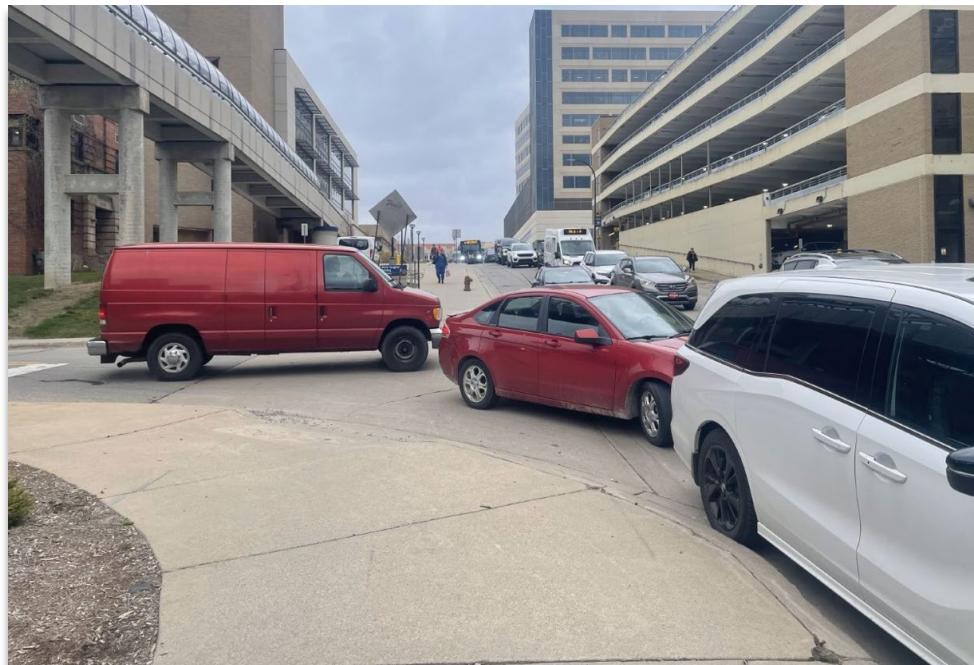
Figure 39 - Vehicles blocking crossing and Disturbing Traffic Operations on Catherine Street

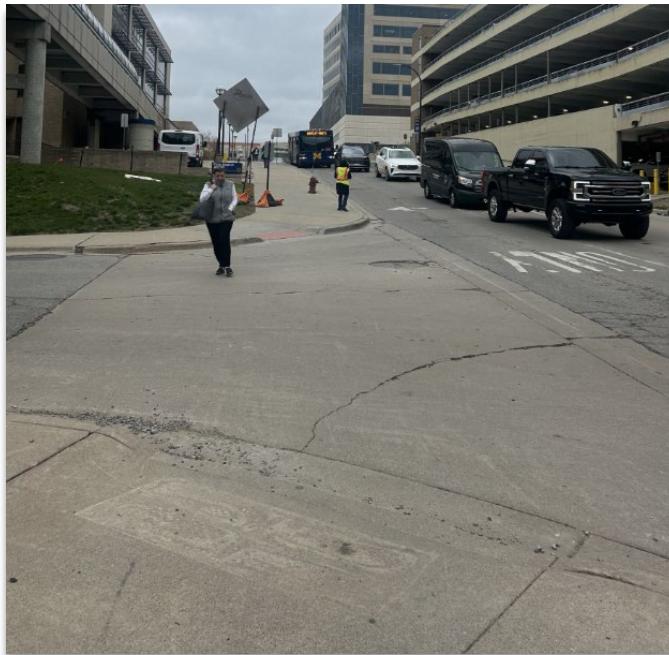
Missing Pavement Marking

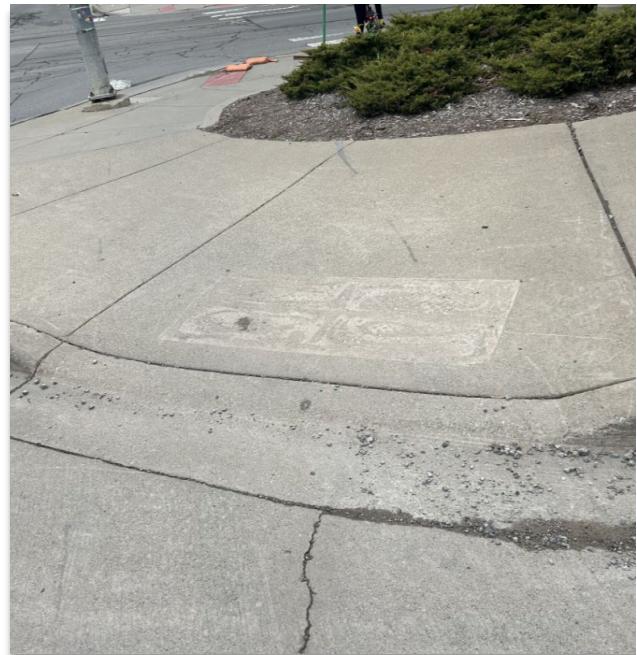
Missing Detectable Warning Pad
