Council Planning Session

December 10, 2018

Presentation Agenda

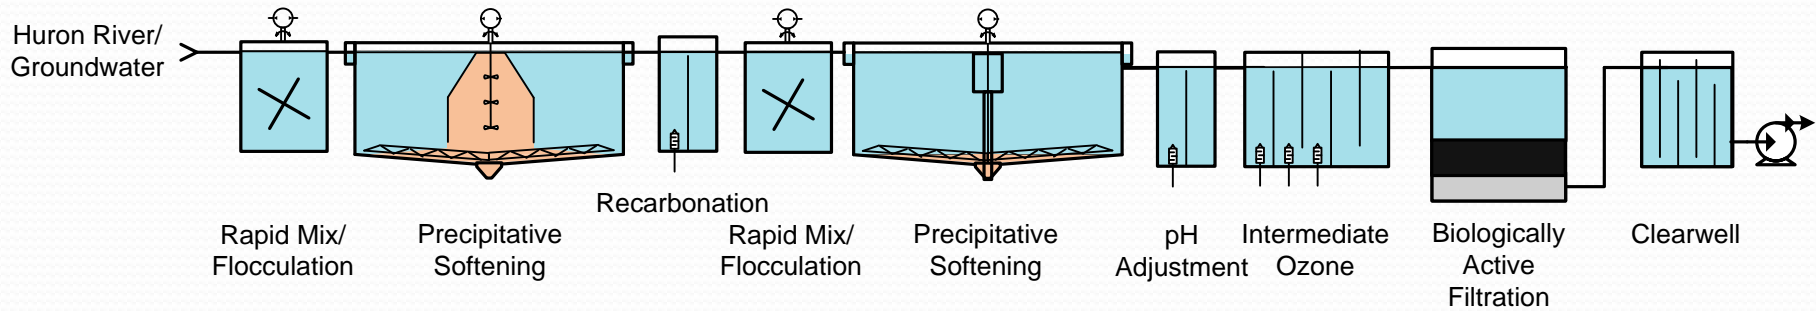
Current Contaminant Barriers

Turbidity		✓		✓			✓	
Pathogens		✓		✓		✓ ^{4,5}	✓ ⁴	✓ ⁴
DBP Precursors and DBPs		✓				✓	✓	
Inorganic Macro-Pollutants		✓ ¹		✓ ³				
Inorganic Micro-Pollutants		✓ ²				✓	✓ ²	
Organic Micro-Pollutants						✓	✓	
Taste & Odor Compounds						✓	✓

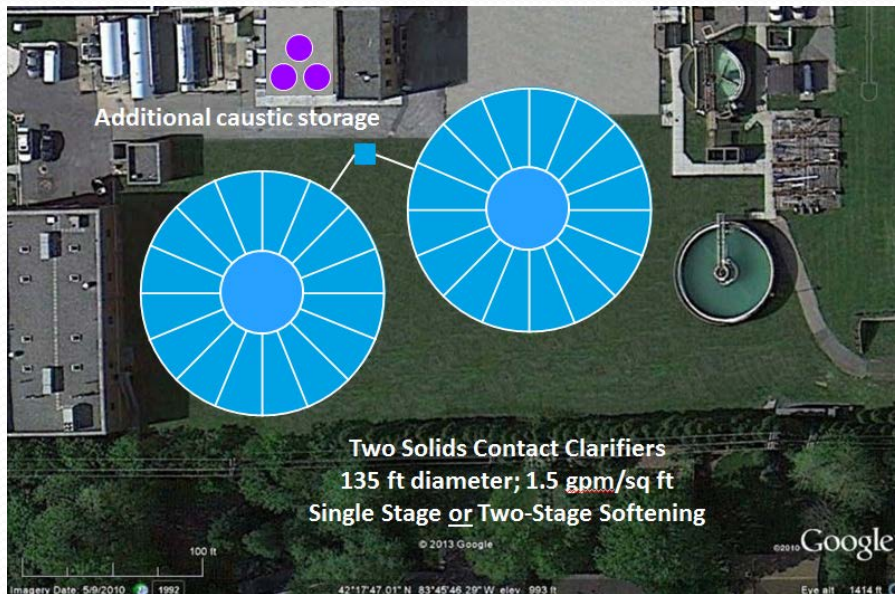
Recommendations

- 1938/1949 Pretreatment Facilities Replacement (Plant 1):
 - New solids contact clarifiers
 - UV Disinfection
- Recommended improvements position City for future needs

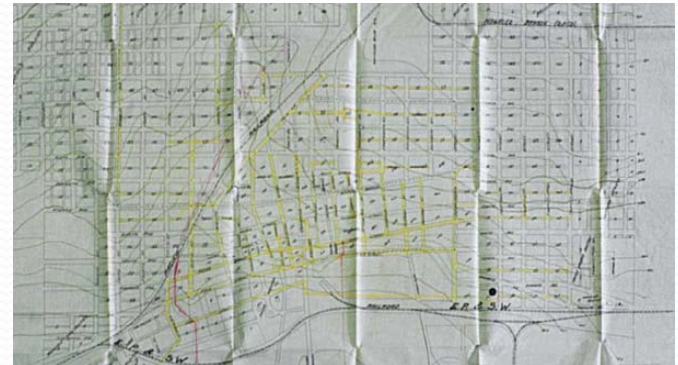
Old Maintenance Program

- Followed a schedule of cleaning by identified “Districts”...
 - Jetting
 - Rodding
 - Televising

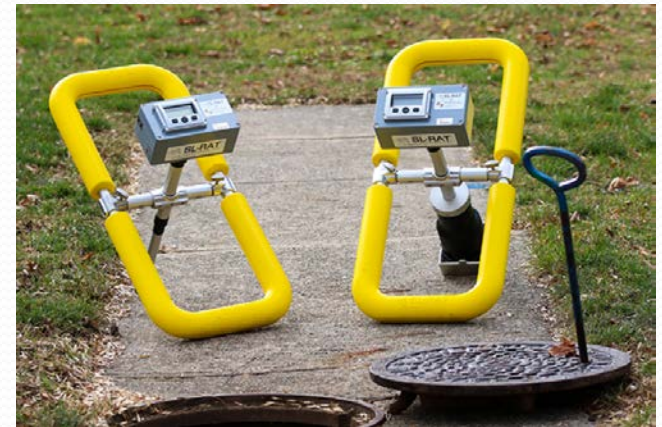
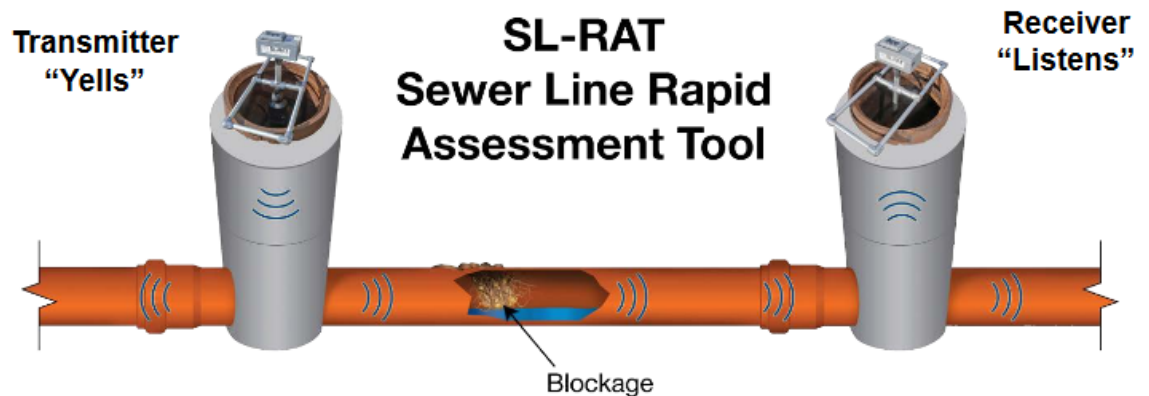
Acoustic Inspections

Identifies potential blockages

Screening Tool used for:

- Cross Lot* Sewers
- High Risk or Known Problem Spots
- Pre Maintenance
