ANN ARBOR HISTORIC DISTRICT COMMISSION

Staff Report

ADDRESS: 1310 Hill Street, Application Number HDC15-227

DISTRICT: Washtenaw Hill Historic District

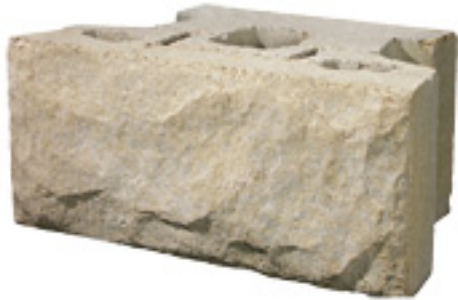
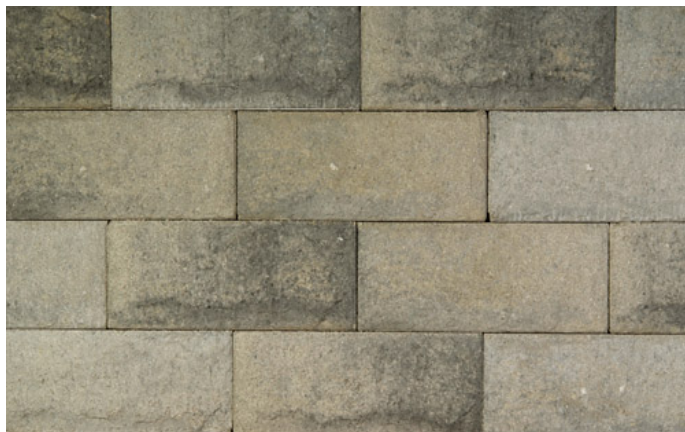
- The retaining wall sides of both stairways are constructed with Keystone Compac Hewnstone in Limestone Blend. The color and texture of this material reflects, but does not exactly match, the existing cut stone that comprises the exterior basement walls. The east side of the east entranceway will also incorporate boulders in the retaining wall.

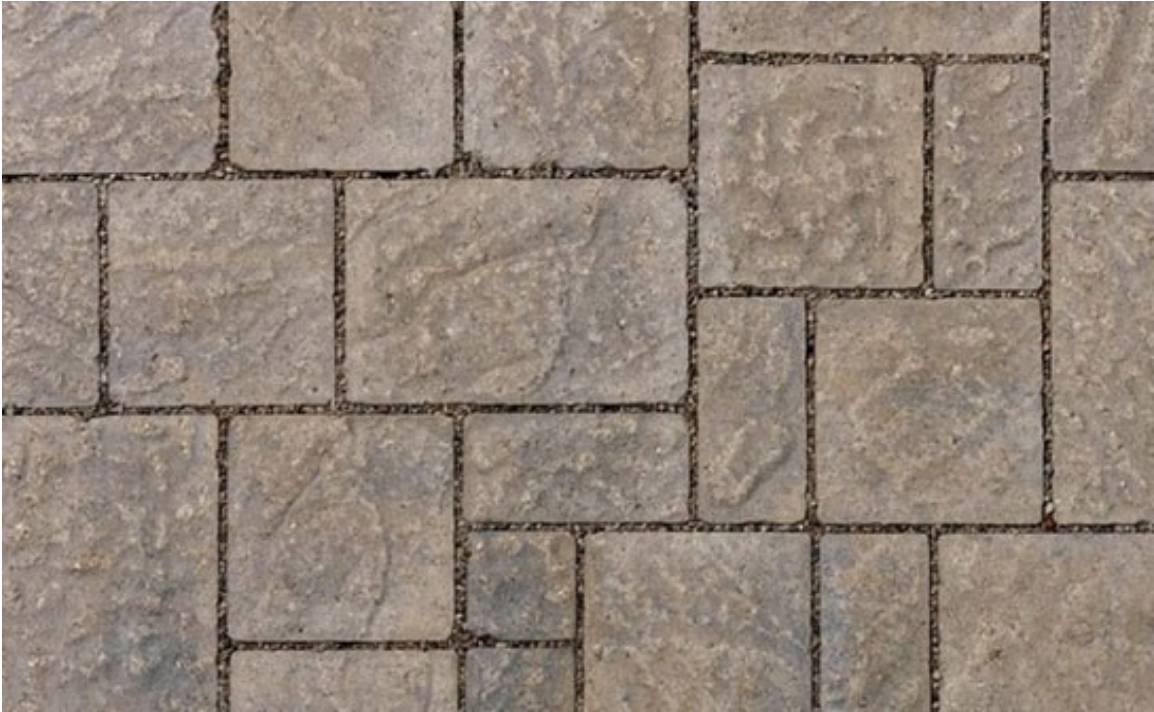
- The 5' square entryway at the bottom of the south entrance and the steps and landing of the east entryway is composed of Hydr'eau Pave porous pavers from Oaks Concrete in the colors Silversand and Onyx. The pavers are of mixed dimensions. Again, these products reflect, but do not exactly match, the texture and color of the existing cut stones of the exterior basement walls. There is a base of approximately 12" of crushed limestone below the porous pavers for rainwater drainage.

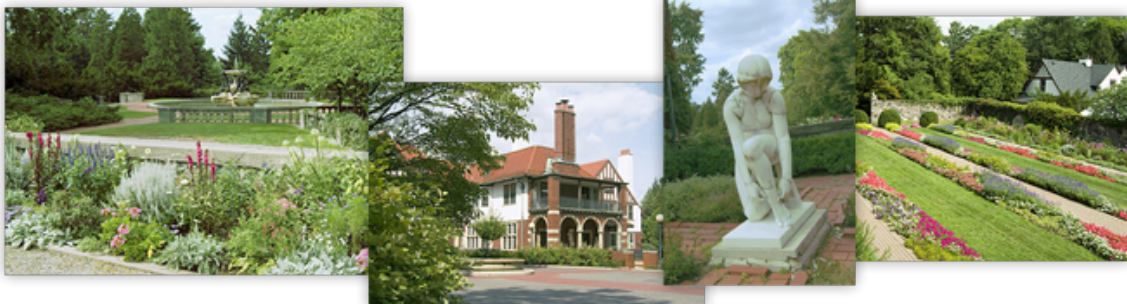
The east entrance is currently under development. The east side of this entrance will have a lower level Keystone wall along with a boulder retaining wall and landscaping.

We have retained the Head Gardener of the Historic Cranbrook Gardens in Bloomfield Hills to landscape the terraced area of this east entrance after it is completed. <http://housegardens.cranbrook.edu/>
