ANN ARBOR HISTORIC DISTRICT COMMISSION

Staff Report

ADDRESS: 200 East Washington Street, Application Number HDC14-027

DISTRICT: Main Street Historic District

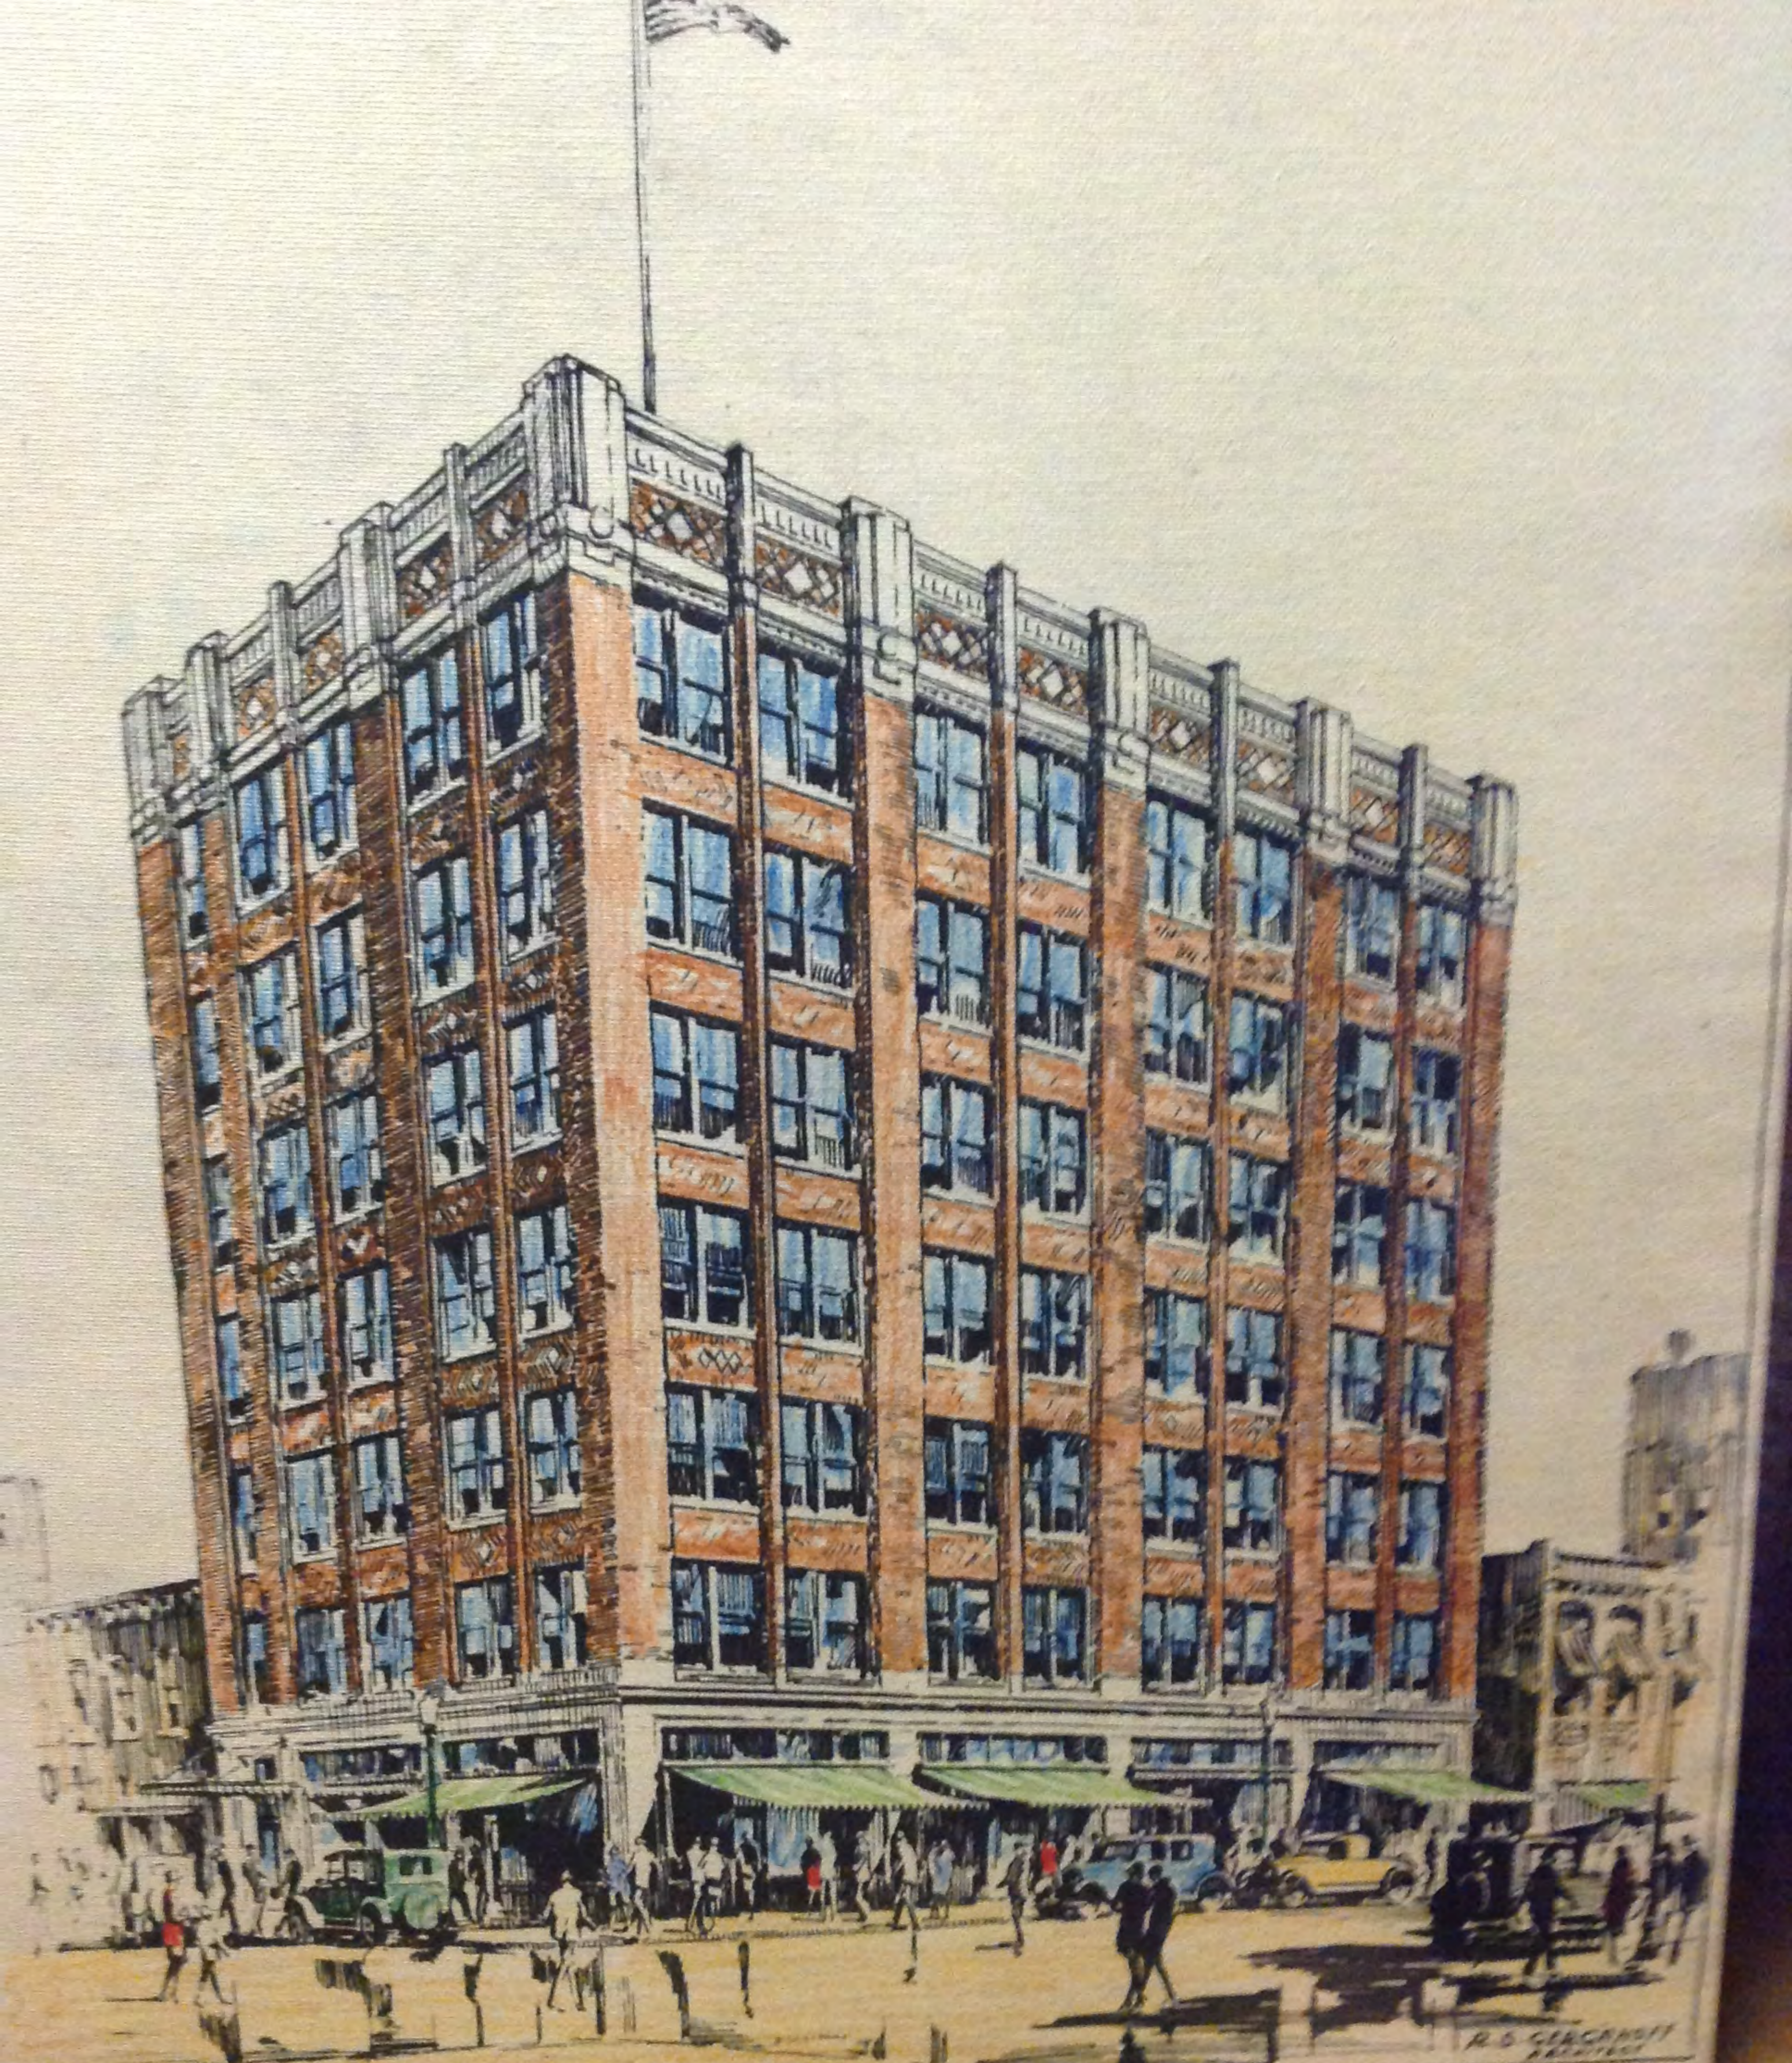
3. Parts of the metal window framing have rusted away completely. The building manager told staff that the wood beams dividing the windows from the transoms are also heavily deteriorated. The wood kickplates, which rest on a limestone base, have shifted as a result of construction in the street, and show some signs of visible deterioration.

200 Washington – existing structure. Note structural instability close to the entryway.

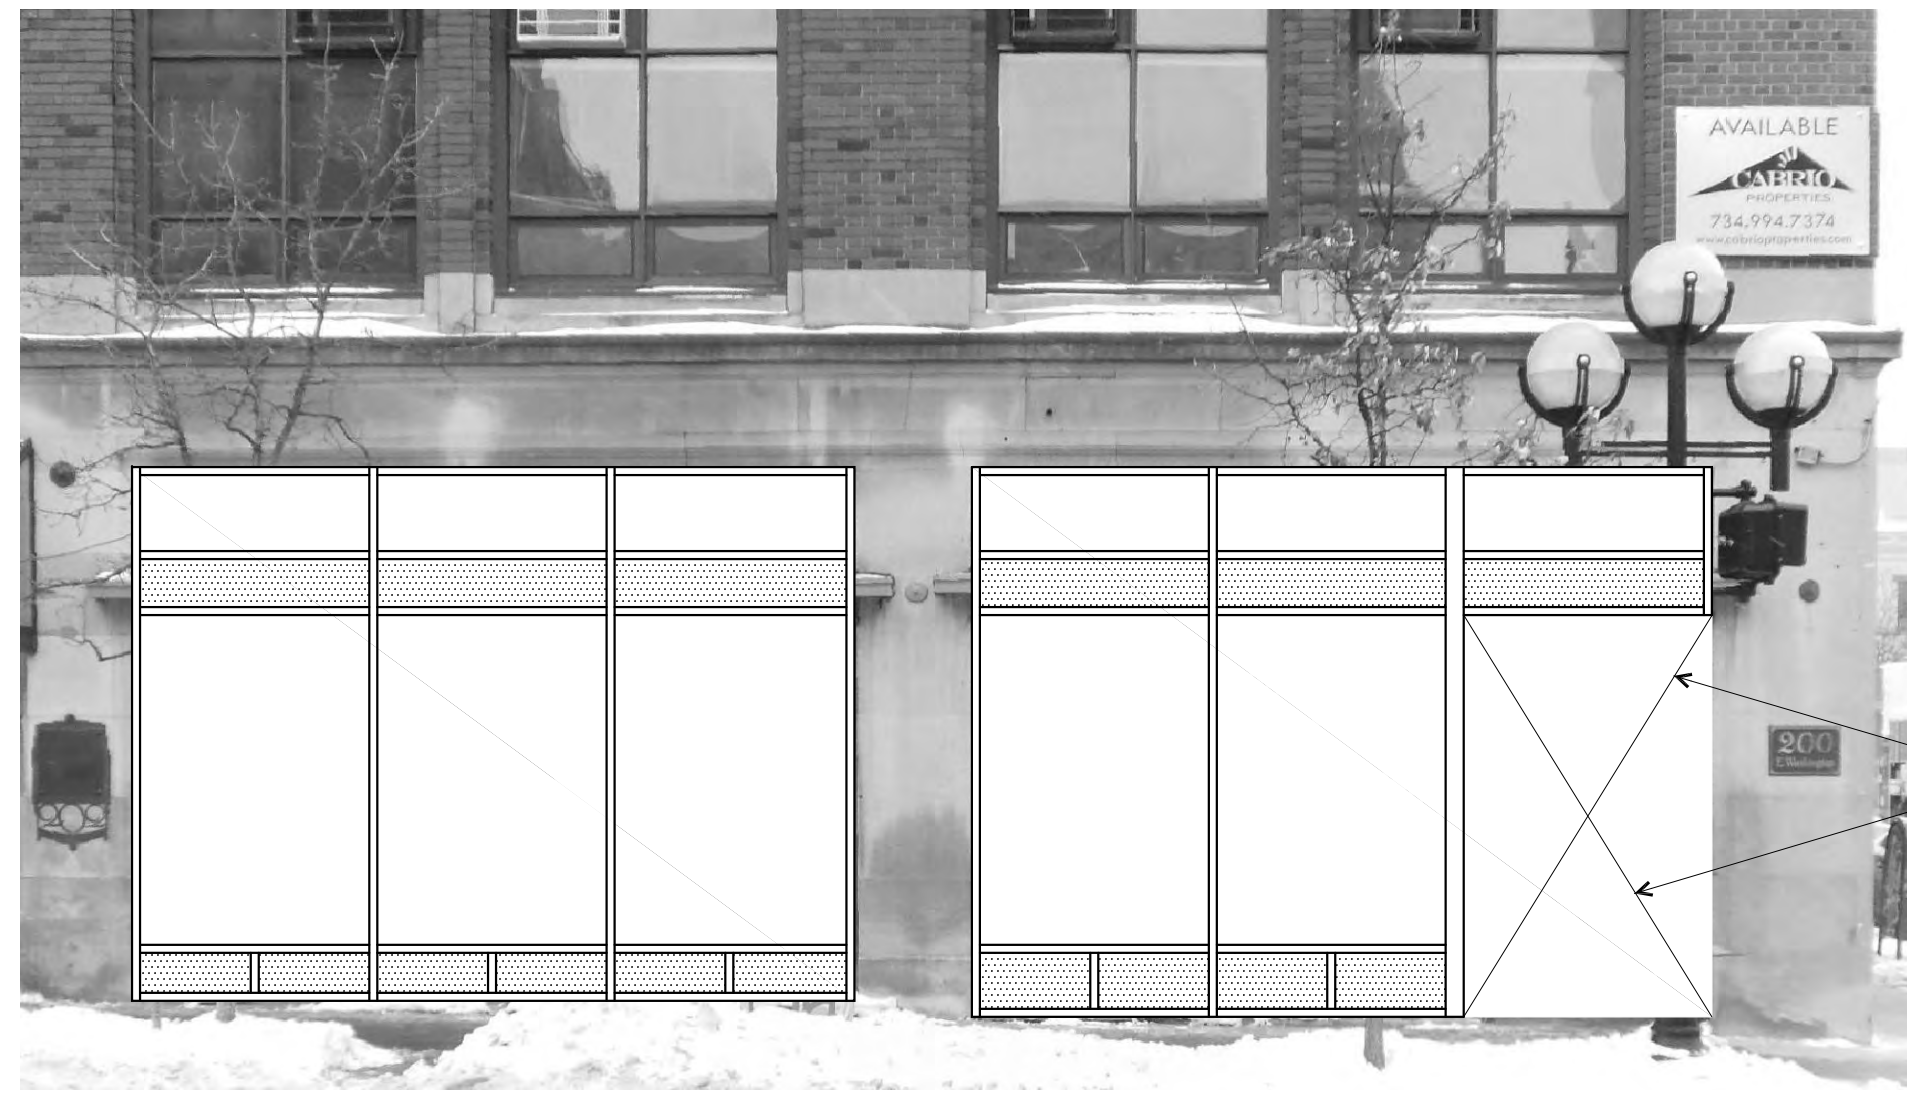
200 Washington – close up of structural damage.
