## ANN ARBOR HISTORIC DISTRICT COMMISSION

### Staff Report

**ADDRESS:** 2781 Packard Road, Application Number HDC12-241

**APPLICATION:** The applicant seeks HDC approval to replace the cedar shake roof on the 1986 barn with imitation shakes.

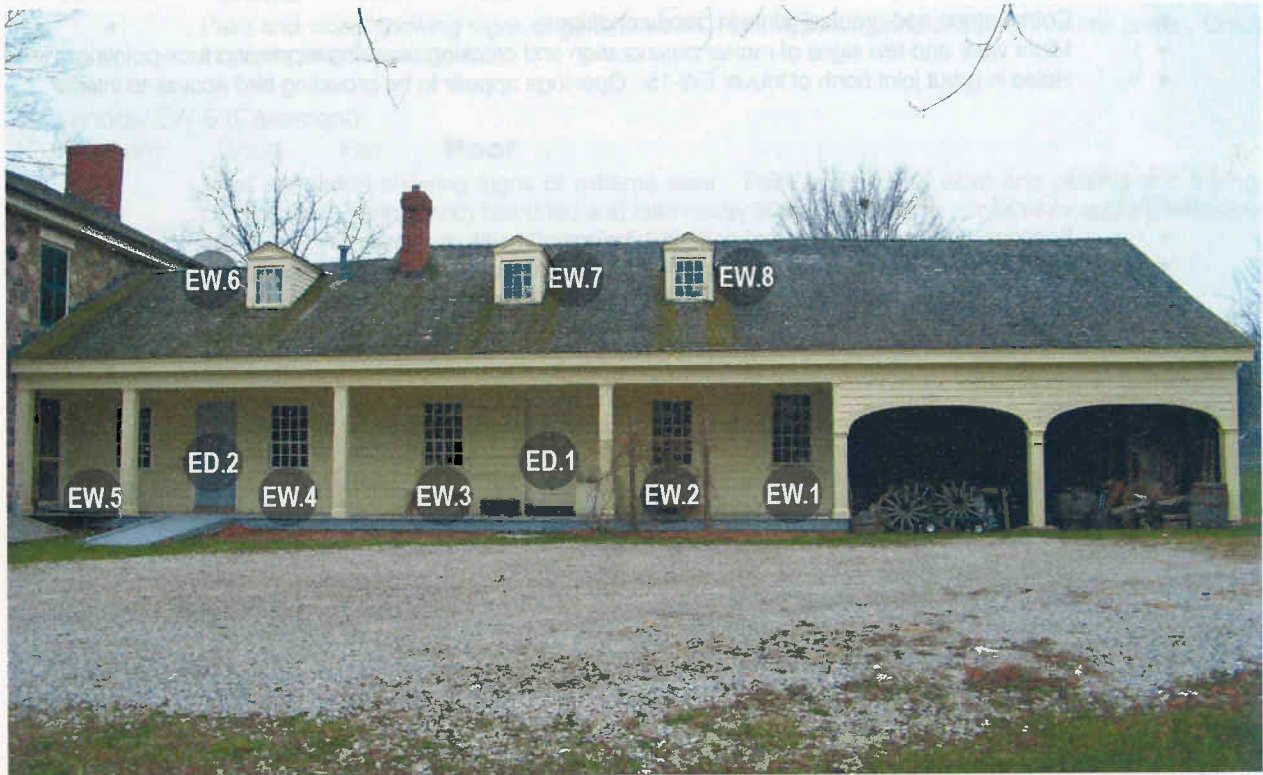
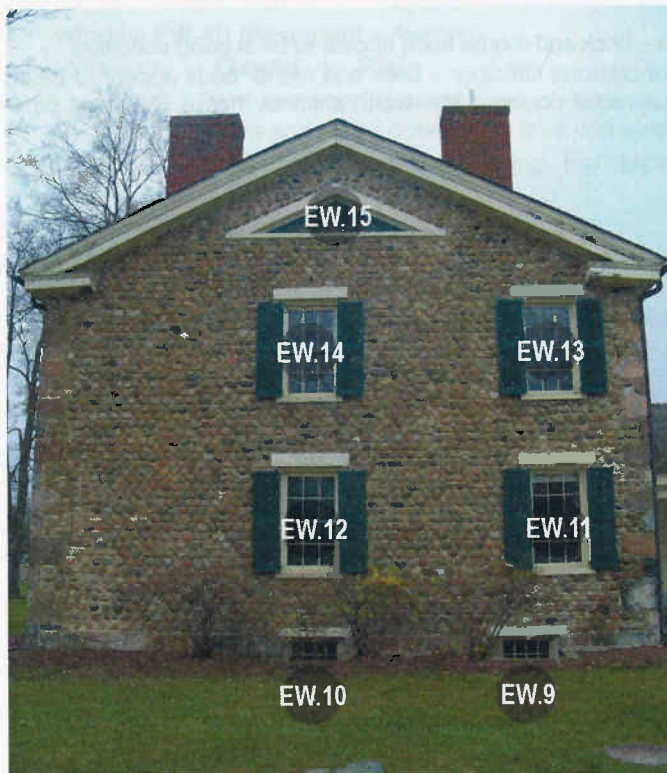
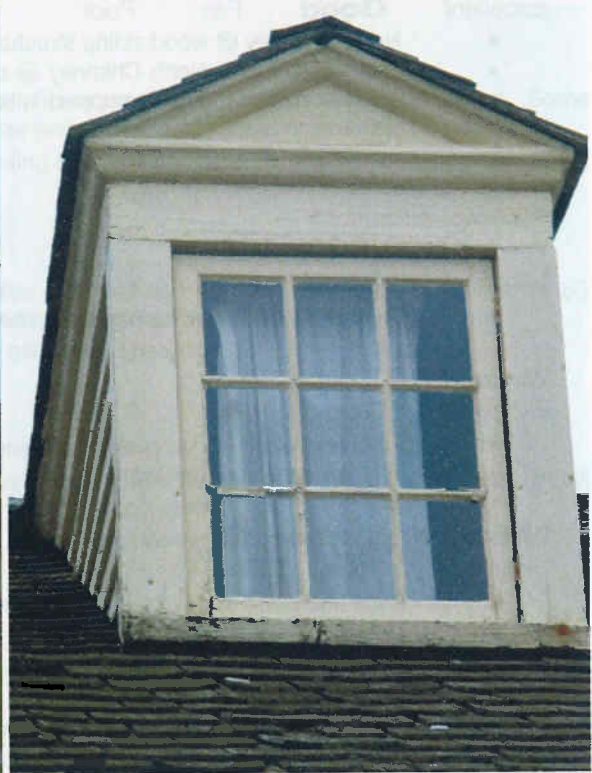
The East elevation is divided into two sections. The Main cobblestone house and the wood sided rear addition. Two (2) entry doors providing access to the Dining Room and Kitchen spaces are situated under the covered porch which extends along the entire length of the rear addition.

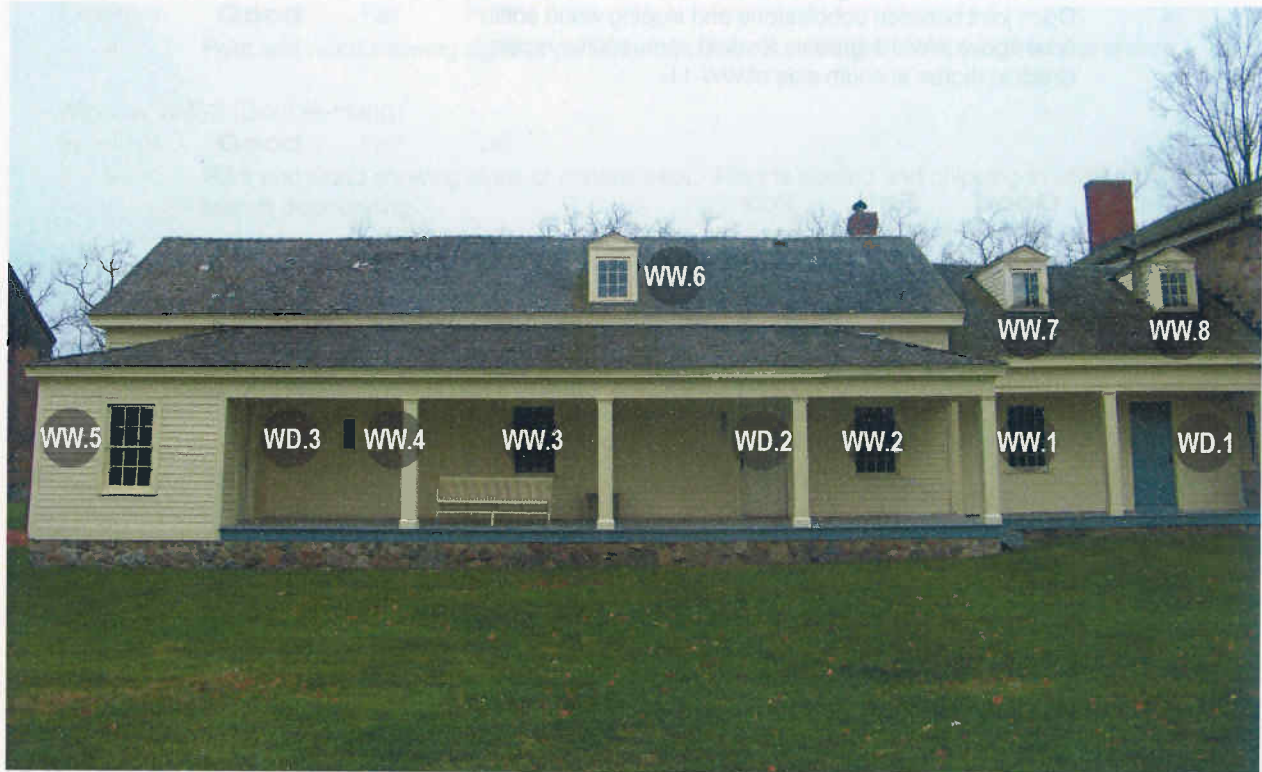
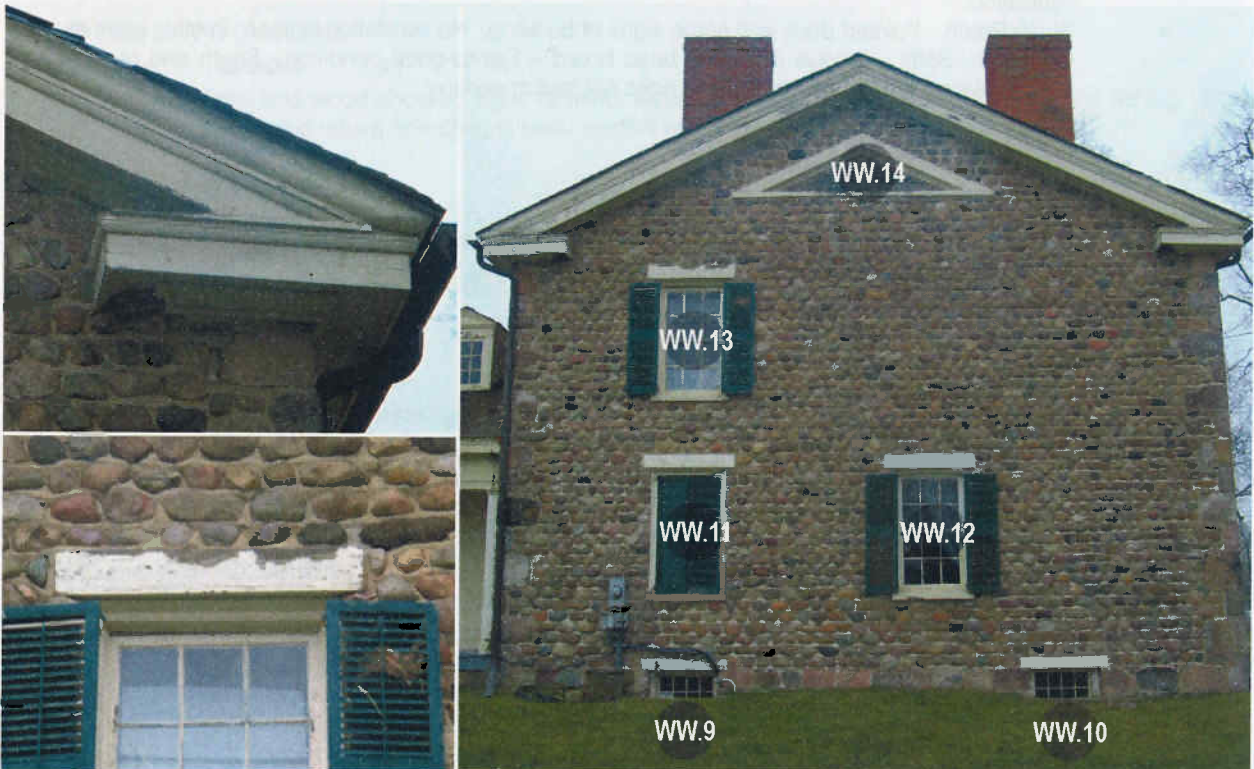
The West elevation is divided into two sections. The Main cobblestone house on the South end and the wood sided rear addition to the North. Three (3) entry doors provide access to the Dining Room, Kitchen and Storage space, situated under the covered porch which extends along the majority of the rear addition.
