City of Ann Arbor MRF Audit

Company/Dept.: CP MFG / Customer Service		Title: System Audit		Document Number: Audit

Author: M. Augustyn-Morales	Date: 2/9/2017	Rev 1

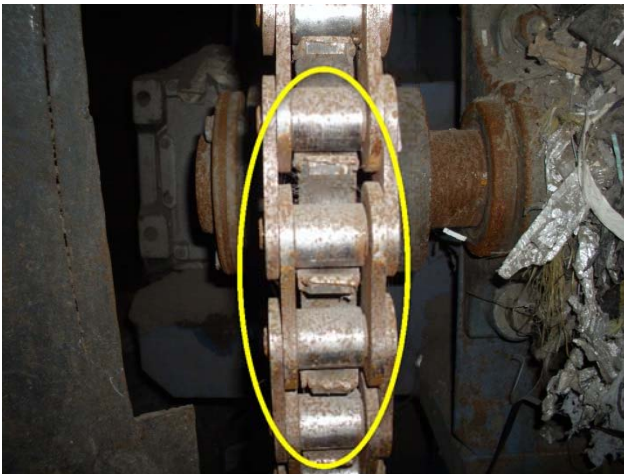
Head sprocket and Motor sprocket needs to be replaced. When sprockets are replaced, it is advised to change chain.

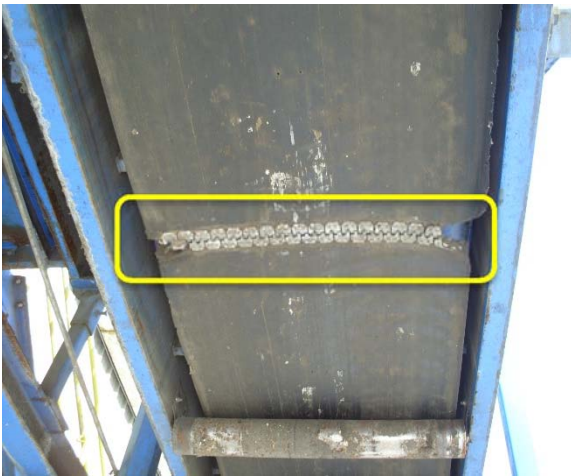
Lacing is damaged. Belt is torn.

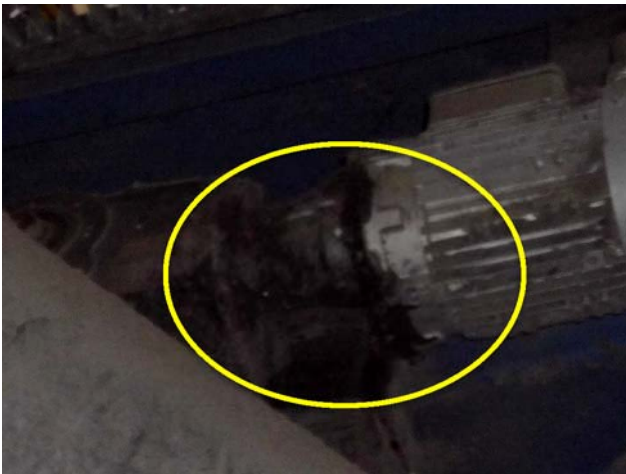
Gearmotor is leaking.

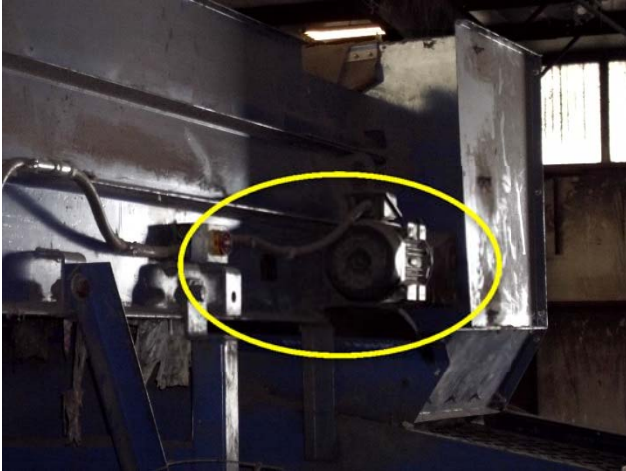
Gearmotor is leaking, replacement needed.

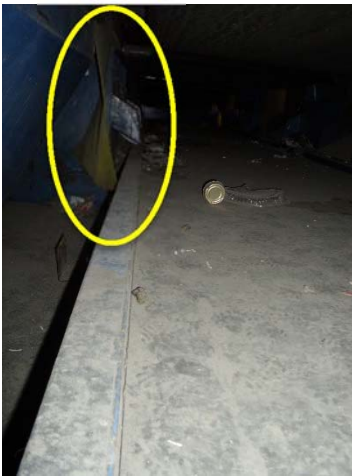
Guarding needs to be repaired/replaced.

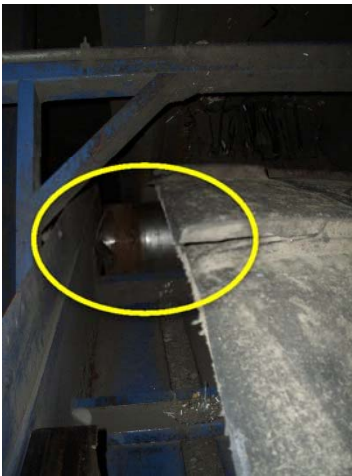
Belt tracking and tensioning completely off to the right.

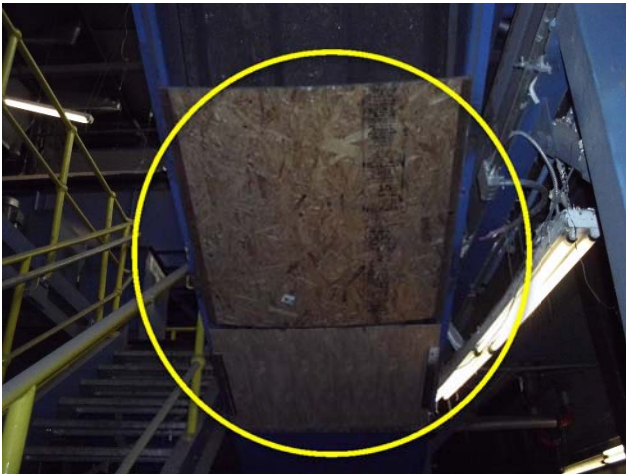
Plywood installed as belly pans, removal required.

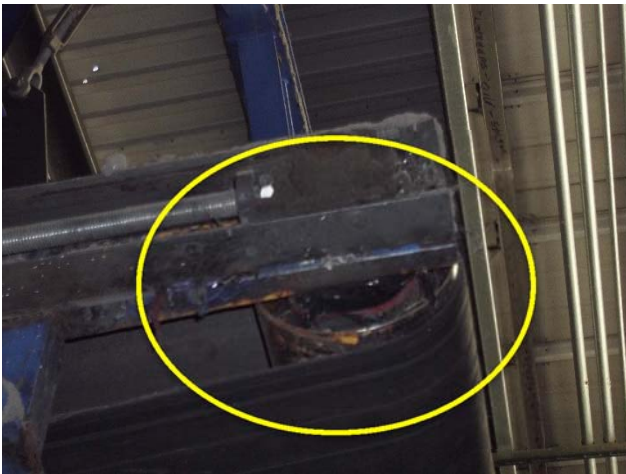
Picture shows severely worn pulleys and bearings.

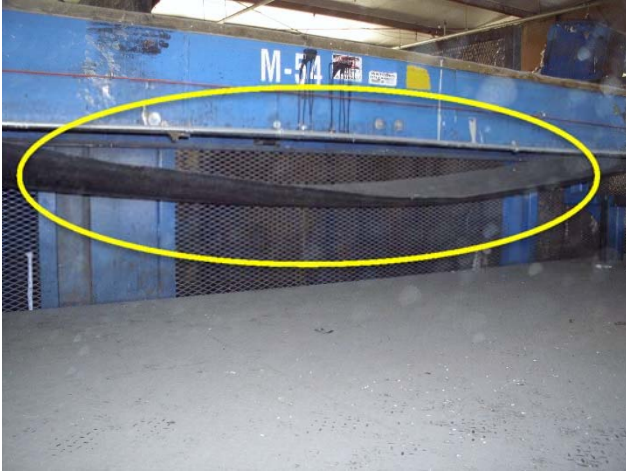
Tensioning is off, belt is not supported by any rollers.

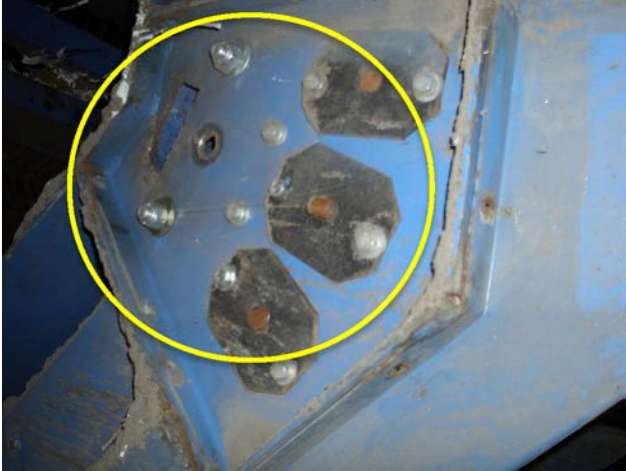
Return rollers omitted, replacement required.

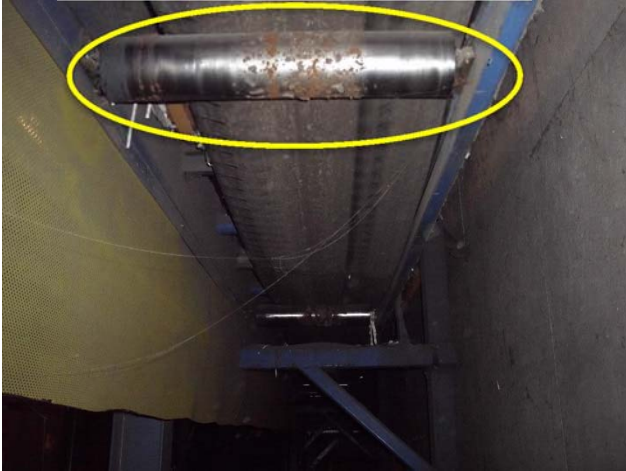
Return rollers are worn, replacement required.
