STRUCTURAL EVALUATION REPORT

Chimney at 415 W. Washington Ann Arbor, Michigan

DNCE Project No. : 18-1339

Date Submitted: November 20, 2018

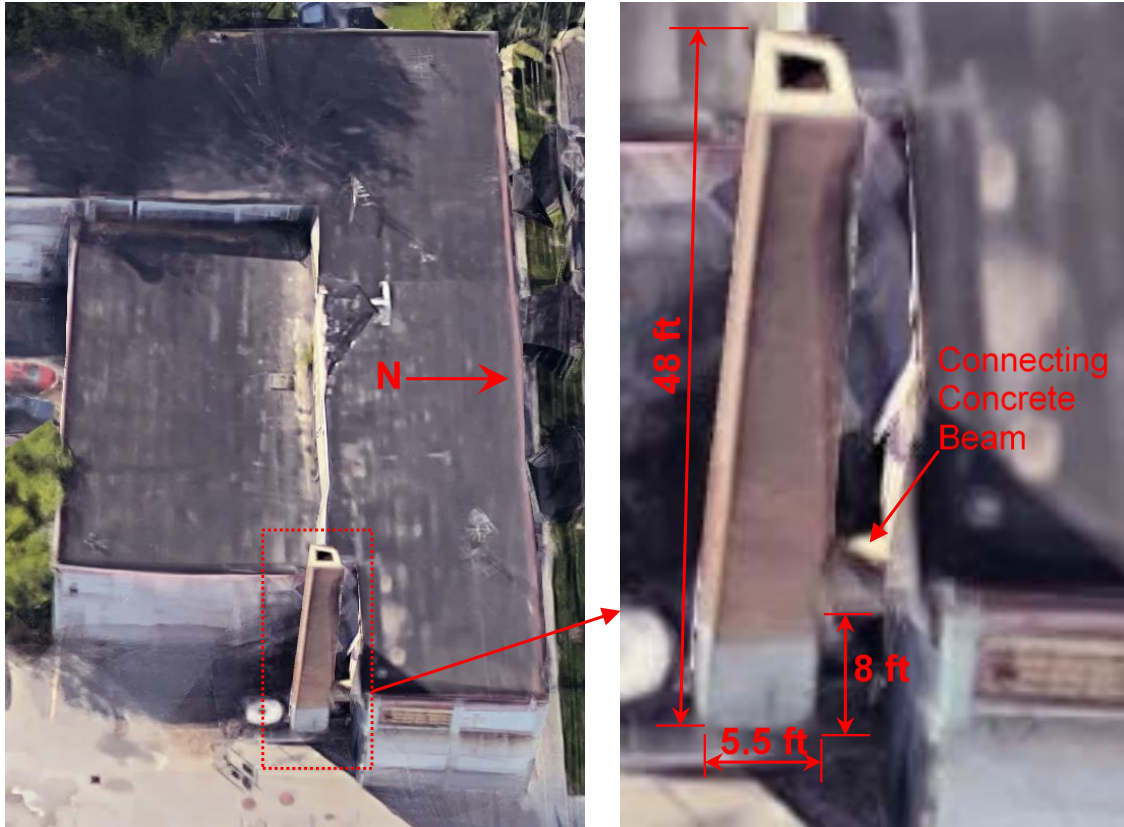
The chimney is approximately 48 ft tall with plan dimensions of approximately 5.5 ft x 5.5 ft, constructed from clay bricks and supported on a reinforced concrete base (Figure 1). The concrete base of the chimney is connected to the adjacent building through a concrete beam that is approximately 6 ft long, 2.75 ft x 2.75 ft in section, and 8 ft above ground level. There is also a 7 ft high masonry wall connecting the chimney (at the north-west corner) to the adjacent building wall (Photoset 3). Due to the lack of Existing Structural Drawings and the visual nature of the inspection, the chimney foundation layout is assumed to be isolated from the adjacent building foundation.

Figure 1. Chimney configuration and attachment to adjacent building.
