Ann Arbor City Council Regular Session: January 6, 2014
Email Redactions List Pursuant to Council Resolution R-09-386

INTRODUCTION:	
Scope and Objective of Report	1
Methodology	1
Report Team	1
Facility Assessment	
Background Statement	2
Existing Building Plan	3
Flood Assessment	4-5
Building Systems	
Exterior Facade:	
Building 1	6-13
Building 2	14-19
Interior:	
Building 1	20-23
Building 2	24-27
Roof:	
Existing Roof Systems	28-29
Building 1 & Building 2	30-33
Electrical Assessment	34-37
Mechanical Assessment	38
Structural Assessment	39
Hazardous Materials	40-41
Accessibility	42-43
Cost Analysis	
Proposals	
721 Gallery and Studios	44-45
Allen Creek Sustainability Center	46-47
721 N. Main Street Architectural Explorations	48-50

The overall goal of this report is to assess and evaluate the existing conditions of the Maintenance Garage structure at 721 N. Main Street; provide recommendations for the treatment and maintenance of the facility; determine related costs and phasing for these treatments; and propose suggestions for possible adaptive re-use potentials which the facility may be redeveloped for.

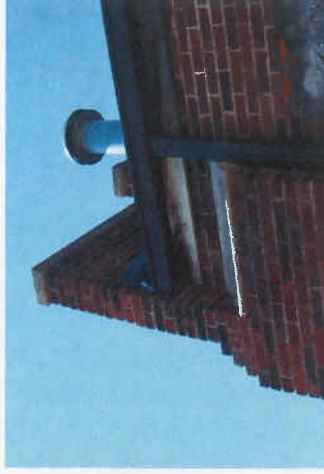
E1.4 An open joint between the fascia and South Elevation parapet wall was observed. The wood fascia board is in poor condition and is displaying signs of severe rot and deterioration. There appears to be structural failure in the South Elevation parapet wall which is bowing towards the north.

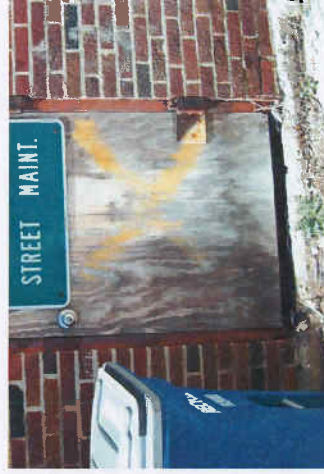
E1.5 The entry door is an untreated wood door in poor condition. Visible signs of deterioration and rot were observed. A substantial door undercut is allowing air and water to infiltrate the building. The adjacent steel jambs are exhibiting signs of moderate corrosion. The concrete slab at the door threshold appears worn and deteriorated. Existing hinges are in poor condition with moderate levels of corrosion. The door knob is in good condition.

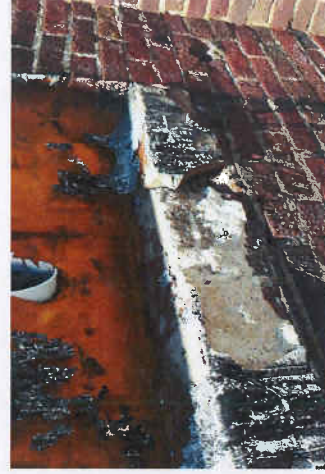
E1.6 The existing concrete sill has failed at some locations in the window bays. The pre-cast material has cracked and separated from the building exposing the interior wall system to water and air infiltration. The mortar joint between the outer brick wythe and concrete sill has deteriorated in many locations.

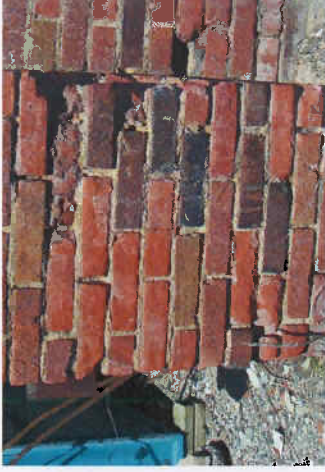
S1.4

The existing brick at the SW corner of the building is in extremely poor condition. At the base and in sections throughout the entire wall, the mortar has completely deteriorated and the brick has spalled & flaked. Typical root causes can be attributed to frost or water which has leaked into the brick structure at any entry point (i.e. a crack; or at openings in the roof or window and door penetrations.)

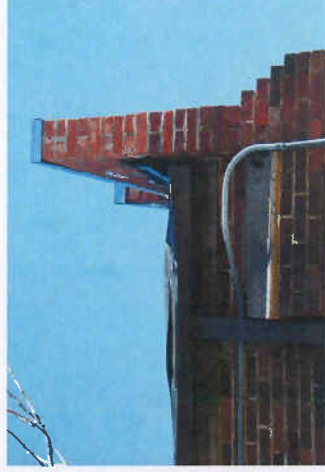
S1.5

Newer galvanized cap flashing has been applied over the brick parapet wall on the west end of the South Elevation. An open joint between the fascia and South Elevation parapet wall was observed. The wood fascia board is in poor condition and is displaying signs of severe rot and deterioration. Mortar has completely deteriorated in some areas of the parapet wall and the brick has spalled and cracked in many locations.

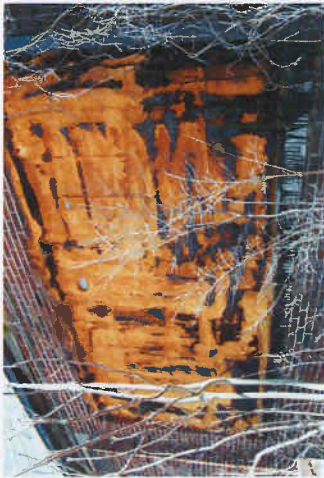
W1.1
Typical Window Bay;
Spray-on insulation has been applied to the existing steel sash windows, jambs, head and sill; bonding to the steel and glazing. The original fluid applied weather-resistant membrane has deteriorated exposing the spray-on insulation to the elements. Original application of the fluid applied membrane has left staining on the concrete window sills and adjacent face brick.

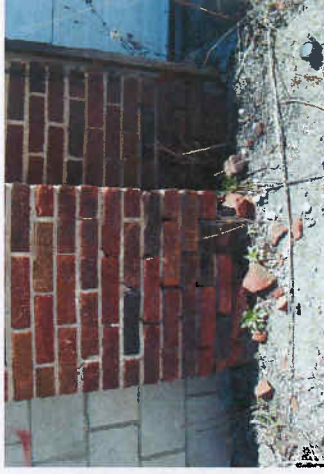
W1.4
The existing brick base is in poor condition. The mortar has completely deteriorated and the brick has spalled and cracked. Typical root causes can be attributed to frost or water which may have leaked into the brick cavity. Lack of proper flashing and weep holes in the first course of masonry above finished ground level has contributed to the damage as water entering the cavity could not properly drain.

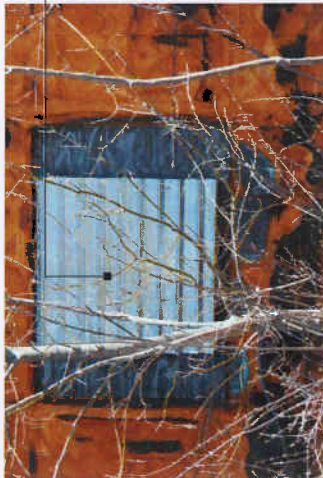
W1.2
A section of the existing steel window sash and glazing has been removed to accommodate the installation of a louvered vent. A sheet of untreated, moderately deteriorated plywood creates a perimeter seal at the glazing opening. Sealant between the steel sash and plywood sheathing has deteriorated.

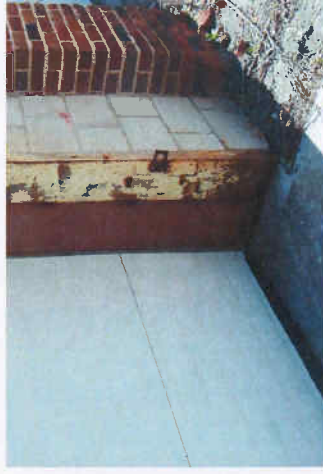
W1.5
A portion of the existing brick wall has been removed to accommodate the insertion of an overhead door and associated structure. A section of the original brick wall has been replaced with a concrete masonry unit infill wall. The steel jamb structure is in fair condition. A jamb cover plate (missing on the opposite side of the door) is tack welded to the jamb column and exhibiting signs of moderate corrosion.

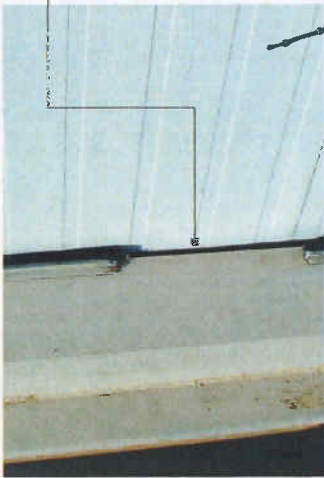
S2.1

Exterior weather stripping at overhead door has been removed or has broken away from the door jamb. Door perimeter is open to air and insect infiltration.

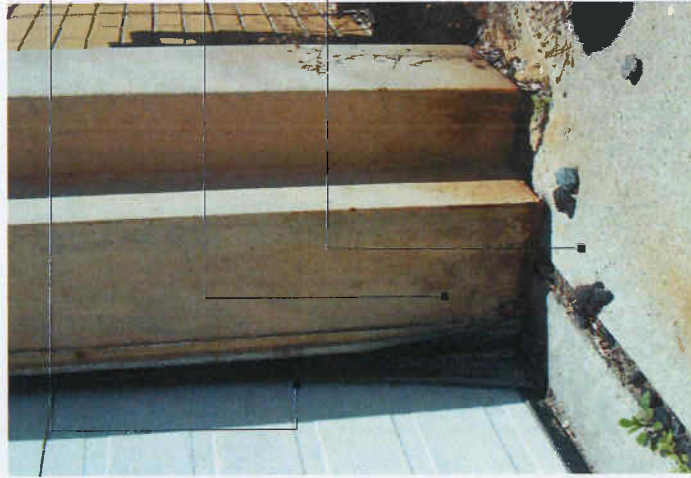
S2.2

Sealant between steel jamb and brick has completely dried and cracked away in some areas exposing the interior cavity of the wall to air and insect infiltration.

Paint on the existing steel columns has deteriorated in areas and signs of minor to moderate corrosion was observed.

Some deterioration in the concrete slab at the overhead door threshold. Evidence of air infiltration and insect infiltration at large gap between door and steel jamb.

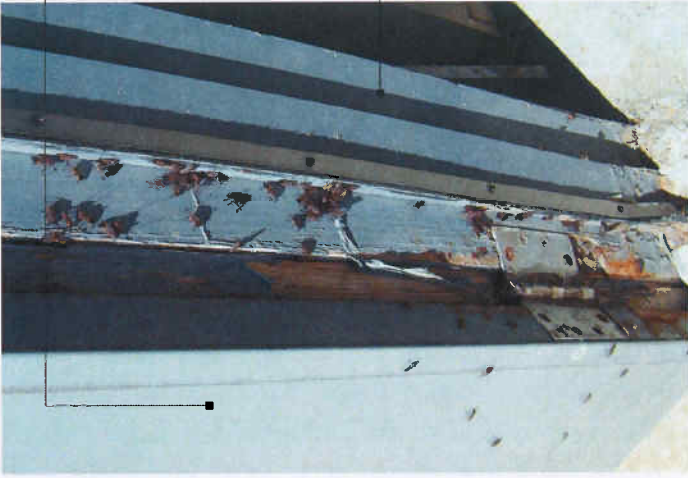
S2.4

Steel entrance door is in fair condition, however painted wood jambs and head are showing signs of severe rot and deterioration. Sections of the wood jamb have been pulled away and cracked and signs of water damage at the slab level were observed. Insect infiltration was observed and it appears that the integrity of the wood jamb has been compromised by insect habitation.

Concrete slab deterioration was noticeable at the door threshold and base of the adjacent side-light window.

Door hardware in Fair-Poor condition showing signs of corrosion and separation from the wood frame.

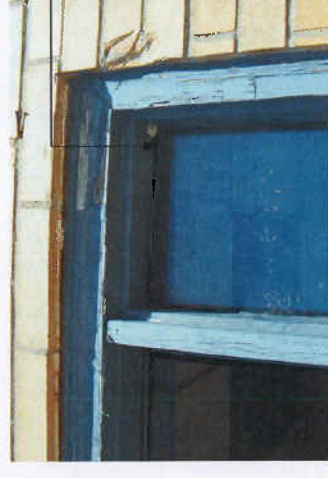
S2.5

The wood framed side-light window is showing signs of deterioration and rot. The paint has flaked and peeled away and the glazing caulking at the window perimeter has deteriorated leaving the interior open to further air infiltration. Signs of water damage at the slab level and insect infiltration were observed.

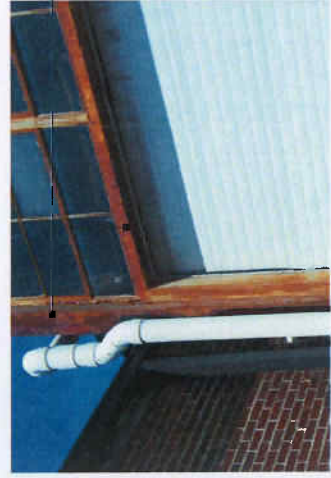
S2.3

Steel window sash and lintel above overhead door appears to be moderately corroded. Air and water infiltration at joints between the glass and steel sash were observed where the glazing putty has deteriorated. Exterior paint on the upper steel columns and steel windows has deteriorated and/or been stained with rust.

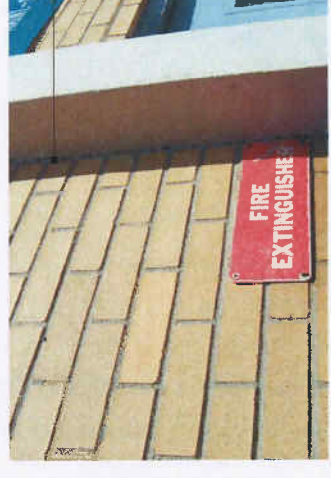
S2.6

The existing brick veneer and mortar joints appear to be in good-to-fair condition with minor signs of deterioration. The caulked joint between the brick and steel column has cracked and opened along the entire facade. As a result the inner wall cavity has been exposed to both air and water infiltration.

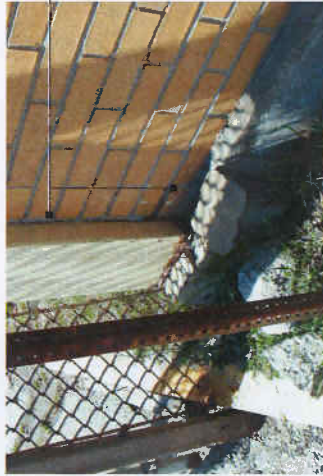
E2.1 Separation between the brick facade and steel column has occurred at NE corner of the building (see structural assessment for further evaluation). The resulting aperture between the brick and steel structure has caused separation of the joint sealant and exposed the internal cavity wall system to water, insect and air infiltration.

Signs of moderate corrosion along the face and at the base of the steel column was observed. The painted surface of the steel column has deteriorated with only small patches of paint remaining on the exposed structure.

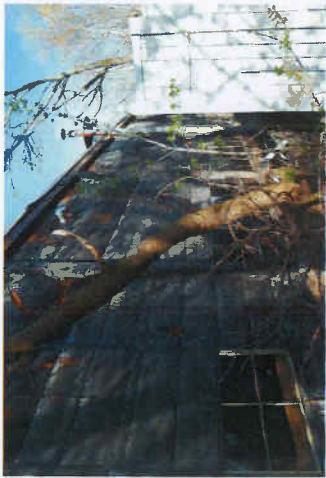
N2.1
Glazing is mostly covered with foam insulation panels that are rotted and blackened in color.

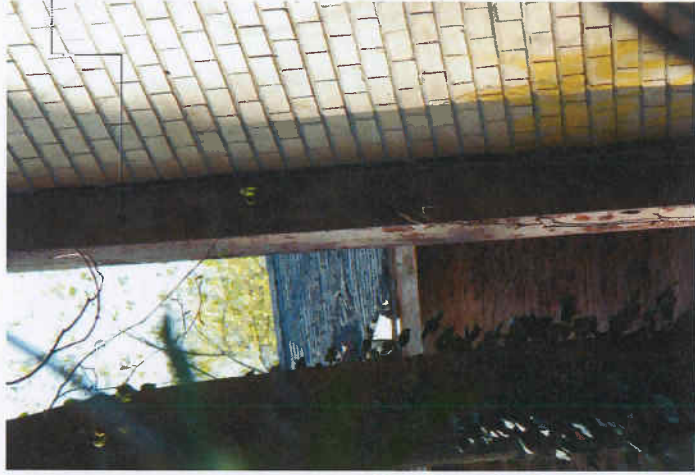
N2.2
Steel structural columns are separated from brick paneling.

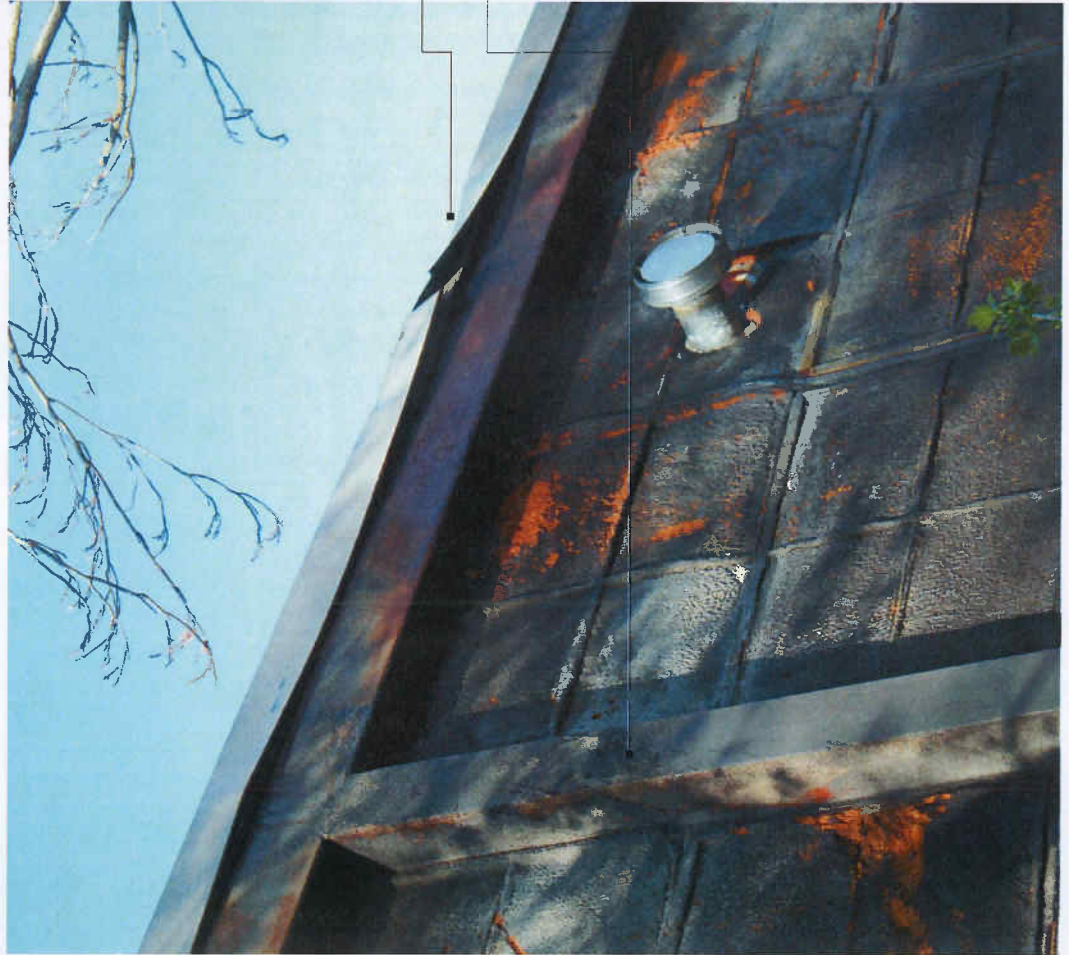
N2.3
Flashing at roof line is separated.

Steel columns are corroded.

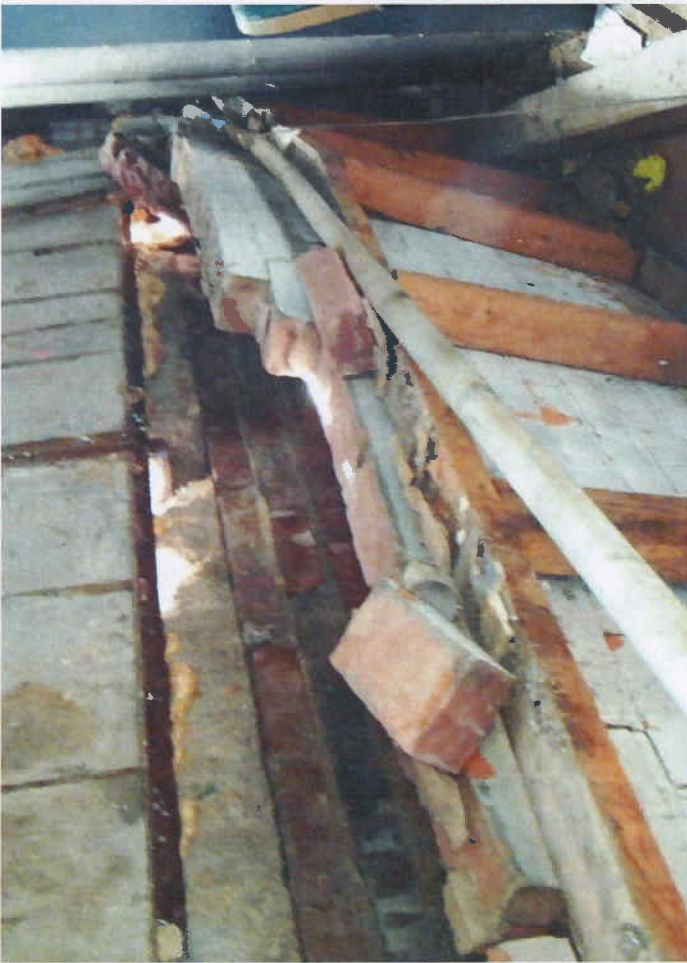
B1.1

A section of the outer brick wall has completely failed at the interior of the 'Break Room' and is buckling inward. There has been an obvious attempt to stabilize the wall with a 2x4 knee wall which has buckled inward as well. Water infiltration at the slab and interior cavity of the double brick wythe wall was evident. Many bricks have come completely loose from the system and are scattered around the area. The concrete window sill has cracked and fallen away and the steel sash window base spans from jamb-to-jamb unsupported. Large openings to the exterior were apparent.

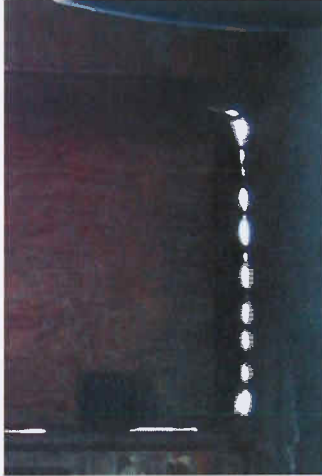
B1.4

The entry door in the East Elevation is in poor condition. Visible signs of deterioration and rot were observed. The perimeter of the door is unsealed and a large gap at the undercut is allowing air and water to infiltrate the building. The adjacent steel jambs are exhibiting signs of moderate corrosion. The concrete slab at the door threshold appears worn and deteriorated. Existing hinges are in poor condition with moderate levels of corrosion.

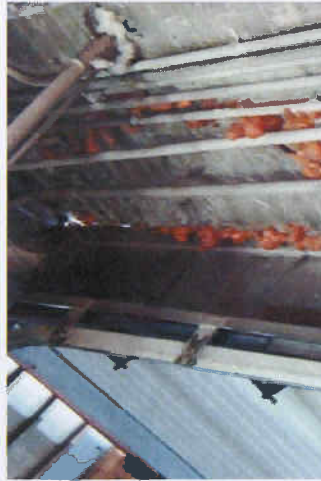
B1.2

Interior wall condition adjacent to the overhead door is in poor condition. Patched grout and spray foam insulation have been utilized in an attempt to seal the perimeter. Open joints at the jamb and head of the door allow for water and air infiltration.

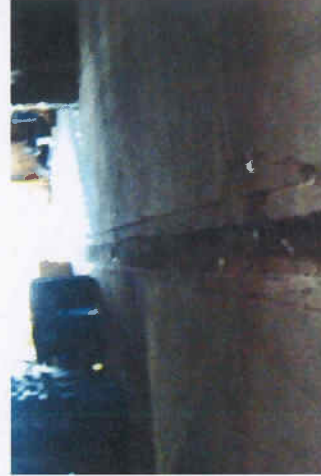
B1.5

A linear trench has been cut into the existing concrete slab. The edges of the trench have crumbled and deteriorated. In general the slab is worn with moderate cracking and spalling in areas

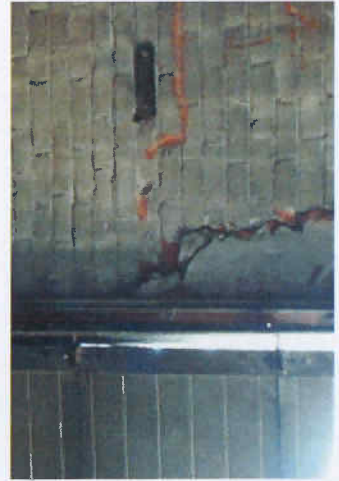
B1.3

Sections of the original brick adjacent to the overhead door in the South facade have been patched with cast-in-place concrete. The joint between the concrete and brick has opened and the concrete has cracked and deteriorated in many areas. Large gaps at the perimeter of the overhead door have allowed air and water infiltration. Evidence of bird infestation was observed.

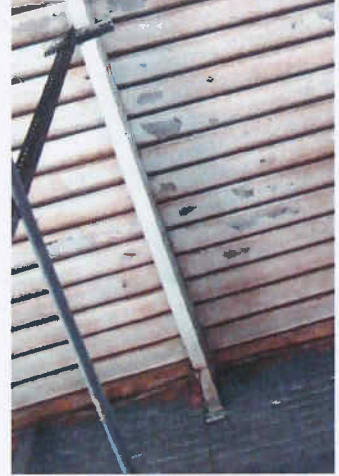
B1.6

Paint at the exposed steel deck has completely deteriorated in some areas. Signs of moderate corrosion at the edge condition adjacent to the North and South parapet walls were observed.

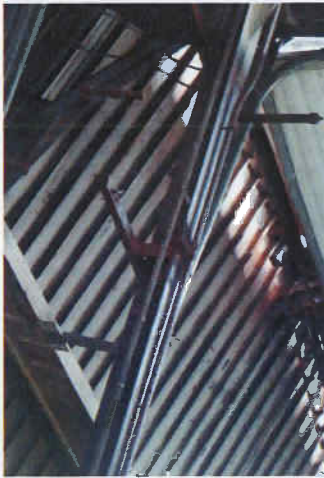
BI.7

The steel deck and paint in some areas remains intact and in fair condition. Minor signs of paint deterioration and corrosion were observed in some areas. Similarly, the paint finish on the existing steel structure appears intact with minor signs of deterioration.

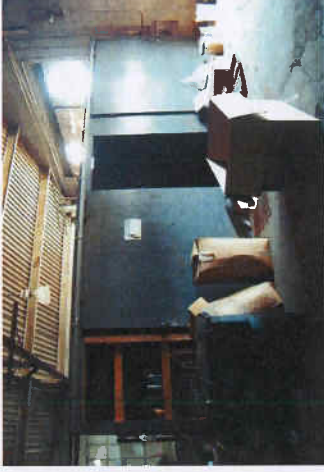
BI.10

A painted wood framed plywood partition in the SE corner of the building served as an employee Break Room. Garbage, refuse and miscellaneous pieces of furniture litter the area. the plywood partition appears to be in fair condition.

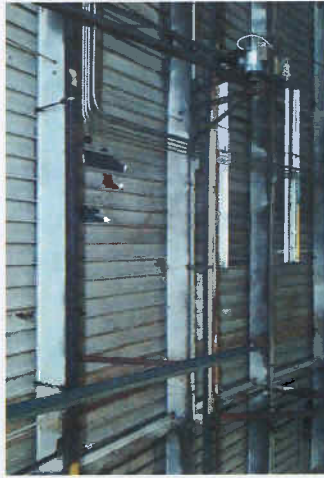
BI.8

The steel deck and paint in some areas remains intact and in fair condition. Minor signs of paint deterioration and corrosion were observed in some areas. Similarly, the paint finish on the existing steel structure appears intact with minor signs of deterioration.

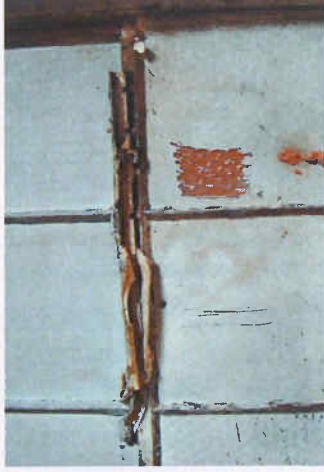
BI.11

The steel windows appear to be heavily corroded in the sash, frame and sub-frame. The glazing putty has completely deteriorated or is dried and cracked. Interior paint has flaked away and some panes have been painted. Overall the existing steel windows appear to be in poor condition. Many of the glass panes are cracked. The exterior spray-on insulation prevents visibility or light penetration to the interior.

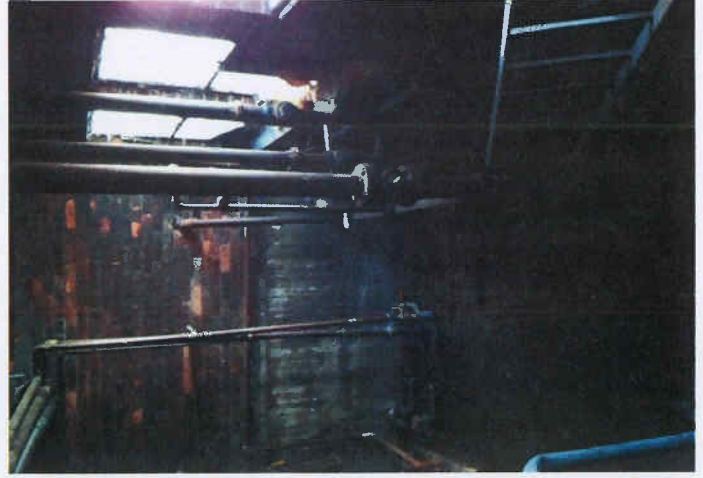
BI.9

The existing Boiler Room is situated partially below grade and was flooded with water at the time of observation. The concrete slab is approximately 4'-6" below grade. Access to an adjacent Coal Bin storage is provided by a single man-door in the western wall which could not be accessed.

Two existing steel sash windows are situated in the east wall of the boiler room. Sections of the steel sash have been removed and covered with untreated plywood sheathing and spray-on insulation. The steel window sash is corroded and several of the glass panes are broken.

A painted plywood door and wood frame provide access to the exterior from the boiler room landing. The frame and door are exhibiting signs of decay and rot. Open joints between the brick facade and door frame are open allowing for water & air infiltration.

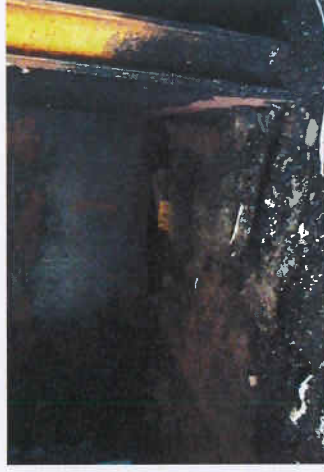
BI.12

Asphalt storage area. Steel columns have been installed and sheathed in the SW corner of the building to create an area for asphalt storage. Remnants of asphalt remain on the surrounding structure and slab.

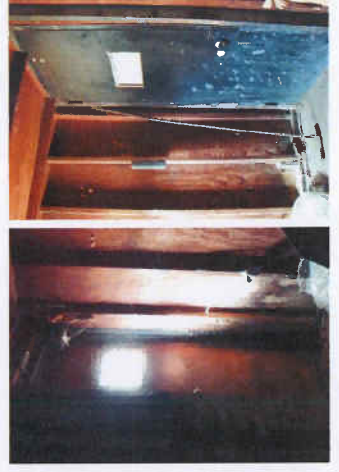
BI.13

An operable interior steel door connects the north and south sections of Building 1 through the interior demising wall. The door is in fair condition.

The untreated exterior plywood door is in poor condition with noticeable signs of decay. The interior hardware is severely corroded. The steel jamb is moderately corroded and in poor condition.

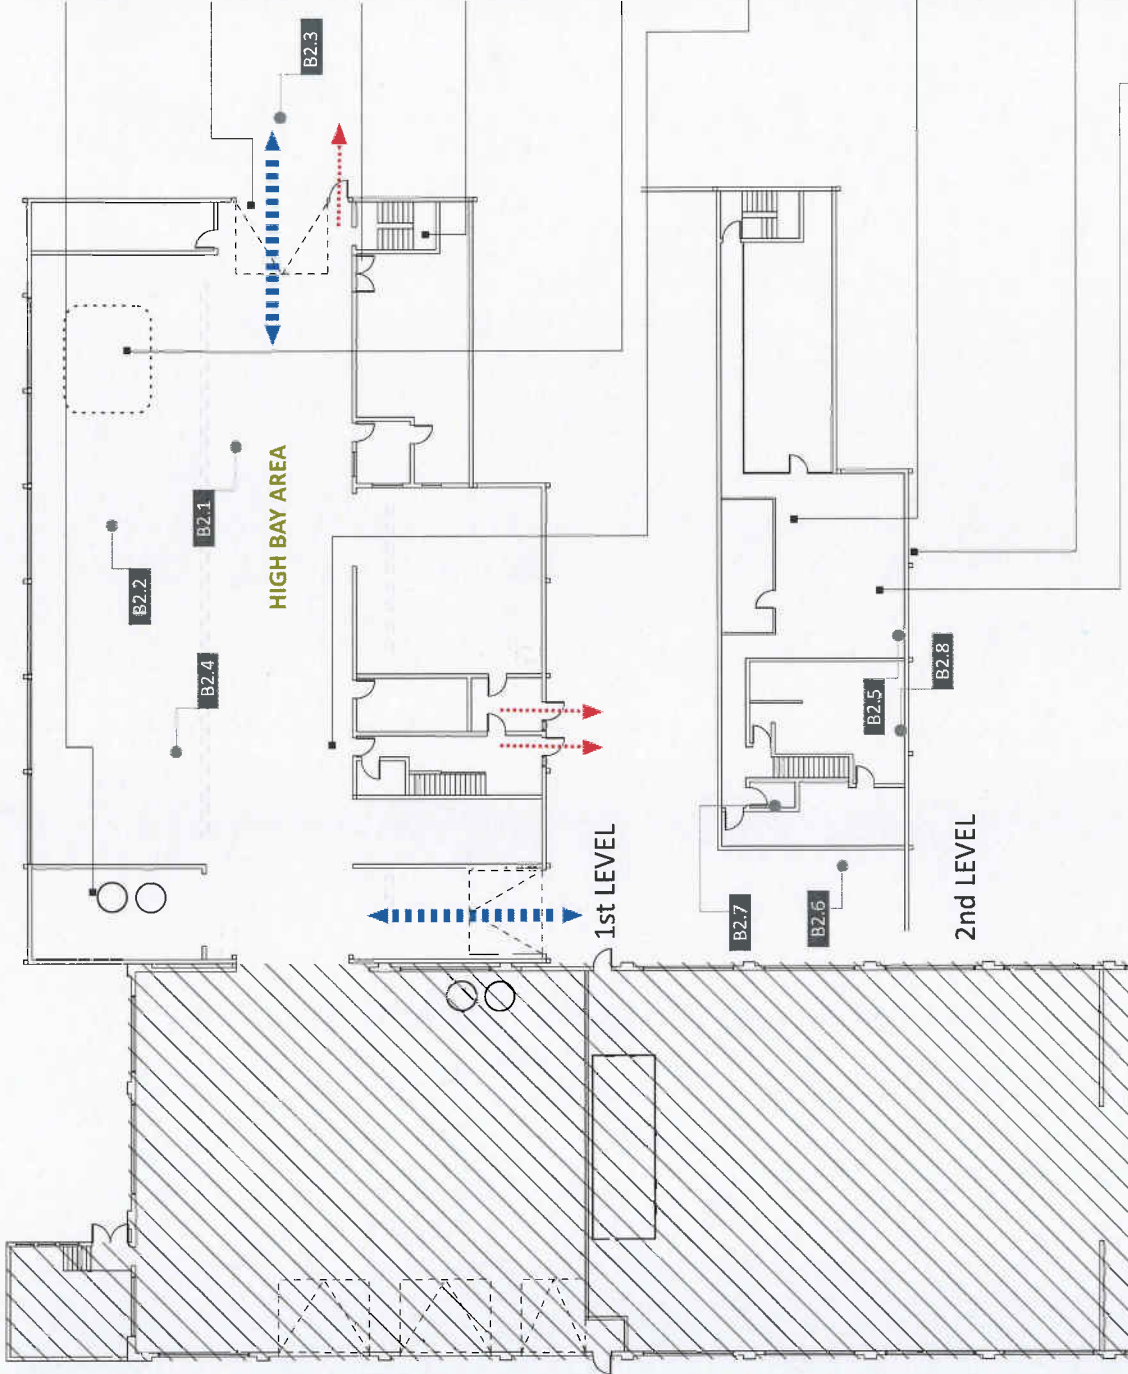
Dirty ponding water was observed in the location of the original Paint Room. Sections of the concrete slab in the room are discolored and stained yellow.

Painted cement panels installed at interior above overhead door and adjacent man door. Original drawings identify the material as 'Cemesto', a waterproof & fire-resistant panel comprised of a sugar cane fiber insulating core surfaced (both sides) with asbestos and cement.

Existing steel pan stairway with concrete treads in good condition. Existing guard and hand rail at the stair and landing does not meet current code requirements.

Steel grating mezzanine provides access to concrete roof of the chemical storage room and a roof access hatch. Mezzanine and painted finish appear to be in good condition.

Sections of the exposed Tectum roof deck are stained with evidence of water infiltration and point to larger issues with the existing roof membrane.

Extensive use of resilient floor tile in the upper mezzanine administrative area is in poor condition. Asbestos was a very popular ingredient in floor tiles and mastic between 1920 and 1960.

The steel sash windows are moderately corroded and the glazing putty is dried and cracked. Some sections of glass are cracked.

Existing 2x4 lay-in ceiling tile is in poor condition and heavily damaged in some areas due to water infiltration through the Tectum roof deck above.

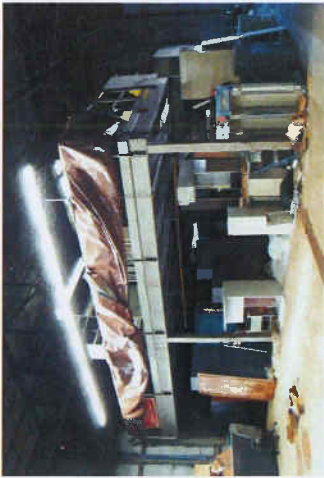
B2.1

A raised steel mezzanine provides access to the concrete roof deck of the Chemical Storage/ Tire Storage where the roof access hatch is located. The steel structure of the mezzanine appears to be in good condition. The painted finish is worn and deteriorating slightly with age.

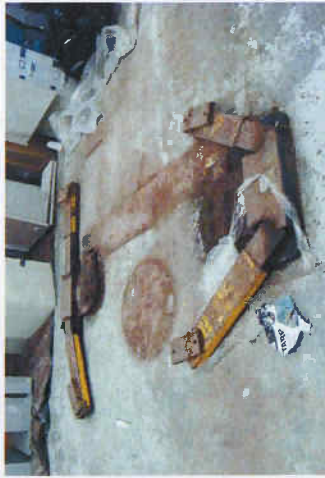
B2.2

The existing concrete slab has worn and cracked in some areas but is generally in fair condition. Three derelict vehicle bays with lifts with jack hole shaft below finish floor plate are set in the northern portion of the floor plate. Access to a hydraulic oil underground storage tank was observed. The equipment is moderately corroded. A crane hoist and associated structure is positioned east of the vehicle bays.

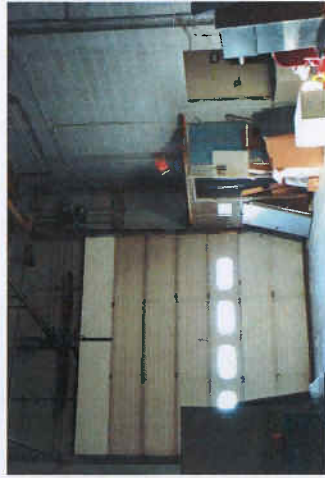
B2.3

The overhead door and adjacent man-door in the East elevation are in poor condition with perimeter seals breached allowing water and air infiltration. Panels above the doors are identified on the original drawings as "Cemesto", an asbestos-based cement board. The door hardware and suspension system for the overhead door appears to be moderately corroded.

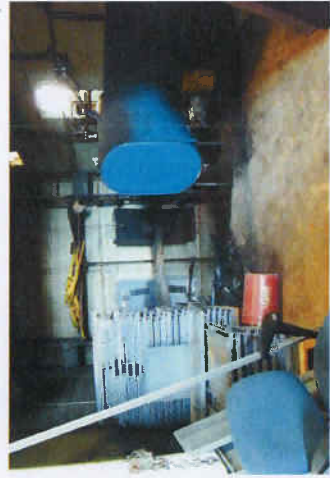
B2.4

The vehicle Paint Room is partitioned from the main high bay area with a painted concrete masonry unit wall in fair condition. Standing water. An above ground storage tank is positioned within the space. Ponding water and damaged Tectum roof deck was observed in this location. The concrete slab is discolored and stained.

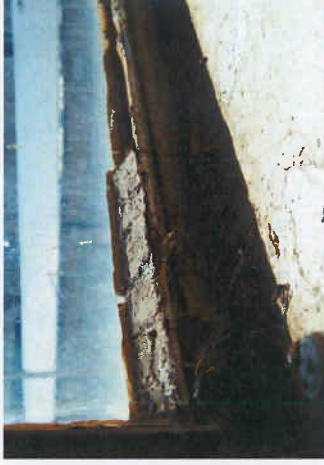
B2.5

The sash, frame and sub-frame of the steel windows in the south wall of the mezzanine level are heavily corroded and deteriorating. The existing glazing putty is dried and cracked. The single pane glass is broken in some areas and lacks thermal efficiency.

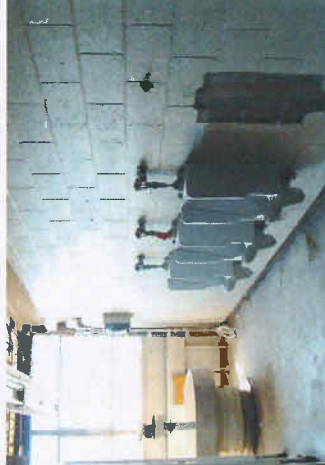
B2.6

The interior painted concrete masonry units appear to be in fair to good condition. The wall base has deteriorated in many areas and is in poor condition. The plumbing fixtures appear to be in fair condition. The water is currently turned off in the building so functionality of the fixtures could not be determined.

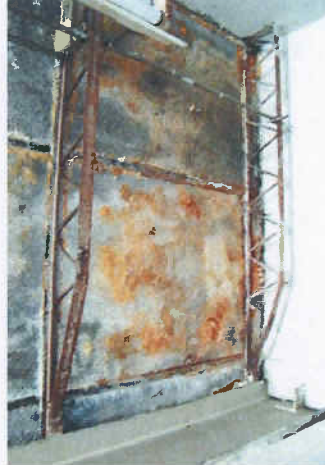
B2.7

Exposed Tectum roof deck is in poor condition as sections of stained and decaying roof deck were identified at areas of water infiltration on the mezzanine level. The roof joist structure appears to be moderately corroded in areas where water has entered the building.

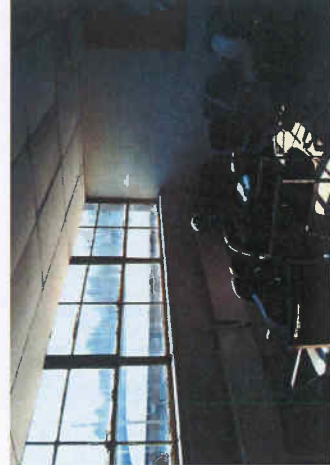
B2.8

The existing lay-in ceiling is in poor repair. Water damage and staining were observed throughout the mezzanine level. Furniture and refuse litter the space. Many ceiling tiles have decayed and crumbled under the weight of infiltrating water. The floor finishes in the mezzanine are generally in poor condition and beyond repair. Resilient tile has been water damaged and is deteriorating.

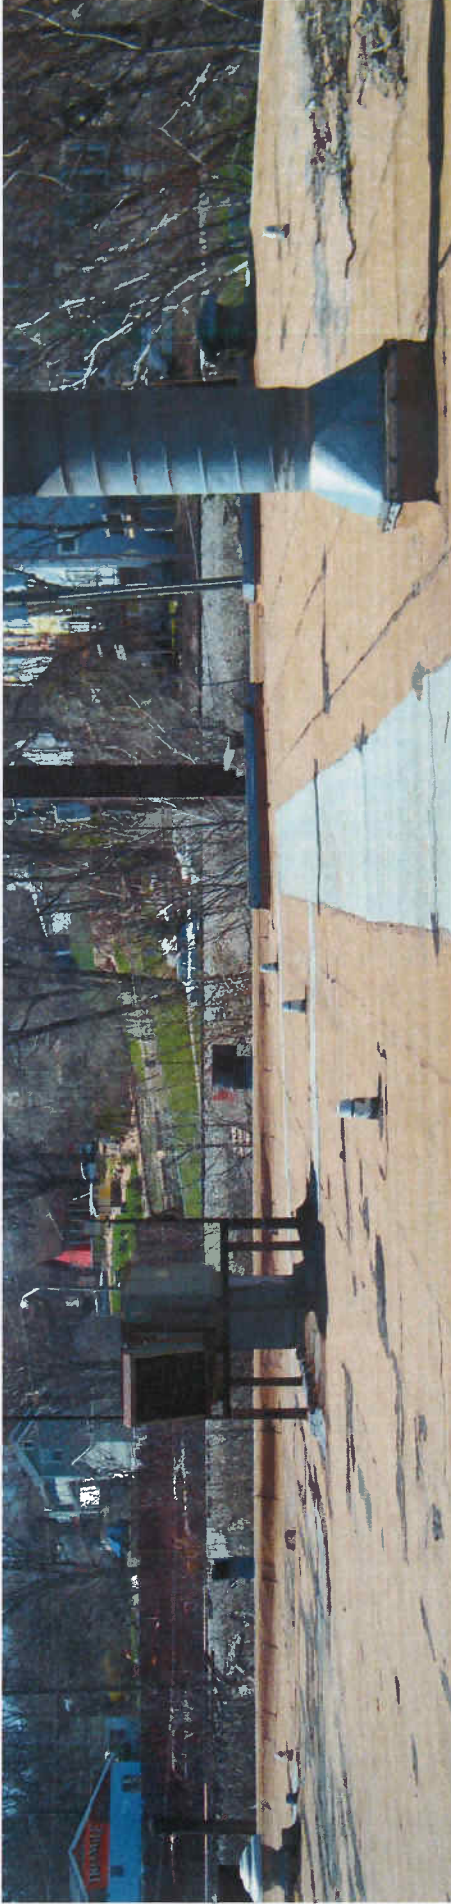
R2.1

View looking west of the existing Modified Bitumen (MB) roof. The mineral surface coating appears worn and some staining is noticeable. Flashing at the roof curbs is moderately deteriorated. From the interior it is apparent that the Tectum roof deck has sustained moderate to heavy damage from water infiltration. This potential structural instability prevented a thorough examination of the condition of all roof penetrations.

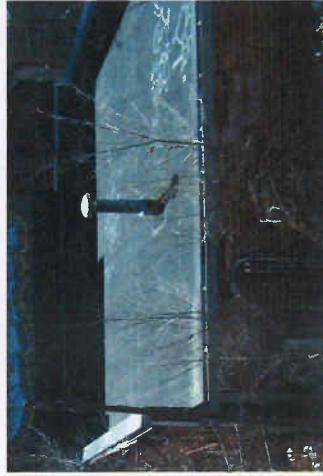
R1.2
Flashed membrane connection at the North and South parapet walls appears to have been compromised. Joints in the envelope have allowed air and water infiltration as evidenced by the condition of the existing parapet brick wythe walls. The existing gutter has disconnected from the fascia in areas along the East and West elevations.

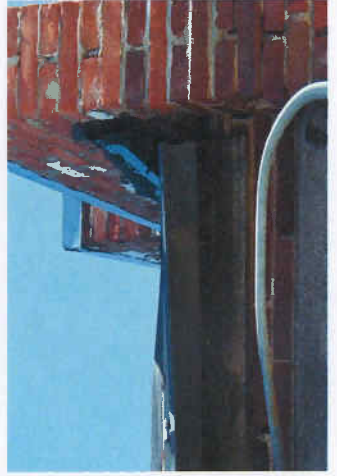
R1.3

Viewed from a distance, the overall condition of the existing single ply membrane appears to be fair. However, loose sections of membrane at the East and West eaves appear to be unsecured and are lapped into the gutter. Lack of roof access prevented a thorough examination of the condition of all roof penetrations.

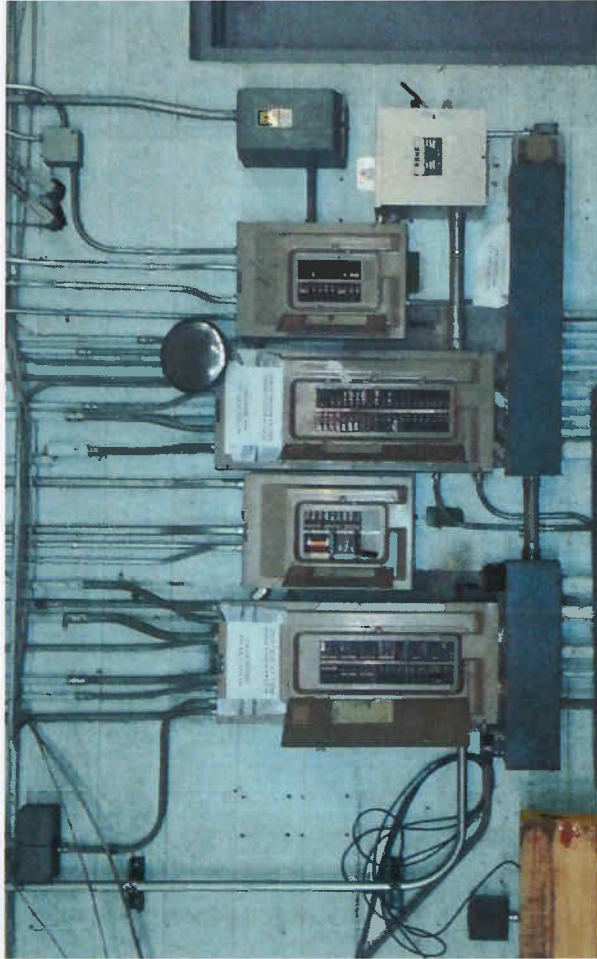
The main electrical service for Building 2 is located in the northwest corner of Building 1, and is described in the Building 1 section of this report. There is a group of single-phase and three-phase panelboards located in the garage area of Building 2 that serves the local lighting and receptacle circuits. The panels are Cutler-Hammer load centers, and some of the breakers are missing leaving the panelboard interiors open to the environment. There is no visible date on the panelboard nameplates, however the equipment appears to be approximately 20 years old, and nearing the end of their useful life.

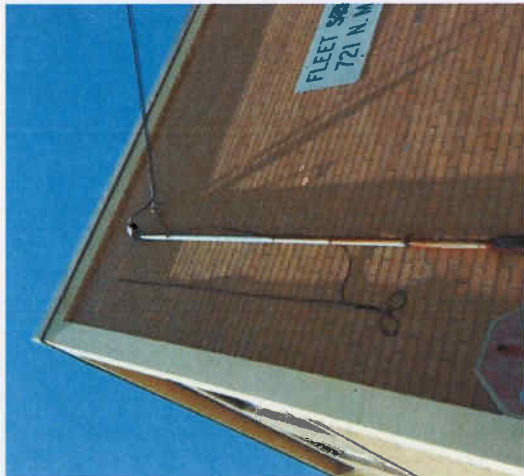
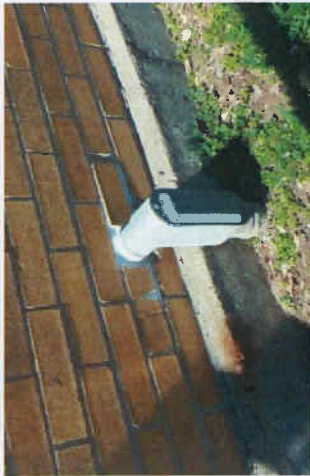
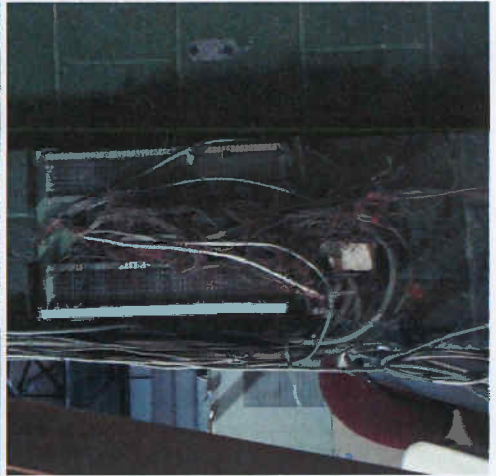
There is an existing overhead telephone service drop along the south elevation of Building 2. Below the service drop there is also a 2 inch conduit that is stubbed up from underground and then penetrates into the building. It appears this conduit may have been used for incoming phone or cable lines as well.

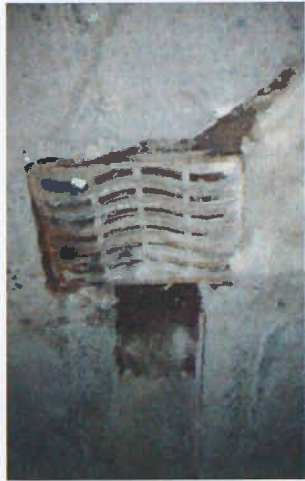
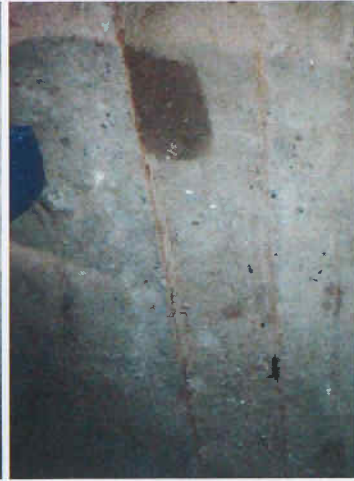
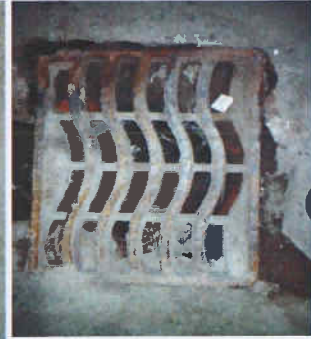
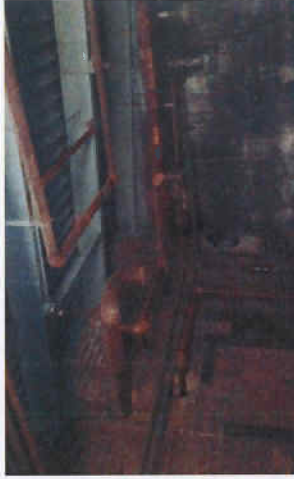
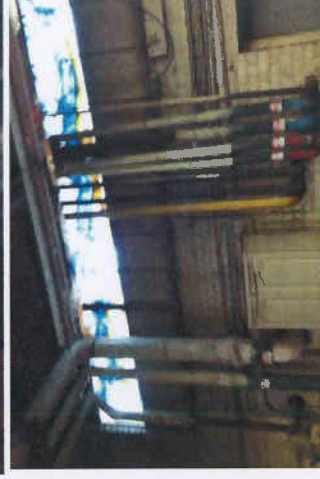
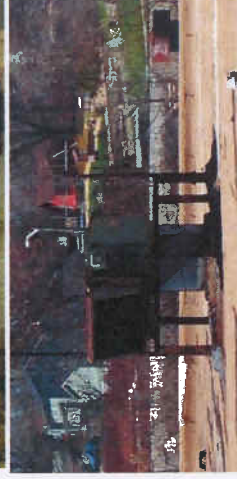
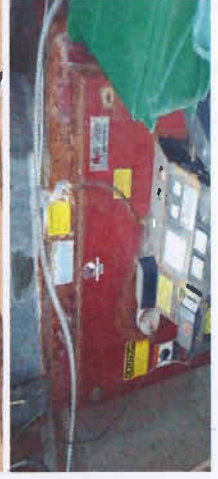
There is an existing trench drain that runs down the center of the building which is deteriorating badly in some locations and is full of dirt and debris, the catch basin at the south end of the drain was also full of dirt. The sanitary system appears to be in poor condition and should be cleaned out and videoed to determine the actual condition and location of the underground lines.

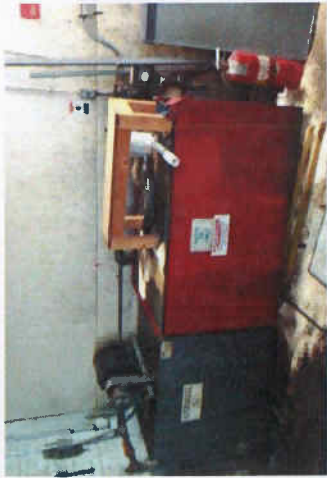
It appears there was a domestic water meter along the east side of the building near the south end. The meter has been removed and the piping has been left abandoned, the municipal water service from the street is a 1-1/2". It appears that the entire domestic water system will need to be replaced, the piping is galvanized and been abandoned for quite some time. The original drawings for building 2 indicate there was a 2" domestic water service in the boiler room at the north end of the building but this could not be verified because the boiler room was flooded and non-accessible. There were no plumbing fixtures located in Building 1.

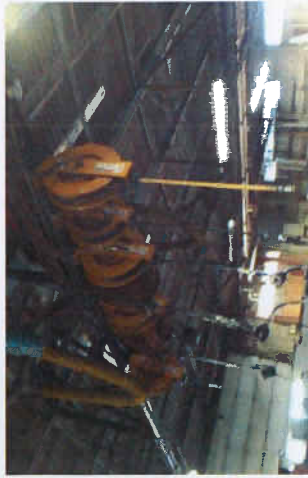
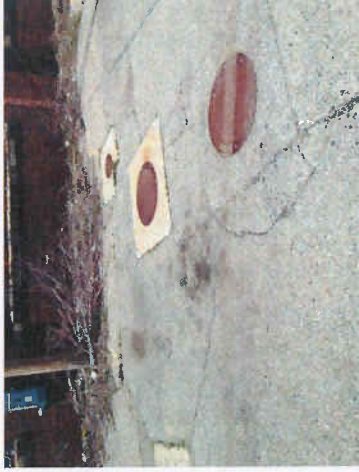
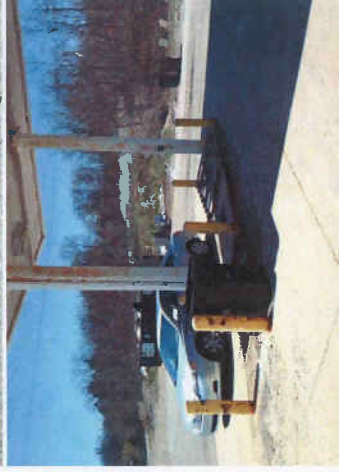
The northern portion of the building was used for vehicle service, there is compressed air and oil piping running throughout the space and hose reels mounted above. Waste oil and hydraulic oil tanks still remain, these tanks appear to be single wall tanks.

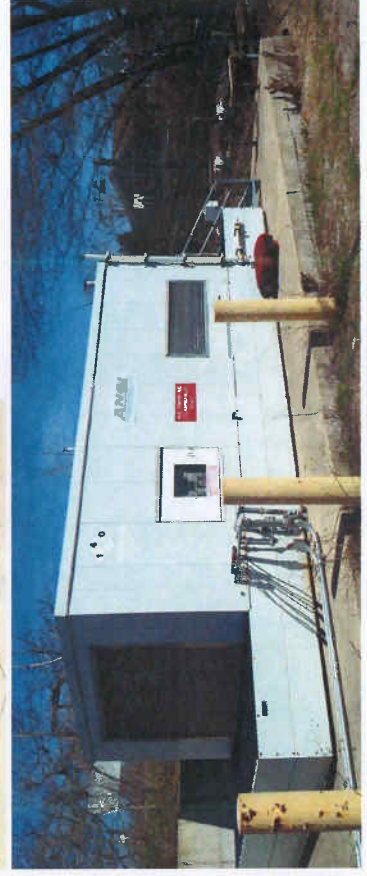
There are underground fuel storage tanks located just east of the building, and a fuel dispensing island south of the building. From our visual inspection we were not able to determine the type of tanks installed, there was also a Veeder Root monitoring and control system with the main panel located in Building 2. The fuel dispensing pumps have also been removed from the dispensing island.

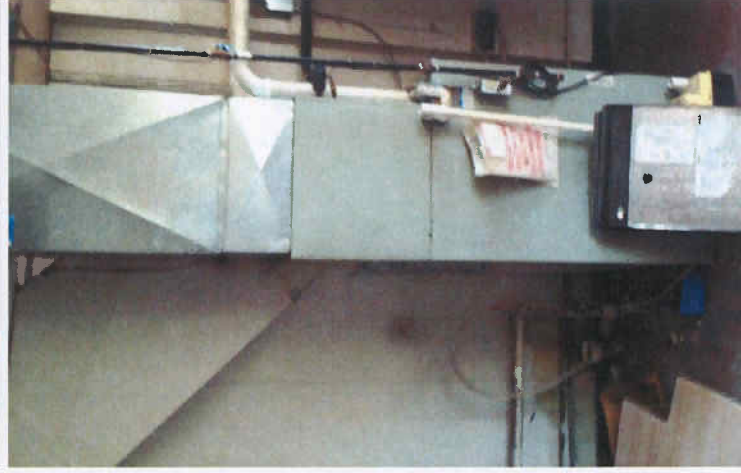
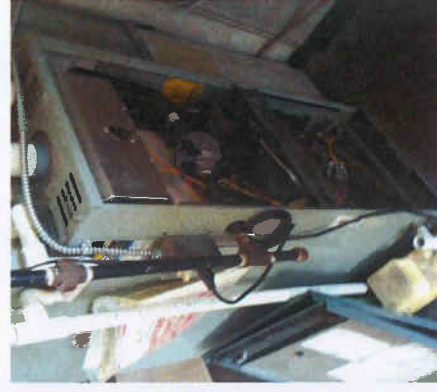
The high bay shop area was originally heated by steam unit heaters that were fed from the boiler located in Building 1, the unit heaters and piping still remain. The piping has been abandoned for such a long time it is most likely full of scale and not reusable, steam system are also typically not used anymore.

The two story Office area was last served by two high efficiency gas furnaces with remote air cooled condensers, there is one system for the lower level and one for the upper. The units appear to be in fair to poor condition and have not been used recently, because of limited ceiling heights the ductwork is exposed and both units have single point returns at the units. Finned tube radiators also remain throughout the office area from the old steam system.

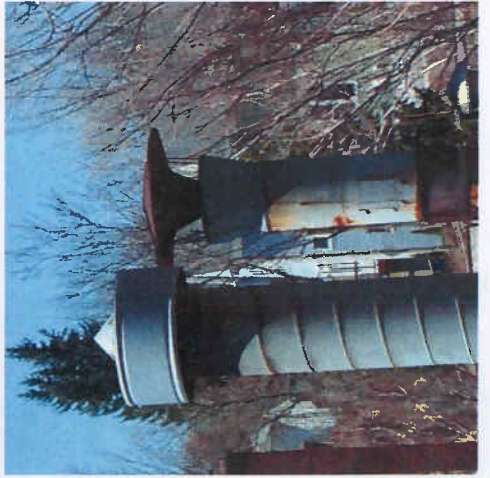
There are remnants of an old paint spray booth with exhaust ducts that run up through the roof, this is of no possible use and will need to be removed.

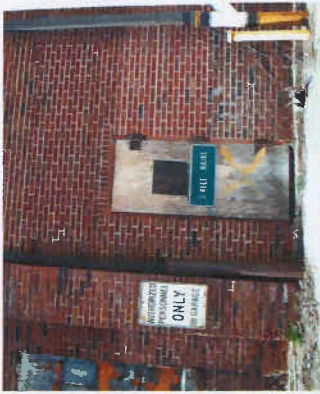
There are three operable man sized doors in Building 2. They are located on the east and south facades of the structure. The approaches are at grade level and do not require stairs or ramps. The routes have proper horizontal clearances for passage. Minor slab deterioration may contribute to accessibility issues for wheelchair and people with visual impairment. Repairing, filling, and patching the concrete is recommended. Presently the threshold edges are higher than the ADA limit of 1/4" above grade.

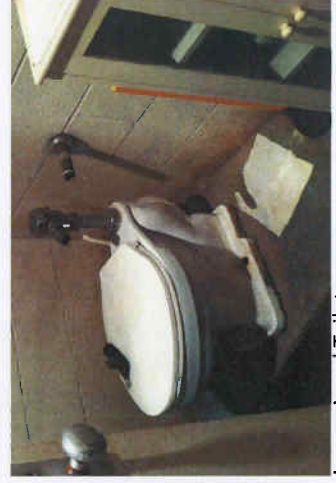
Lower Level Toilet room.

Vertical Circulation:
 There are two stairways in Building 2 which provide access to the administrative mezzanine and toilet room. There is no elevator in the existing building and no barrier free access to the second level toilet rooms. There are no existing ramps.
