City of Ann Arbor MRF Audit

The following report is a maintenance and operations evaluation of the equipment installed at the City of Ann Arbor Materials Recovery Facility by CP Manufacturing. The information gathered for this report was collected by Craig Frisch, Senior Field Project Manager. This information was gathered over a two day period.

Company/Dept.: CP MFG / Customer Service		Title: System Audit		Document Number: Audit

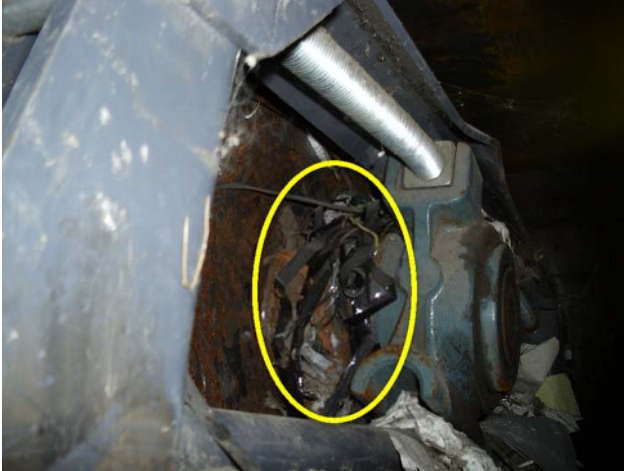
Picture shows wrapped shafts. Take up frame is bent.

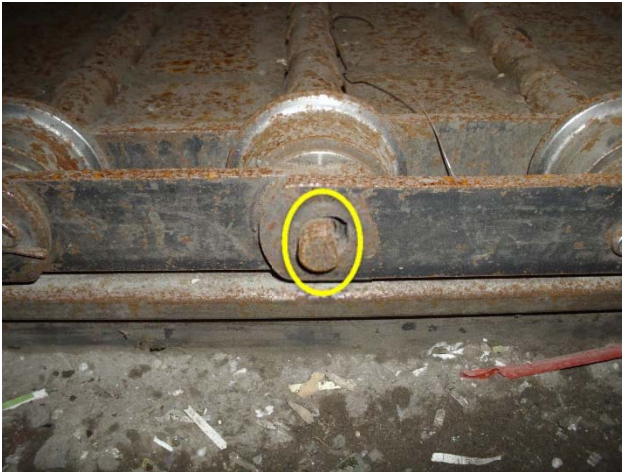
D hole bars are worn out, no cotter pin installed.

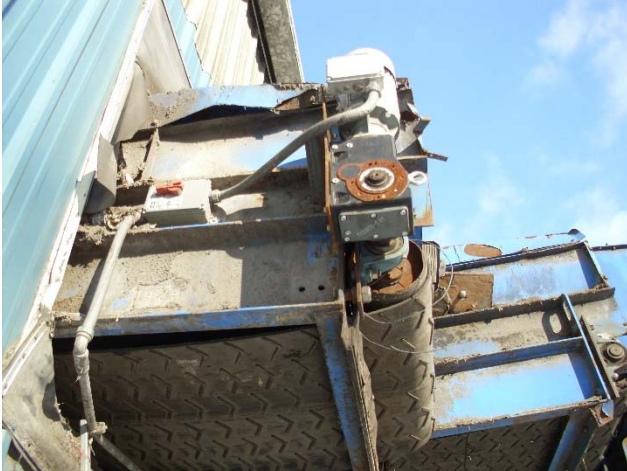
Wire wrapped around pulley and shaft.

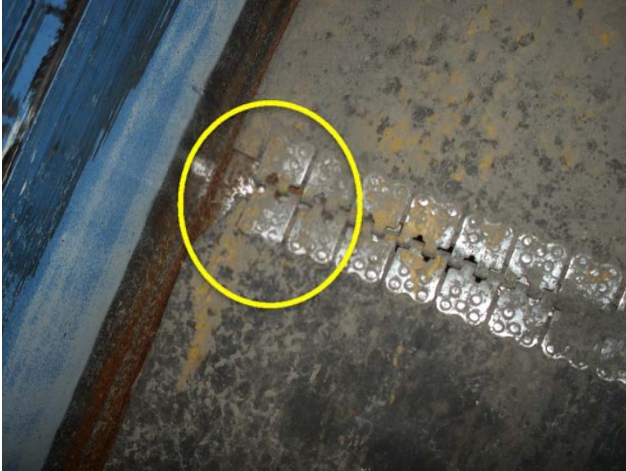
Belt and lacing is torn and needs to be replaced.

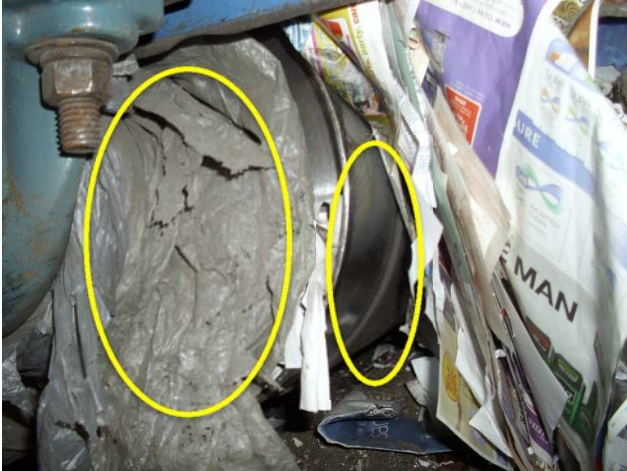
Shaft is wrapped, belt tracking needs to be corrected.

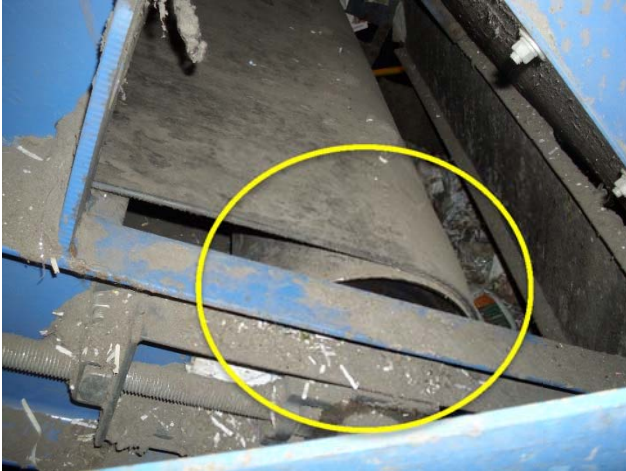
Belt tracking needs to be corrected.

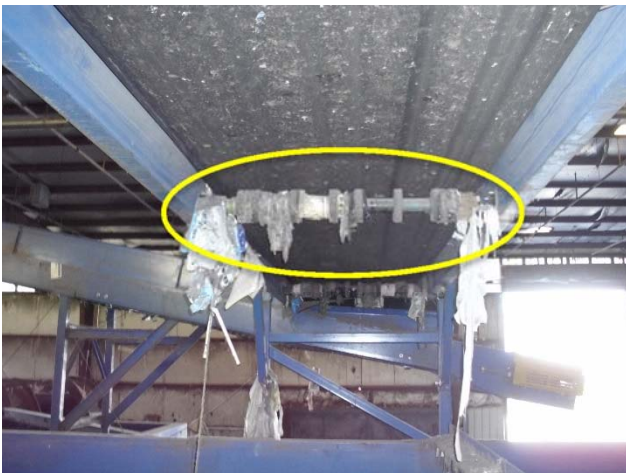
Return rollers are worn and need replacement.

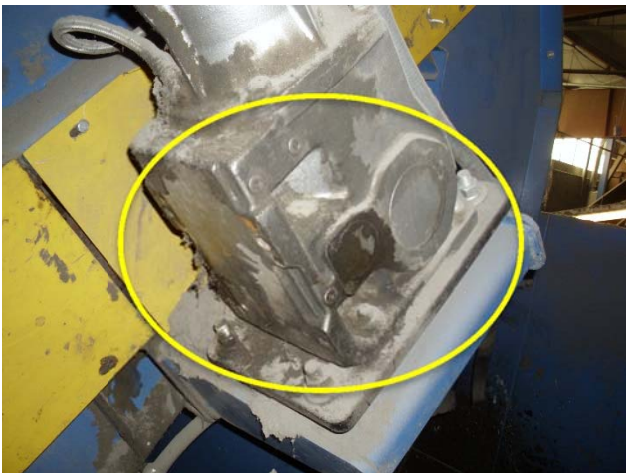
Gearmotors are leaking, replacement required.

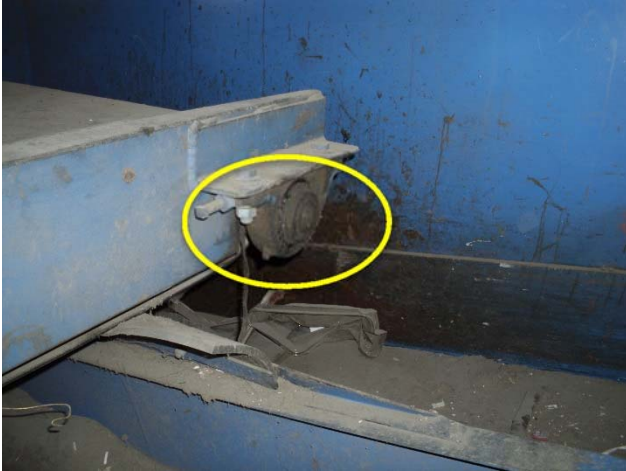
Bearing is worn, replacement required.

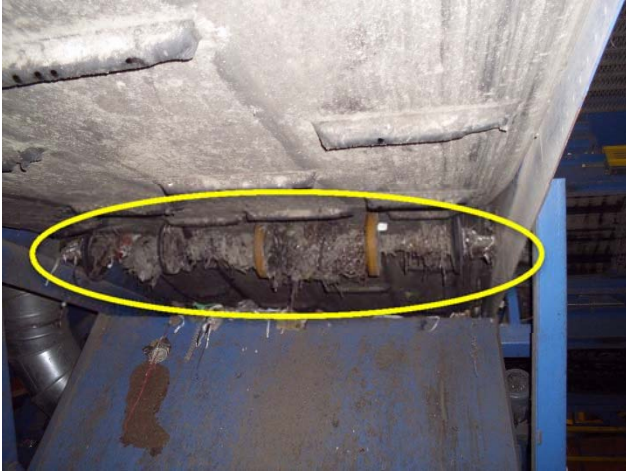
Return rollers are worn and some are omitted. Replacement required.

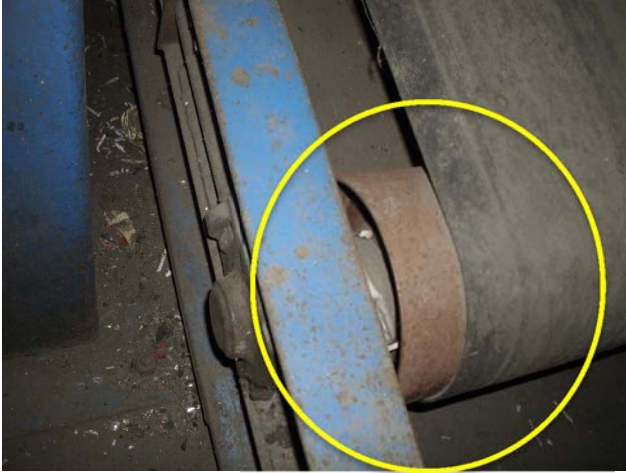
Tracking is to the right, belt is worn.

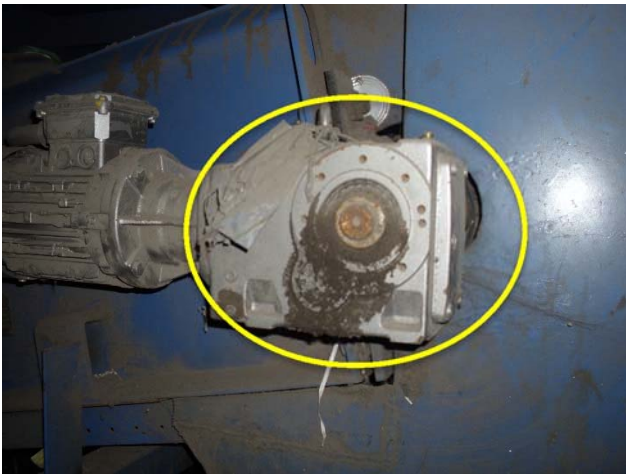
Gearmotor is leaking. It is held stable by zip ties. Replacement required.

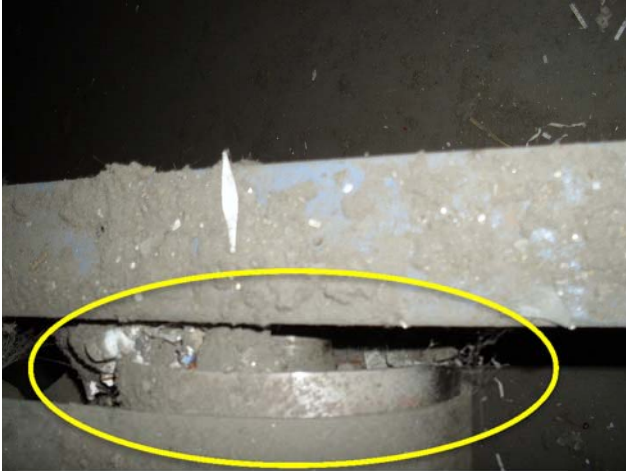
Picture shows a severely worn pulley and belt tracking veering off. Pulleys to be replaced.

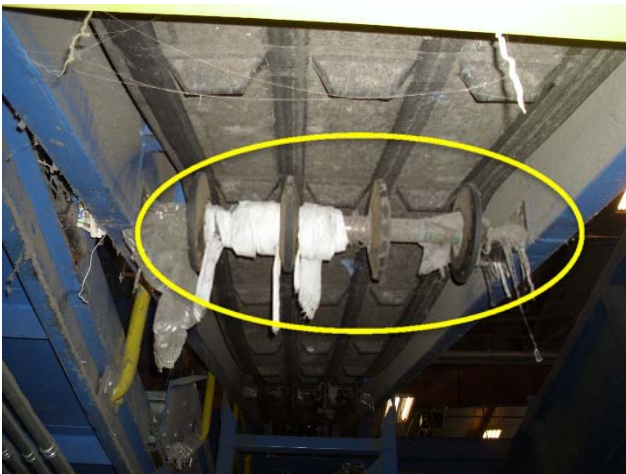
Return rollers are worn and wrapped. Replacement required.

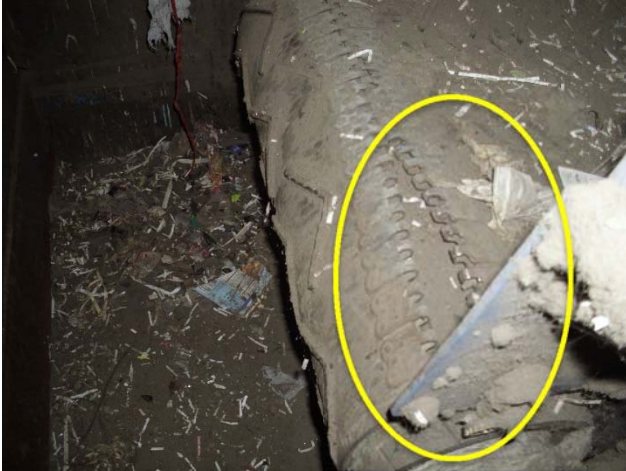
Belt is torn, lacing is ripped, replacement required.

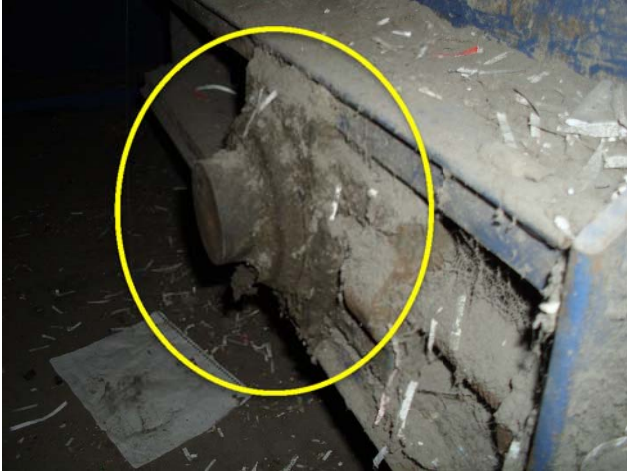
Both head and tail pulley and bearings are severely worn, replacement required.

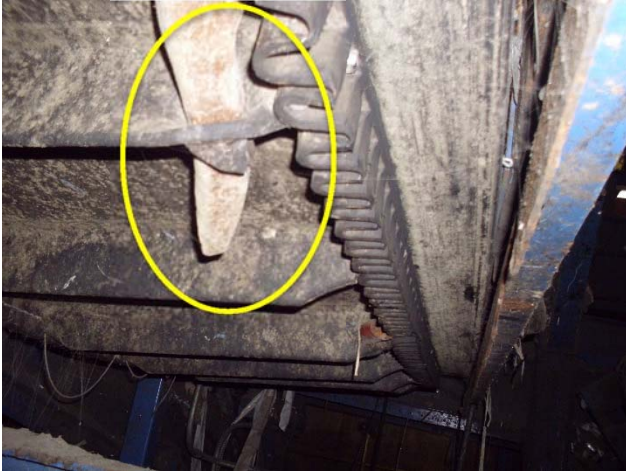
Belt is worn and objects are protruding through cleats, replacement required.

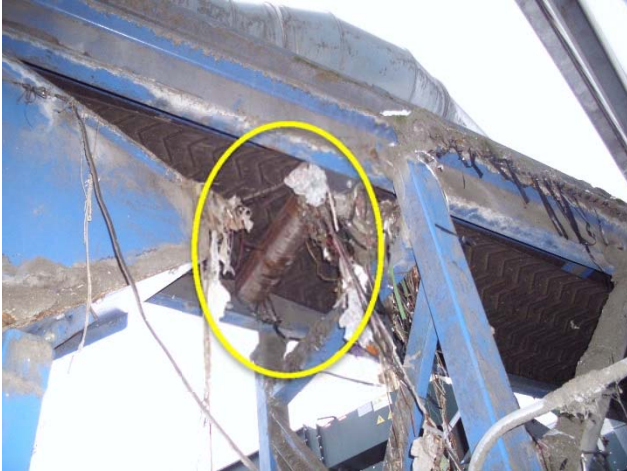
Return rollers are worn, replacement required.

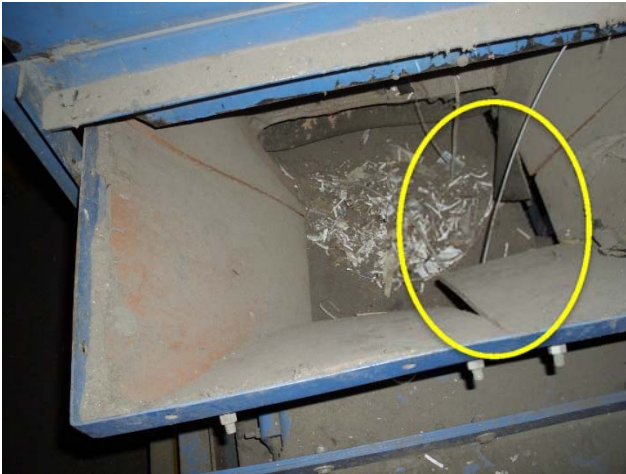
Liners need to be replaced.

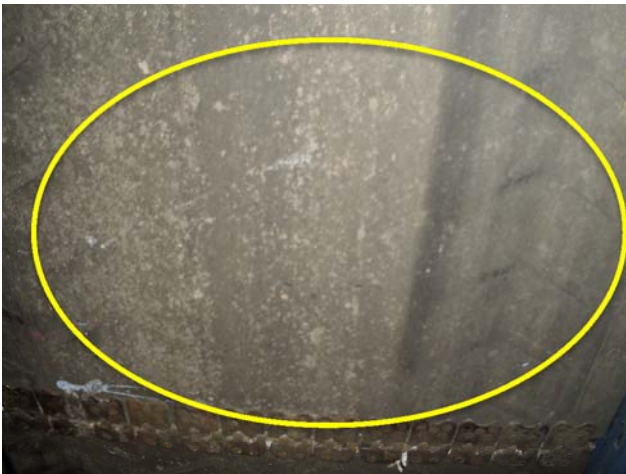
Belt is severely worn, replacement required.

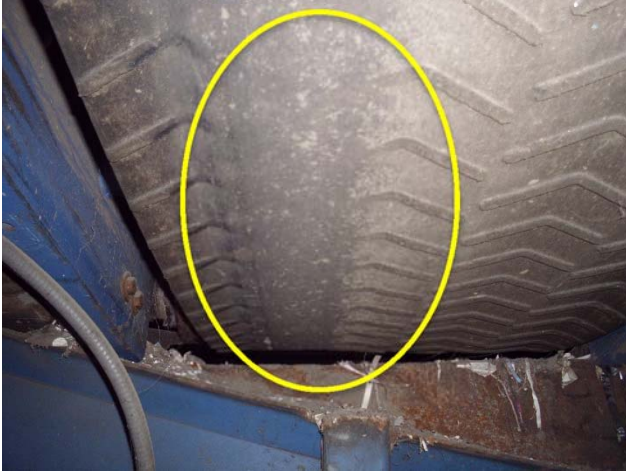
Belt is worn, replacement required.

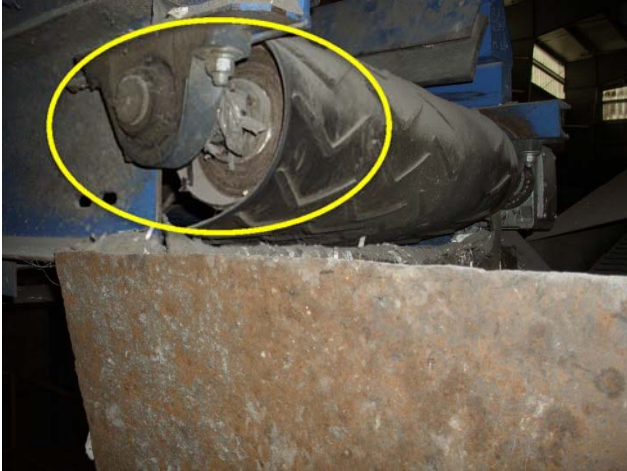
Pulleys and bearings are damaged, replacement required.
