## ANN ARBOR HISTORIC DISTRICT COMMISSION

### Staff Report

**ADDRESS:** 607-609 East William, Application Number HDC12-022

**APPLICATION:** The applicant seeks HDC approval to replace eleven double hung wood windows with new Andersen 400 series wood windows.

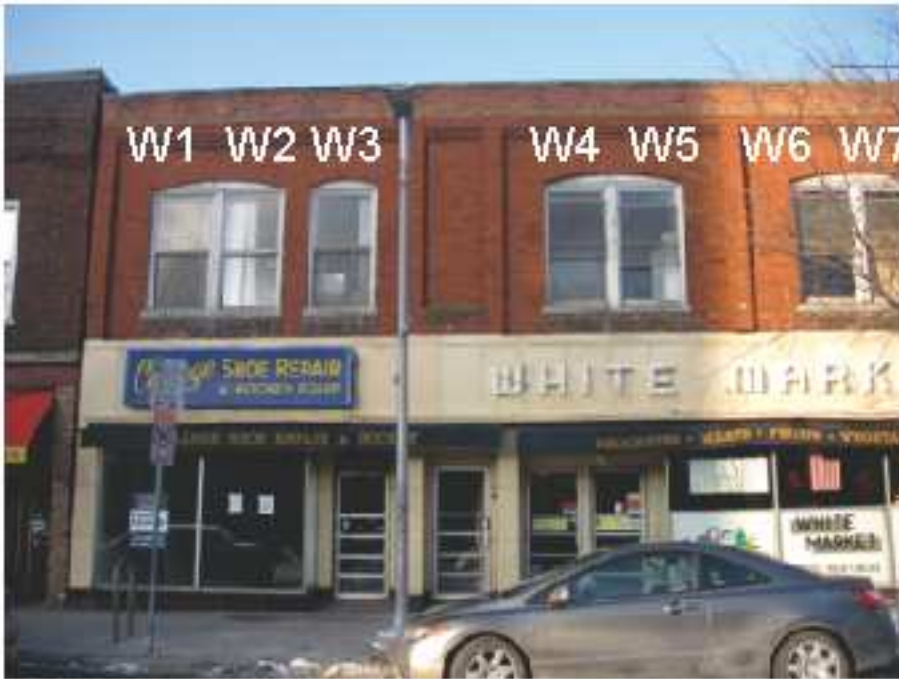
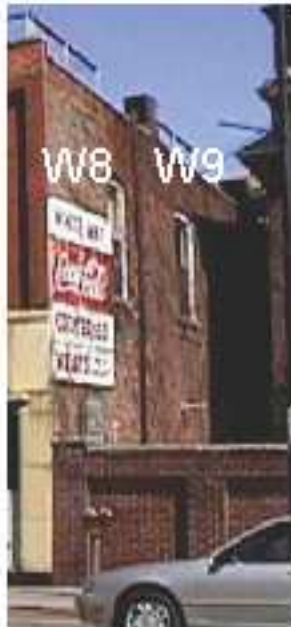
## Window Key

<b>Window Number</b>	<b>Description of problems with windows</b>	<b>Plan of Action</b>
<b>1</b>	Interior and exterior sash and sill are deteriorated. No lock	Remove and replace window
<b>2</b>	Exterior sill very soft. Sash cord missing	Remove and replace window
<b>3</b>	Sash pulling away in the corner. Sill is rotten	Remove and replace window
<b>4</b>	Interior sash separated in the corner. Sill rotten.	Remove and replace window
<b>5</b>	Broken lower pane. Sash area separated. No lock. Cord & Sash missing.	Remove and replace window
<b>6</b>	Upper pane is broken. Sash missing. Window boarded	Remove and replace window
<b>7</b>	Rotten sill, outside sash soft. No lock	Remove and replace window
<b>8</b>	Both sashes held with nails and screws. No lock. No cord sash.	Remove and replace window
<b>9</b>	Sash rotted from inside. Soft sill outside.	Remove and replace window
<b>10</b>	No lock. Window sash held together with screws	Remove and replace window

<b>11</b>	Rotten wood in sash and sill.	Remove and replace window

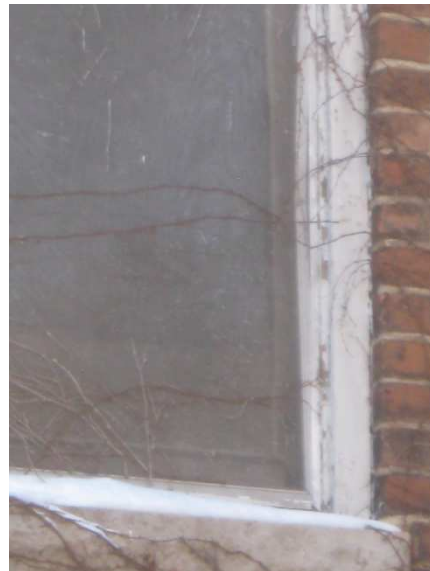
Closeup of Window 5

All windows show similar deterioration
