## ANN ARBOR HISTORIC DISTRICT COMMISSION

### Staff Report

**ADDRESS:** 209 South Main Street, Application Number HDC12-164

**APPLICATION:** The applicant seeks HDC approval to replace six wood windows in the front elevation with six new wood windows.

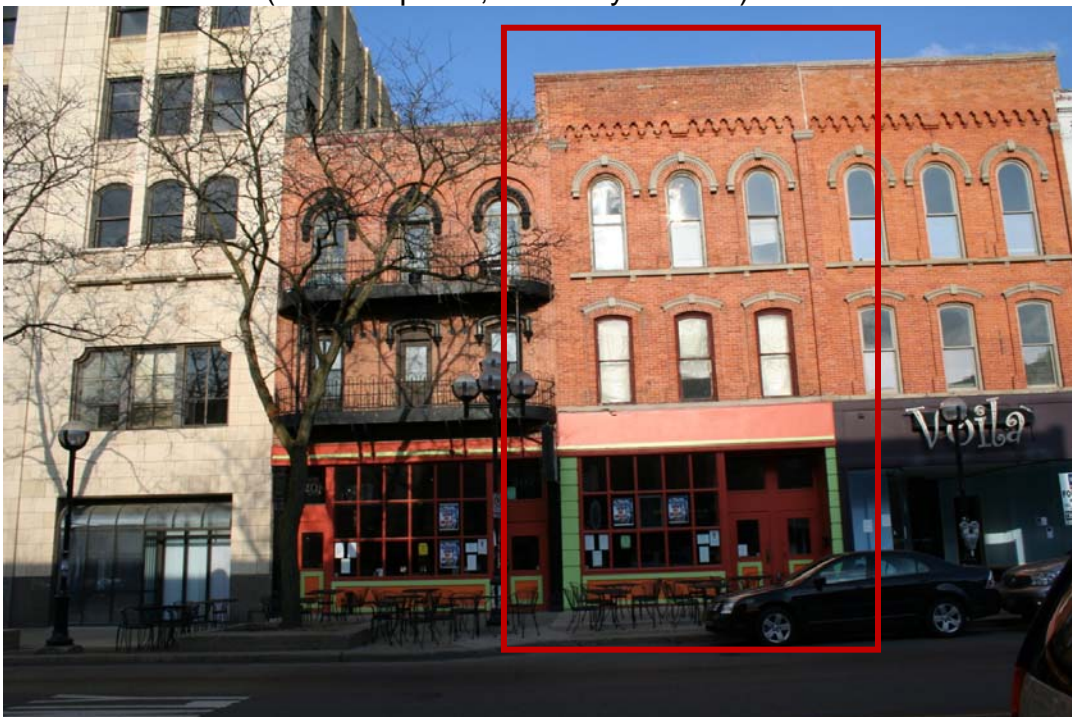
209 S Main Street (undated photo, several years old)

1. The wood windows that are proposed to be replaced are located on the front elevation and are character-defining features of the building. There are three single-hung windows on the second floor and three single-hung windows on the third floor. The windows on the second floor have segmented arched tops, and the windows on the third floor have round arched tops.

2. A survey of current window conditions was included with the application. The windows exhibit severely damaged wood, missing sash and frame components, and missing glass.

2. Provide a description of existing conditions. rotted sills, sashes & jambs.  
Glass has fallen out of the frames onto  
public sidewalk

3. The wood windows that are proposed to replace these are wood single-hung units with dimensions nearly identical to the existing windows (see Window Worksheet Specifications). The proposed units are not likely to significantly alter the building's exterior appearance.
