DANGEROUS BUILDING NOTICE AND ORDER

Re: 111 South Main Street, Ann Arbor, Michigan
Parcel Identification Number ("PIN"): 09-09-29-132-014

REPORT

July 1, 2015

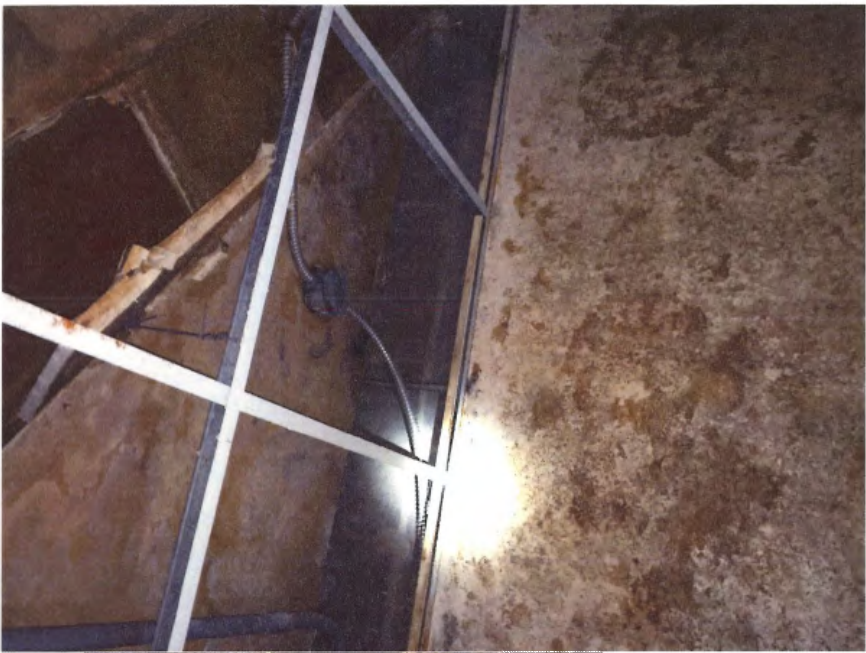
Our inspection revealed that there is significant water damage to the structure occurring mostly in the west 60' of the building. The water damage includes saturation of the plywood flooring throughout the visible portions of the west 60' and localized damage to a portion of the floor joists. See Image 1 attached. In addition there is a large tree growing from the roof and the framing around that tree is severely damaged. See Image 2 attached.

The majority of the plywood subfloor is damaged beyond repair due to water saturation and while still providing some structural integrity to the floor is not considered adequate as a subfloor material or bracing material to the joists below. As such, the joists in the floor have an unbraced compression flange and do not meet strength requirements required for the loading. The majority of the joists appear to be in good condition, however there may be localized rotting at the bearing points of the joists where water could accumulate. These areas were not able to be inspected due to the mold throughout the building.

Typical floor framing condition showing saturated subfloor, localized water damage to floor joists and mold growth.

Due to the conditions noted above the structure does not meet building code requirements. Access to the building should be limited and we recommend that efforts to remediate and remove the mold and all interior non-structural elements be taken as soon as possible. Once that effort has been completed the plywood should be removed in order to expose the top face of the wood joists and bearing conditions. Once those conditions are exposed an additional inspection will be required to determine which joists or portions of joists will need repair, replacement or strengthening. Once this is completed the joists can be re-supported with a new sub-floor and roof, and the building will again meet structural building code requirements and can be considered safe.
