West Park Historical Band Shell

Building Foundation Investigation
Summary of Findings and Recommendations

Presented by Rich Nacey, P.E.
Structural Department Head

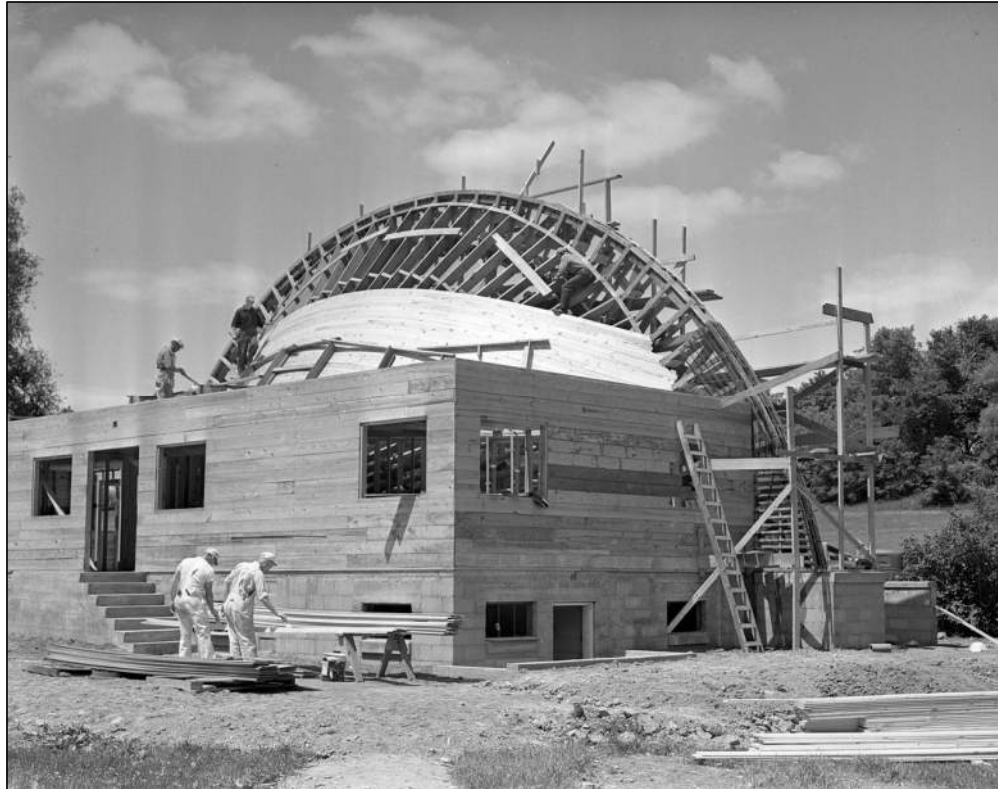
Historical Photos

1938 Construction Dependent Wood Structures
NOTE: Below grade door and windows

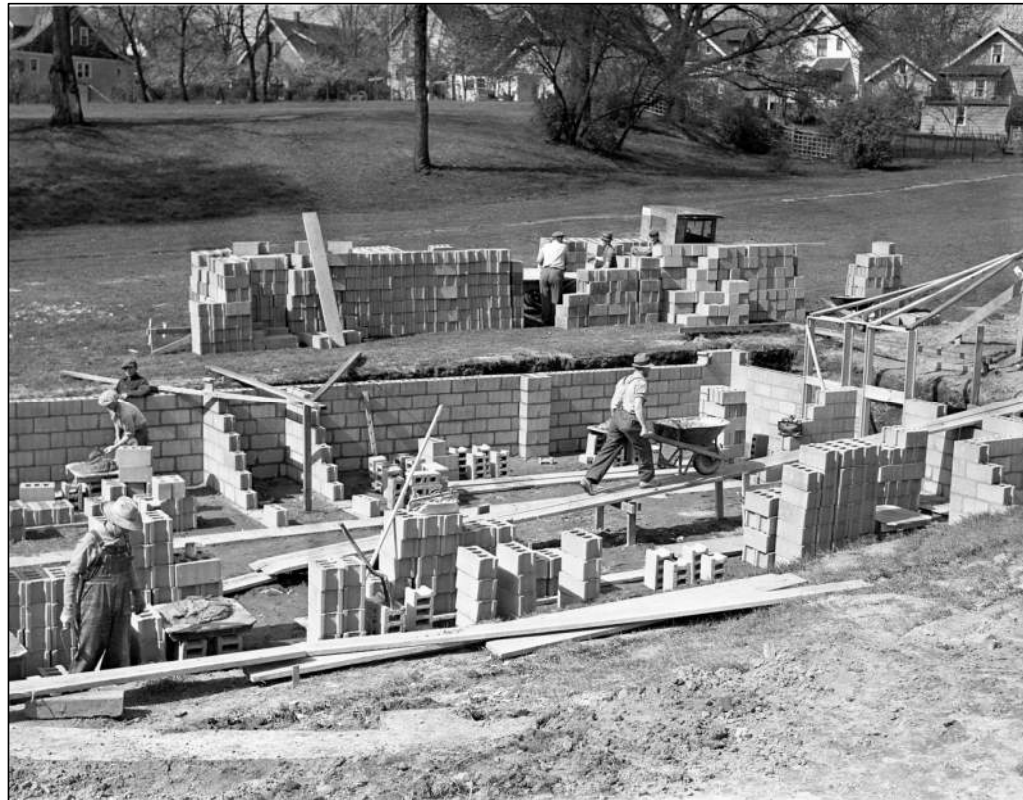
Historical Photos

1938 Construction of Basement oundation

- Full basement of masonry walls and concrete strip footings

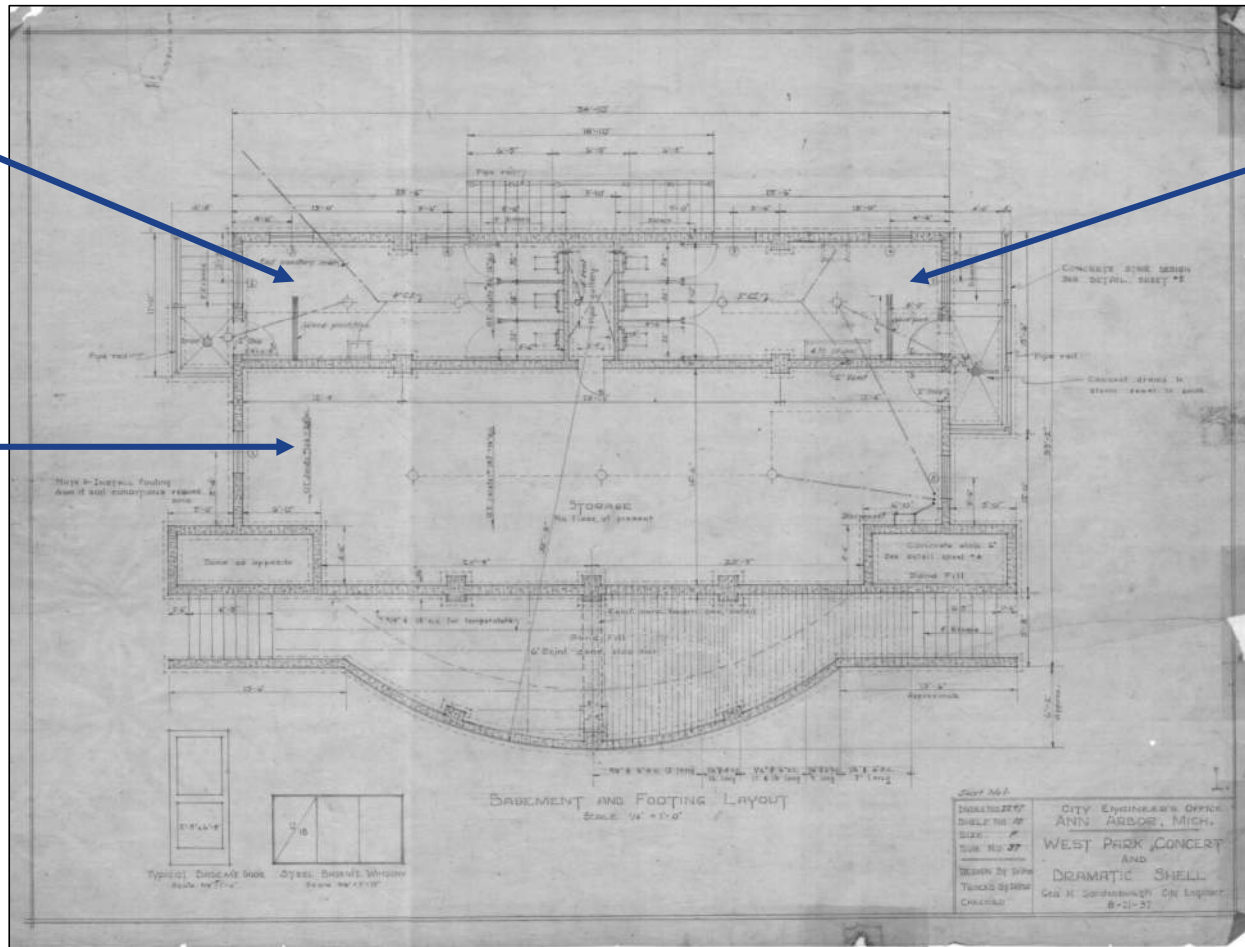
1938 Historical Basement and Footing Drawing

Basement public restroom
(concrete floor)

Basement storage area
(soil floor)
