415 West Washington Historic Structure 2017 Reassessment

415 West Washington, Ann Arbor, MI, 48103
Follow-up to Rueter Associates Assessment of August 29, 2013
November 1, 2017

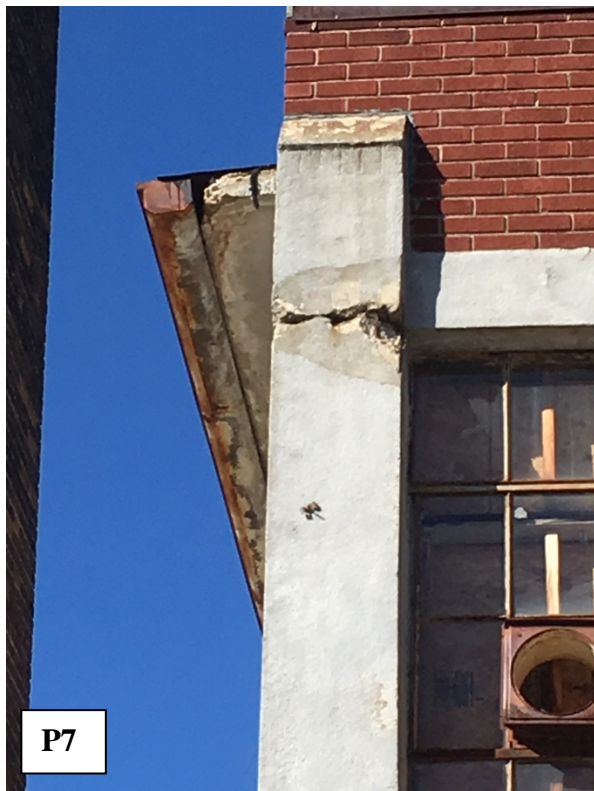
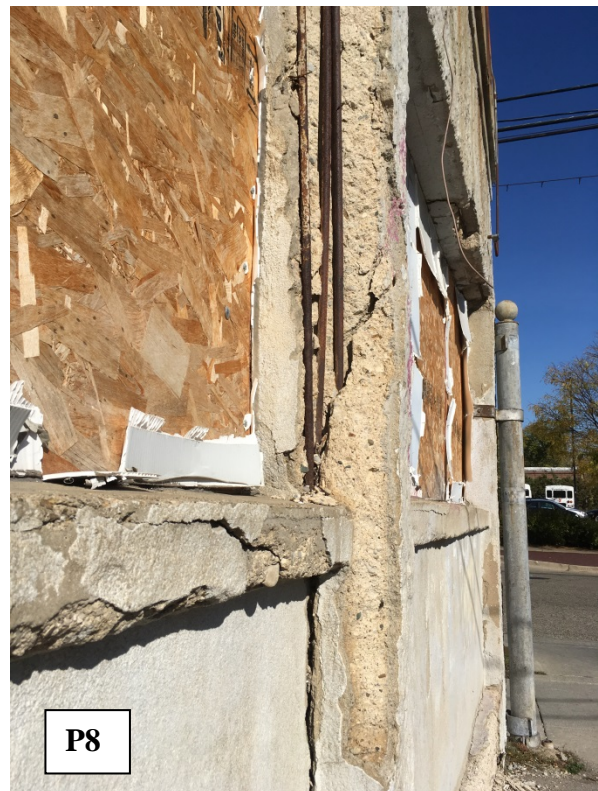
Area B Condition Evaluation - Area B appears to have experienced significant progressive deterioration since the 2013 Assessment. This is evidenced by debris on grade along the base of the wall from recent spalling concrete (P11), severe cracking of reinforced concrete columns exposing internal reinforcing bars (P7 & P8), and stress cracks at window lintels along north wall (). We believe that these and other observations are indicative of significant degradation of the primary load bearing structural components of the building. The interior finishes are not suitable for reuse of any type (P15 & P16). Although the 2013 Assessment suggested repairing the existing windows due to their historical character, we do not believe this would be possible while still meeting the current Michigan Energy Code.
