## **Notice to Proceed - 1218 W. Huron St.**

## **1218 W. Huron Garage**

## Repairs needed (Larger repairs)

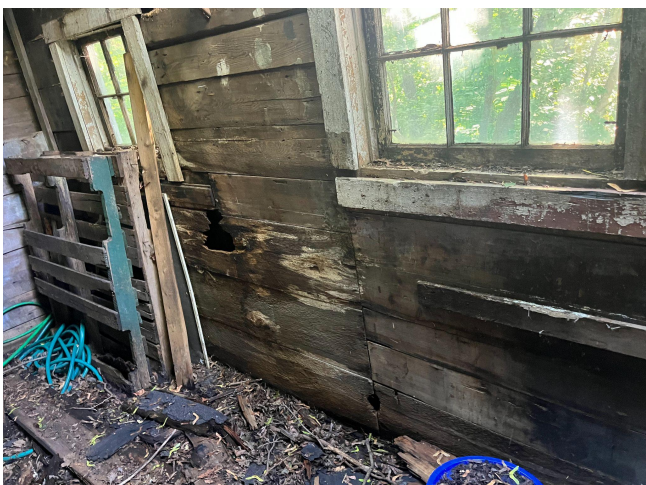
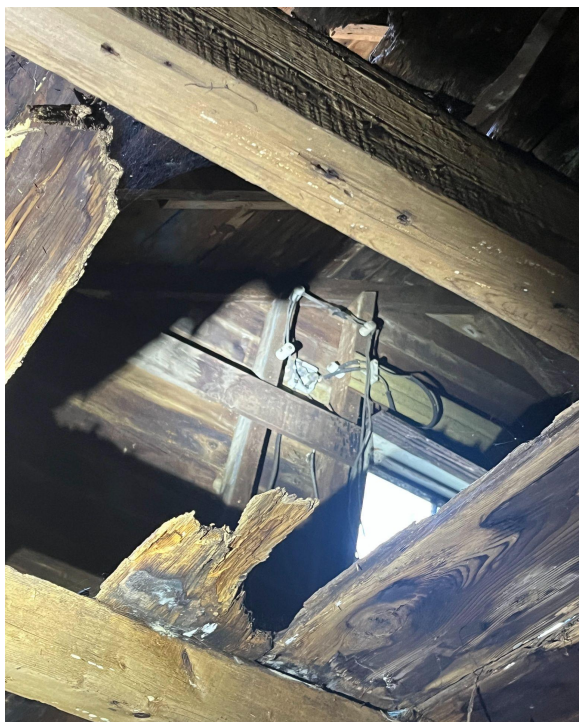
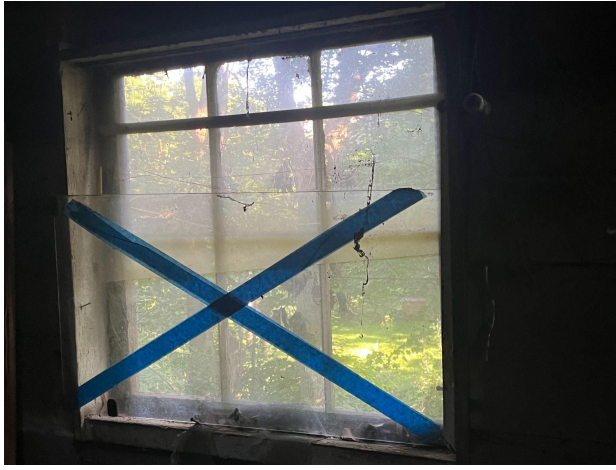
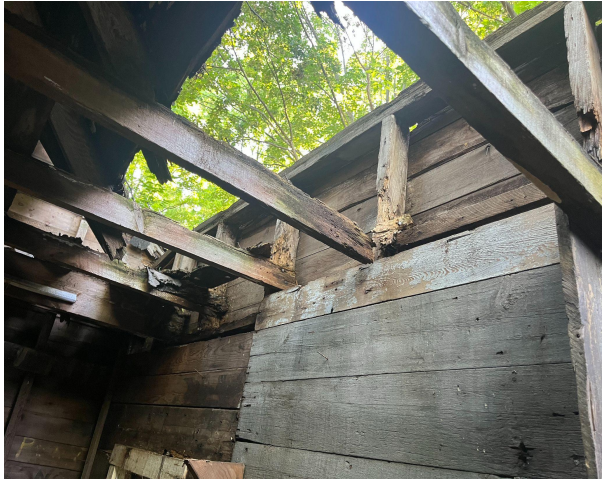
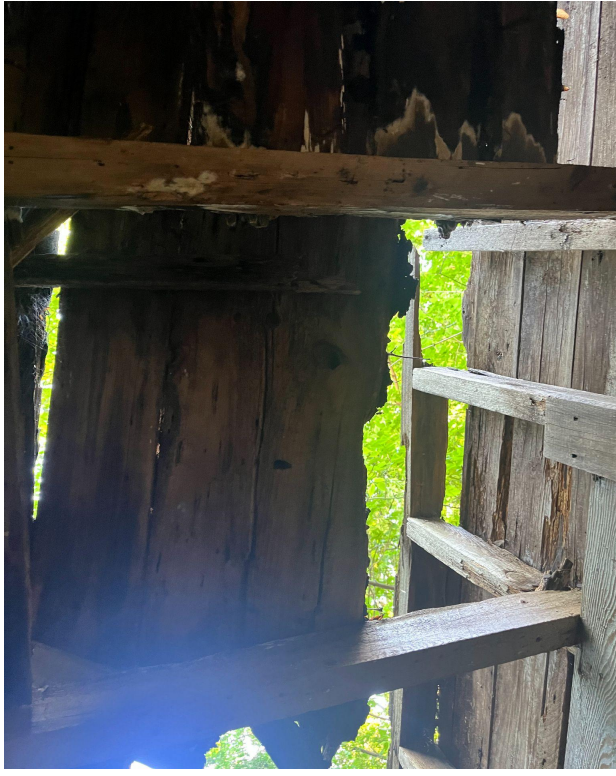
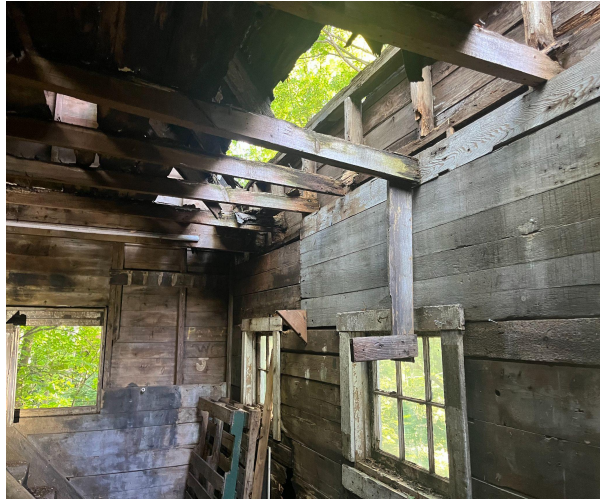
### **Photos of interior:**

The entire floor is weak, rotted and patched together. The current floor is not weight bearing. The floor frame and subfloor need to be replaced.

The east side of the roof is completely caved in. From the interior, the rafters, ridge beam, decking, gable ends and connections are all destroyed. There would be no way to salvage material for the roof. The side of the roof that hasn't fallen has cracks allowing moisture and comprising the whole structure. It would need to be completely re-shingled as well.

Many of the interior boards, framing and joists are rotted and would need to be replaced. Much of the interior had repairs with varying sizes that don't support a strong structure.

Glass is broken in the two back windows, the framing on most of the windows has rotted and is in need of replacing.
