ANN ARBOR HISTORIC DISTRICT COMMISSION

Staff Report

ADDRESS: 223 E Ann Street, Application Number HDC22-1097

DISTRICT: Old Fourth Ward Historic District

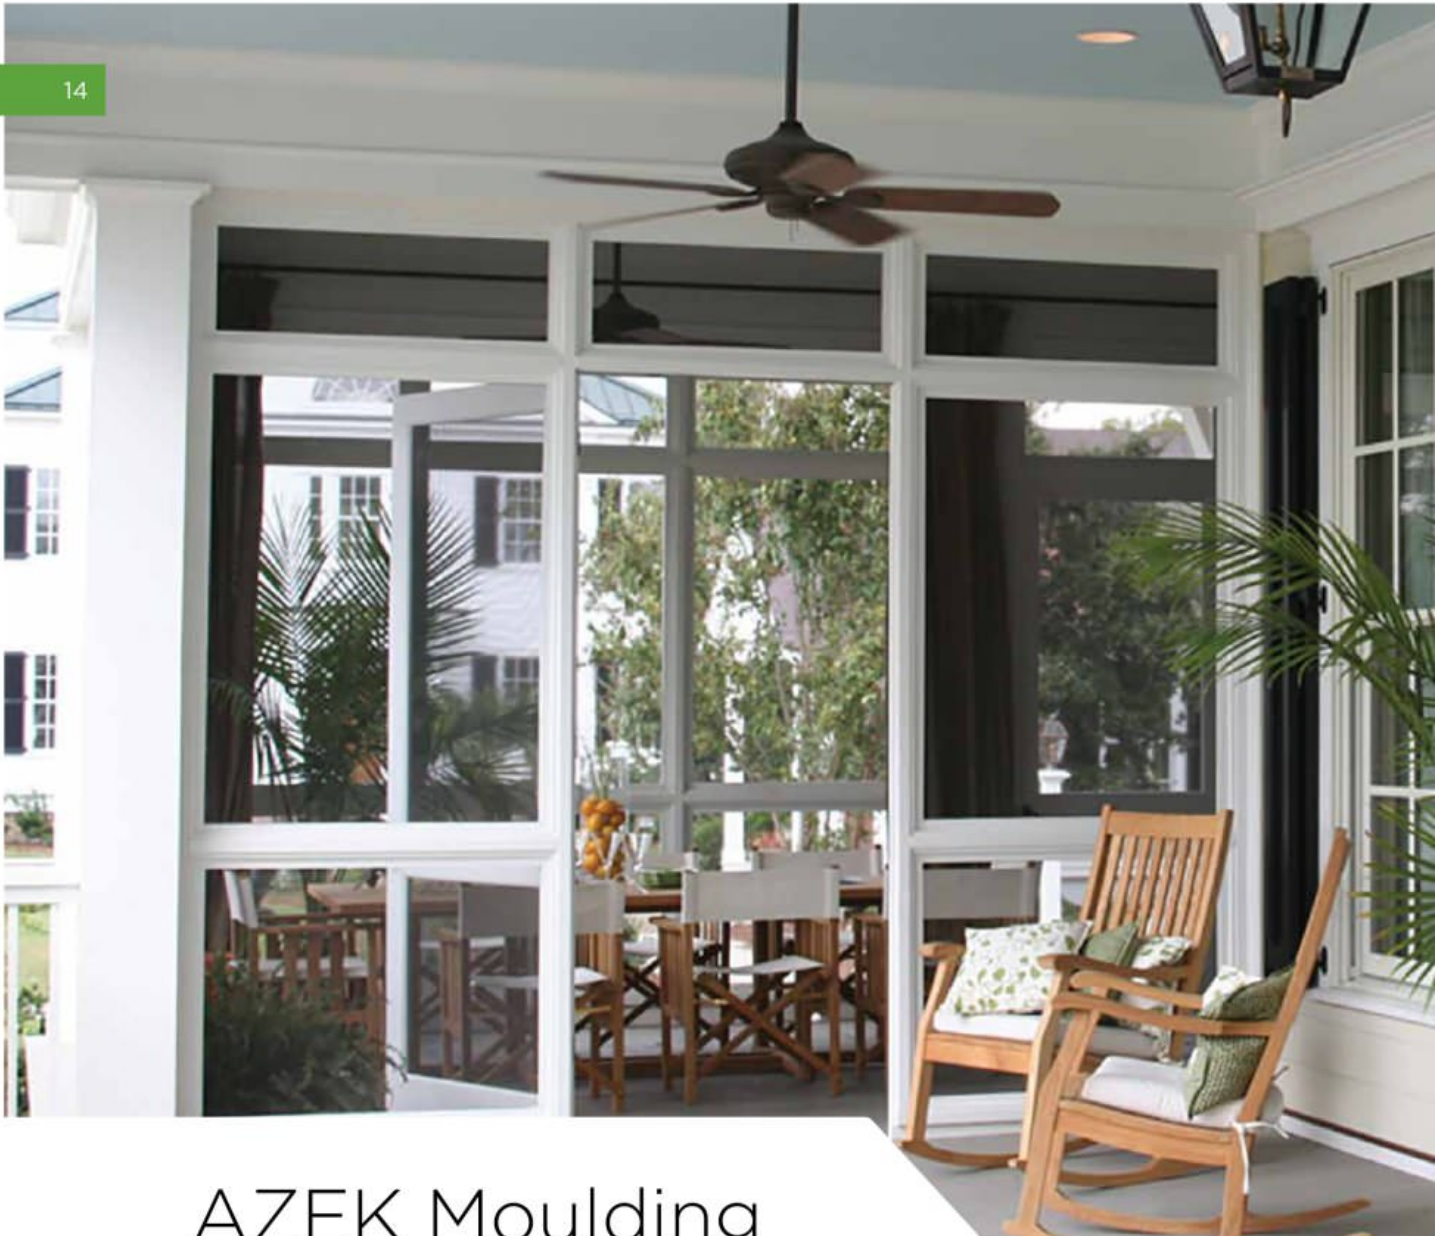
Here is a photo of the two materials. The trim piece on the left is the pine that is currently on the armory and rotting, and the trim piece on the right is PVC

We are proposing to replace the rotted pine with an identical Azek PVC which is the leading building material for this application and has gone through rigorous testing for longevity. This material is rated to last 30-50 years whereas pine is rated only for 20. I have attached the material spec sheets to the application. We will also be looking to install a window flashing waterproofing tape on the rough framing of the windows underneath the trim to maintain a waterproof and more airtight seal.
