# ROAD SAFETY AUDIT

## PLYMOUTH ROAD

ANN ARBOR, MI

DATE: OCTOBER 2025

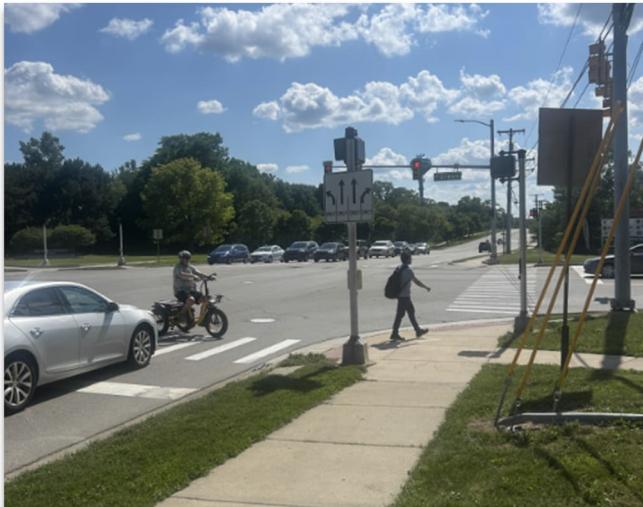
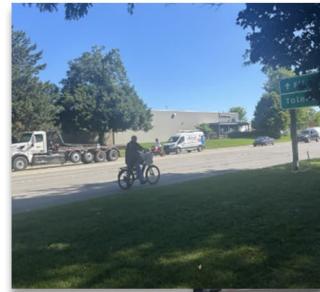
**Figure 4 - Vulnerable Road User Observations**

*Vulnerable Road Users – Plymouth Road at Green Road*

*Cyclists along Plymouth Road*

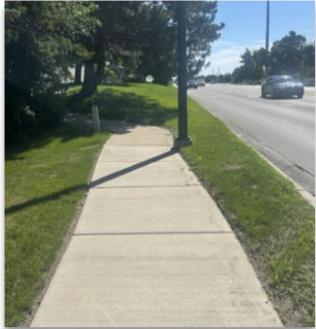
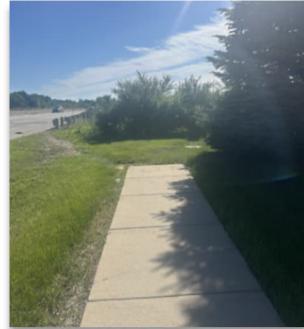
**Figure 6 - Sidewalk Infrastructure**

***Sidewalk Facilities***

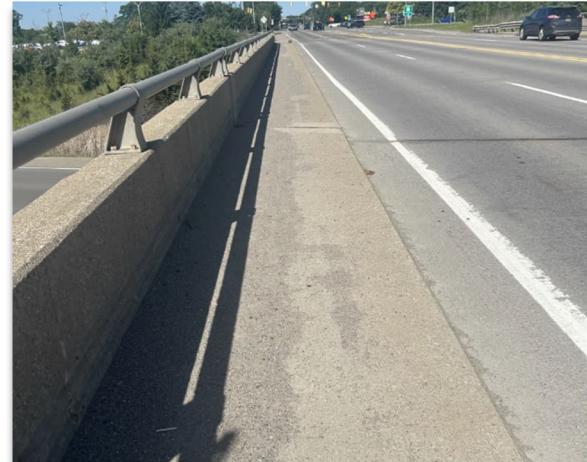
***Sidewalk along Bridge over US-23***

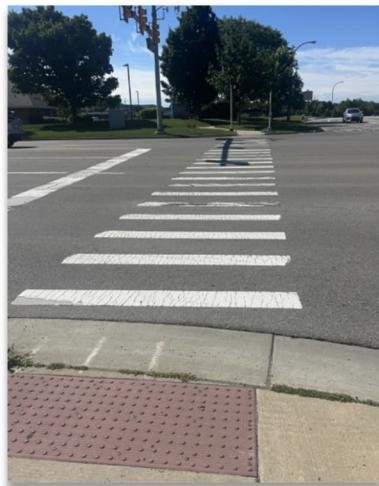
***High Visibility Crosswalk – Plymouth Road  
at Green Road***

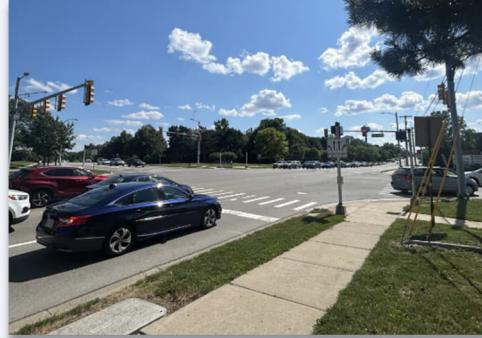
Existing Safety Measures	
<b>Modern Features at the Intersection – Plymouth Road at Green Road</b> <p>Plymouth Road at Green Road is modernized with a box span signal configuration, backplates, high visibility crosswalks, detectable warning pads, countdown pedestrian signals, and leading pedestrian intervals (LPIs). Countdown timers, high visibility markings, and LPIs help improve non-motorized user safety. Box span layouts align traffic signal heads with approaching vehicles while backplates help delineate the signal heads against background visuals and low angle sun positions.</p>

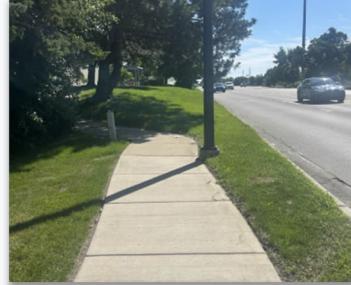
<b>Good Sidewalk Conditions</b> <p>Sidewalks are present along the western limits of the study corridor. The sidewalks have minimal cracking, and in some areas, there is an adequate buffer zone between the sidewalk and the roadway. This buffer enhances pedestrian safety by providing separation between vulnerable road users and motorists.</p>

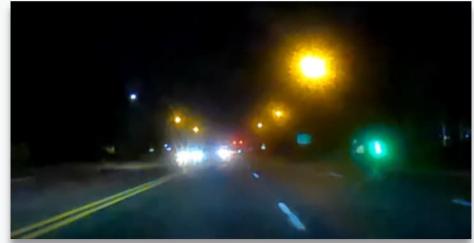
<b>Adequate Corridor Lighting – Western Limit</b> <p>Overhead lighting is present along Plymouth Road on the western limits. Well-lit corridors help reduce the potential for crashes by improving visibility for both pedestrians and motorists.</p>

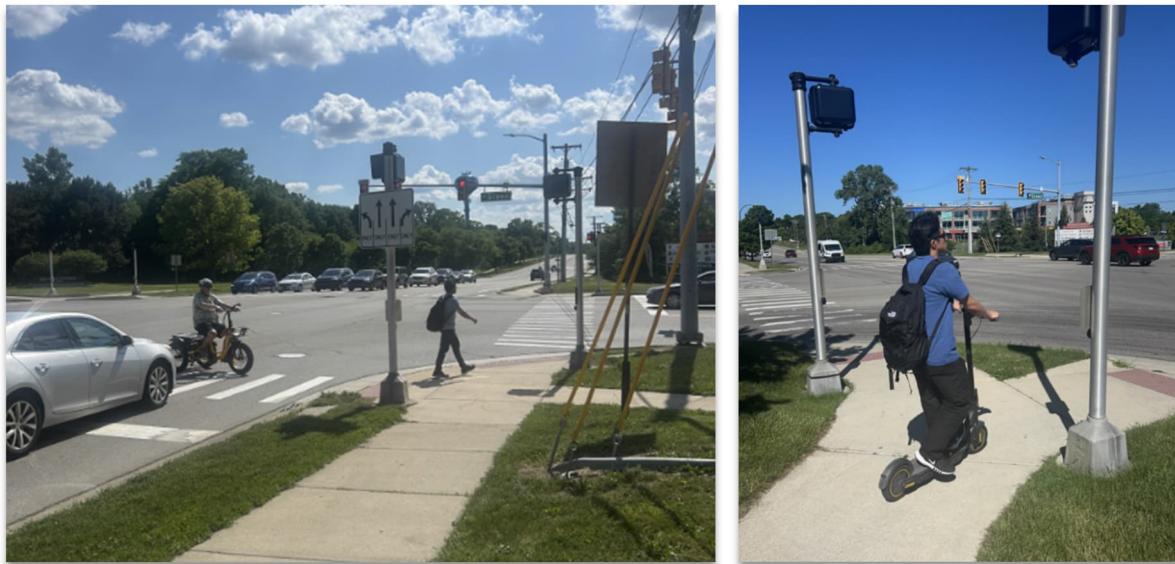
**Figure 16 -Vulnerable Road User Observation Examples**

Vulnerable road user (VRU) safety concerns were noted as primary focus areas in the original road safety audit request. Based on conversations with local stakeholders, review of available crash data, and field observations made by the audit team, issues related to vulnerable road users along the corridor were confirmed as a focus area. The western limits of the study corridor in particular experience a significant amount of pedestrian and bicyclist traffic. Figure 16 provides examples of vulnerable road users observed during the field review. The majority of vulnerable road user traffic appeared to be university students and residents walking and biking through the area. The field observations occurred during the summertime, and while VRUs were observed, their presence is expected to increase during the fall and winter months as university classes are in session at those times. The RSA team noted multiple safety concerns for people walking, biking, and scootering through the study area.

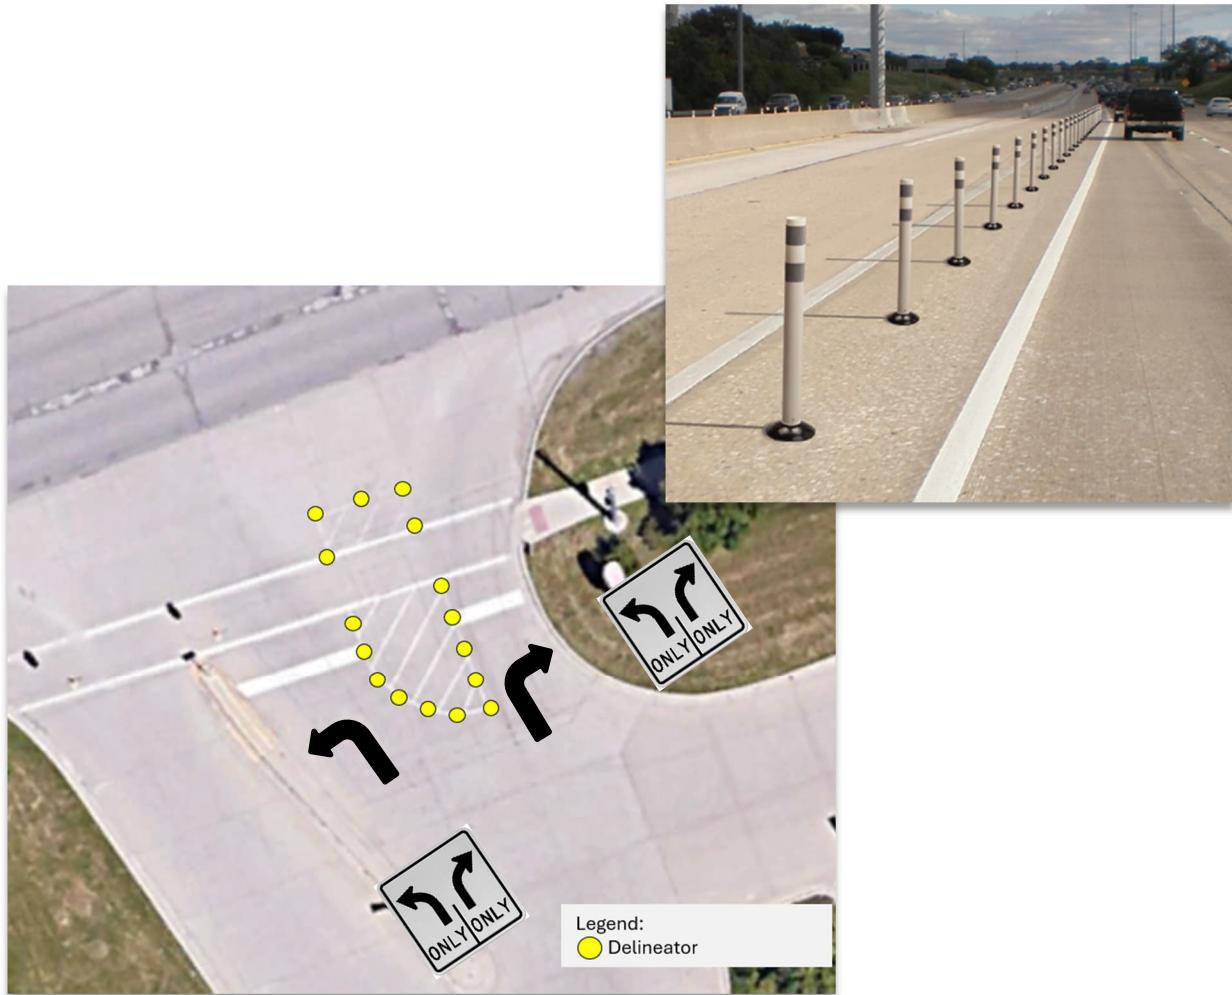
**Figure 37 - Plymouth Road Park and Ride Approach Concept<sup>6</sup>**

Furthermore, the stop bar at the Plymouth Road Park and Ride includes a gap to separate the left turn and right turn movements which is delineated by hatched pavement markings. This hatched area is significantly worn, resulting in a lack of clear delineation. Additionally, there is no signage to inform drivers of lane designation. This absence of distinct information can lead to confusion for drivers, potentially resulting in improper lane usage and increased potential for sideswipe crashes. Figure 36 depicts the gapped stop bar at the Park and Ride.

Consider adding delineators to the gapped stop bar, as well as adding arrow pavement markings and lane use signage on the approach. These improvements may enhance safety by providing clear and visible guidance to drivers, reducing confusion and the potential for crashes. Refreshed hatched markings and delineators will clearly indicate the separation of lanes, helping drivers follow the correct paths. Updated arrow markings and lane use signage will provide clear instructions on lane usage, reducing the likelihood of improper lane changes.

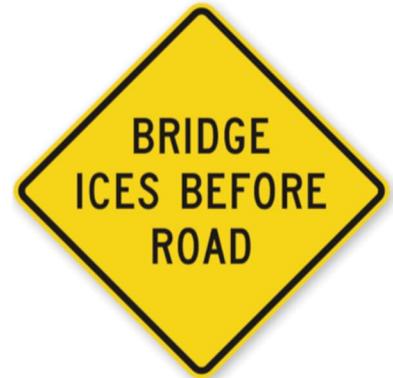
Figure 39 - MUTCD Compliant US-23 Overpass Signage<sup>7</sup>

It was observed that the "Bridge May Be Icy" signs placed before the US-23 overpass were cracked and exhibited minimal retroreflectivity at nighttime. This reduced visibility and legibility increases the potential for drivers to be unaware of the presence of the bridge. Additionally, these older style signs have been replaced in the current version of the MMUTCD (Michigan Manual on Uniform Traffic Control Devices). The sign present for the eastbound traffic is shown in Figure 38.

It is recommended to replace the current "Bridge May Be Icy" signs at the US-23 overpass, as they are worn, with reduced visibility under dark or inclement weather conditions. These should be replaced with current MMUTCD-compliant "Bridge Ices Before Road" signs, as seen in Figure 39. Updating the signs will enhance their visibility and effectiveness, helping drivers receive clear and timely warnings about potential icy conditions on the bridge.

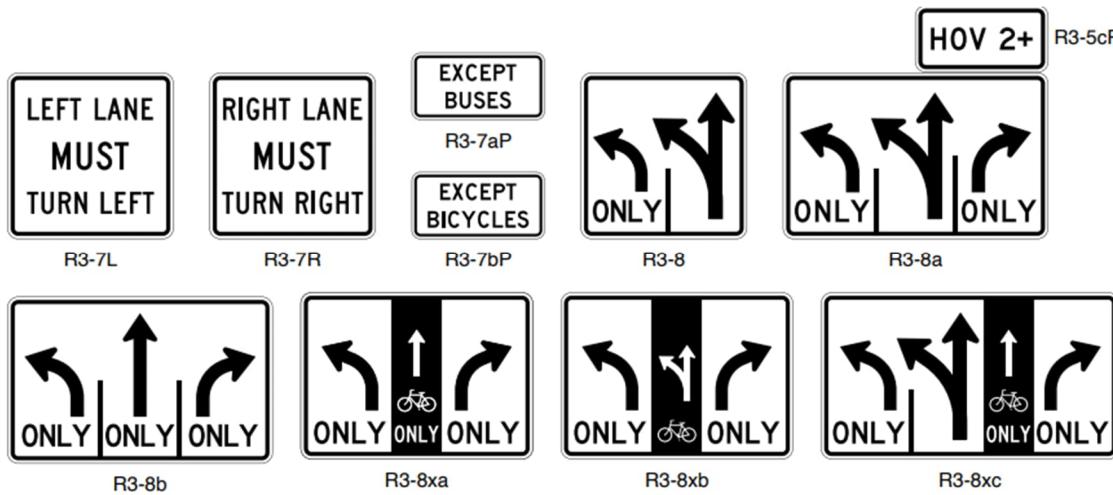
**Figure 41 - Lane Use Sign Examples<sup>9</sup>**

Field reviews revealed that there were no lane use signs for the eastbound and westbound approaches at the US-23 interchange intersections. This lack of positive guidance may contribute to driver confusion and potential lane violations. Without clear lane use signs, the potential for improper lane changes and sudden maneuvers increases, which can result in rear ends and sideswipe crashes and disrupt the smooth flow of traffic.

Consider installing lane use signs for the eastbound and westbound approaches at the US-23 interchange intersections, such as the ones shown in Figure 41. Lane use signs will provide clear guidance to drivers, indicating the correct lanes for turning or continuing straight, reducing the potential for last minute lane changes, potentially resulting in sideswipe same or rear end crashes.
