## ANN ARBOR HISTORIC DISTRICT COMMISSION

### Staff Report

**ADDRESS:** 200 East Washington Street, Application Number HDC14-060

**DISTRICT:** Main Street Historic District

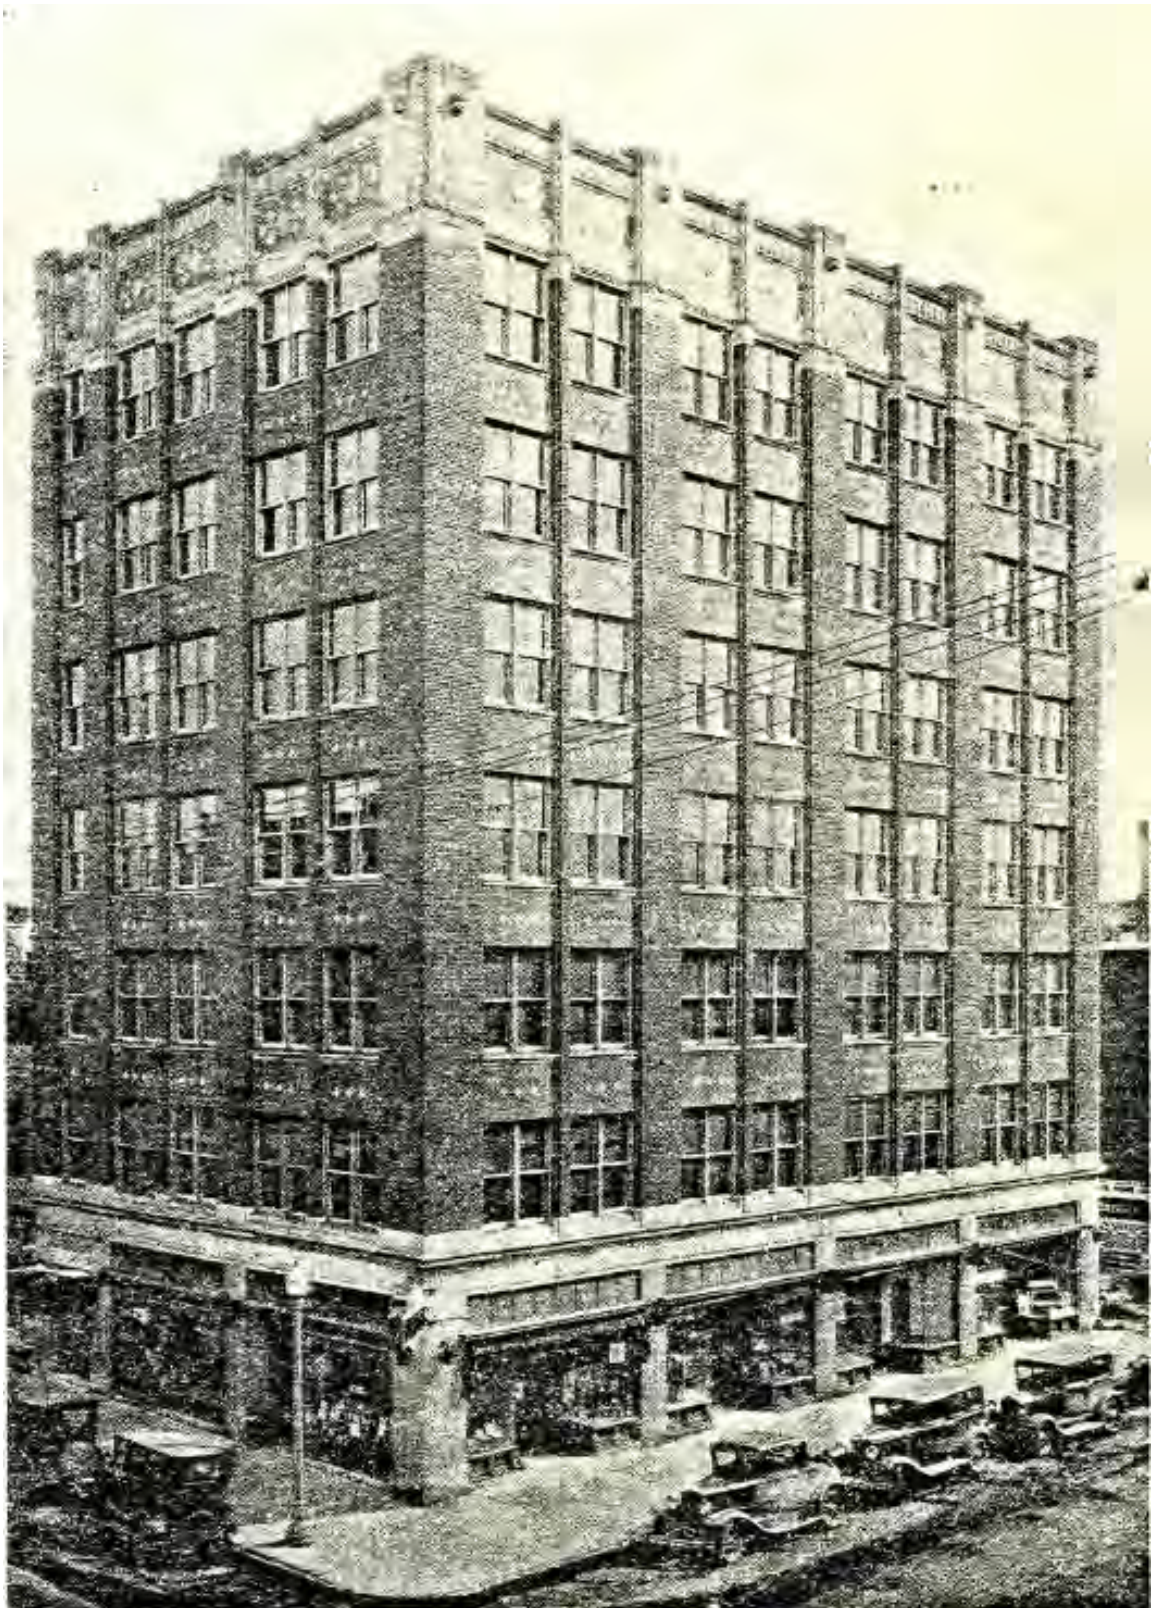
Undated photo of the northwest corner of the building, circa 1930 based on the cars, and similar to the colored rendering of the building from the same time. Note the small windows above the transom, and the four storefronts on S. Fourth, all having the same configuration.

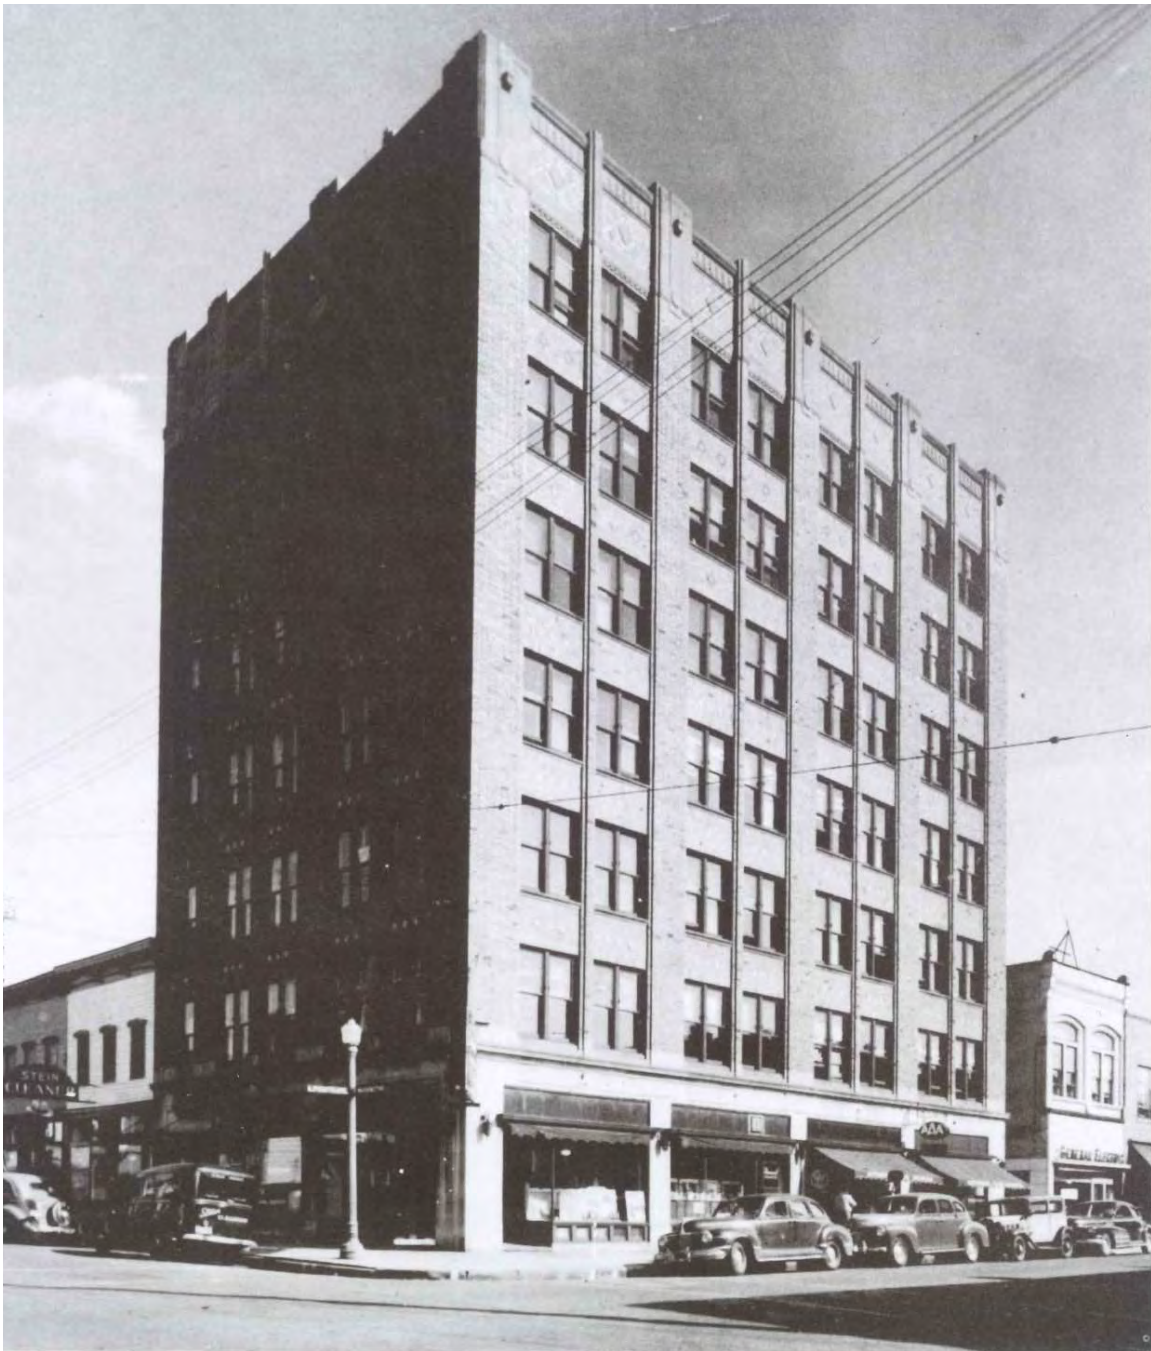
Undated photo of the northwest corner of the building, circa 1950 based on the cars. Note the small windows above the transom, and the four storefronts on S. Fourth. By the time this photo was taken, the corner tenant space and its four openings had been modified. Although taken after the period of significance, this photo illustrates how much of the original fabric remained by c. 1950, and can be compared to extant materials in place today.
