## **415 West Washington Historic Structure Assessment**

415 West Washington, Ann Arbor, MI 48103

Final Report August 29, 2013

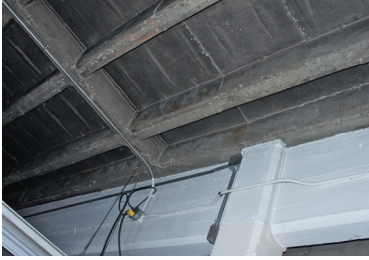
Steel pan formed roof deck. The floor system is similar.

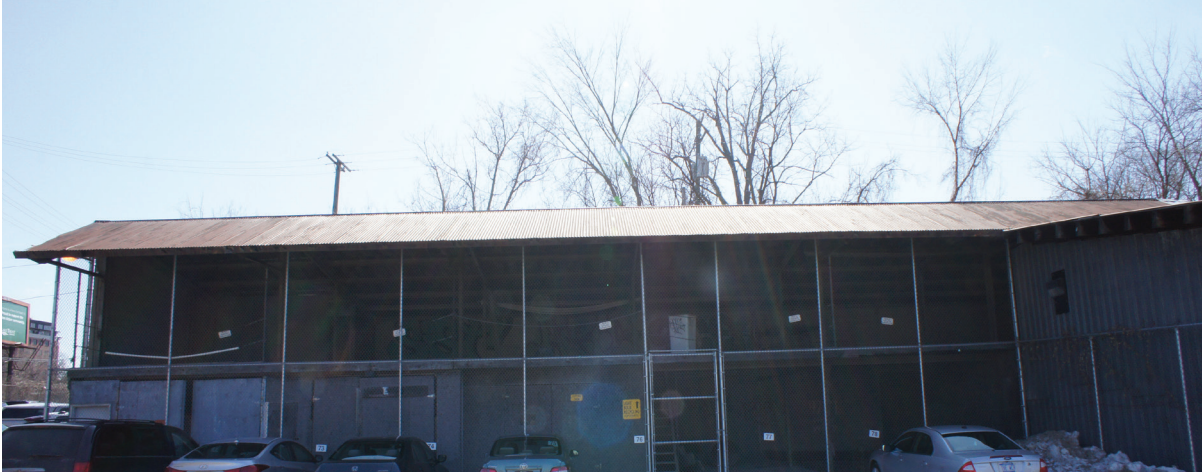
2012 photo of the 1934 CWA Welfare steel shed addition.

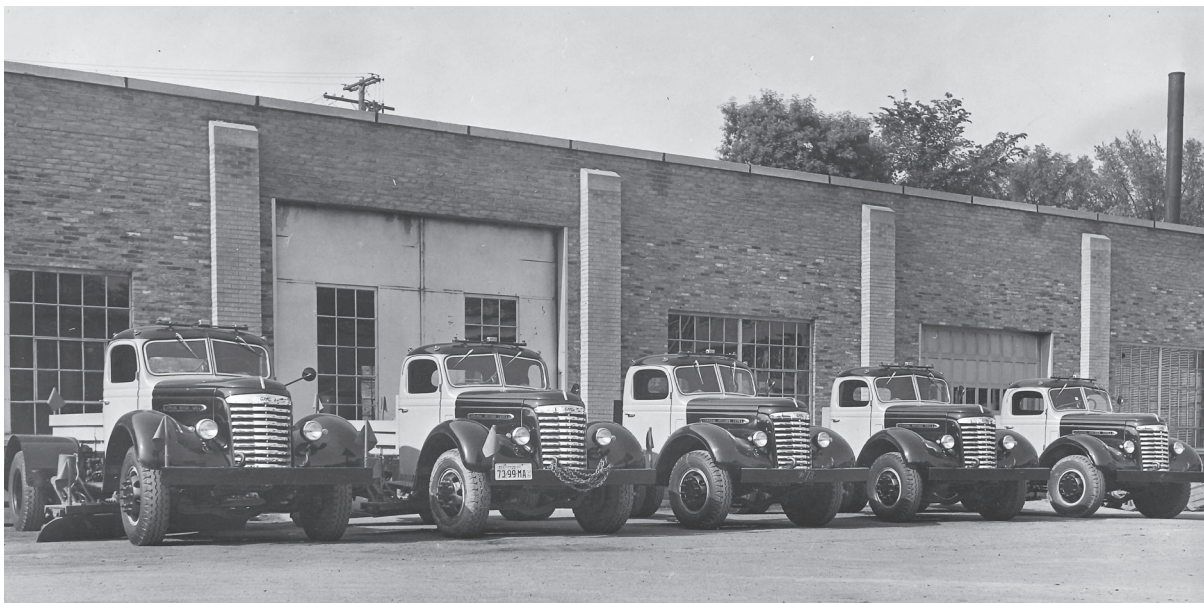
June 4, 1940 photo of the 1934 CWA Welfare Garage with five new GMC snowplow and utility trucks. The brick used for the lower 2/3 of the walls is reclaimed. It is possibly from the two-story bean warehouse on the site which had been recently demolished. The upper third is new brick. The "rug-brick" cream colored pilasters are also new brick.

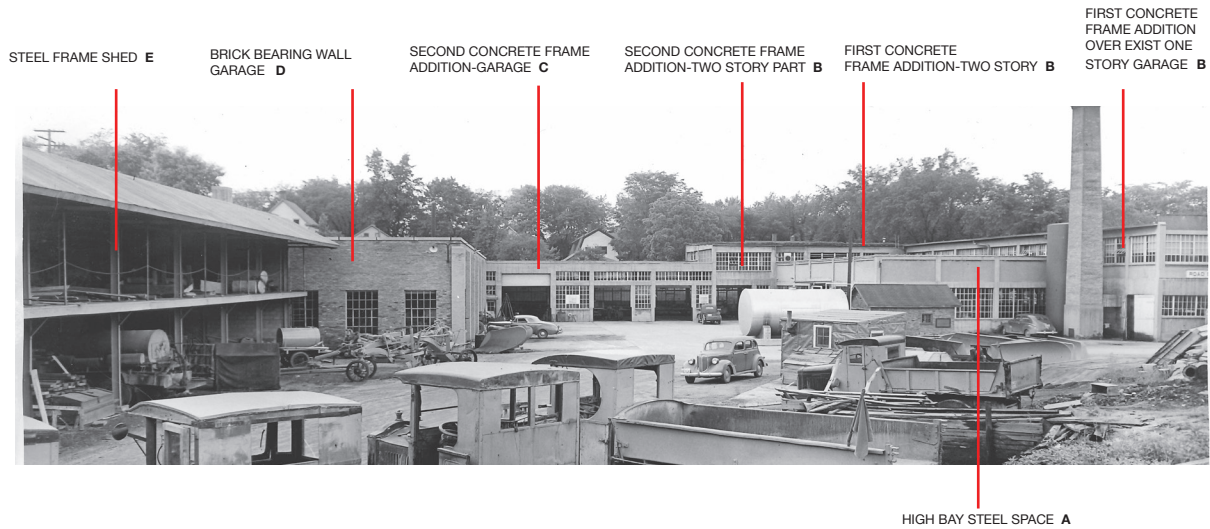
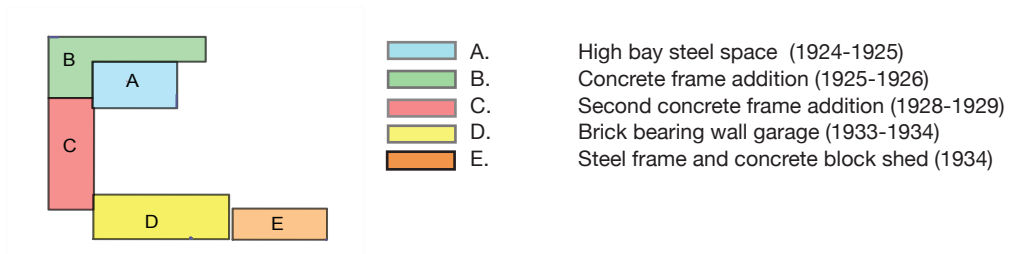
Below is a key plan that represents the different building areas and the dates they were constructed. Adjacent to the key plan are listed the five different areas of investigation.

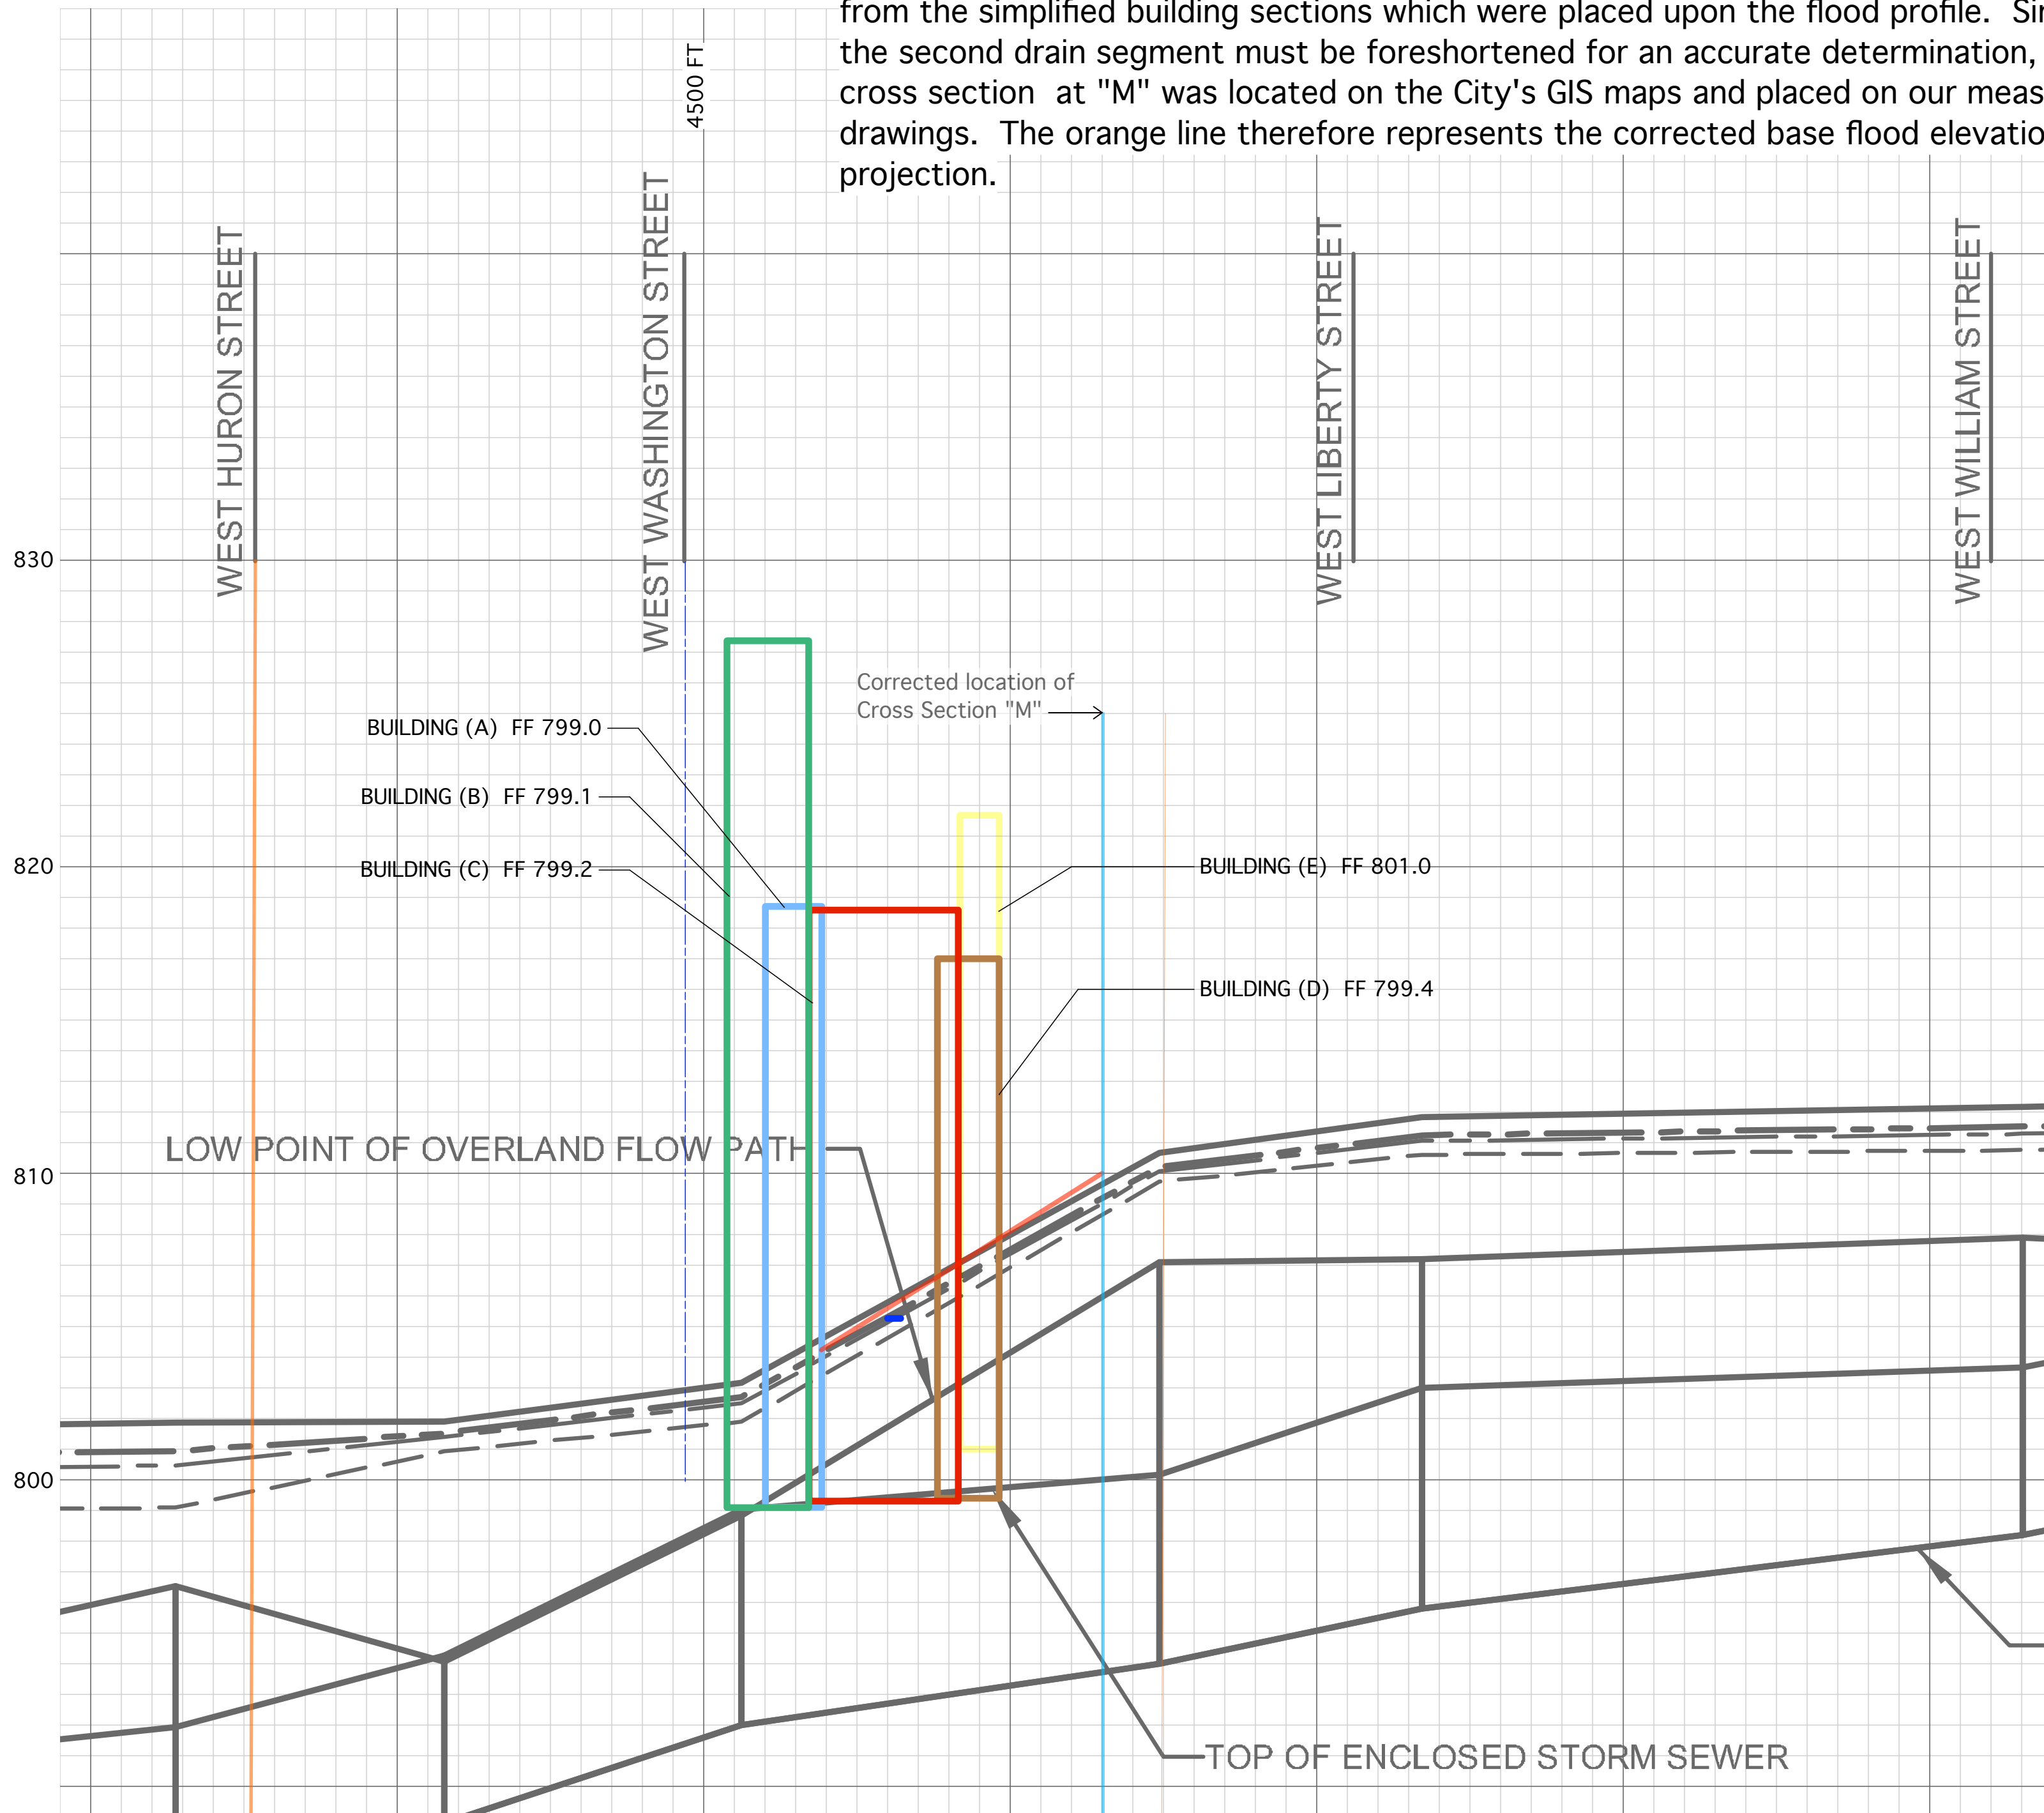
**PARTIAL FEMA FLOOD PROFILE OF ALLEN CREEK DRAIN:**

The base flood elevations can be read quite accurately for the first segment directly from the simplified building sections which were placed upon the flood profile. Since the second drain segment must be foreshortened for an accurate determination, the cross section at "M" was located on the City's GIS maps and placed on our measured drawings. The orange line therefore represents the corrected base flood elevation projection.

**CORRECTED 1% FLOOD LINE (ORANGE)**

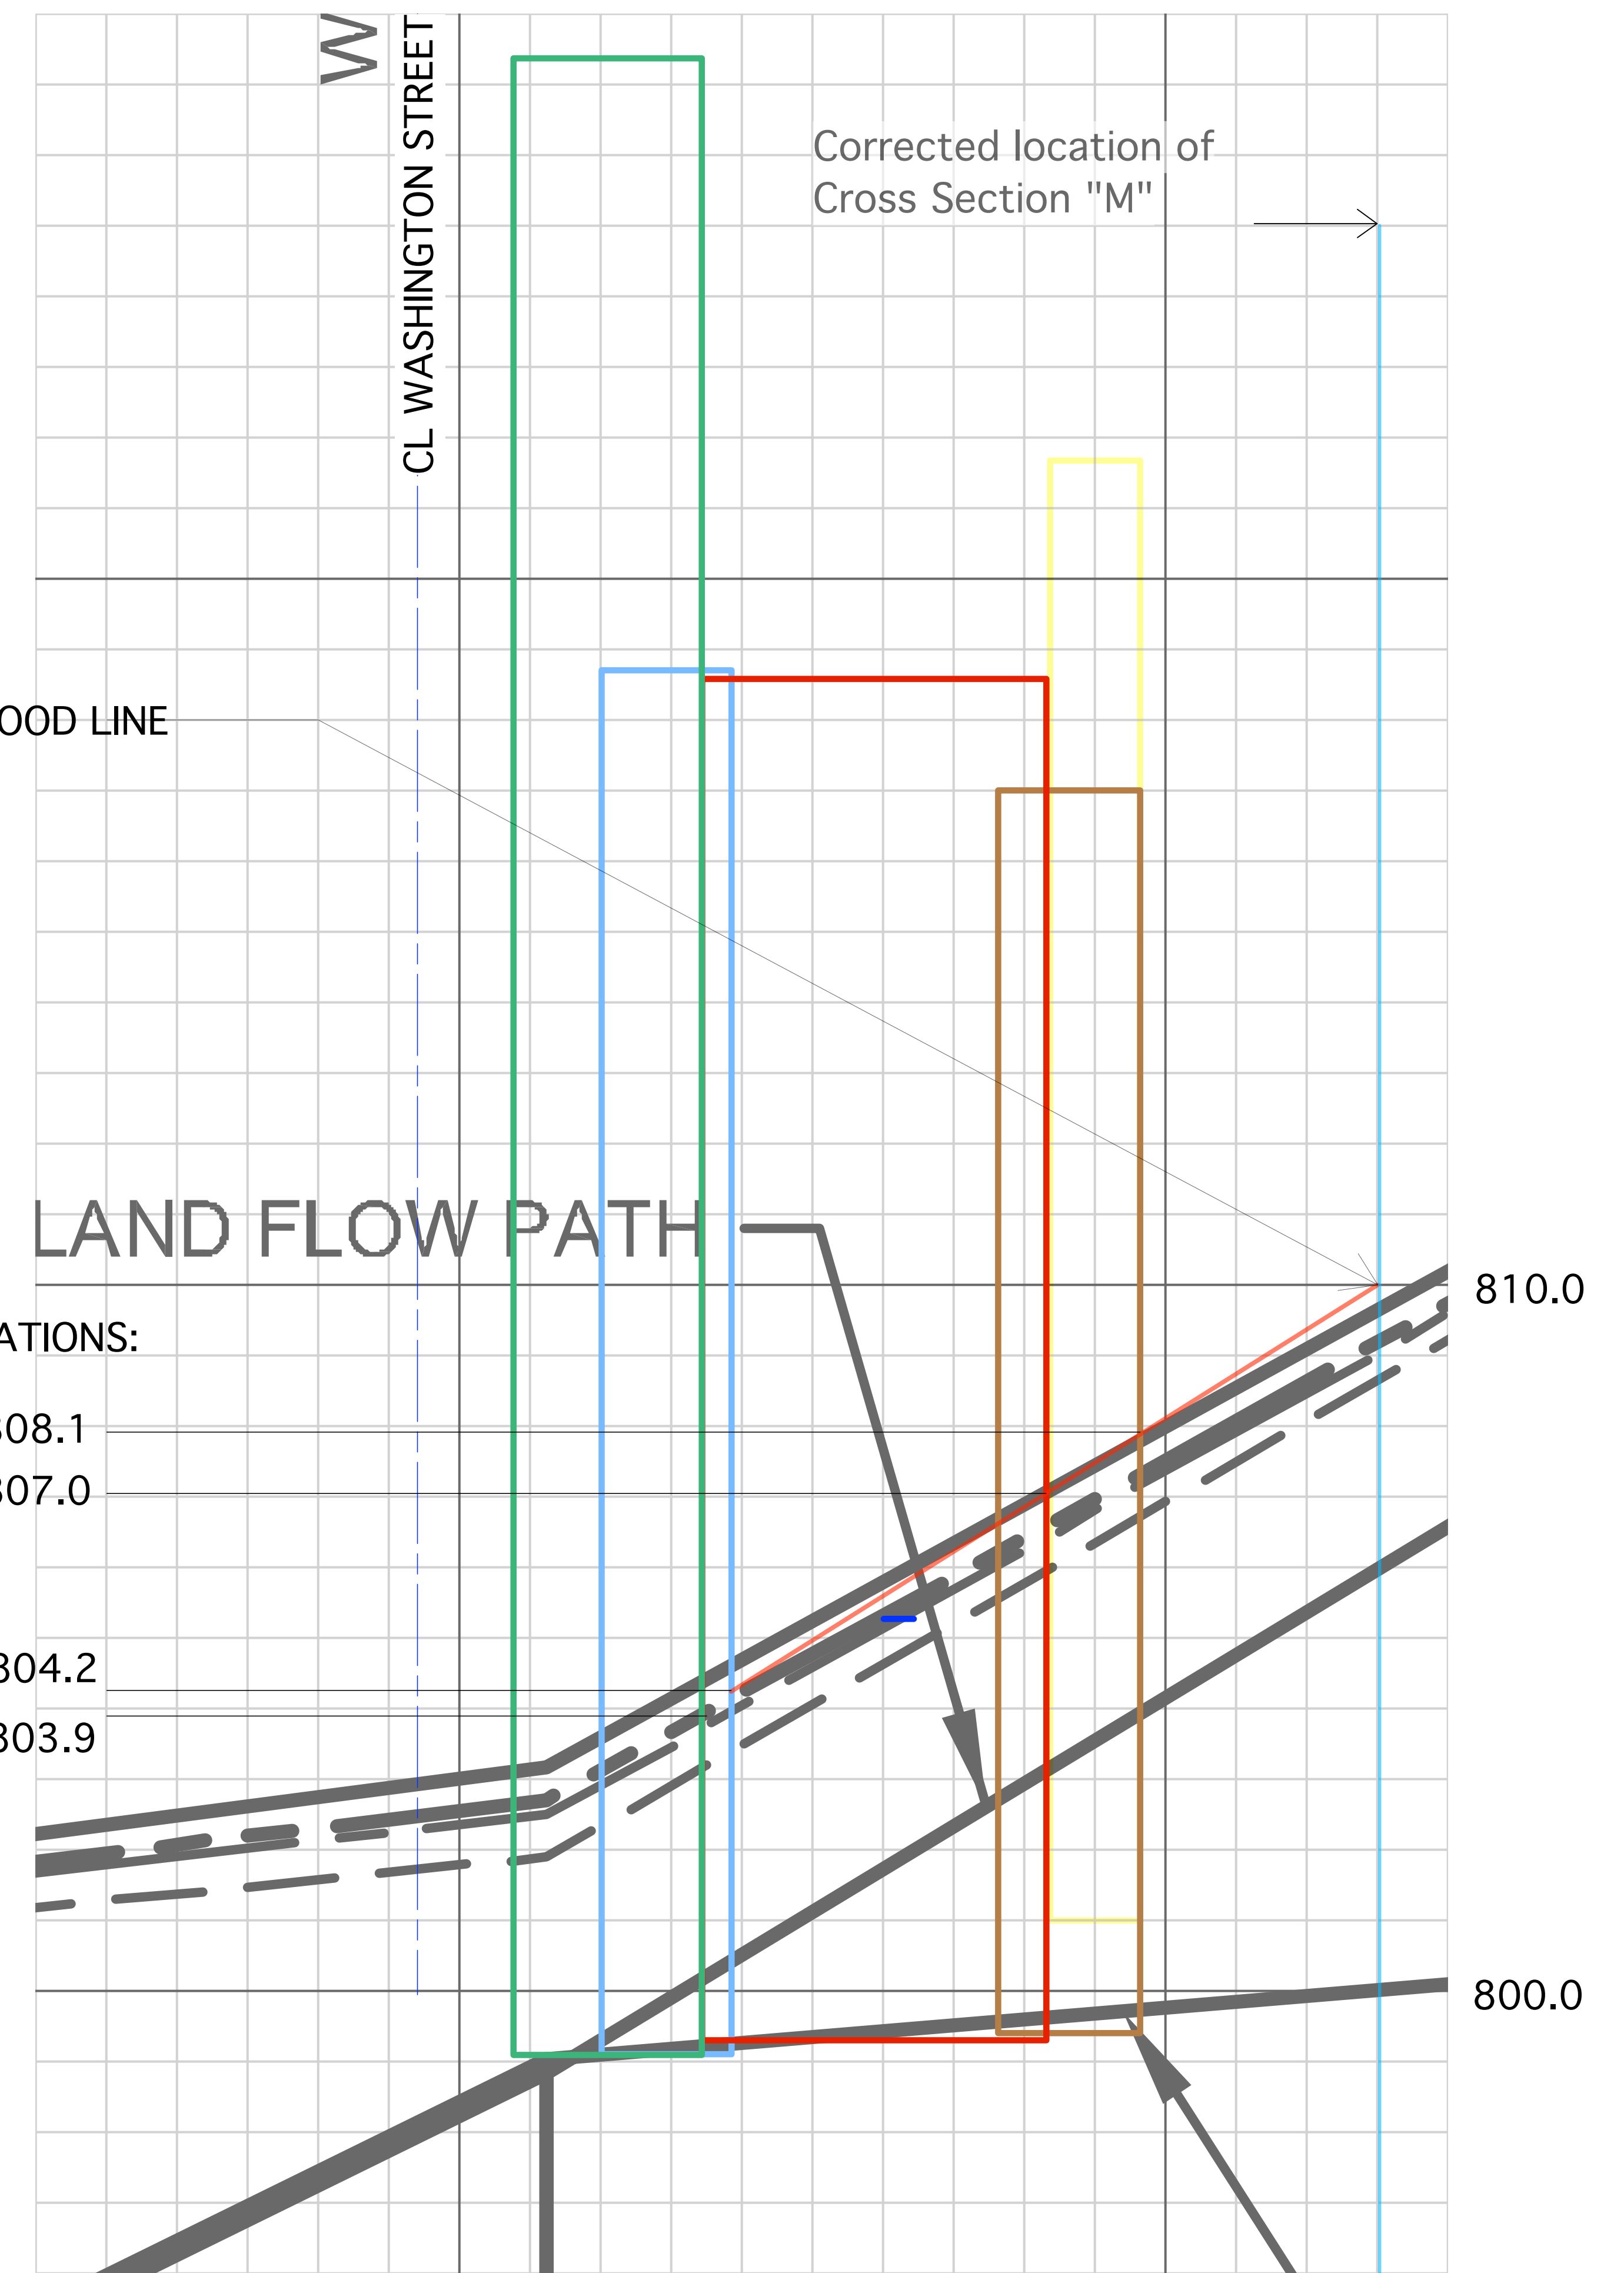
**BASE FLOOD ELEVATIONS:**

BUILDING (D & E)	808.1
BUILDING (C)	807.0
BUILDING (A)	804.2
BUILDING (B)	803.9
