ROAD SAFETY AUDIT

JACKSON AVENUE

ANN ARBOR, MI

DATE: OCTOBER 2025

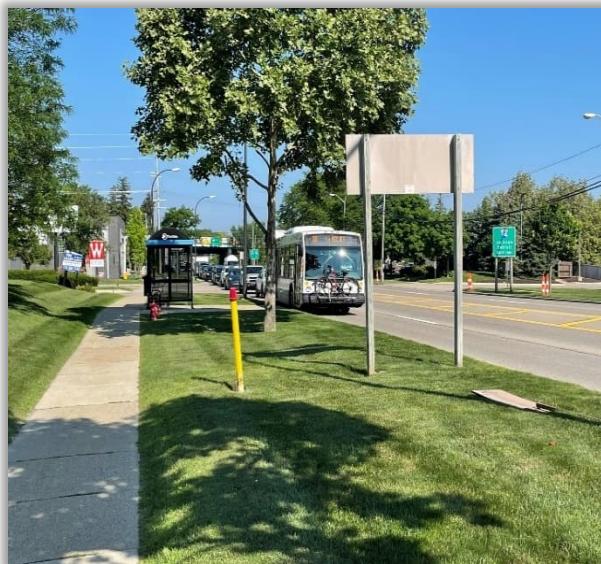
Eastbound Jackson Ave Bus Stop, South of Maple

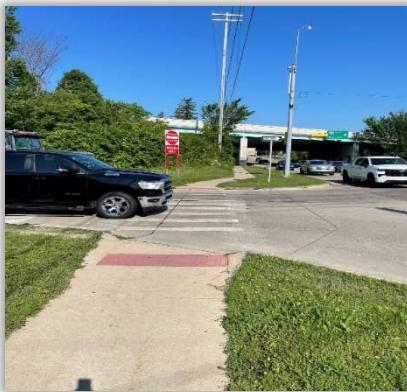
Pedestrian Crossing (Westbound I-94 Exit Ramp)

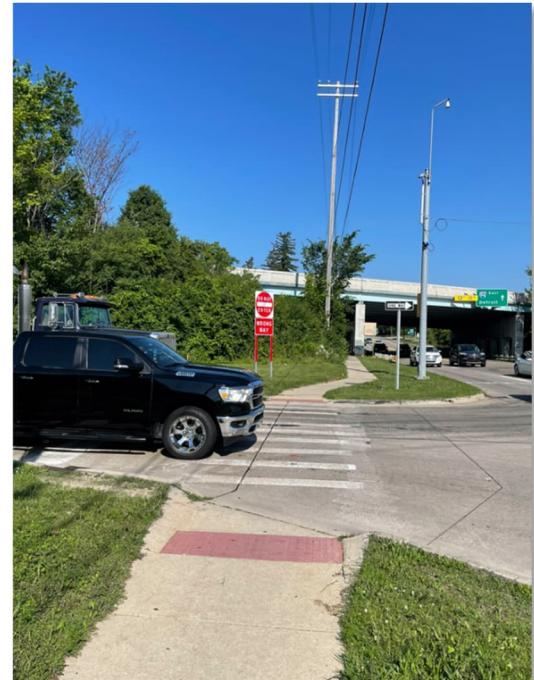
Figure 17 -Westbound I-94 Off-ramp Crosswalk

There are no pedestrian signals in place at the westbound I-94 off ramp to Jackson which can create confusion for pedestrians and a potential conflict with high-speed vehicle traffic exiting from the freeway. Figure 17 shows the current pedestrian facilities at the intersection.

The addition of countdown pedestrian signals at this intersection would help improve pedestrian safety and add clear guidance for both vehicles and vulnerable road users to navigate the intersection safely. At these intersections, crosswalks should be marked with high visibility, continental markings as shown in Figure 20 to increase driver awareness of pedestrians crossing at the intersection. In addition, backplates and tethers could improve visibility of the signals for approaching drivers, increasing their compliance, and potentially limiting conflicts between vehicles and pedestrians by reducing the likelihood of red-light running.

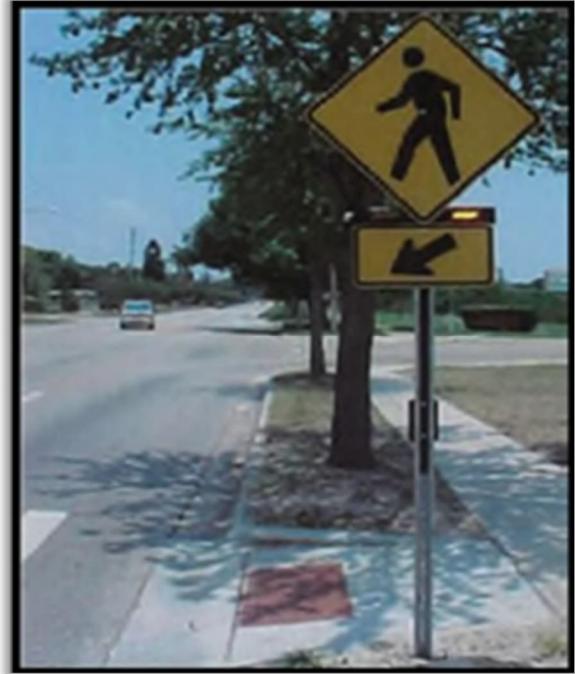
Figure 21 - Mid-block RRFB Crossing Sign

Another improvement for consideration is to provide a high-visibility pedestrian crossing across Jackson Avenue, directly accommodating crossing demand along the desire line between bus stops. Pedestrians take the shortest route to reach their destination and are unlikely to significantly deviate to another intersection. This was observed by the RSA team several times especially involving bus riders who got off and wanted to cross to either side of Jackson Avenue. A delineated pedestrian crossing could provide a more comfortable and marked crossing location to reduce the perceived need to cross at other unmarked locations. MDOT requires an engineering study to determine the feasibility of providing a crosswalk, the “*Pedestrian Crossing Treatment Flow Chart for Uncontrolled Crossing*” included in MDOT’s *Guidance for Installation of Pedestrian Crosswalks on Michigan State Trunkline Highways* supports the provision of a marked crosswalk in this location due to distance from the nearest intersection (Maple), which is over 300’ away from adjacent signalized intersections and if the following criteria are satisfied:

- If Jackson Avenue gets a geometric improvement such as a raised median with a pedestrian refuge island, crossing type B⁶ would apply. This remedy could also be used in conjunction with a Rectangular Rapid Flashing Beacon (RRFB) such as the one shown in Figure 21 to alert drivers that a pedestrian is within or entering the crosswalk in the case where there is an unsignalized crossing.

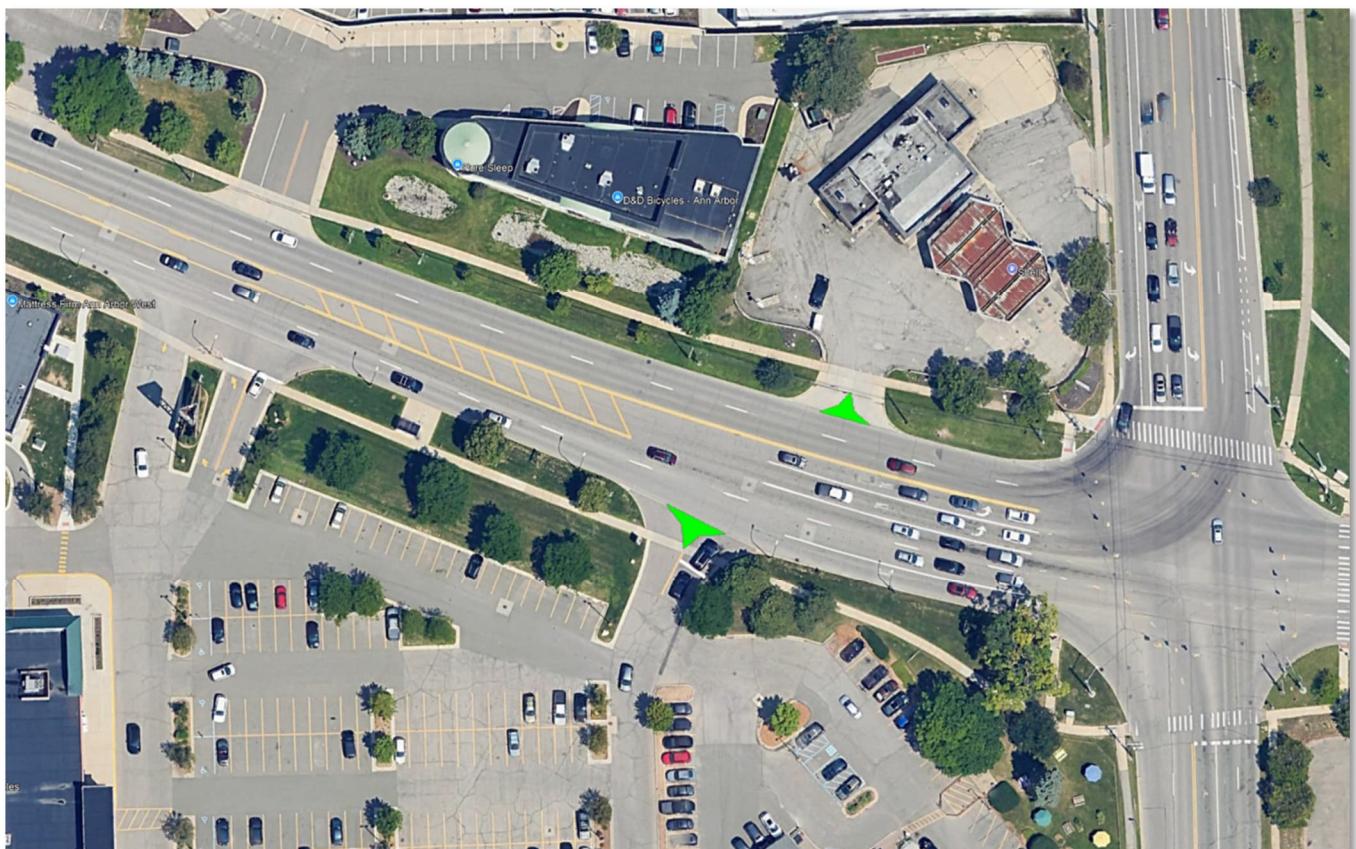
Figure 26 – Potential Right-In / Right-Out Access Management Drives

Access management is an issue near the Westgate shopping plaza, west of Maple, where several cars were observed forcing their way through queues. This scenario was observed just before and during the PM peak hour as vehicles attempted to complete the left-turn movement by crossing as many as five lanes of traffic from the eastern driveway at Westgate shopping plaza. The shopping plaza which is south of Jackson Avenue has two driveways allowing left turns onto Jackson Avenue which increases conflict points with through traffic and pedestrians on sidewalks. The team observed a few hazardous maneuvers and frustrated horn blowing as left-turning vehicles attempted to access westbound Jackson Avenue during the evening peak hour. Turning vehicles have very limited or no line of sight for the westbound vehicles when eastbound queues are present and these through vehicles cannot see the turning vehicles which increases the potential for crashes or other near-miss incidents. There were instances where vehicles were observed driving in the opposing lane of traffic in an attempt to make left turns as the two way left-turn lane was backed up beyond the driveways. Examples of some observed left-turning maneuvers from the east driveway are shown in Figure 25.

Converting the access drives along Jackson Ave nearest to N Maple Rd into right in / right out only movements is a potential safety measure for the sight distance and turning movement related issues. This would help eliminate conflict points for motorists who currently must cross five lanes of traffic, often through significant queues during the peak periods. The channelized right-turn should help encourage lower speed turns across sidewalks to reduce potential conflicts between drivers and vulnerable road users as illustrated in Figure 26. While this approach could be trialed with signs and quick-curb installations, a long-term solution could involve installing raised concrete channelizing islands to solidify this access management strategy. An operations analysis would be required to confirm feasibility of this recommendation prior to implementation.
