ANN ARBOR HISTORIC DISTRICT COMMISSION

Staff Report

ADDRESS: 300 Detroit Street, Application Number HDC19-004

APPLICATION: The applicant seeks after-the-fact HDC approval to install a vapor mitigation system on the front of the building, facing Detroit Street.

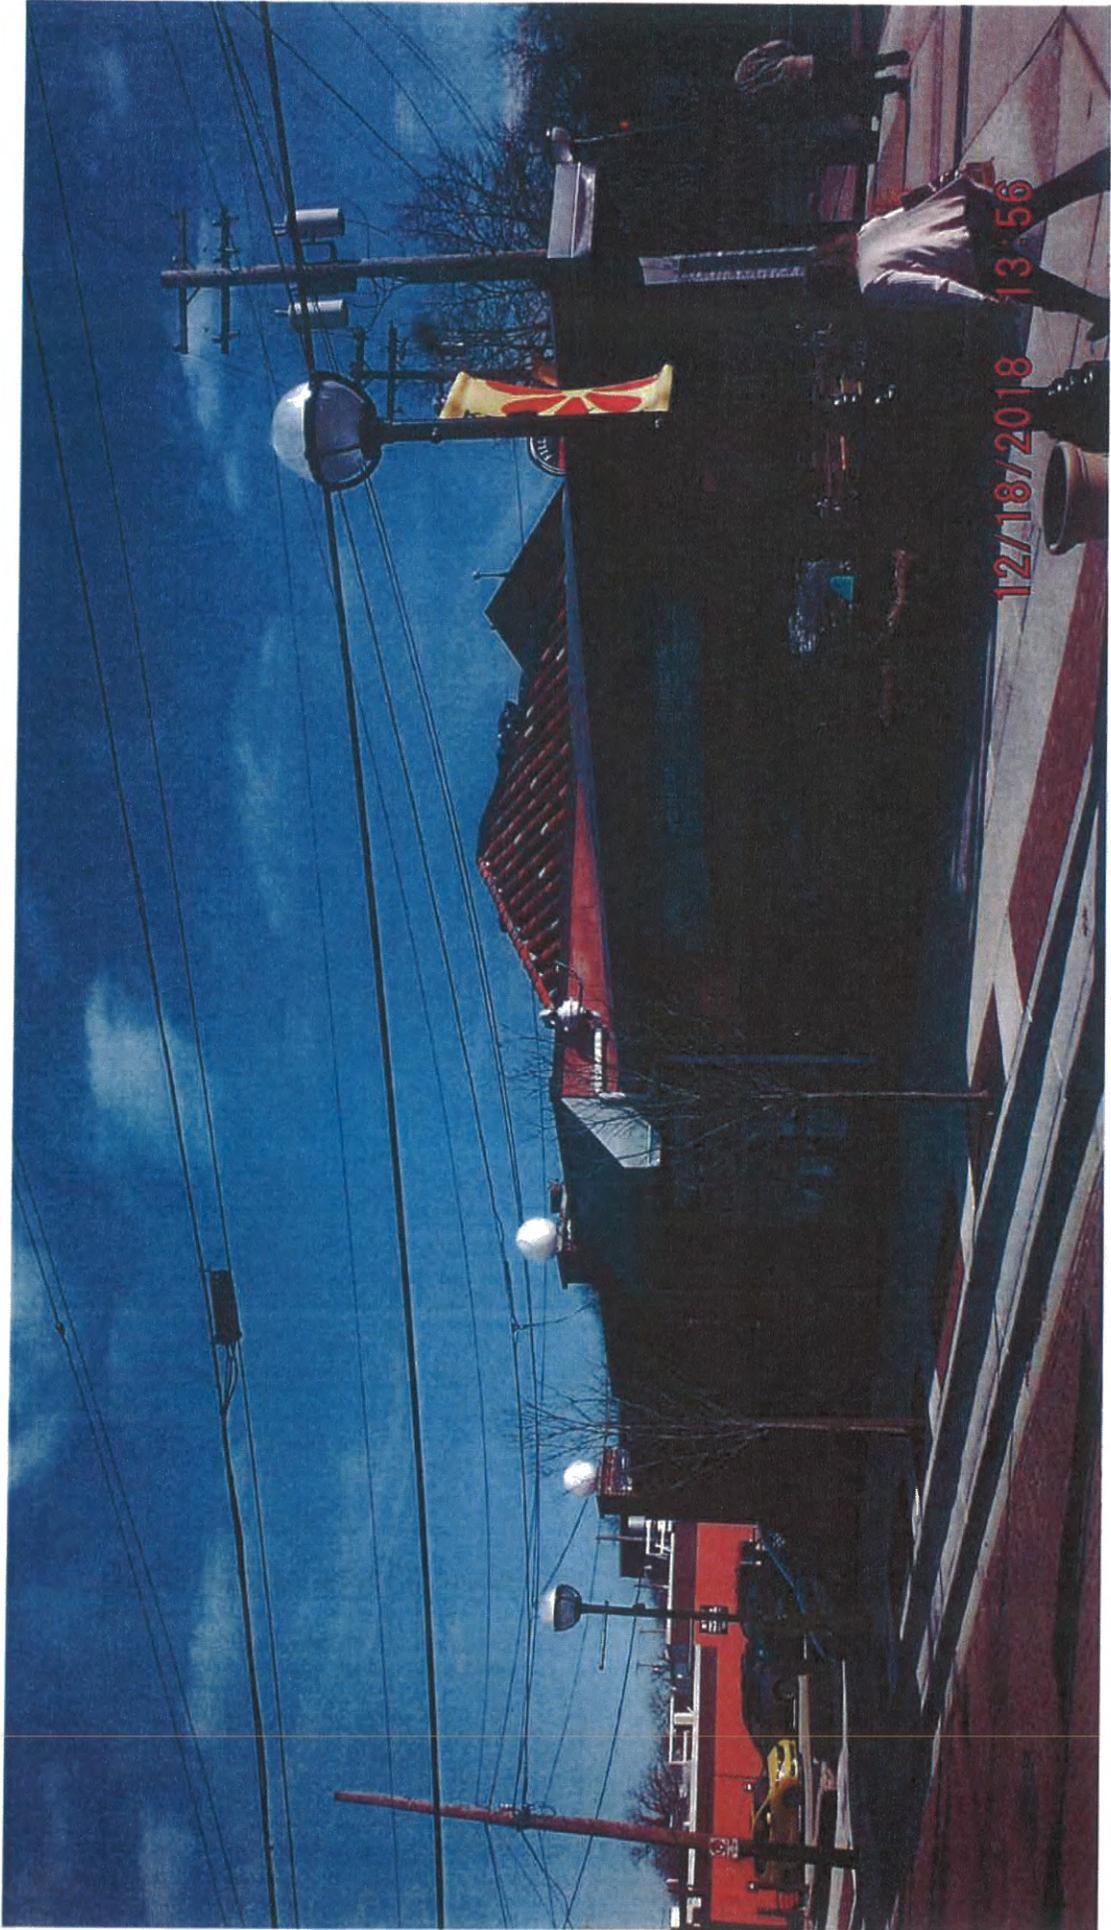
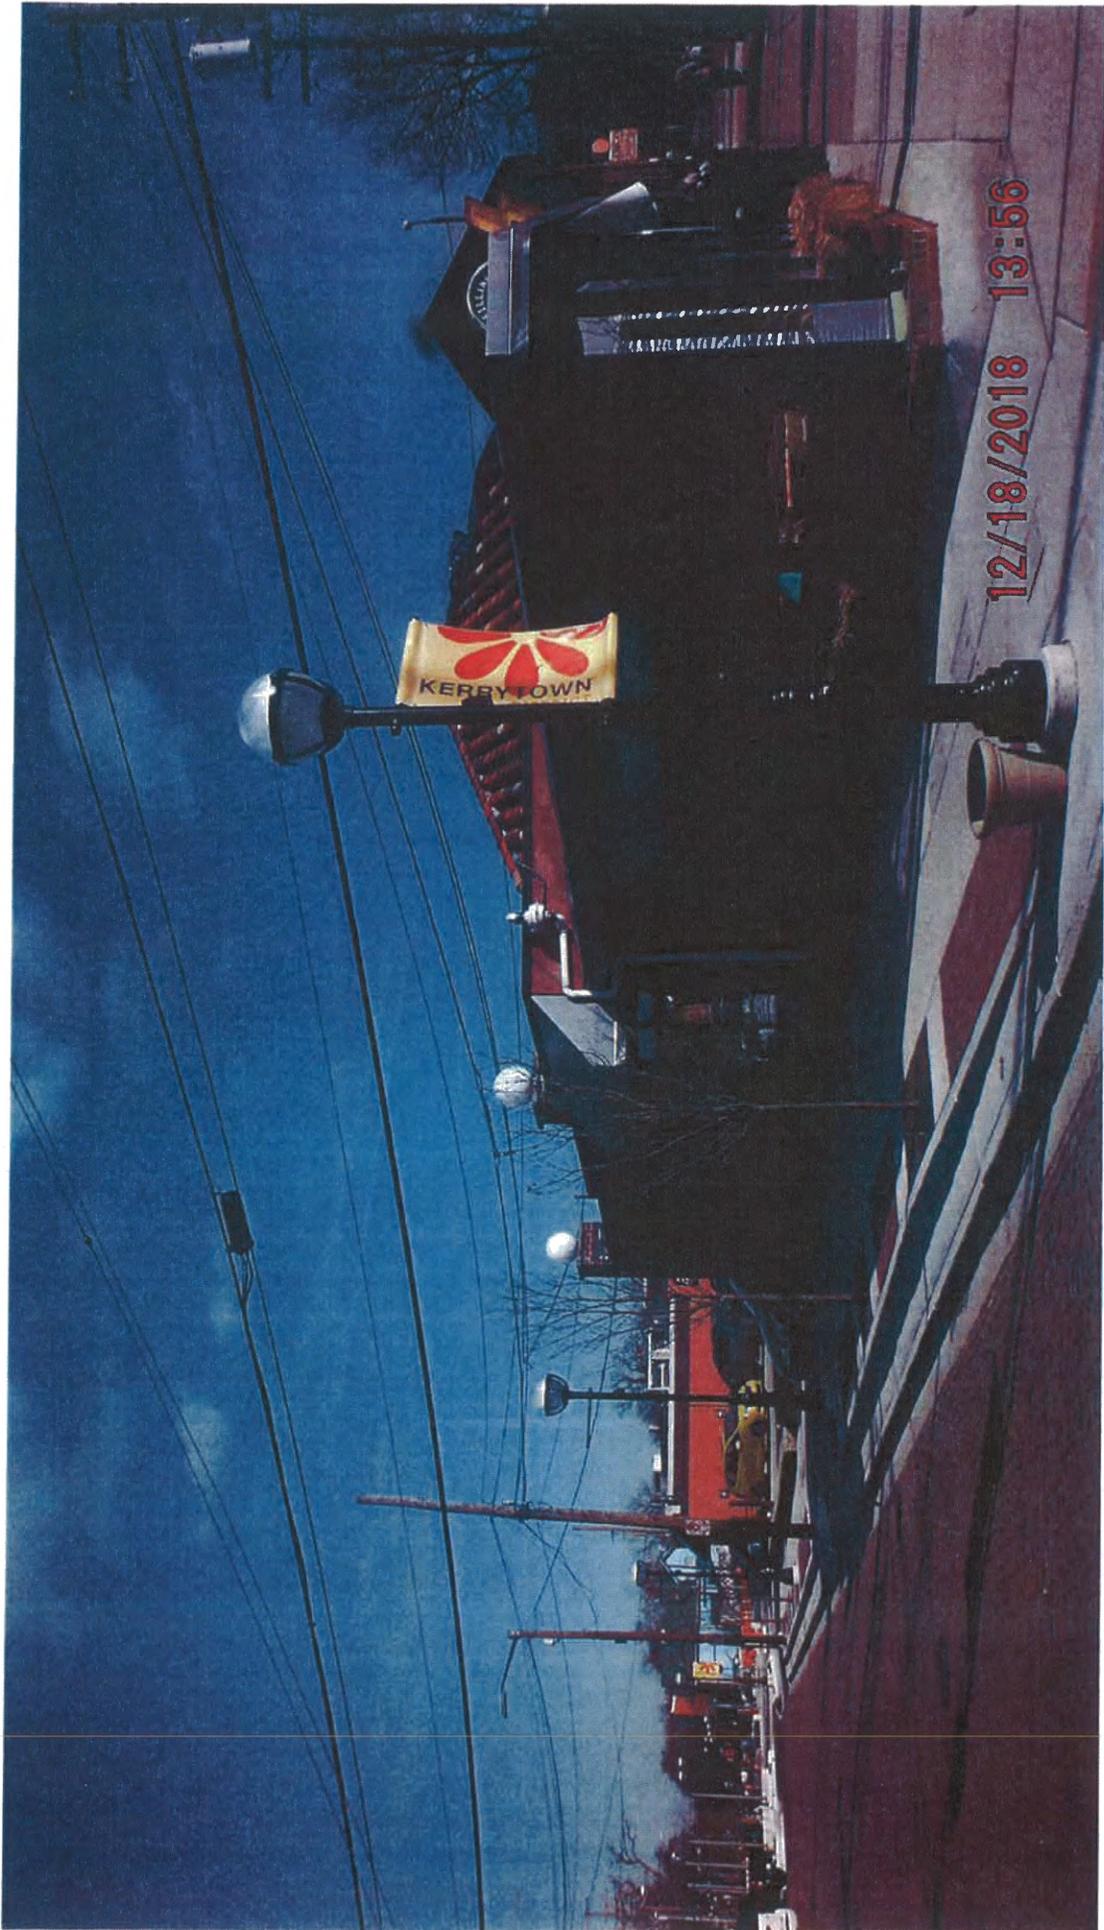
The Soil Vapor System Location:

The current suction point placement got the best performance result to impact the test point near the end of the patio slab as required to provide adequate communication. The suction point could not be placed inside the building as the slab inside the building and the patio slab are two separate slabs divided by the buildings foundation footer, which will not allow sub slab air flow from the patio area to the building slab. The system was placed where it is because it was the best location to do the job it was designed for, it was not placed there for any other reason.
