Ann Arbor Historic District Commission

Application for Certificate of Appropriateness

Old West Side Historic District

536 6th St Garage Restoration, Addition, and Accessory Building

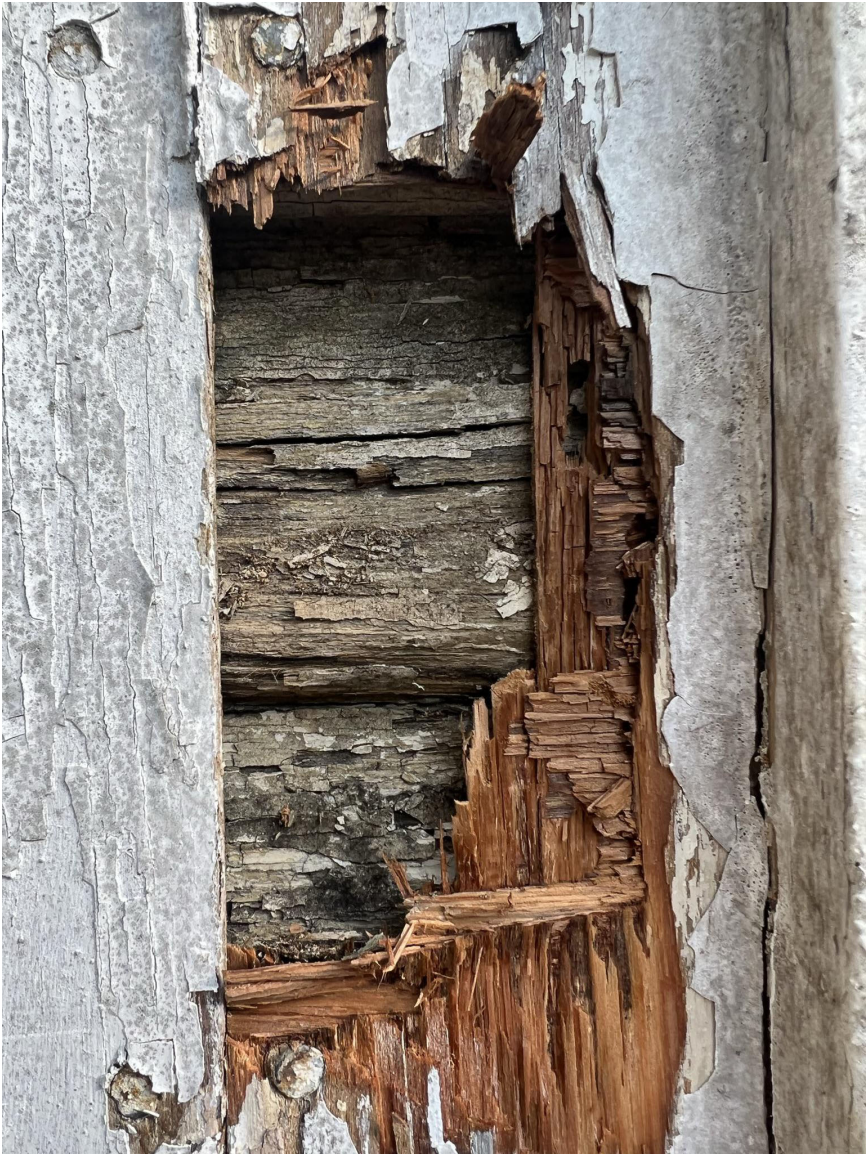
Photo of deteriorated historic cladding behind plywood covering.

(4) Remove plywood sheet cladding to assess condition of historic cladding. If historic cladding is deteriorated beyond repair, then remove historic cladding. Note: During selective demolition, small portions of the historic cladding were exposed and it was determined that the wood was deteriorated beyond repair. See photos.

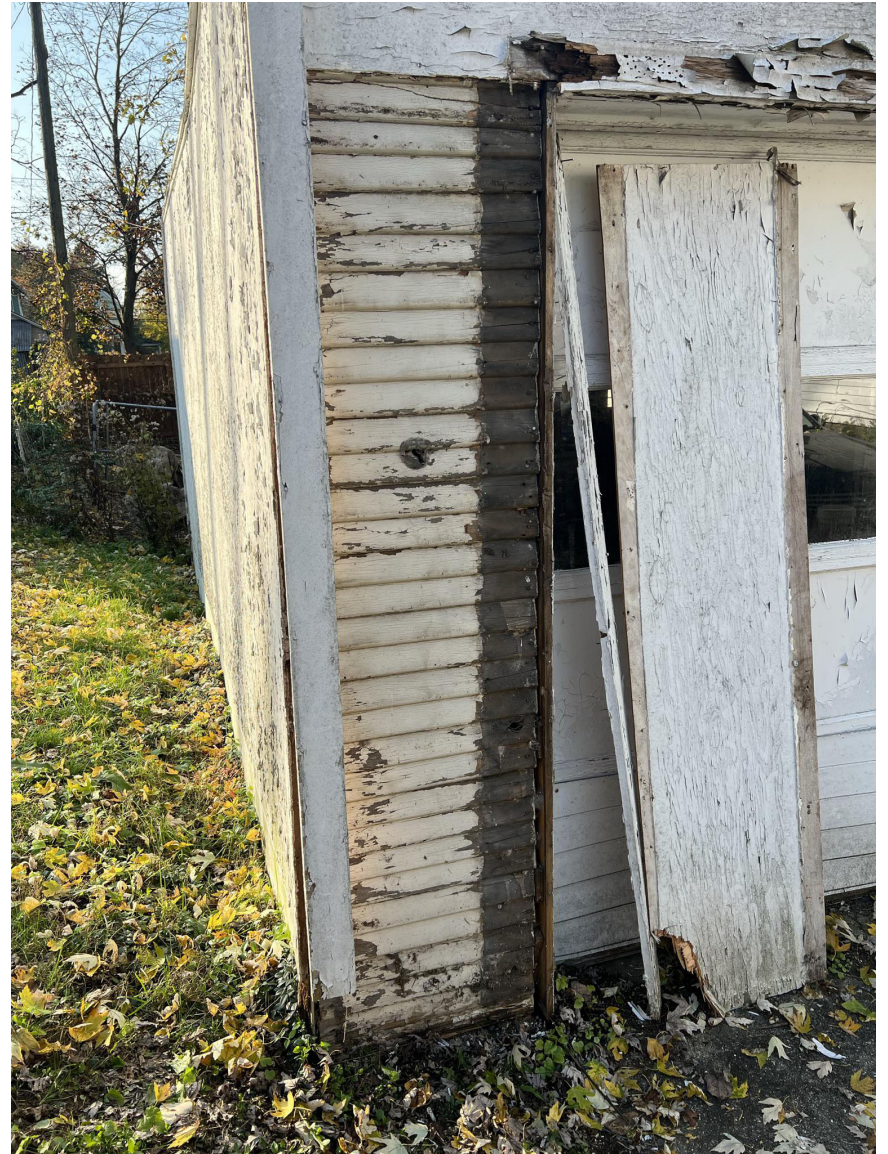
Photo of removed plywood covering with historic cladding exposed.

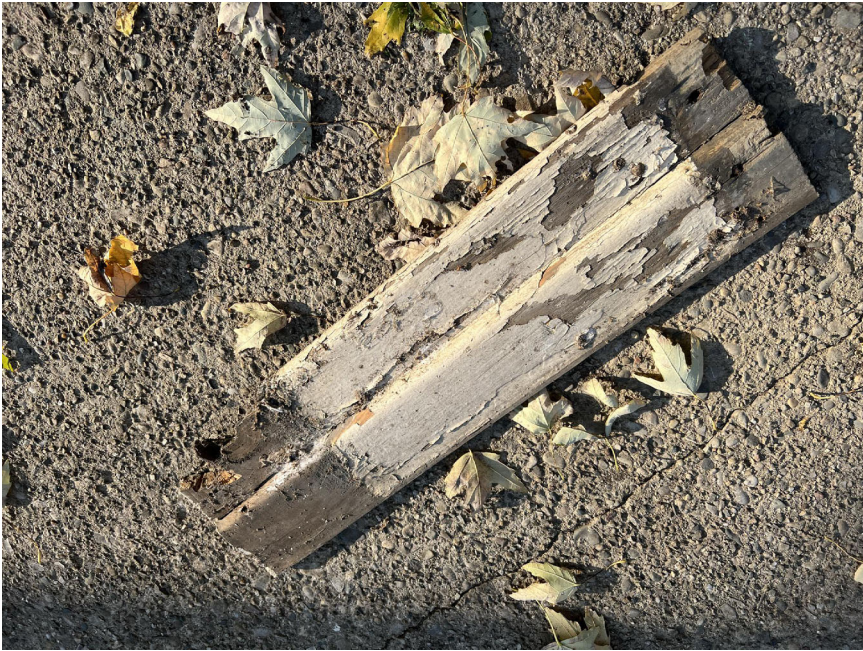
Photo of front of historic cladding from garage.

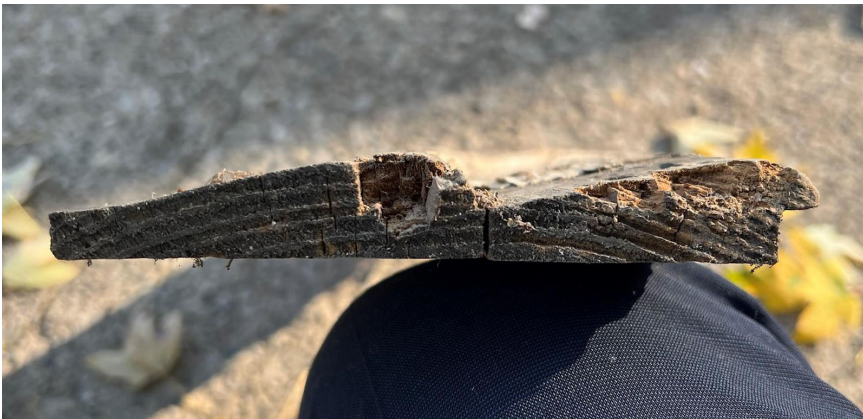
Photo of profile of historic cladding from garage.

There are several different names for this cladding profile:

- Pattern #117
- Washboard
- Double Teardrop
- Double Ogee
- Waterfall
- Boston Clinker

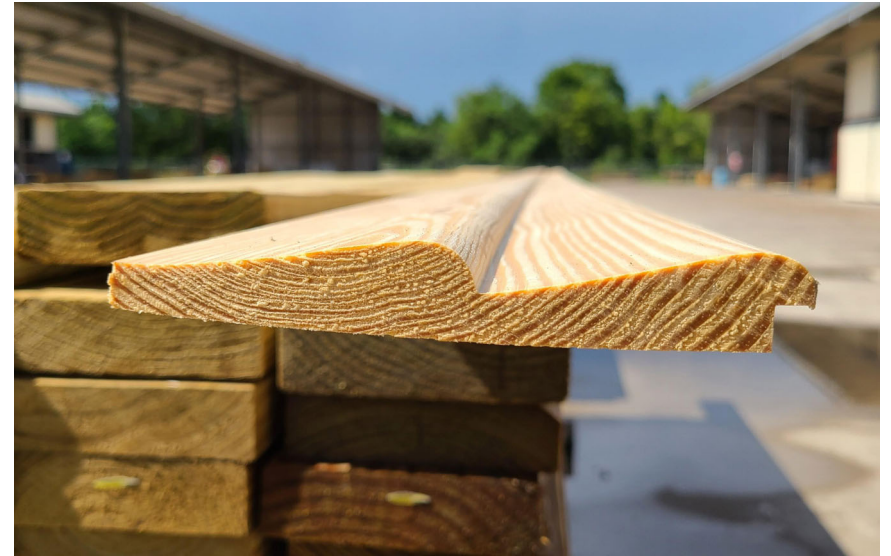
Image of similar cladding available at lumberyard.
(Source: sutherlands.com)

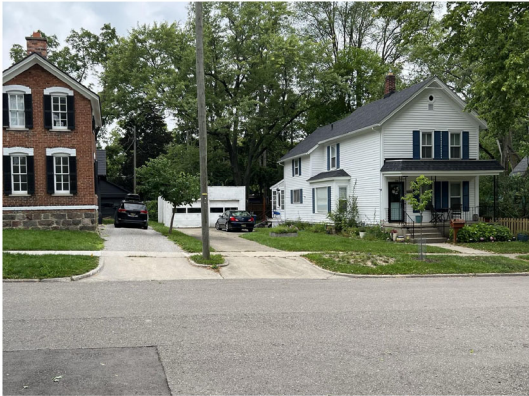
Photo taken from the sidewalk on the east side of 6th St. This is also the approximate location of the camera for the rendering on this sheet.

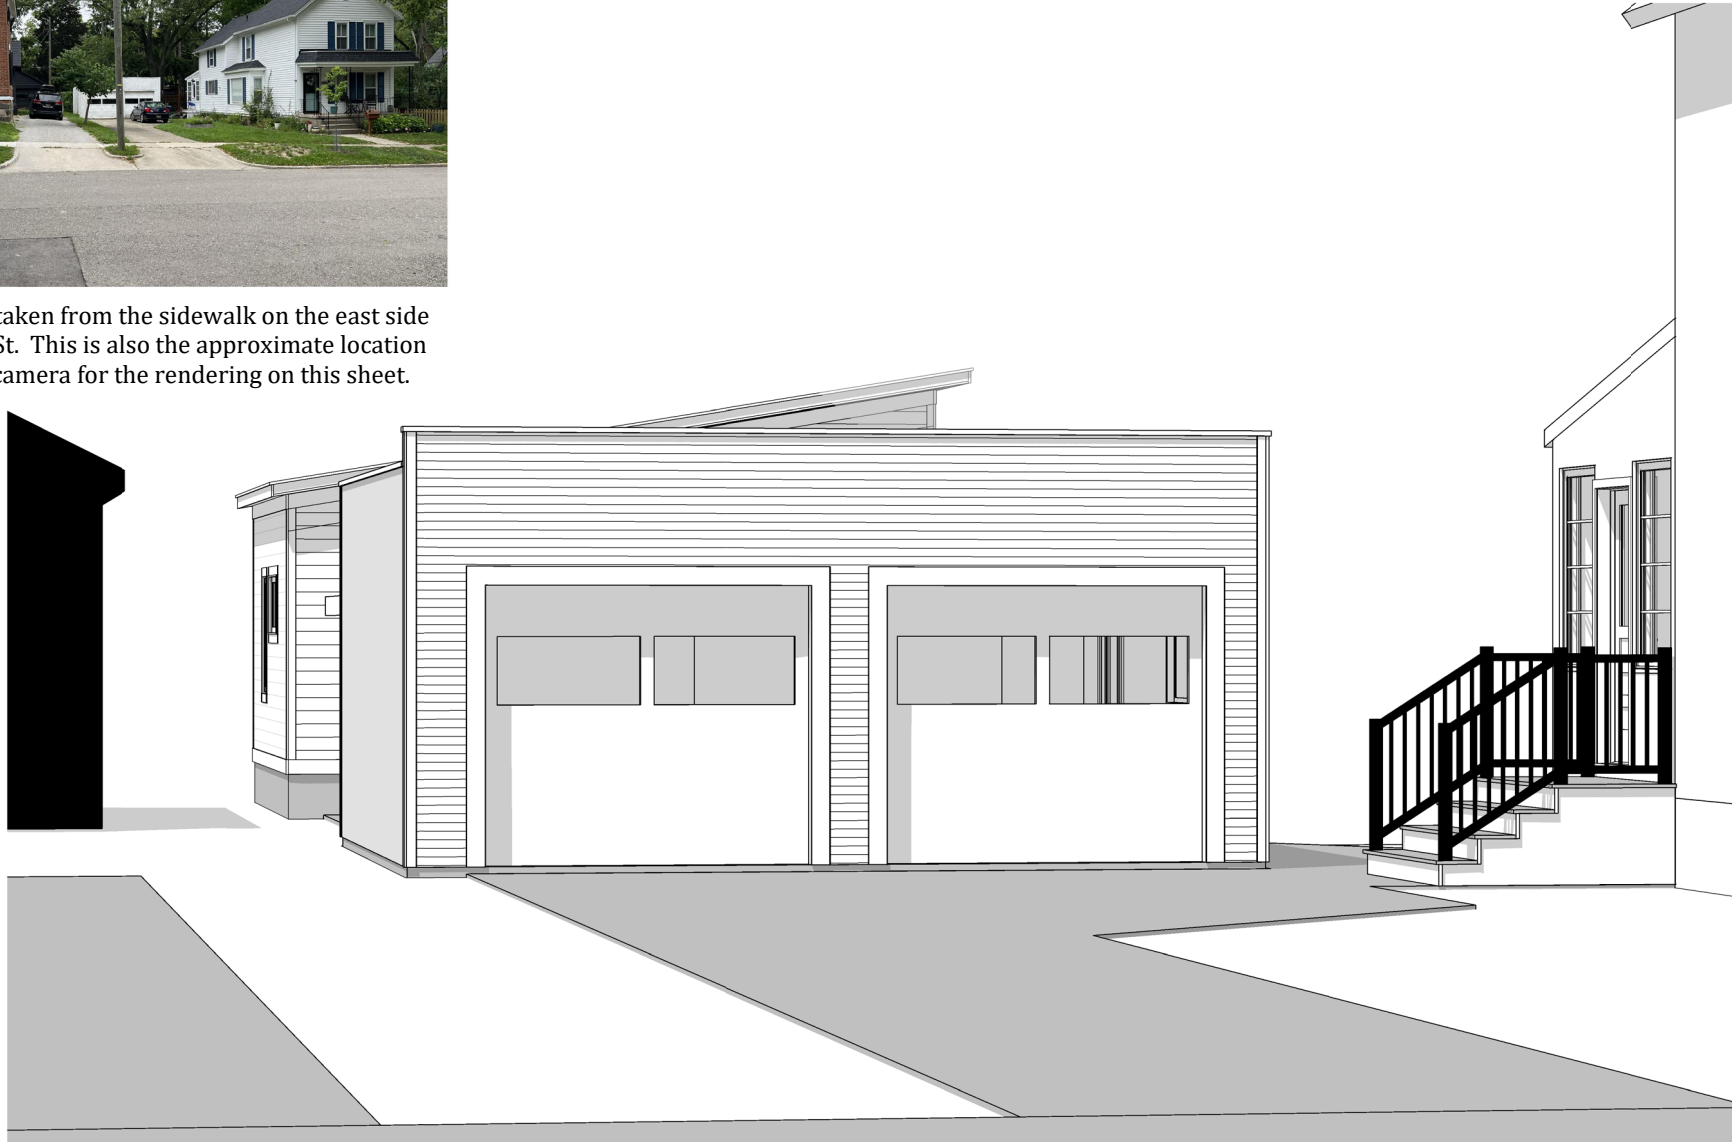
① From Sidewalk on East Side of 6th St

This rendering is "zoomed in" to show detail of what could be seen from the public right-of-way. The included photo shows the approximate distance away that the viewer is from the garage.

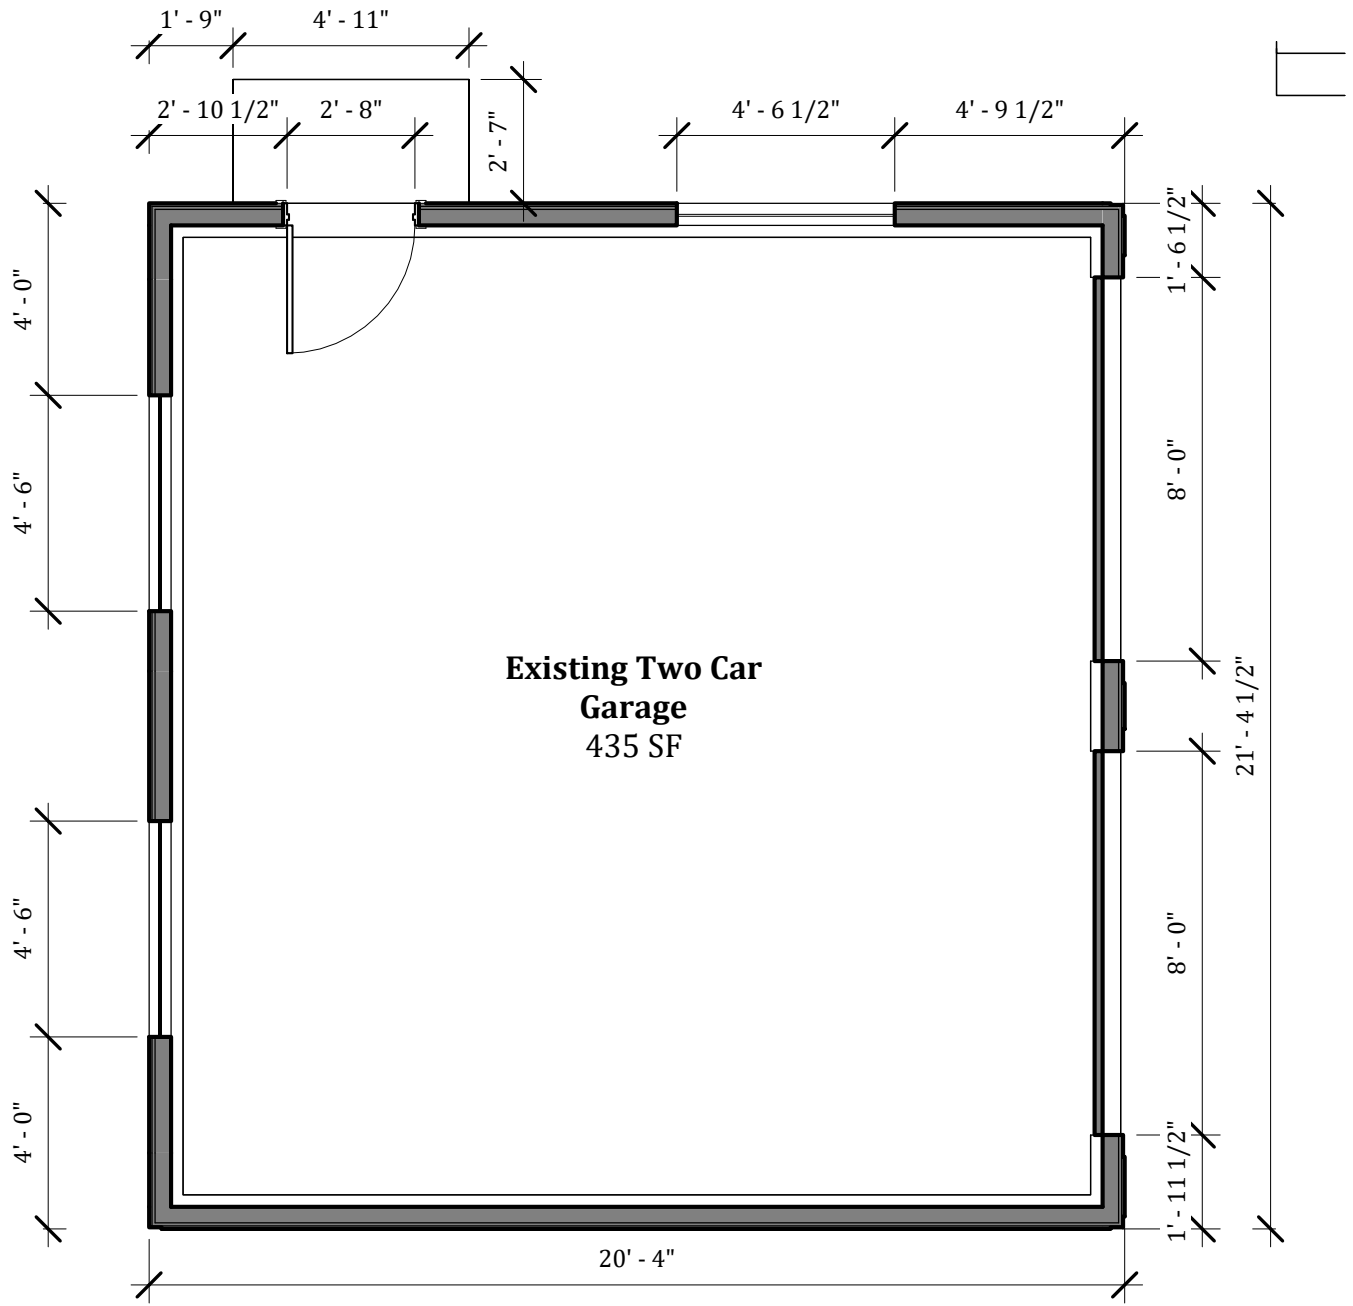
**Existing Two Car
 Garage**
 435 SF

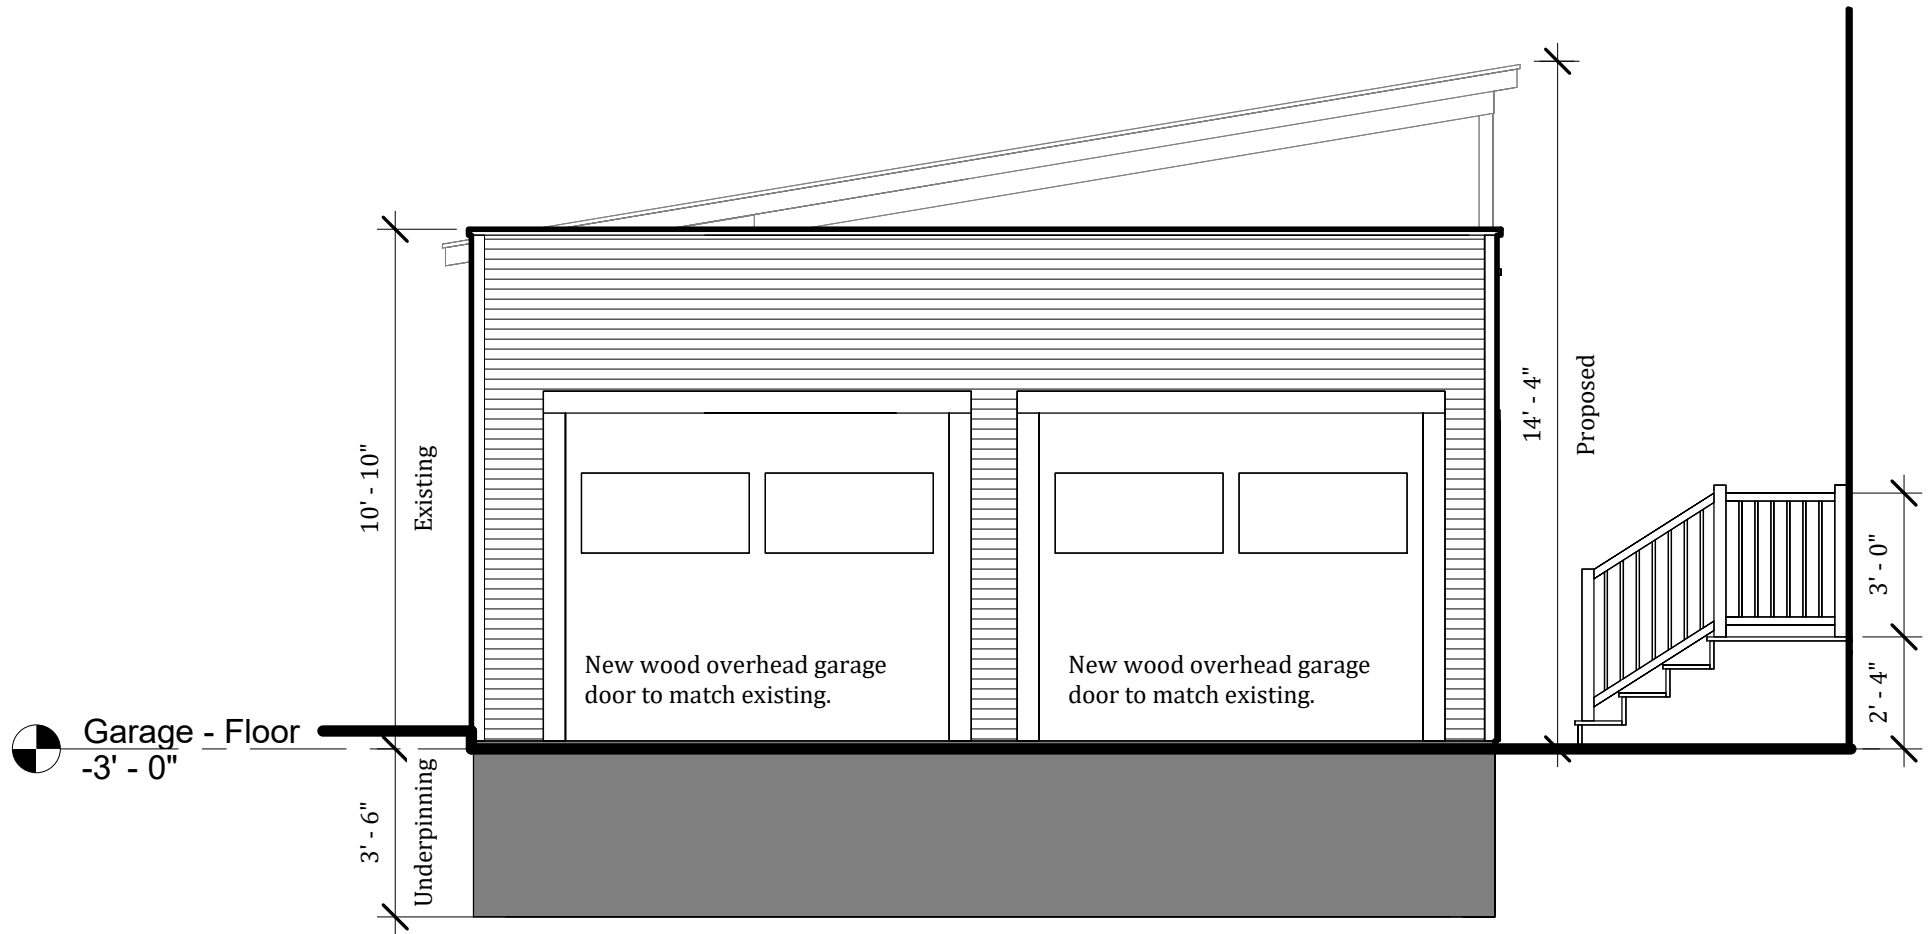
① East Garage & Landing and Stairs Elevation
 1/4" = 1'-0"

Existing window and door
on this elevation to
remain and to be restored.
