ANN ARBOR HISTORIC DISTRICT COMMISSION

Staff Report

ADDRESS: 218 N. Division Street, Application Number HDC22-1157

APPLICATION: The applicant seeks HDC approval to move a first-floor window opening on the south elevation 38" to the west, infill the original opening, and install a new wood window. A second new wood window would replace an existing window next to the moved one, to the east.

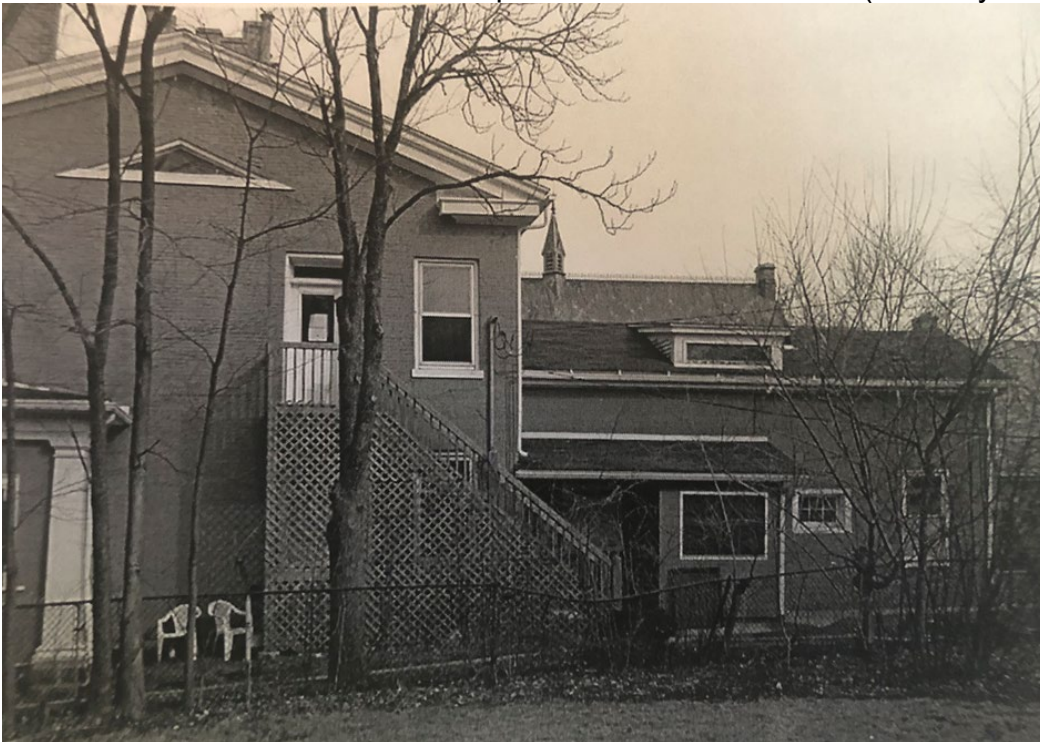
Photo of the south elevation taken prior to the 2004 remodel (courtesy of the homeowner)

1. The south elevation of the house originally had five windows across the second floor, and on the first floor, a center door with two windows on each side, aligned vertically with the second-floor windows. The house has undergone several transformations since then, resulting in numerous windows being infilled, added, and moved. In 1910 the exterior was remodeled in the Colonial Revival style by adding the large front porches, dormers, and center portico, and the entrance door was moved to the south (you can see this in the c. 1942-46 photo at the end of this staff report). In 2004 the house was restored by David Kwan and returned to use as a single-family home. The front entry was returned to the center of the west elevation, most or all of the windows were replaced, the fire escape was removed, and much other work was done.

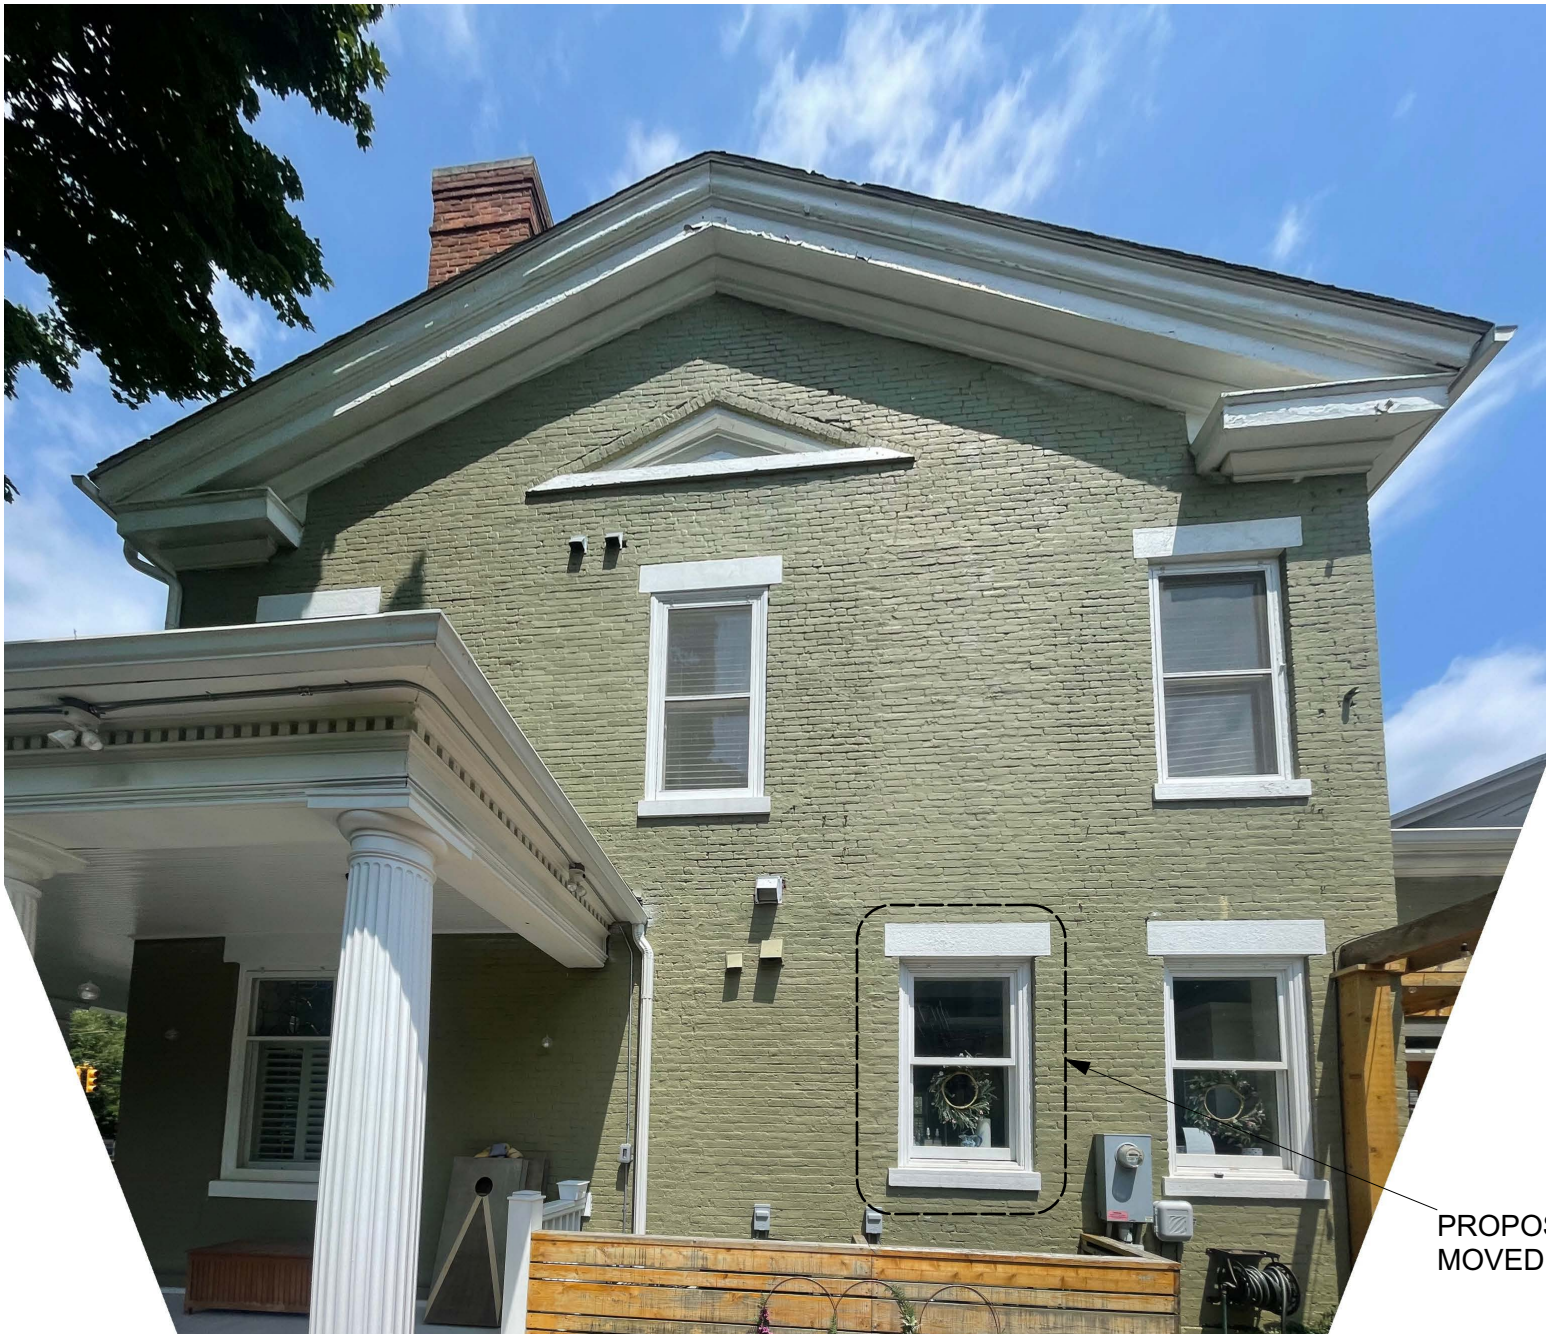
PROPOSED WINDOW TO BE MOVED

3. The window opening proposed to be moved is an opening that is original to the house. Looking at sheet 3 of the applicant's attachments, a missing window on the second floor would have been aligned with this window (the brick has obviously been infilled and patched). Moving the window as shown on sheet 4 brings it out of alignment with both the center window on the second floor and the missing window that was above its current location.

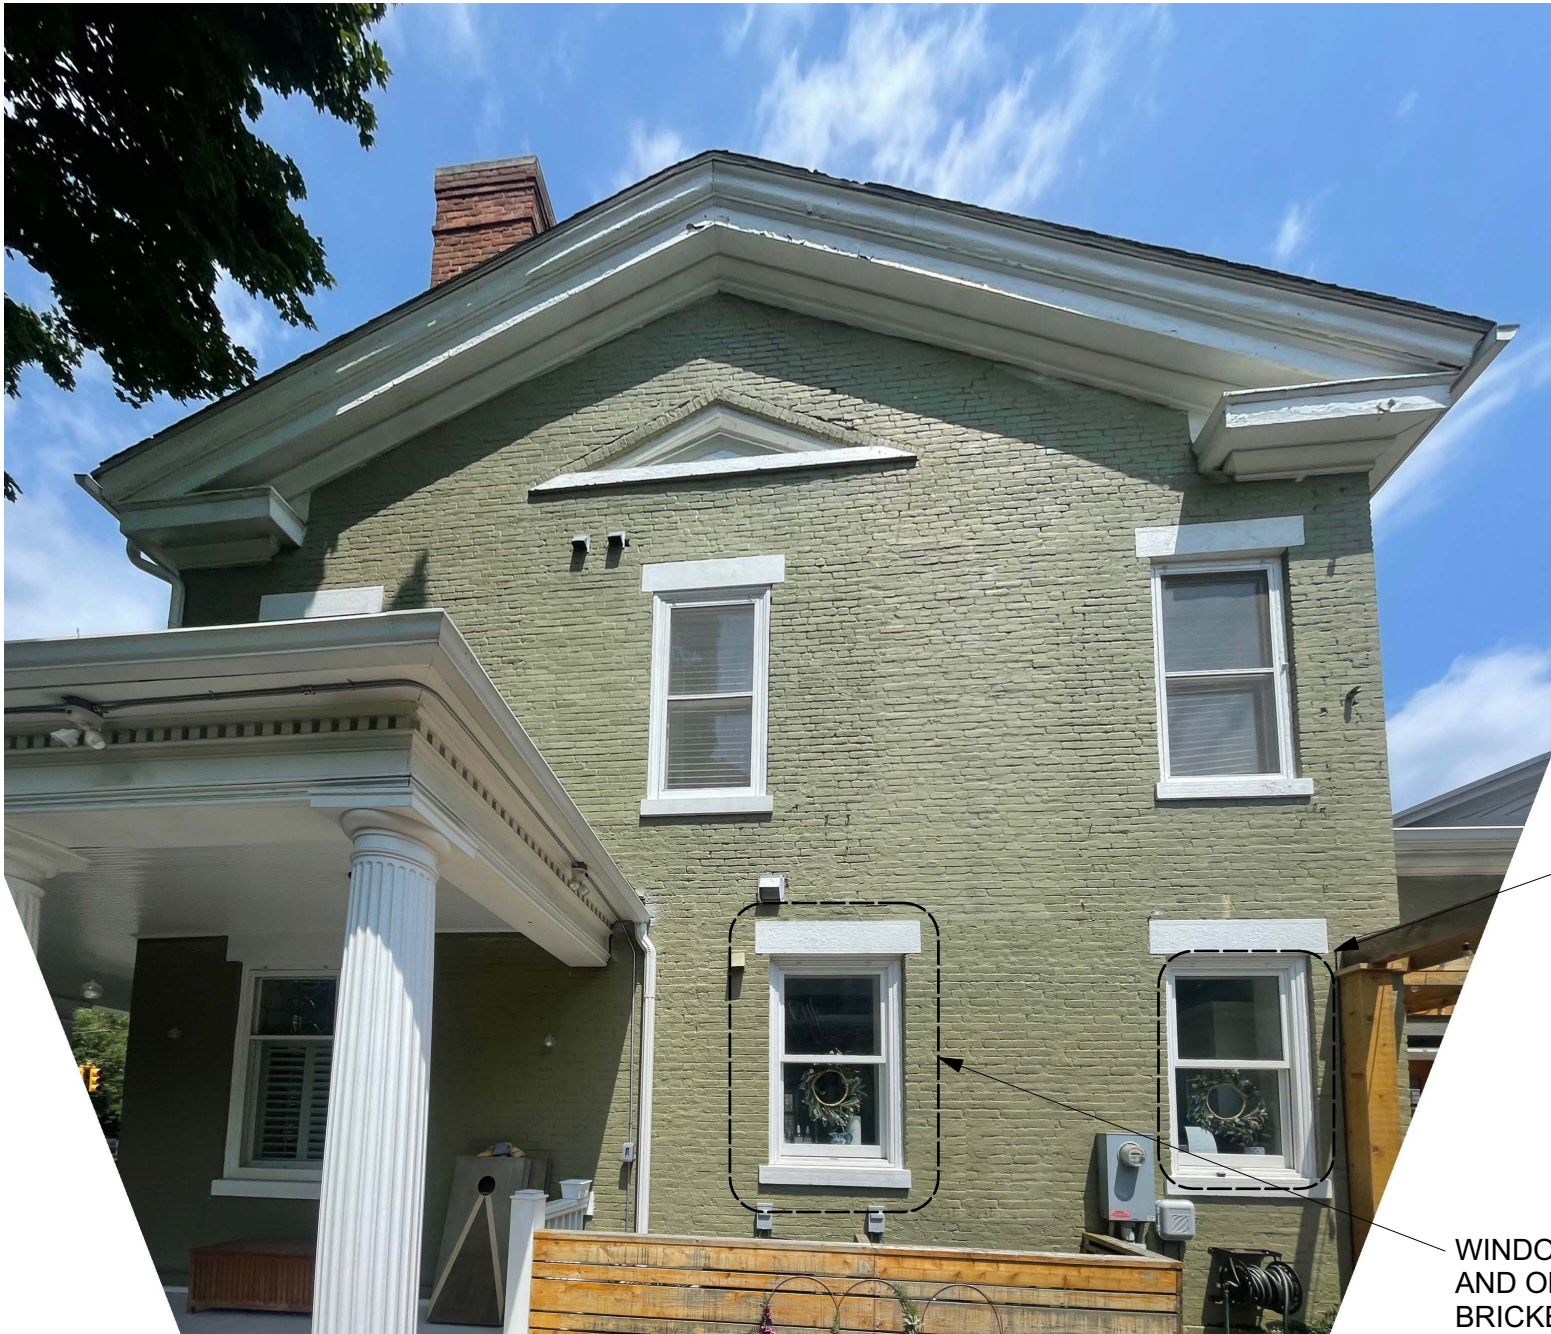
REPLACE FRAME
AND SASH ONLY IN
THIS WINDOW

WINDOW MOVED 38" WEST
AND OLD OPENING
BRICKED IN
