ANN ARBOR HISTORIC DISTRICT COMMISSION

Staff Report

ADDRESS: 317 S Division Street Application Number HDC25-0115

APPLICATION: The applicant seeks HDC approval to:

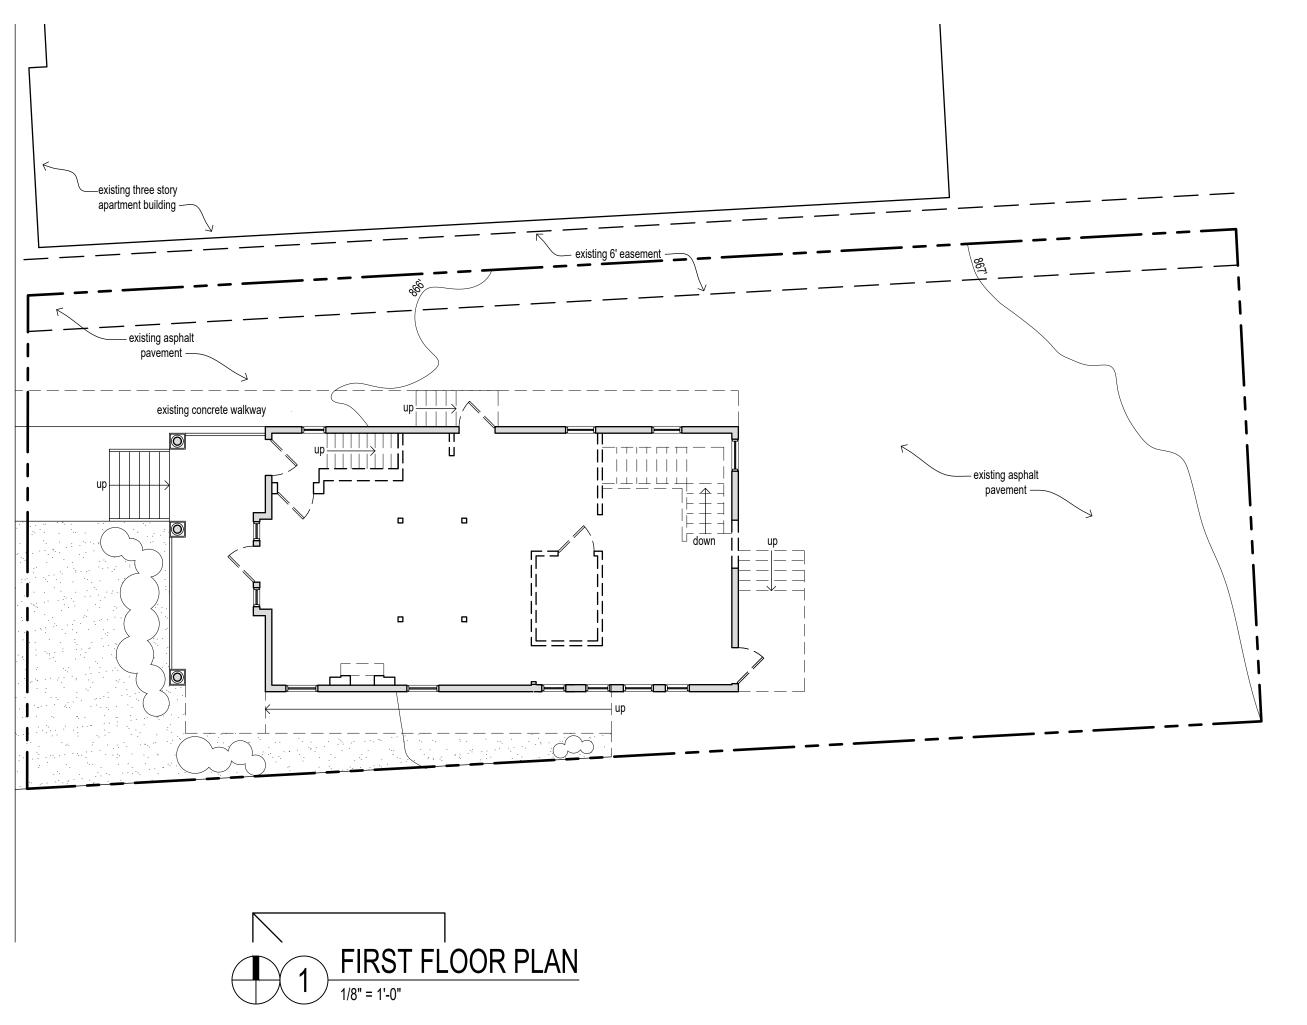
DEMOPLAN project no. 25053

- 1. Remove the existing ramp along the south elevation and add four egress windows in wells.
- 2. Remove a non-original door and steps on the north elevation.

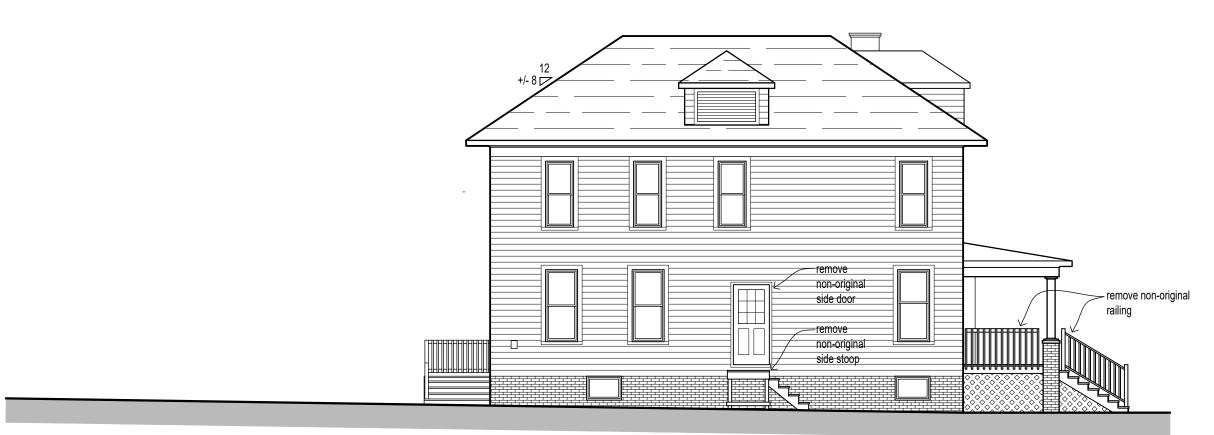
1 EXISTING NORTH ELEVATION (SIDE)

EXTERIOR ELEVATION project no. 25053

3. North Elevation. A door with steps leading up to it is present on the north elevation. The architect reported that it did not correspond to basement steps on the interior, so it is unlikely that there was originally a door here. The drawings say that if a historic opening is found (once the aluminum siding is removed and/or the interior studs are exposed), it will be restored and a door installed. The applicants can work with staff if that is the case. If there is no historic opening found, the opening will be infilled to match the underlying siding.

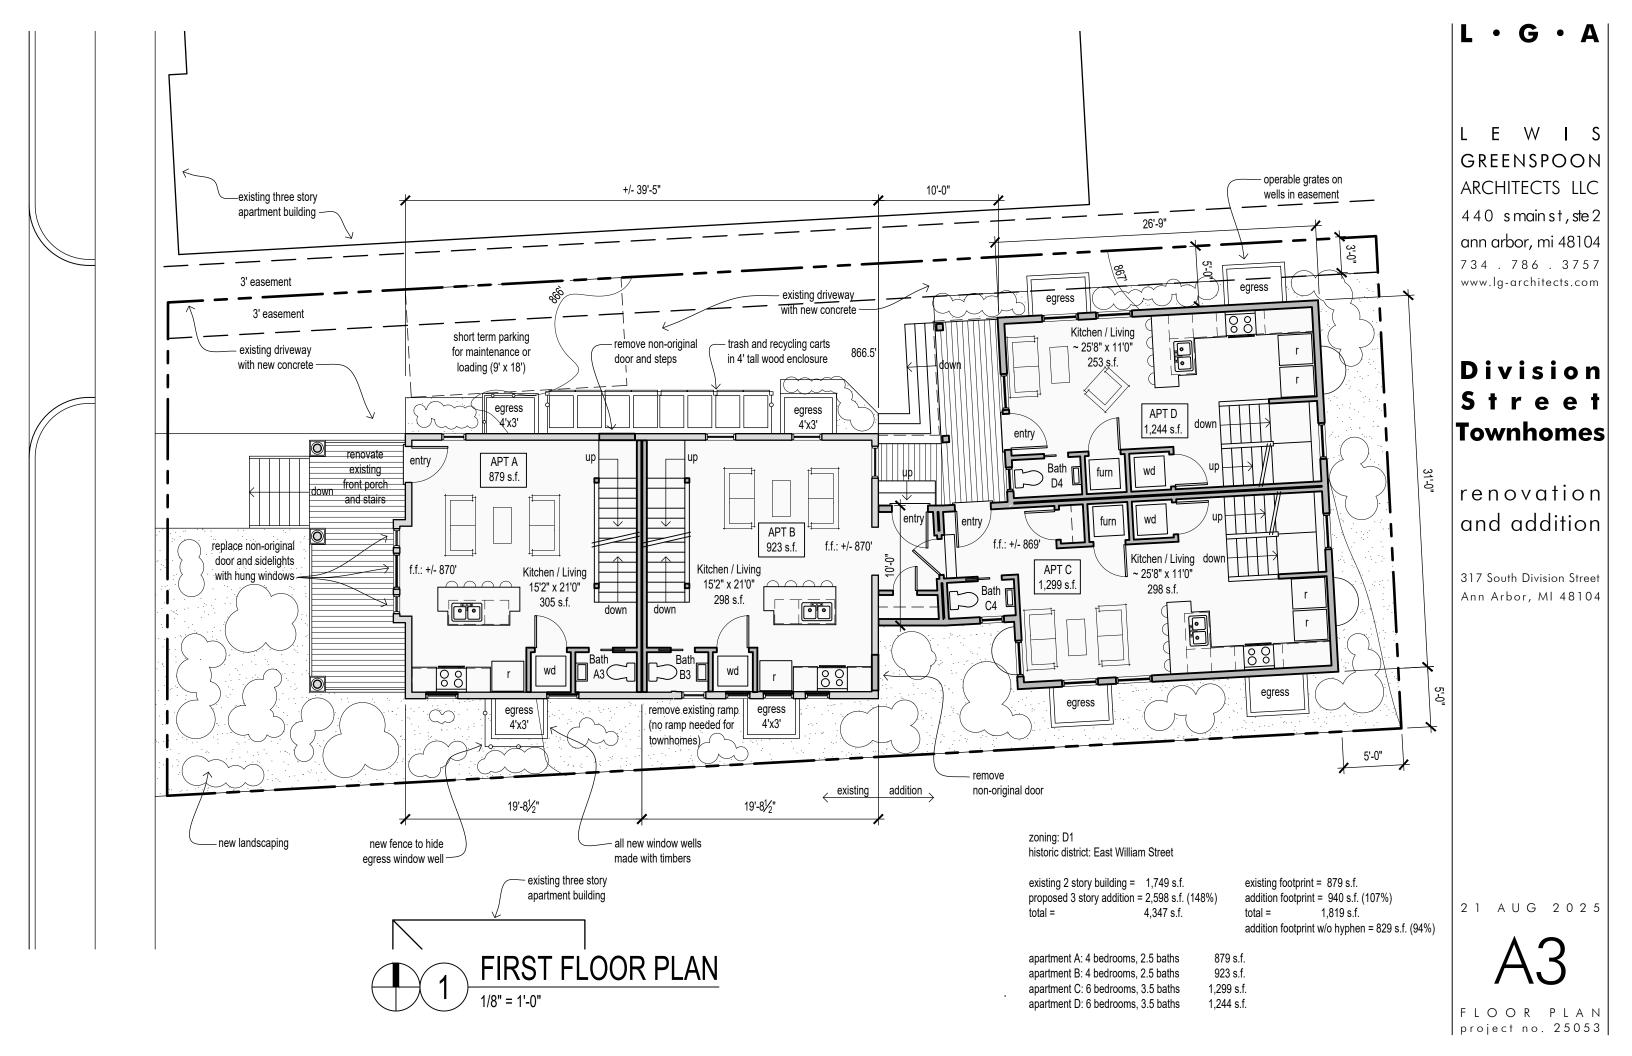
FLOOR PLAN project no. 25053

1. The project would return this house to residential use after nearly four decades of housing the Mail Shoppe. The project would result in four apartments: two four-bedroom units in the historic house and two six-bedroom units in the rear addition. Staff found applying the *Ann Arbor Historic District Design Guidelines* to be problematic: the house is part of a row of houses of a similar era (with the exception of the apartment building to the north), which would suggest applying the residential design guidelines. Its proximity to downtown and the area's dense development, however, calls for more flexibility than strict interpretation of the residential guidelines allows. Also, this block and surrounding area are zoned D1 Downtown Core which does not have side or rear setbacks or limit occupancy the way R residential zoning districts do.

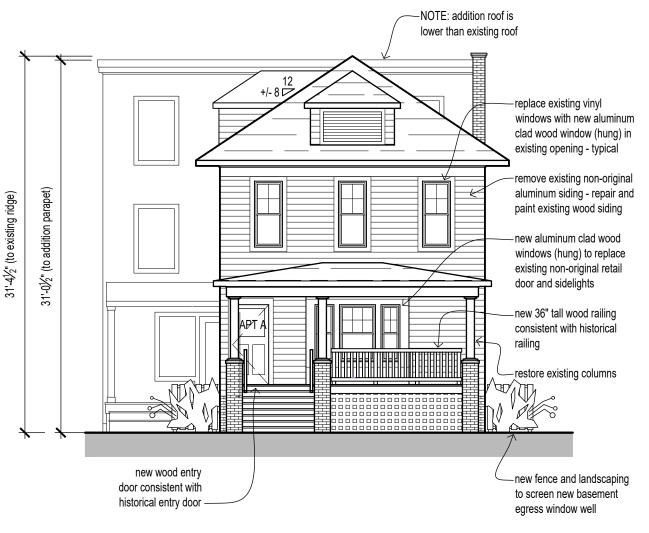
WEST ELEVATION (FRONT)

EXTERIOR ELEVATION project no. 25053

- 4. Front Porch. The restoration proposal for the front porch is generally appropriate. Staff would prefer to see a lower guardrail that is closer to the height of the 1913 one, and which uses additional horizontal "booster rails" (typically painted black to make them recede) on top to make up the code-required height. [This website is a bit silly but has photos of good built examples near the bottom of the page.] Porch skirting is not called out but is shown as a square lattice instead of diamond, so staff assumes it will be replaced with new wood square lattice. Removing the business front door and restoring the front bay window is highly appropriate.

- 5. Windows. All vinyl windows are proposed to be replaced with aluminum clad, one over one wood windows in the existing openings. The style does not match the ones in historic photos, but the four over one style is appropriate since there are no surviving wood windows to use as a prototype.

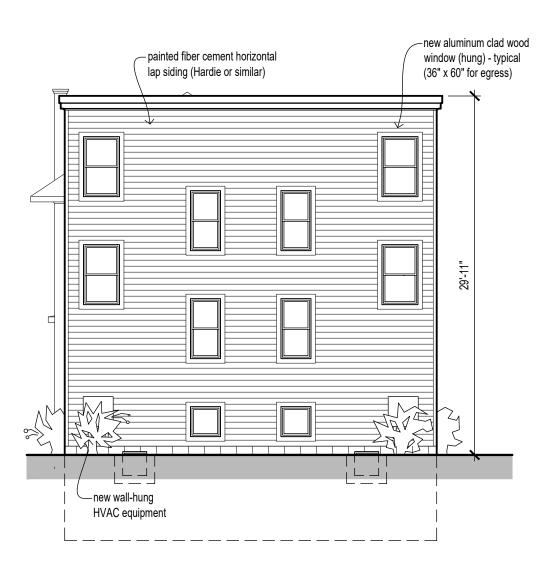
1) EAST ELEVATION (REAR)

EXTERIOR ELEVATION project no. 25053

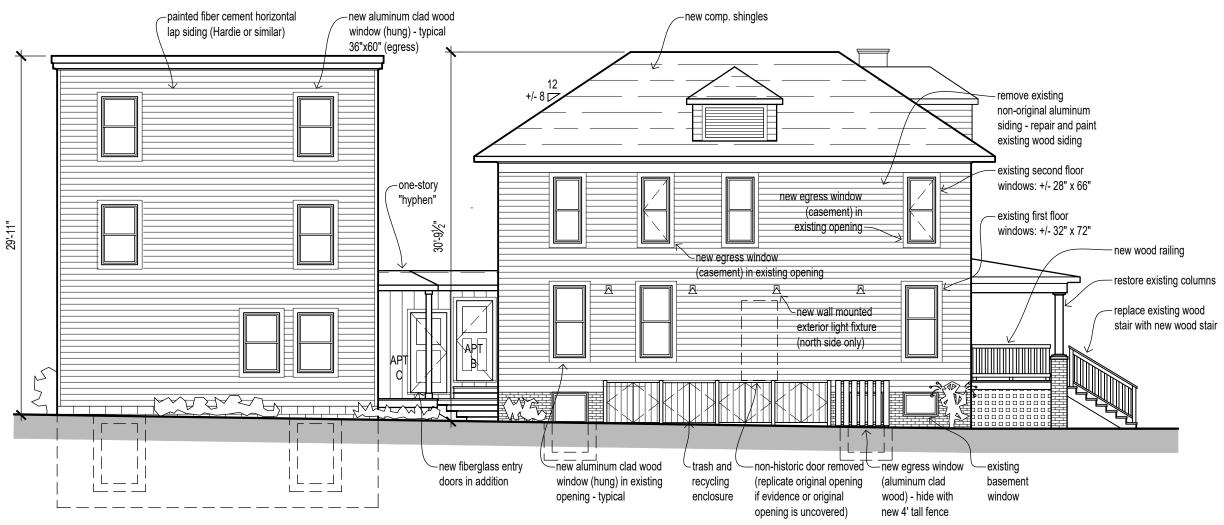
NORTH ELEVATION (SIDE)

EXTERIOR ELEVATION project no. 25053

The trash enclosure is appreciated. There will be a large number of trash and recycling carts and keeping them contained and out of sight is appropriate. The enclosure will be 4ft tall. Materials are not noted on the drawings.
