**00 ANN ARBOR HISTORIC DISTRICT COMMISSION****Staff Report****ADDRESS:** 549 S First Street, Application Number HDC23-0187**DISTRICT:** Old West Side Historic District**REPORT DATE:** November 9, 2023**REPORT PREPARED BY:** Jill Thacher, Historic Preservation Coordinator**REVIEW COMMITTEE DATE:** November 6, 2023**OWNER****APPLICANT****Name:** Nick CollinsKasey Vliet  
In Parallel Architects  
4621 Freedom Drive  
Ann Arbor, MI 48108**Address:****Phone:** (646) 246-8246

## SCOPE OF WORK

We propose to renovate the house and landscape at 549 South First Street in Ann Arbor, MI. This primarily interior renovation will include all three house levels (lower, main and upper) and also the landscape.

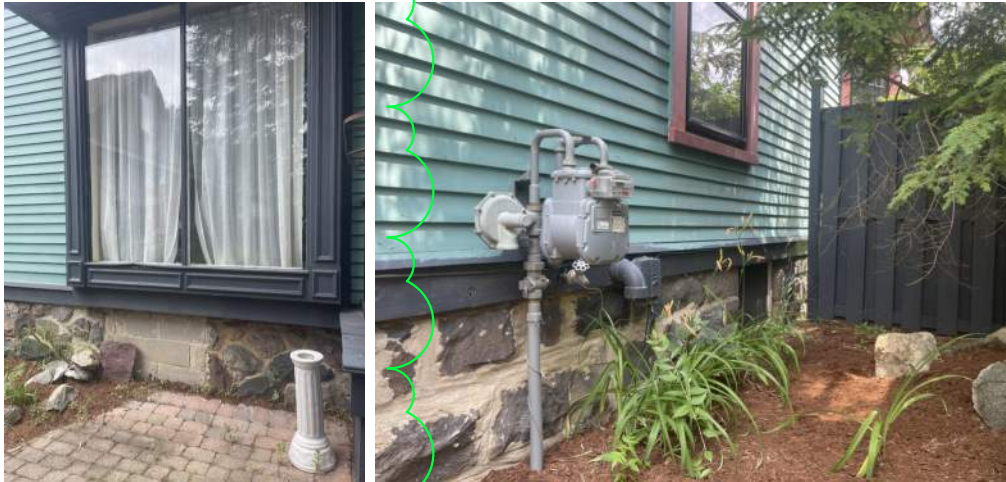
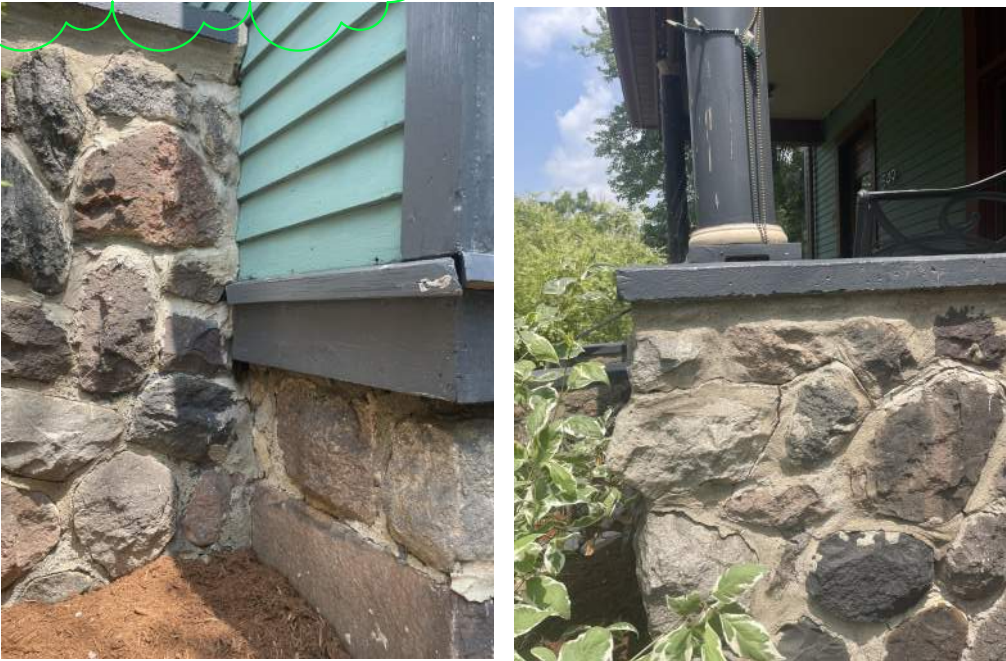
# HDC-1.2

# PROPOSED WALL SECTION

1A

The scope of renovation work includes increasing lower level ceiling height by digging down and lowering foundation and basement floor slab. Existing foundation includes a combination of cut stone and cobblestone, which has been underpinned with concrete below grade at multiple locations. The existing foundation and porch are compromised and require repair. Considerable water damage can be seen at foundation interior. The existing foundation wall encroaches significantly into usable lower level space. Our consultation with several local masons has resulted in a consensus that additional tuckpointing will be insufficient in maintaining existing foundation and that further underpinning the existing already underpinned areas would be structurally unstable and also encroach even further into the usable lower level space, further reducing its function.

We propose to reconstruct the existing house and porch foundation walls using reinforced concrete block below grade and the existing stones with mortar to match the existing color above grade. This would provide a structurally stable and waterproofed foundation wall, while giving back usable space to the lower level function and enabling a higher ceiling height. This higher ceiling height is desired for general function and also for the installation of acoustical panels needed for a semi-professional recording and music practice space.

**SEE HDC 1.2 SECTION FOR MORE DETAILS**

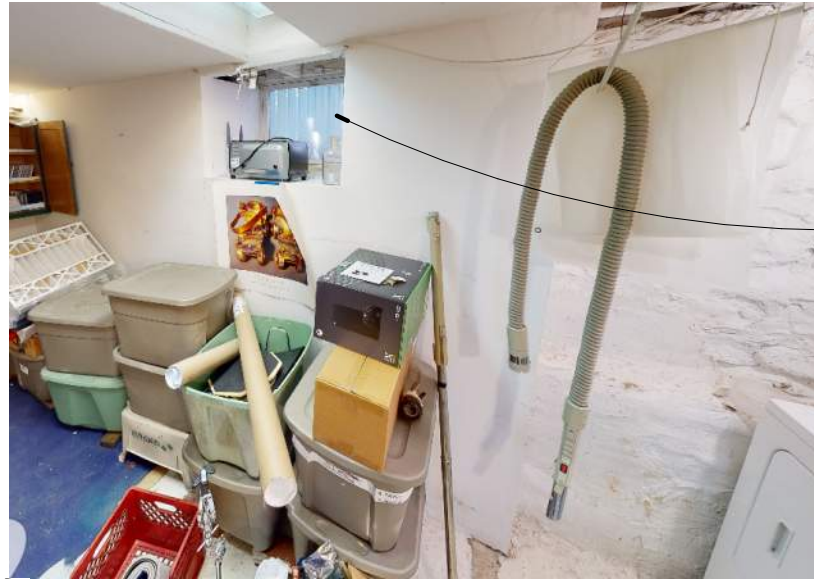
EXISTING WINDOW  
age: unknown  
materials: painted wood  
style: operable

If identified as non-historic, other basement windows are to be replaced with new aluminum-clad wood hopper window units at the same size as existing to improve thermal performance. If identified as historic, existing windows are to be salvaged and re-used.

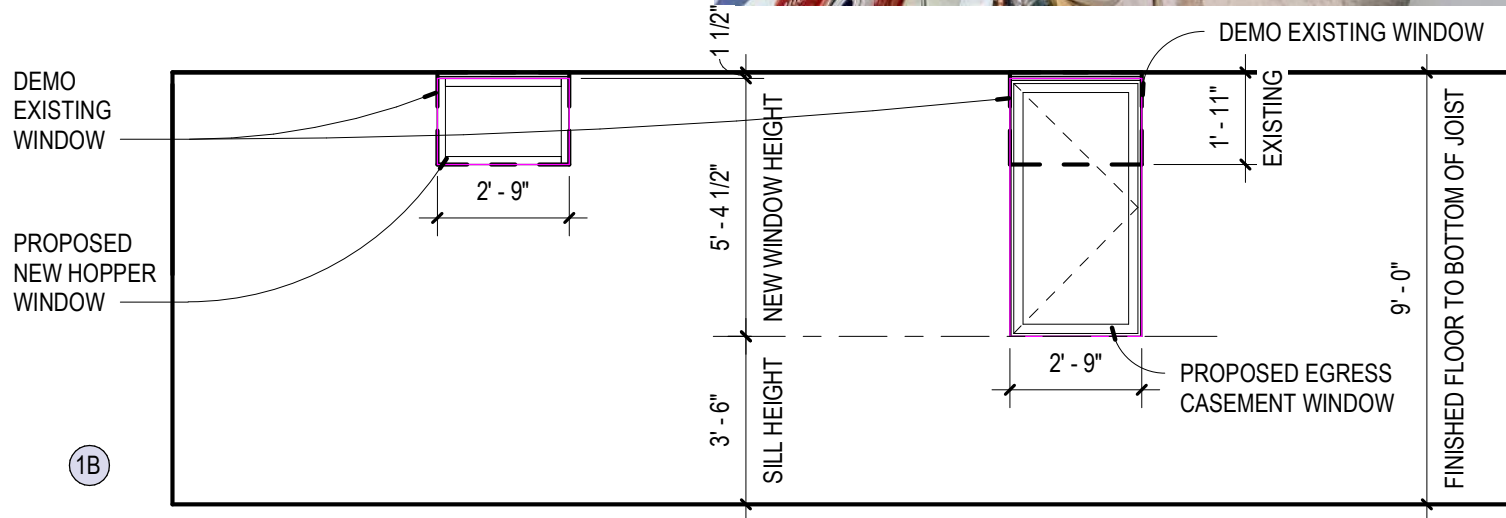
PROPOSED LOWER LEVEL S.  
ELEVATION

1/4" = 1'-0"

We propose to convert existing southwest window to an egress window by extending the opening downward and retaining the existing opening width. The existing operable unit will be replaced by an operable aluminum-clad wood casement window. This location is best-conforming to egress code, and its position on the south elevation will increase natural lighting in the basement.

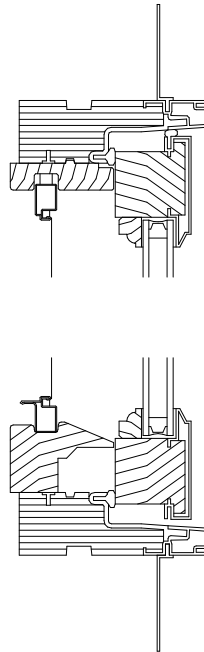
WINDOW HEAD AND SILL PROFILE

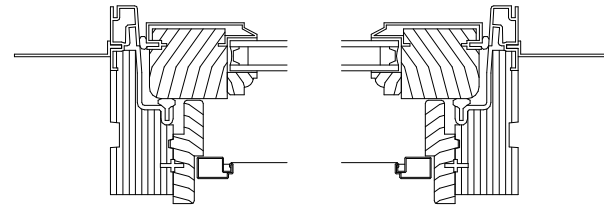
WINDOW JAMB PROFILE

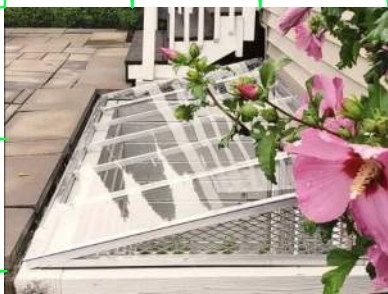
ALUMINUM WELL COVER WITH OPERABLE HATCH OPTION 1

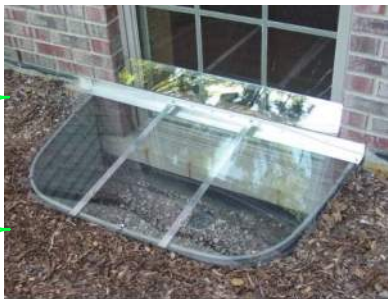
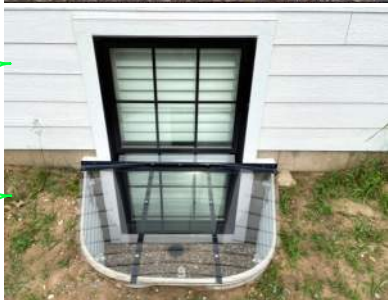
OPTION 2

Well Cover Spec:  
 -Made from Polycarbonate  
 -Safely supports 400 pounds.  
 -Rust-free aluminum framing  
 -Rust-free construction: aluminum – bracing, with stainless steel hardware

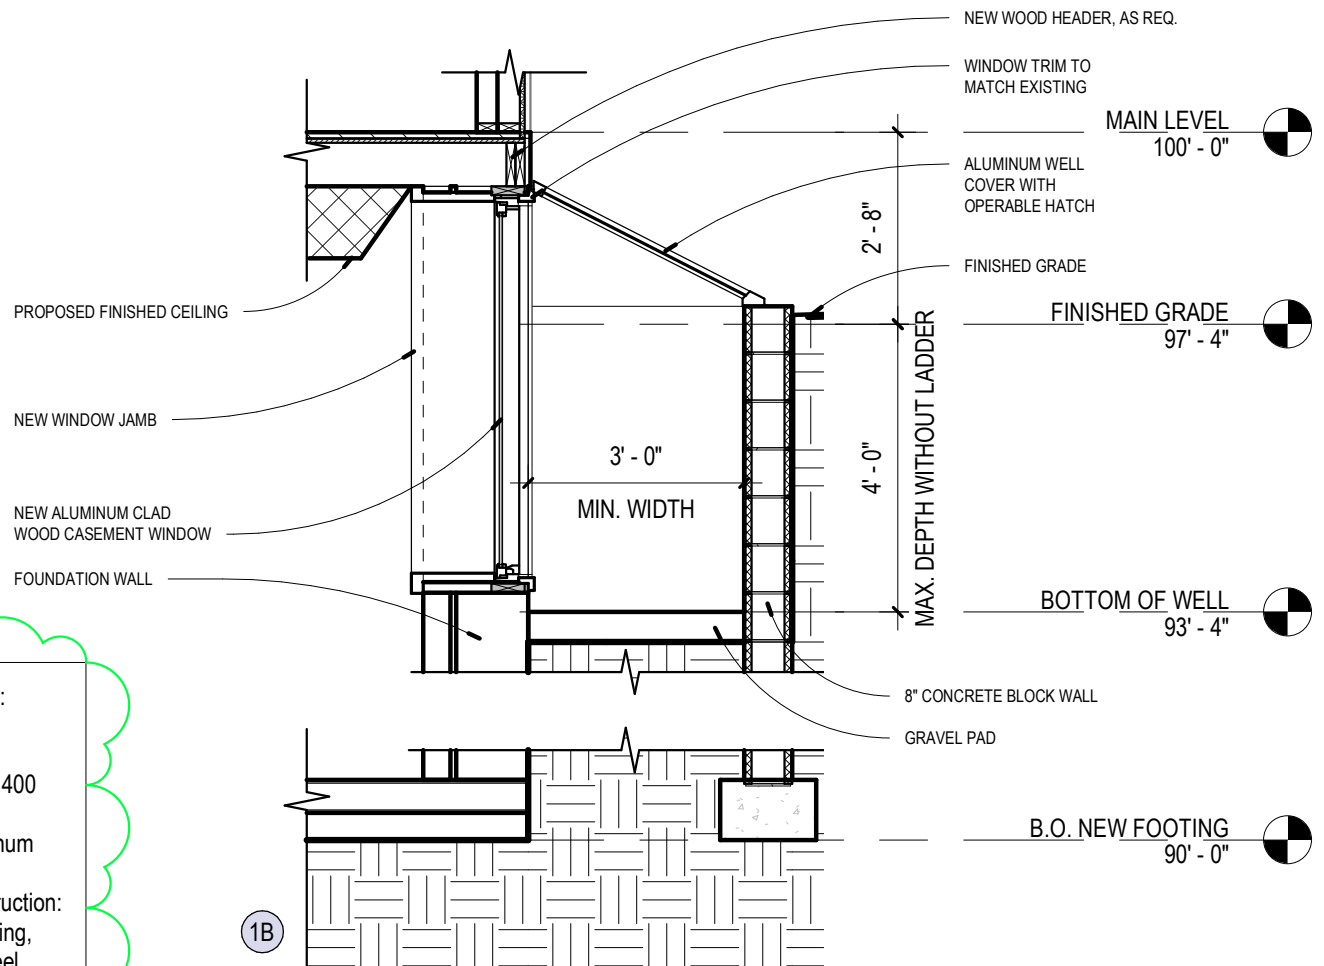
SECTION DETAIL @ NEW WELL  
 3/8" = 1'-0"

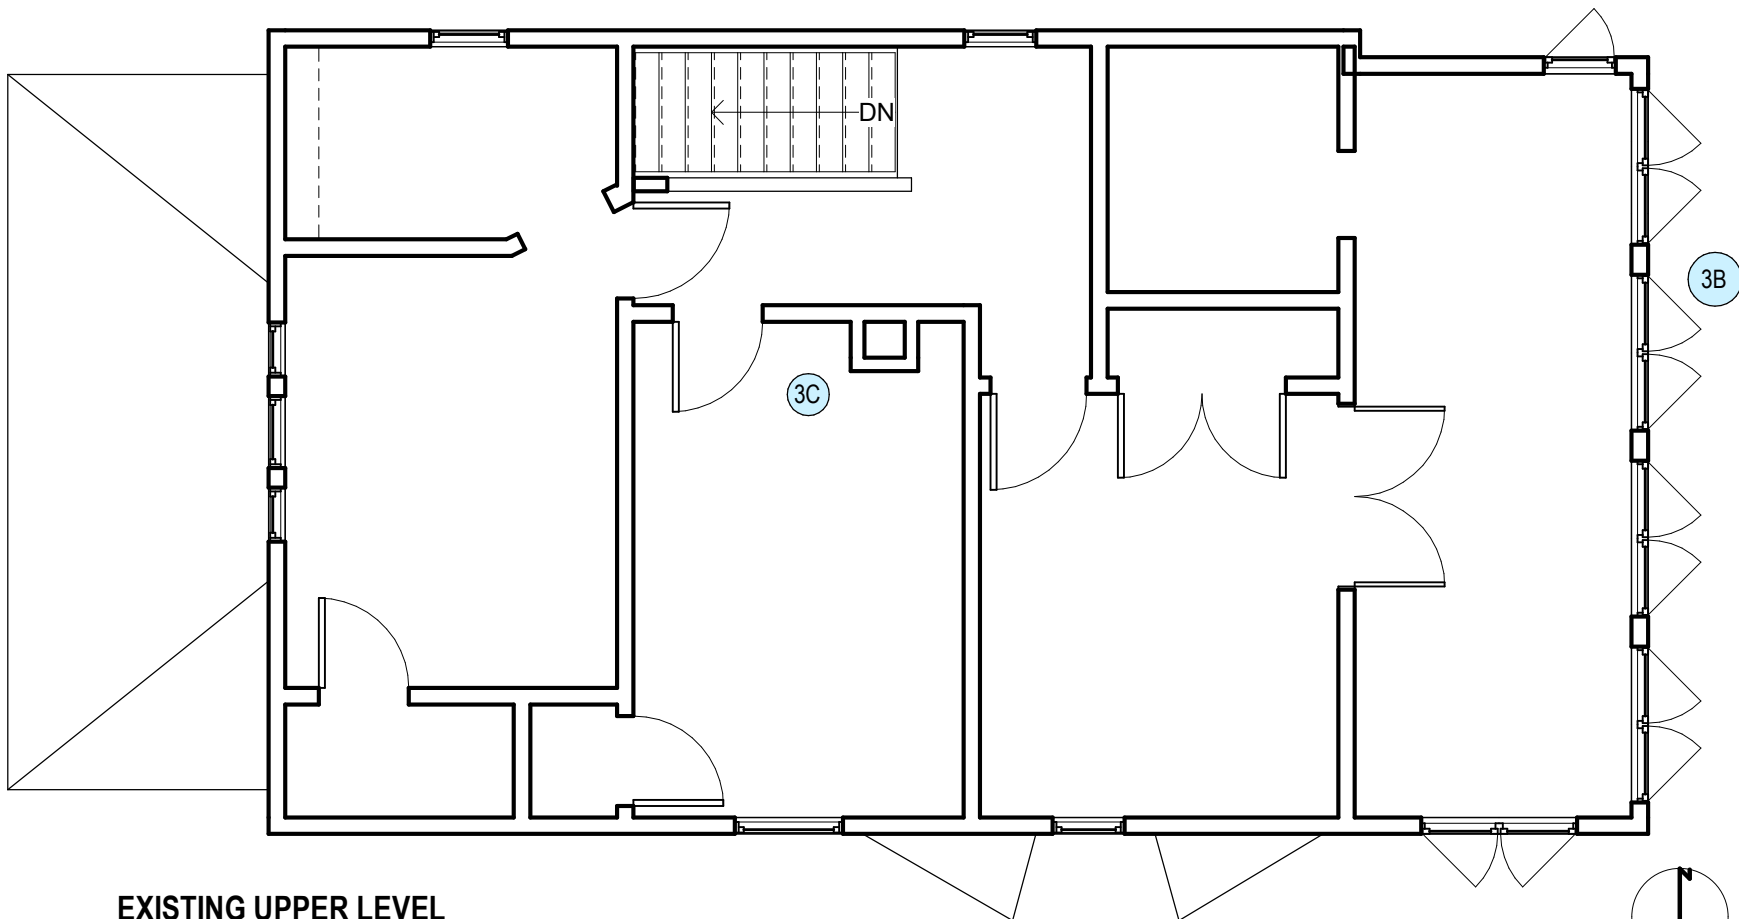
**EXISTING UPPER LEVEL  
PLAN-HDC**  
3/16" = 1'-0"

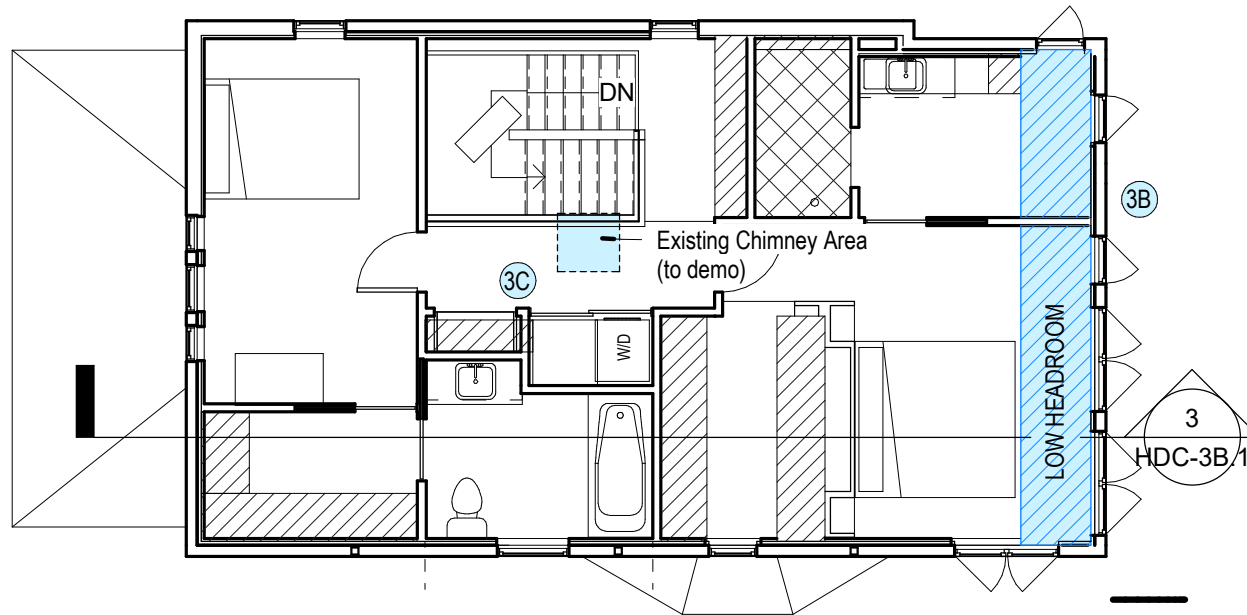
# HDC-3B.0

**PROPOSED PLAN WITH EXISTING  
HIP ROOF**

1/8" = 1'-0"

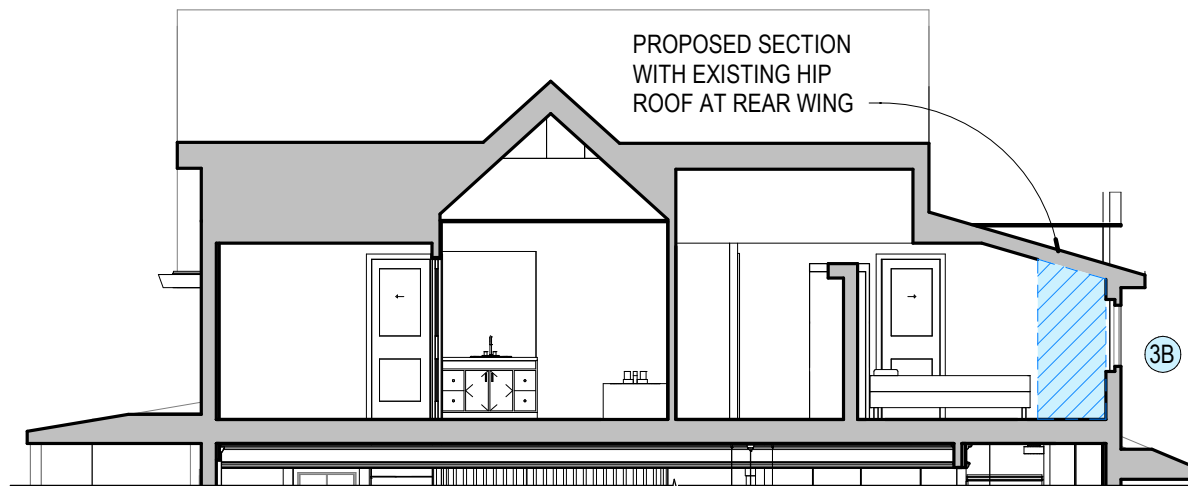
PROPOSED SECTION  
WITH EXISTING HIP  
ROOF AT REAR WING

The existing sleeping porch at the rear (east) wing of the upper level features a hip roof with considerable low-headroom area at the upper level. Based on Sanborn map data, this upper level wing is not yet built prior to 1948 and the existing hip roof is non-contributing to historic quality of the house. Above this roof is an attic window, and spanning across the sleeping porch is a ribbon of non-historic windows.

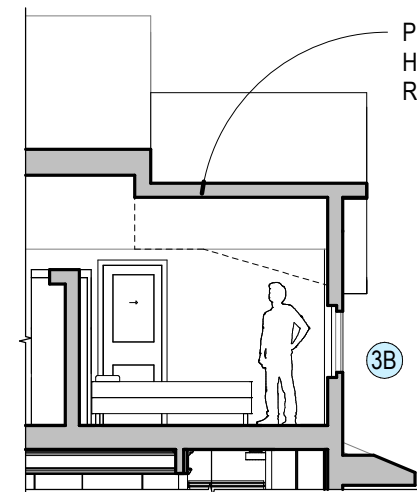
PROPOSED HEAD  
HEIGHT WITH TRUSS  
ROOF AT REAR WING

We propose to replace existing hip roof structure with new gabled truss framing, mitigating low-headroom space on the upper level. This gable is to sit below the primary roof, with shallower pitch to maximize historic primary roof trim detail. The new roof line requires the demolition of existing attic window. New aluminum clad wood windows at the upper level will replace non-historic and energy inefficient sleeping porch windows. Wood trim, siding, and roof material are to match existing. New windows are to receive new boral trim, painted to match existing trim.

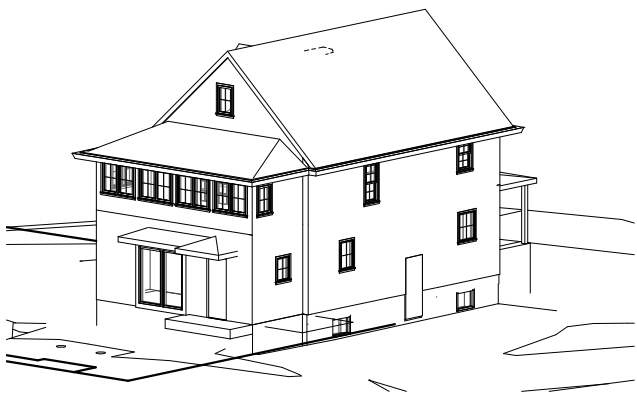
① NE - AXO EXISTING

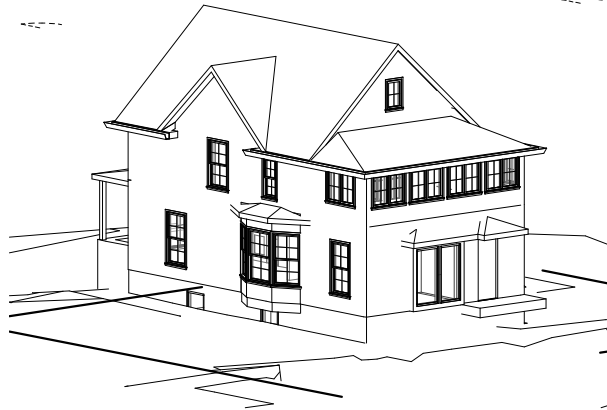
③ SE - AXO EXISTING

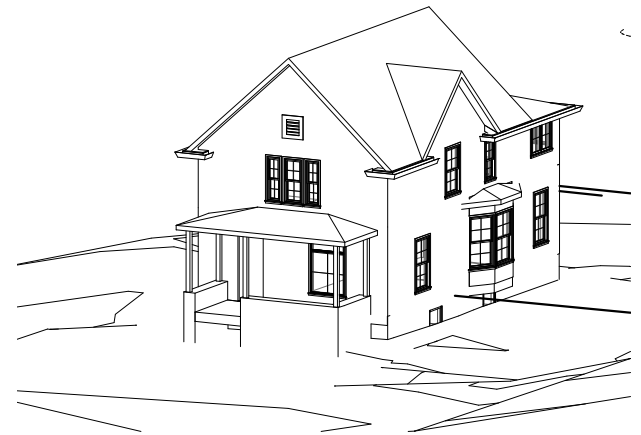
⑤ SW - AXO EXISTING

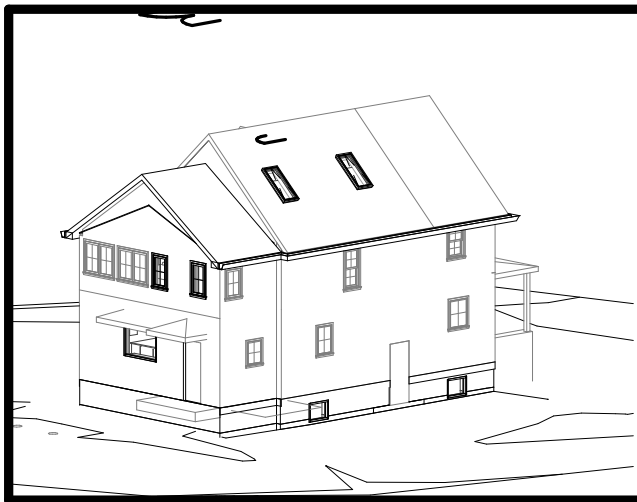
② NE - AXO PROPOSED

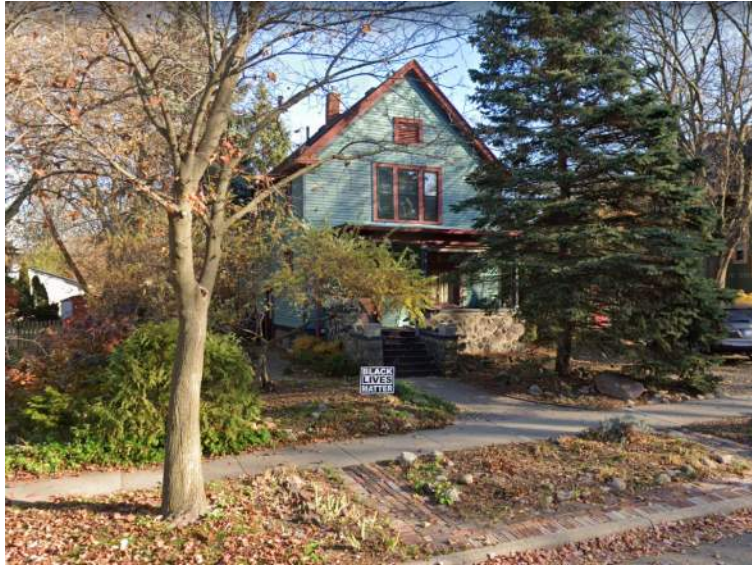
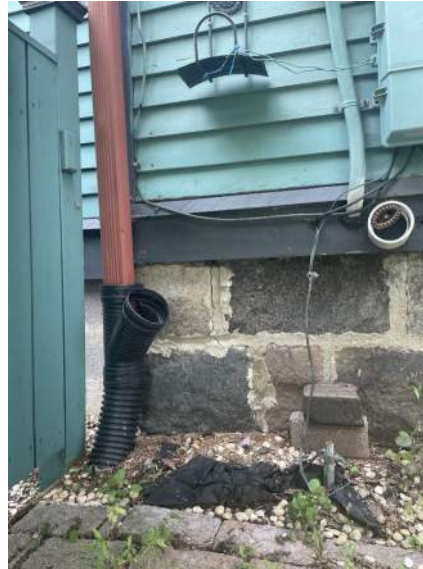
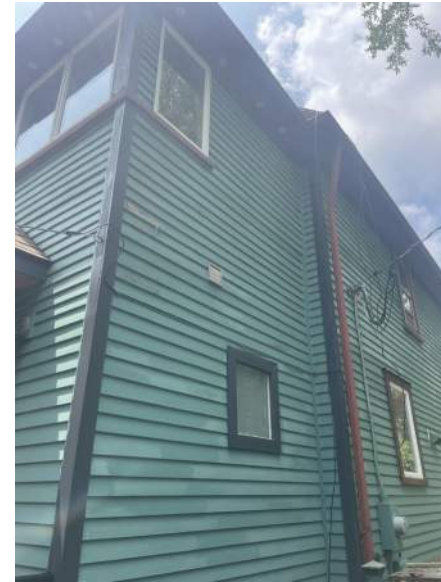
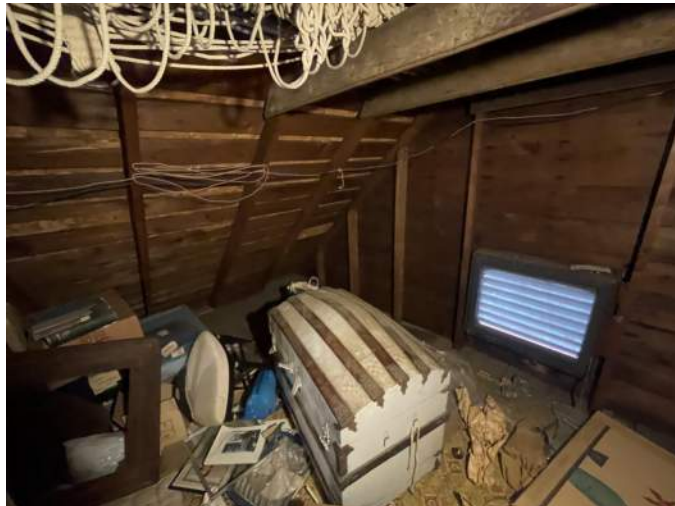
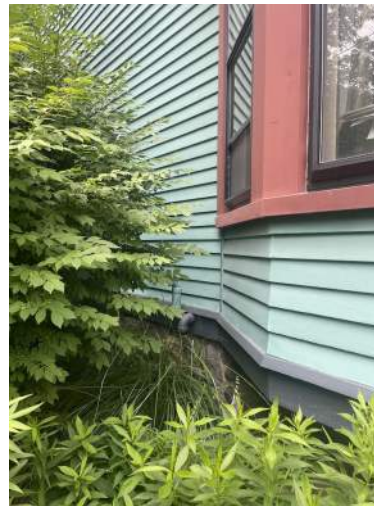
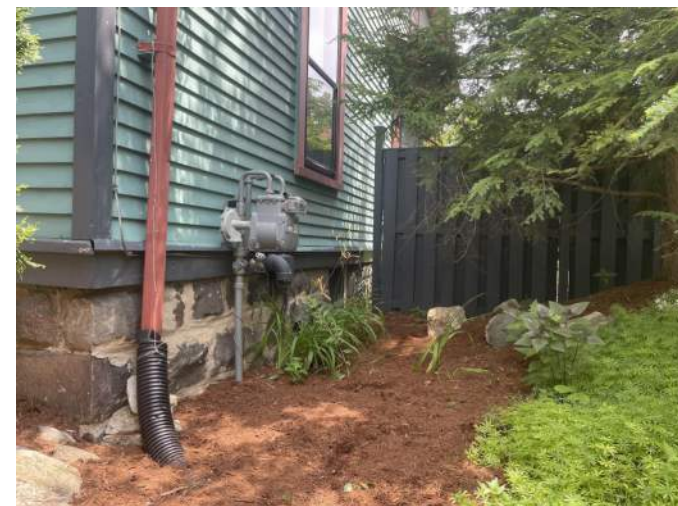
**HDC-3C.1**

The front elevation of the house features an attic vent. It is our assumption that this vent is not historical, and was installed as part of a venting system that includes the non-historic box vents on the roof. In opening up the attic space, this vent will become non-functional, and it will be necessary to seal the vent opening to condition the upper level sleeping space.

**EXTERIOR CLADDING AND  
VENTING**

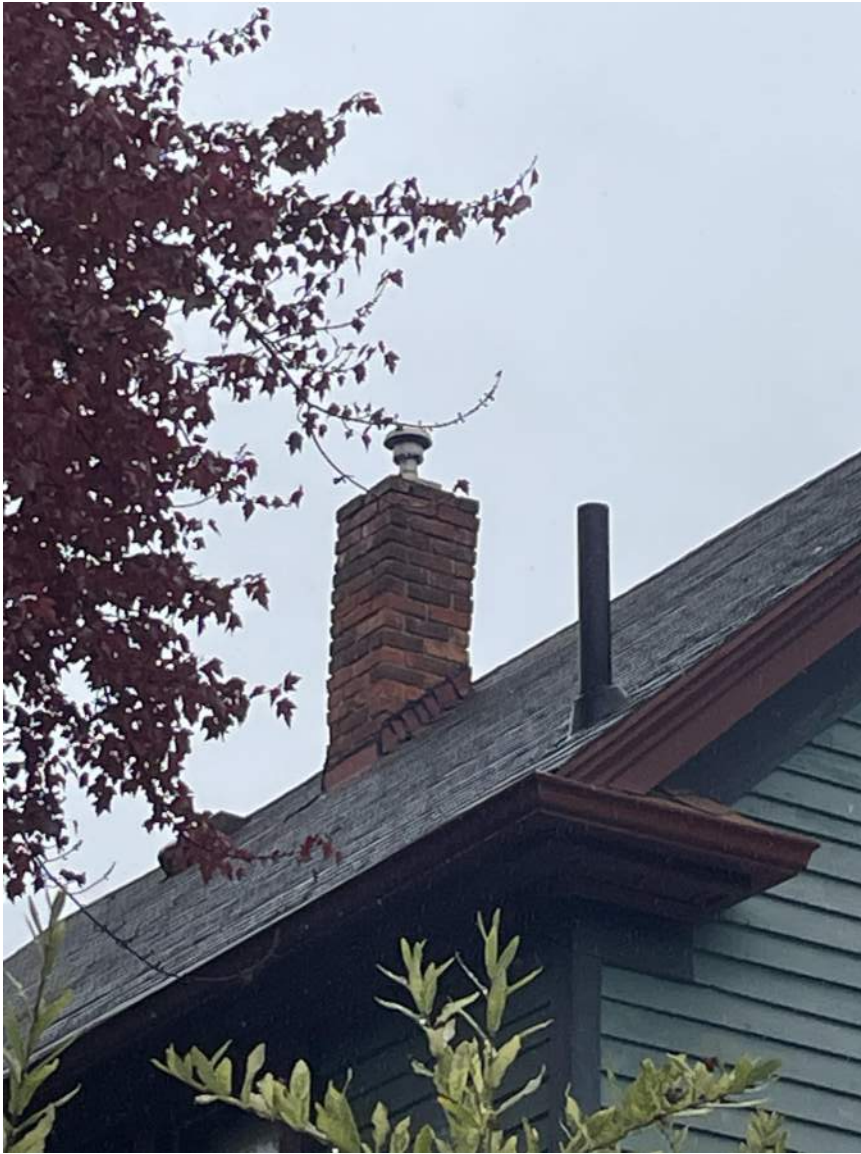
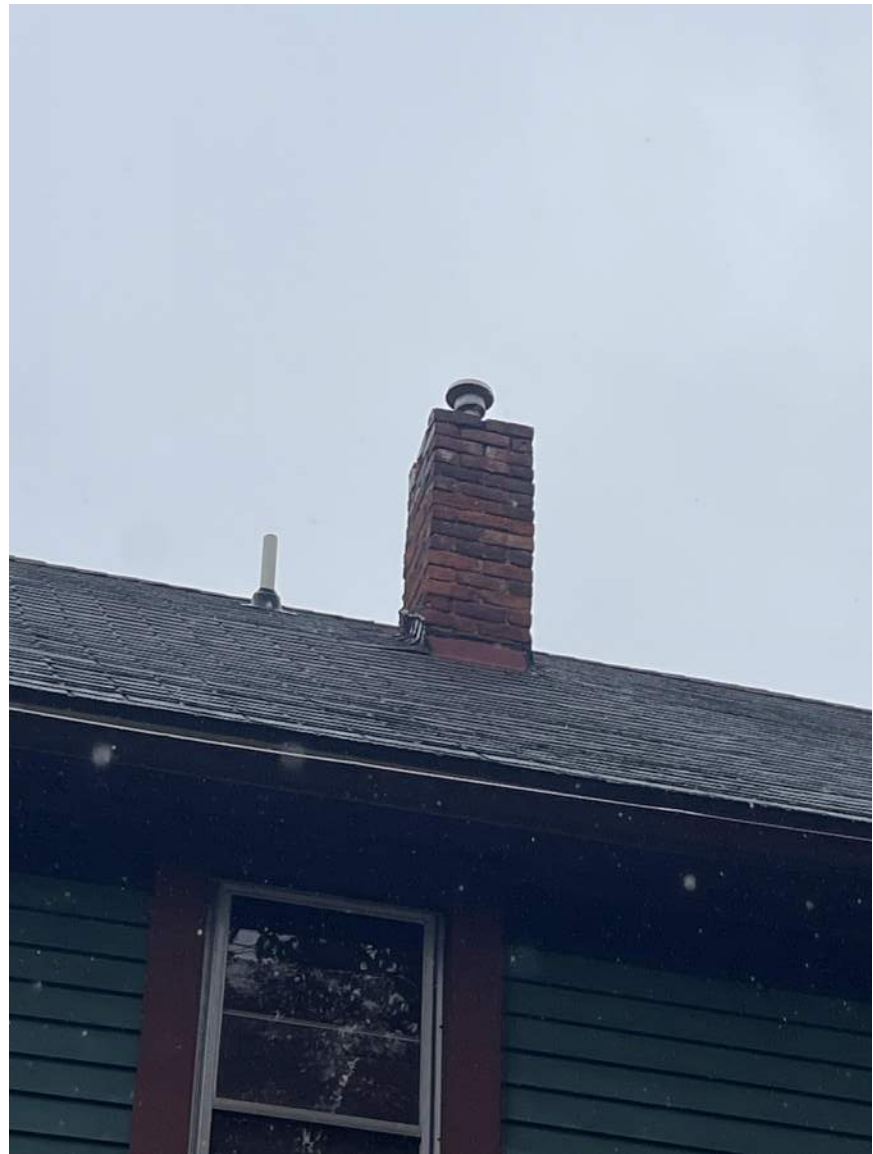
**HDC-3C.2**

We propose to remove the existing chimney to improve the energy performance of the house, mitigate risk of damage and infestation due to pests, and increase the usable area and volume of the interior spaces.

## EXTERIOR CLADDING AND VENTING - CHIMNEY

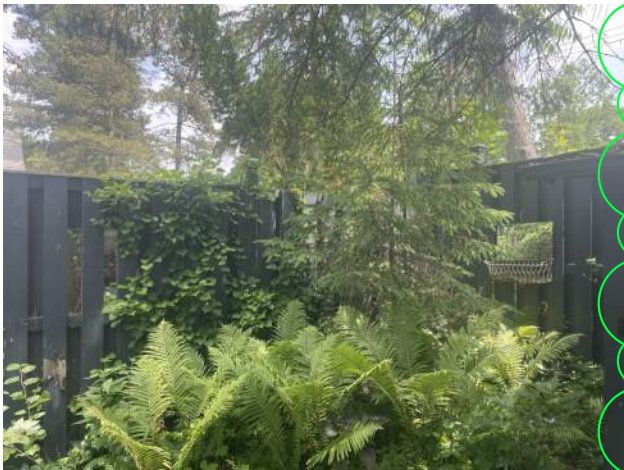
We propose to replace existing fence, as illustrated, to conform to property boundaries, to obscure new egress well from view, and to expand the usable yard space for owner.

New fence will be designed to coordinate / match existing: Painted alternating wood board at 6' height in the side yards, retaining 8' height in rear yard

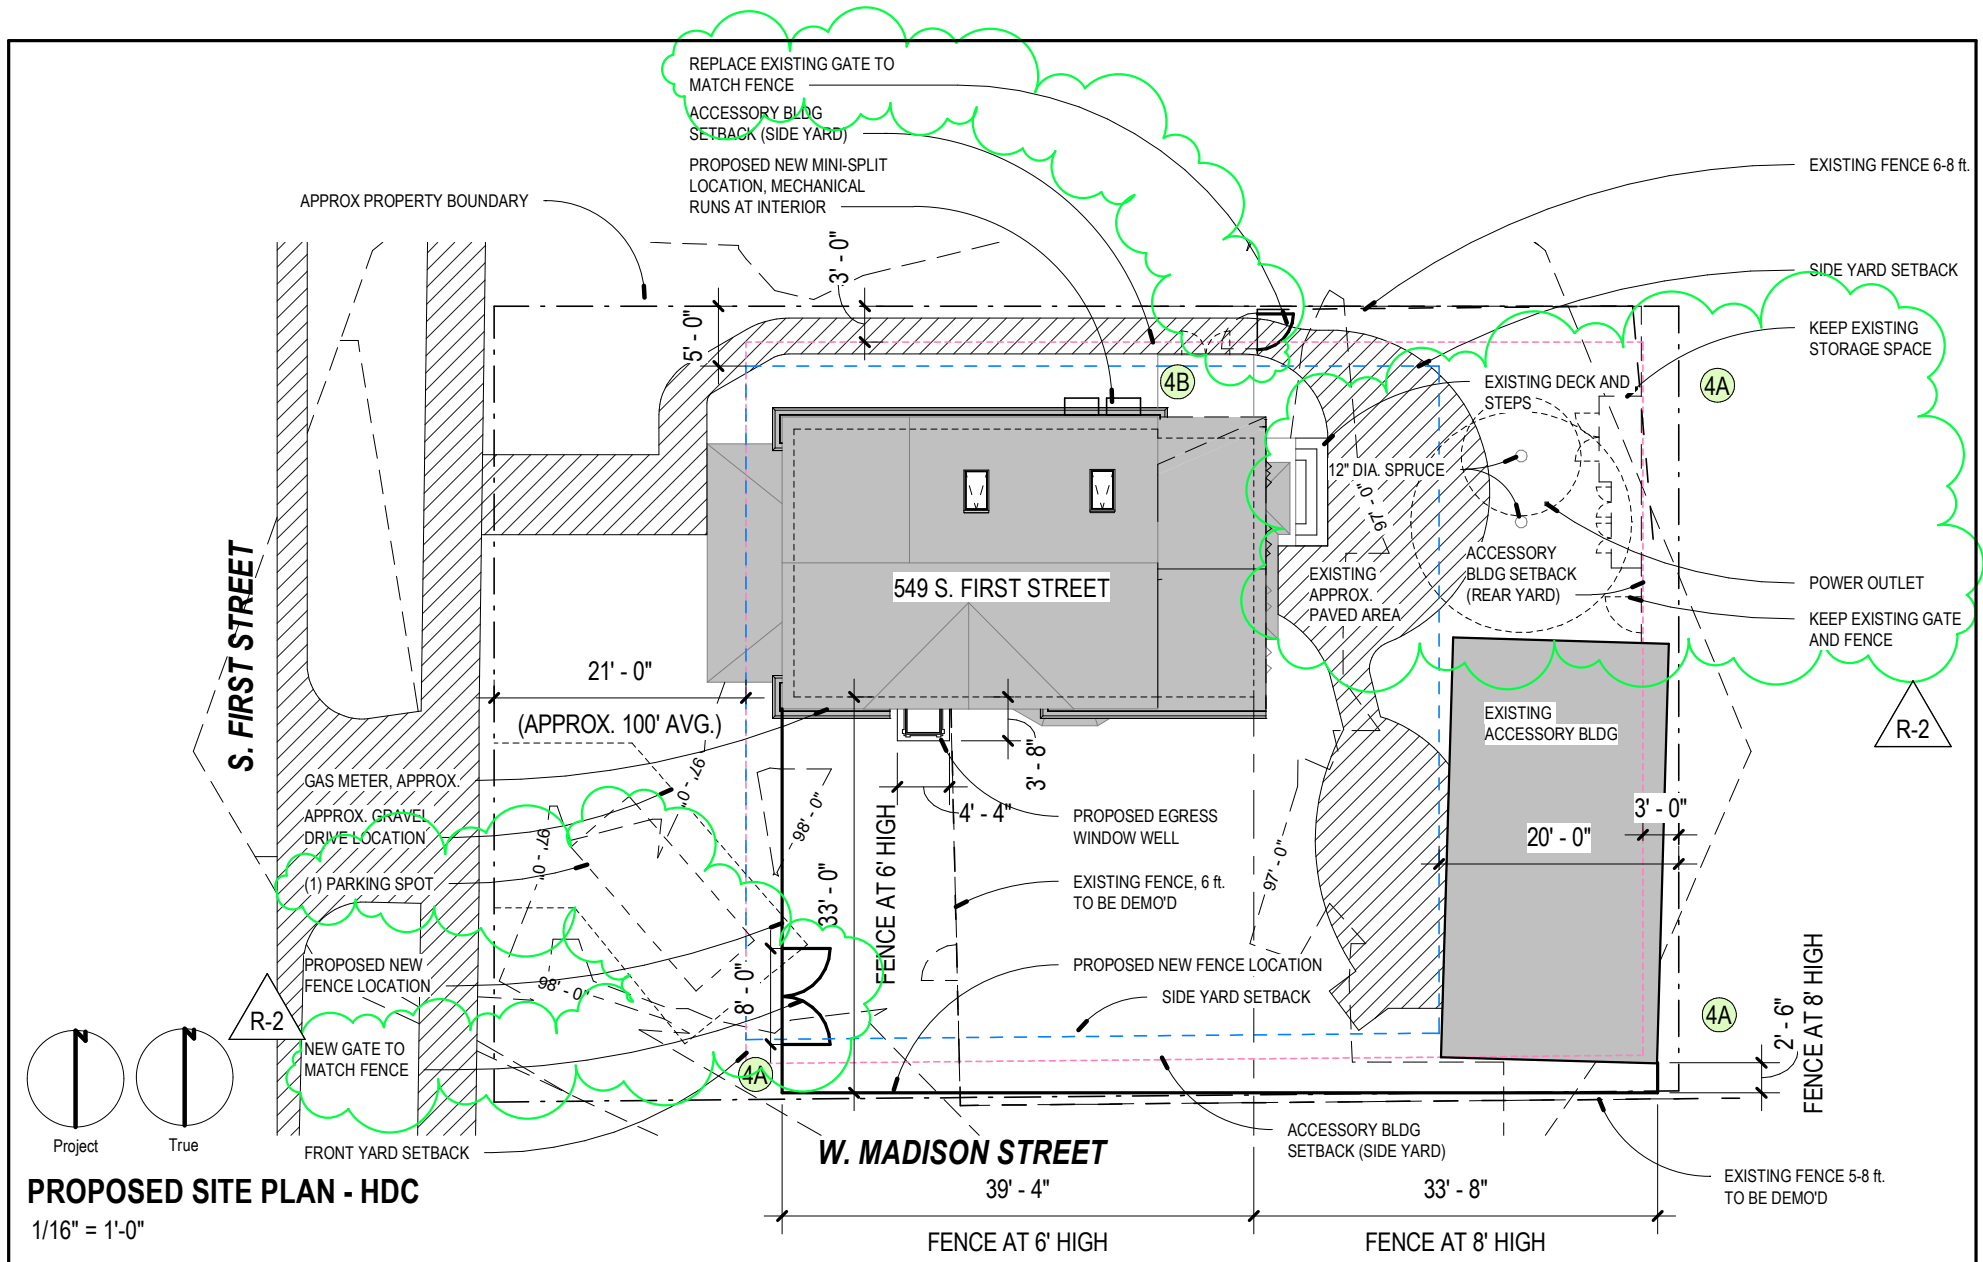
R-2

SITE PLAN
