ANN ARBOR HISTORIC DISTRICT COMMISSION

Staff Report

ADDRESS: 504 High Street, Application Number HDC 14-020

APPLICATION: The applicant seeks HDC approval to replace seven wood windows with wood windows.

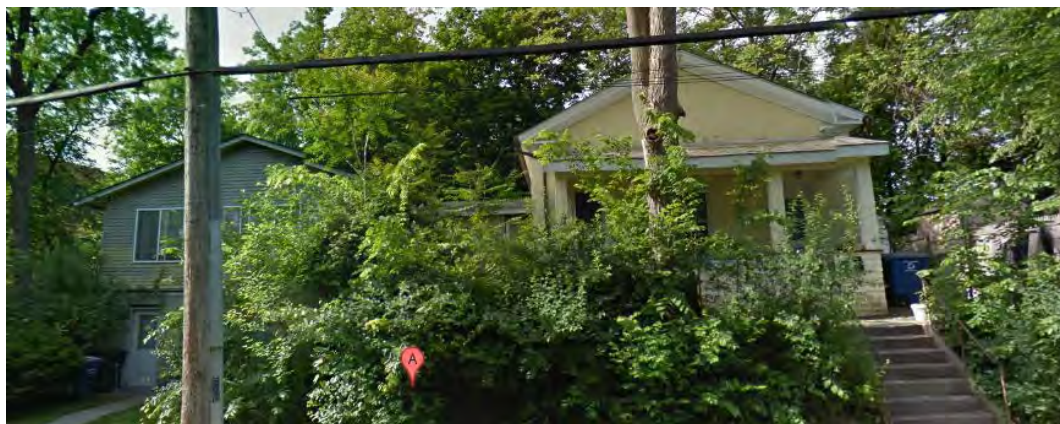
504 High (June 2011 Google maps photo)

BACKGROUND: This Classic Revival, one story rectangular painted brick residence is the 1854 Colored Baptist Church. It features a front gabled roof with returns, double-hung windows with shallow brick arches and stone sills, and a full front porch added after 1908 with a shingled base and short, square columns. Both the 1868 and 1872 City Directories list the Colored Baptist Church at this locations, and the 1854 and 1870 maps indicate Union Church here. The 1881 County History mentions a “flourishing African Baptist church with a house of worship in the 4th Ward”. By 1888, the first Sanborn map indicates that a new Colored Baptist Chhurch was being built on North Fifth Avenue at Beakes. The Centennial History of the congregation, the Second Baptist Church, says that a Rev. Lewis organized the first congregation in 1865 in a “frame dwelling”. The High Street building, however, is a solid brick structure. A large wing on the Elizabeth Street side was added when the house became a day care center in the 1970s. (From the Old Fourth Ward study committee report)
