## ANN ARBOR HISTORIC DISTRICT COMMISSION

### Staff Report

**ADDRESS:** 1317 Broadway Street, Application Number HDC22-1195

**APPLICATION:** The applicant seeks HDC approval to install vinyl siding over existing asphalt siding.

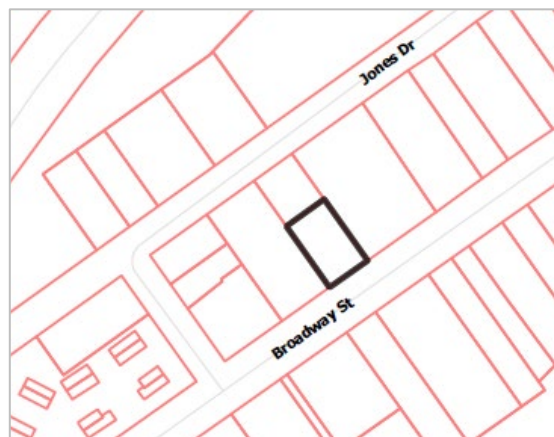
1. Staff was driving up Broadway for the September 6, 2022 Review Committee when they noticed a house having vinyl siding installed over asphalt faux-brick siding. Staff requested that the contractor stop working. The property owner contacted staff promptly the next morning, stating that the faux-brick siding is in poor condition, and submitted this HDC application shortly after. Any openings in asphalt siding will cause deterioration to materials beneath it, so staff applauds the property owner for wanting to address the problems with the current siding.

2. The vinyl siding is proposed to be installed over the faux-brick siding. The application says no fascia, eaves, or window trim on the house would be covered over with vinyl. The half-gable above the side door that has wood decorative shingles would be covered with white vinyl scallops, and the front gable would also have white vinyl scallops installed. The extent is not indicated, and it is unknown whether the front gable has historic decorative shingles under the asphalt siding.

4. If the property owner had contacted staff ahead of contracting for this work, staff would have advised that vinyl is typically inappropriate and the most appropriate approach would be to remove the artificial siding and repair the underlying siding, selectively replacing it with matching materials in matching dimensions as necessary. Exploratory work looking under the asphalt siding would be a good starting place to figure out what this might entail. If there is no siding under the asphalt (unlikely), or if the siding is deteriorated beyond repair, staff could approve an appropriate replacement (wood or cementitious lap, for example). The other option would be to repair the faux-brick siding, which might not be possible since those materials are probably from the 1940s-1960s and are no longer manufactured in the same style. In any case, approval by staff or the HDC is required before work is begun.

5. As is typical of vinyl installed over other siding, the vinyl is installed with J-channels along all edges. This is the third layer of siding (historic, cellulose, vinyl) and staff has concerns about the thickness next to trim. Any cladding should not stand proud of the trim or it will make it look slightly recessed and not in keeping with historic appearances.
6. Staff believes that the proposed work is not appropriate and does not meet the *Secretary of the Interior's Standards*, the *Secretary of the Interior's Guidelines for Rehabilitation*, and the *Ann Arbor Historic District Design Guidelines*.

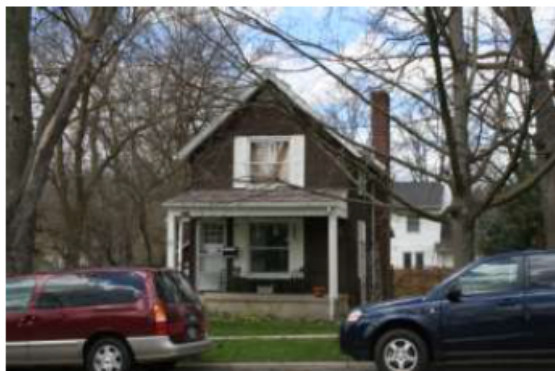
2007 photo

*Style:* Vernacular  
*# Stories:* 1.5  
*Material:* Asphalt brick  
*Windows:* Replacement?  
*Window Type:* Wood, Double-Hung  
*Pane Type:* 1/1

*Roof Shape:* Front Gable  
*Roof Material:* Asphalt  
*Plan Shape:* Rectangular  
*Porch Type:* Full Front  
*# Dormers:* N/A  
*Dormer Type:* N/A

Wood frame house on cut stone block foundation; shall bay on south elevation has one large double-hung 1/1 window under small shed roof; front porch has shed roof with triangular eave supports with pointed shingles set into fascia; front porch has been extensively modified – porch supports are 4x4 over a concrete pad.
