118 W LIBERTY
ANN ARBOR

FACADE RENOVATION

SHEET # 1

11.18.2022

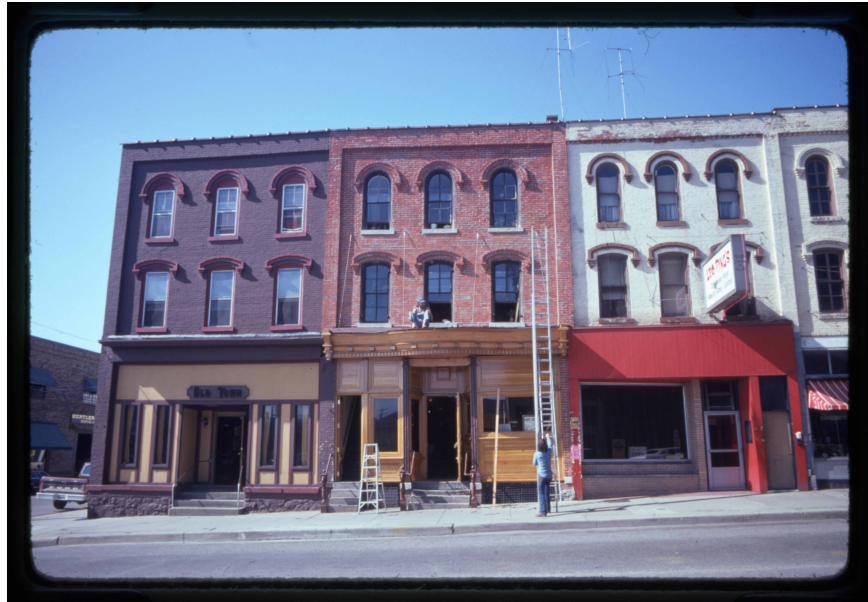
LEO PING'S - 1975

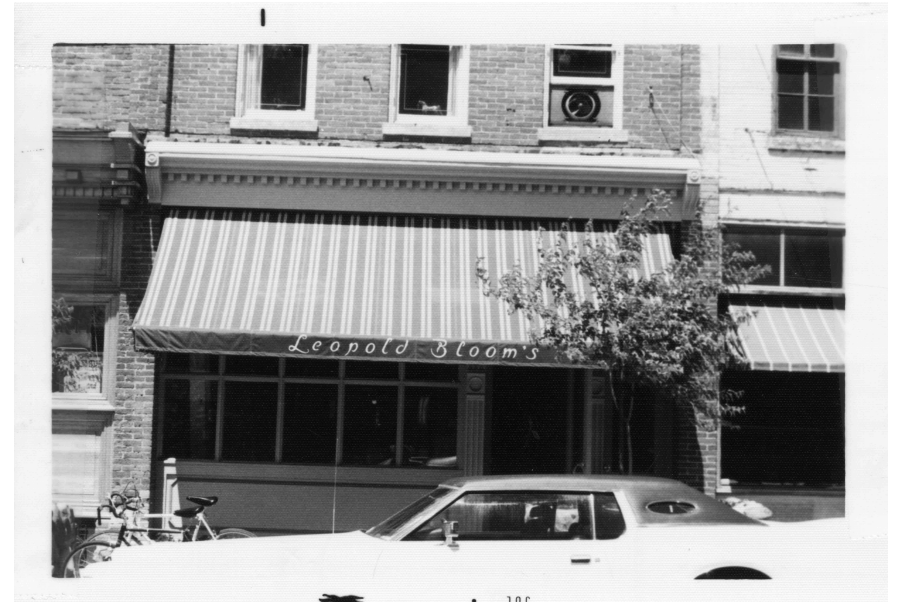
LEOPOLD BLOOM'S - 1980

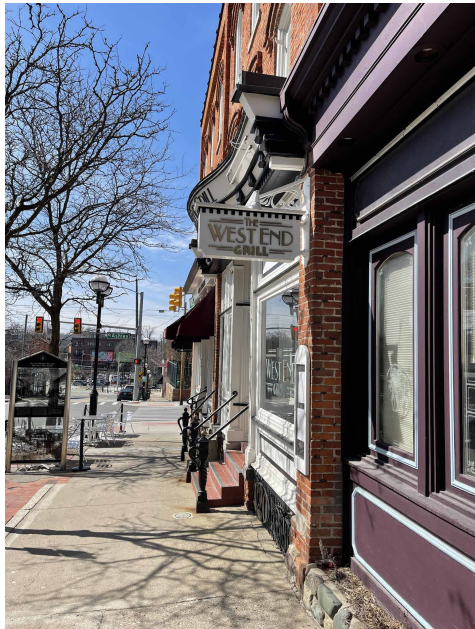
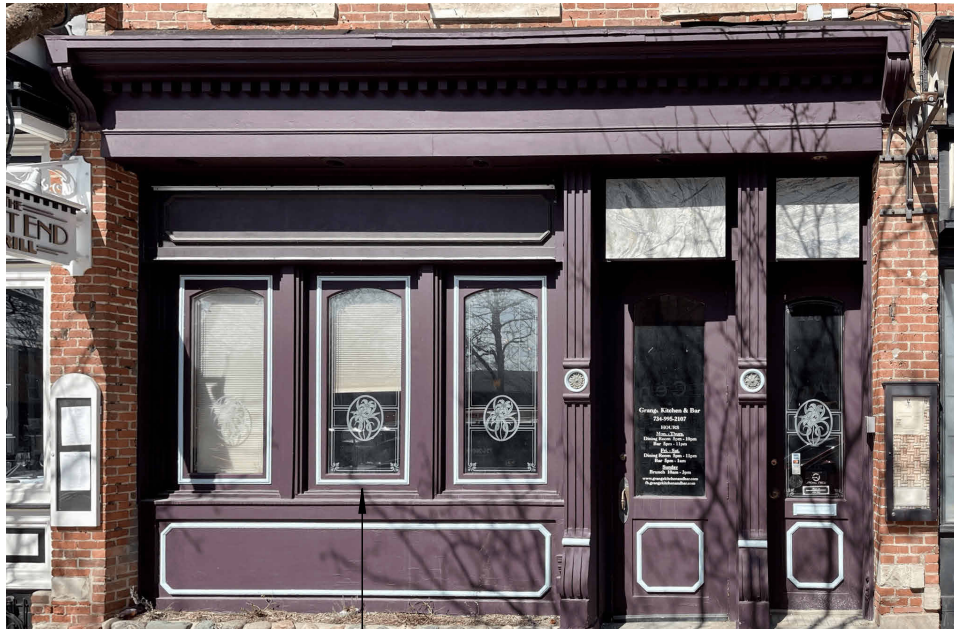
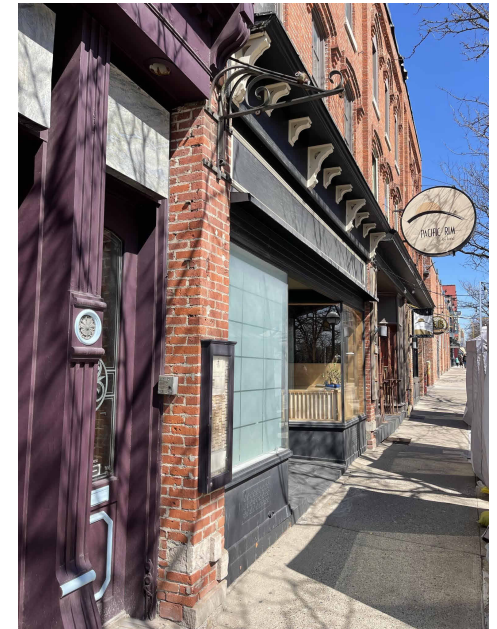
SHEET # 5

(3) EXISTING WINDOWS TO BE REPLACED

CURRENT FACADE PHOTOS

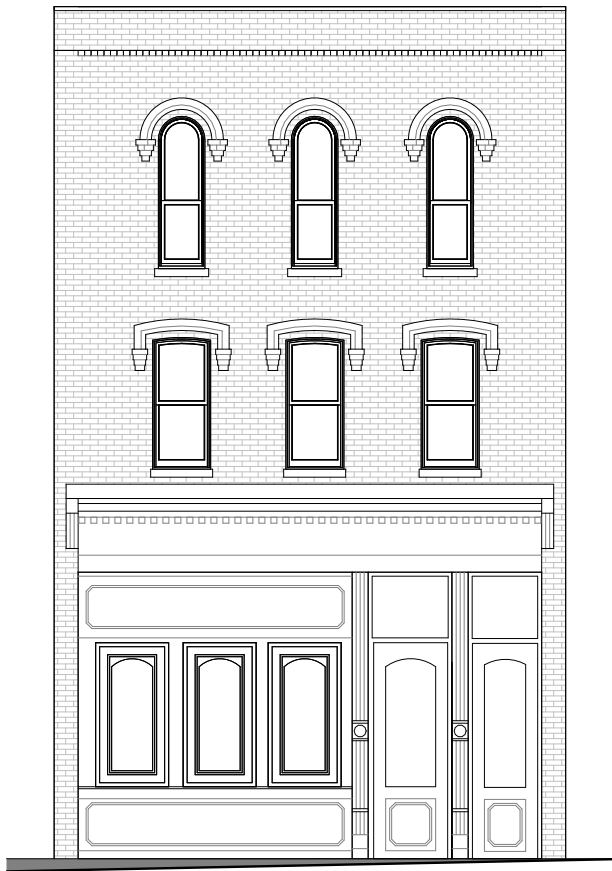
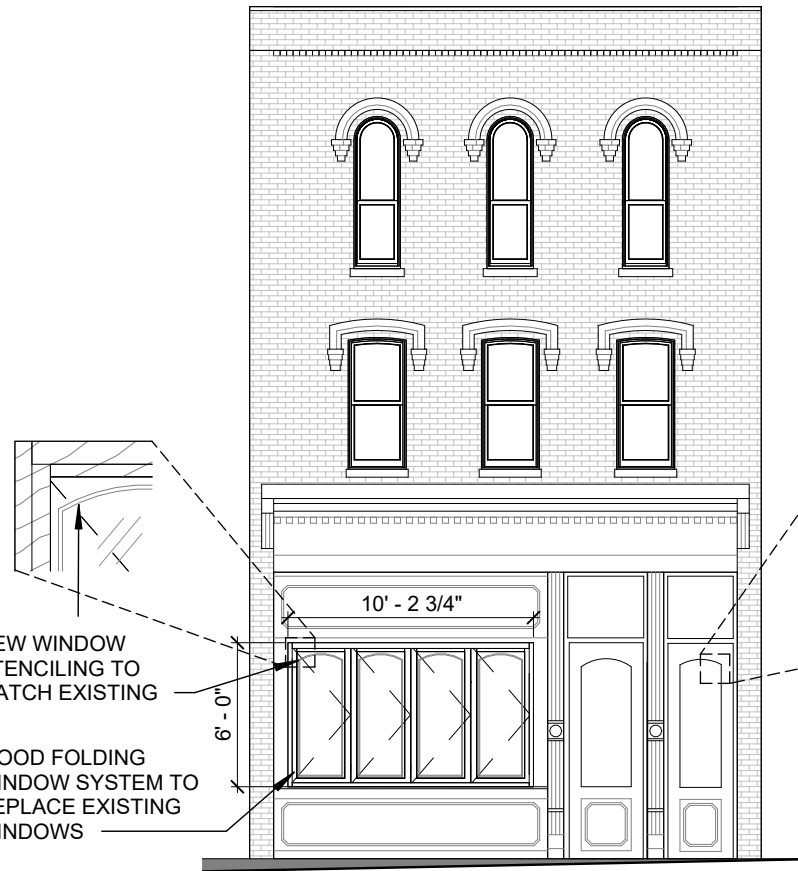
SHEET # 6

NEW WINDOW
STENCILING TO
MATCH EXISTING

WOOD FOLDING
WINDOW SYSTEM TO
REPLACE EXISTING
WINDOWS

STENCIL PATTERN
ON EXISTING DOORS
TO REMAIN,
REPLICATE ON NEW
FOLDING WINDOWS

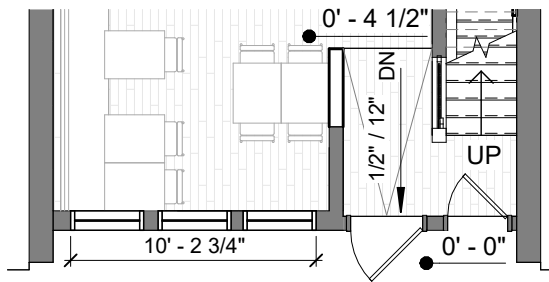
EXISTING ELEVATION AND PLAN

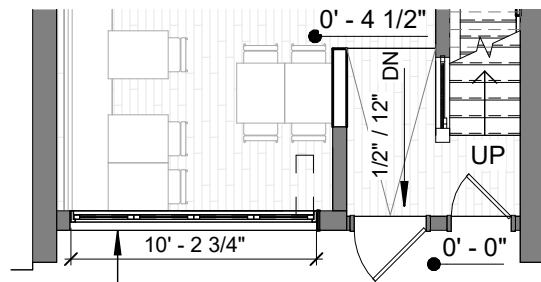
FOLDING WOOD
WINDOW SYSTEM TO
REPLACE EXISTING

PROPOSED ELEVATION AND PLAN

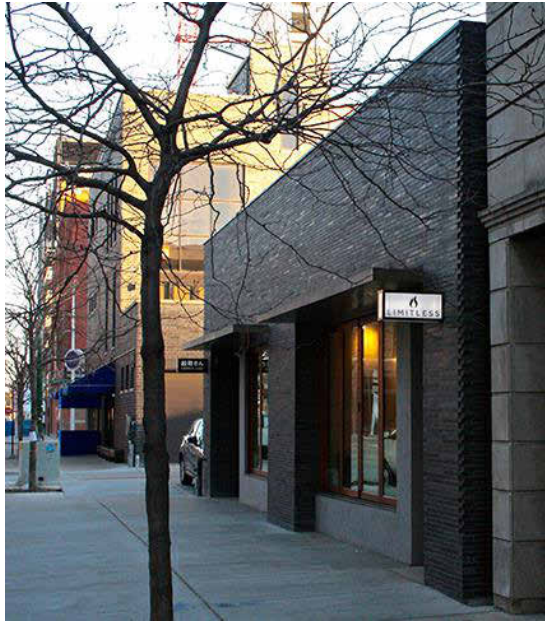
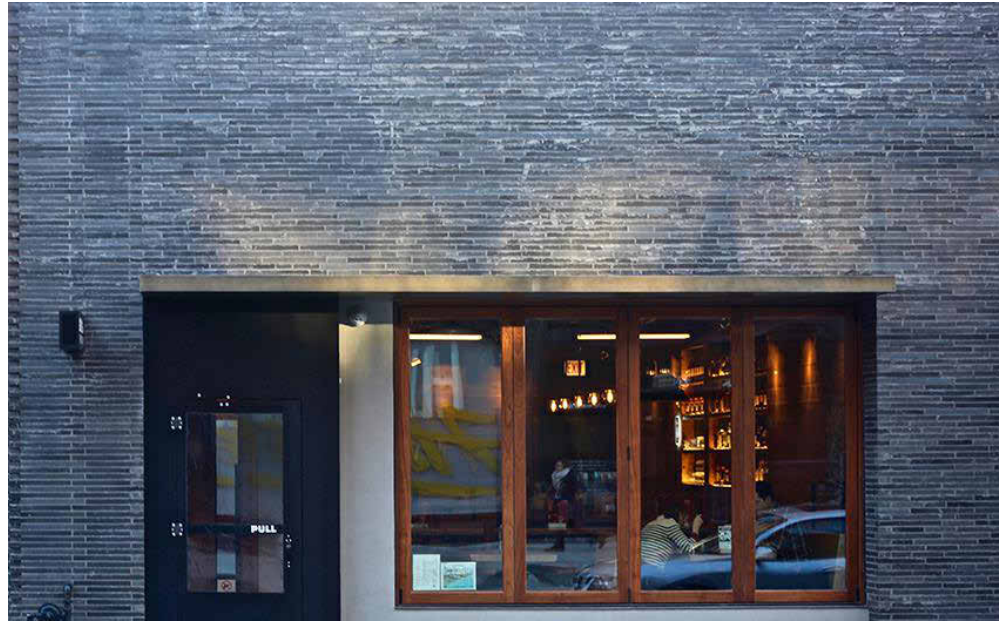
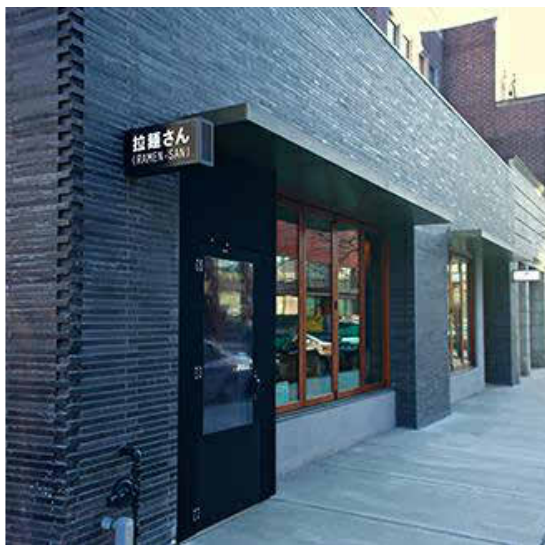
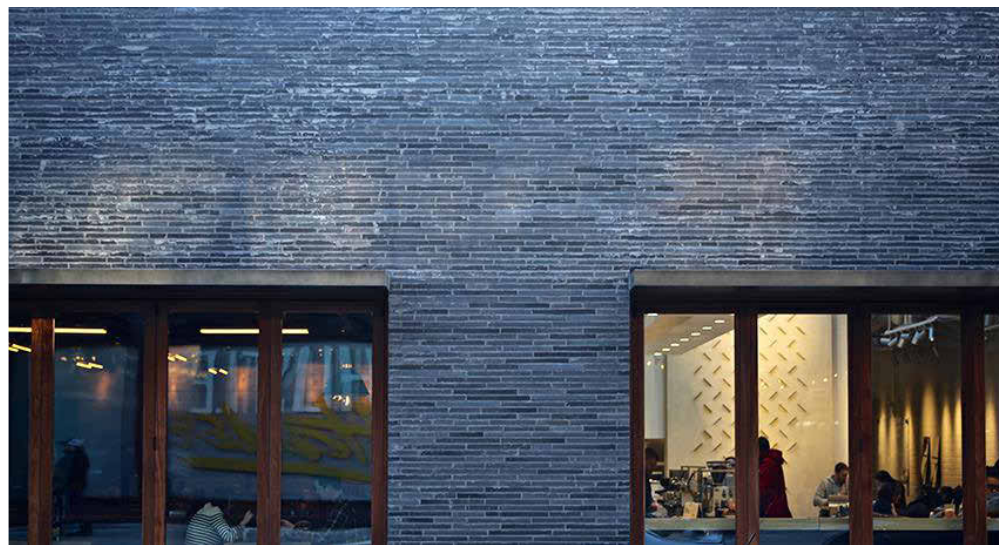
SHEET # 7

WOODEN FOLDING WINDOW SYSTEM - EXAMPLE
3/4" = 1'-0"

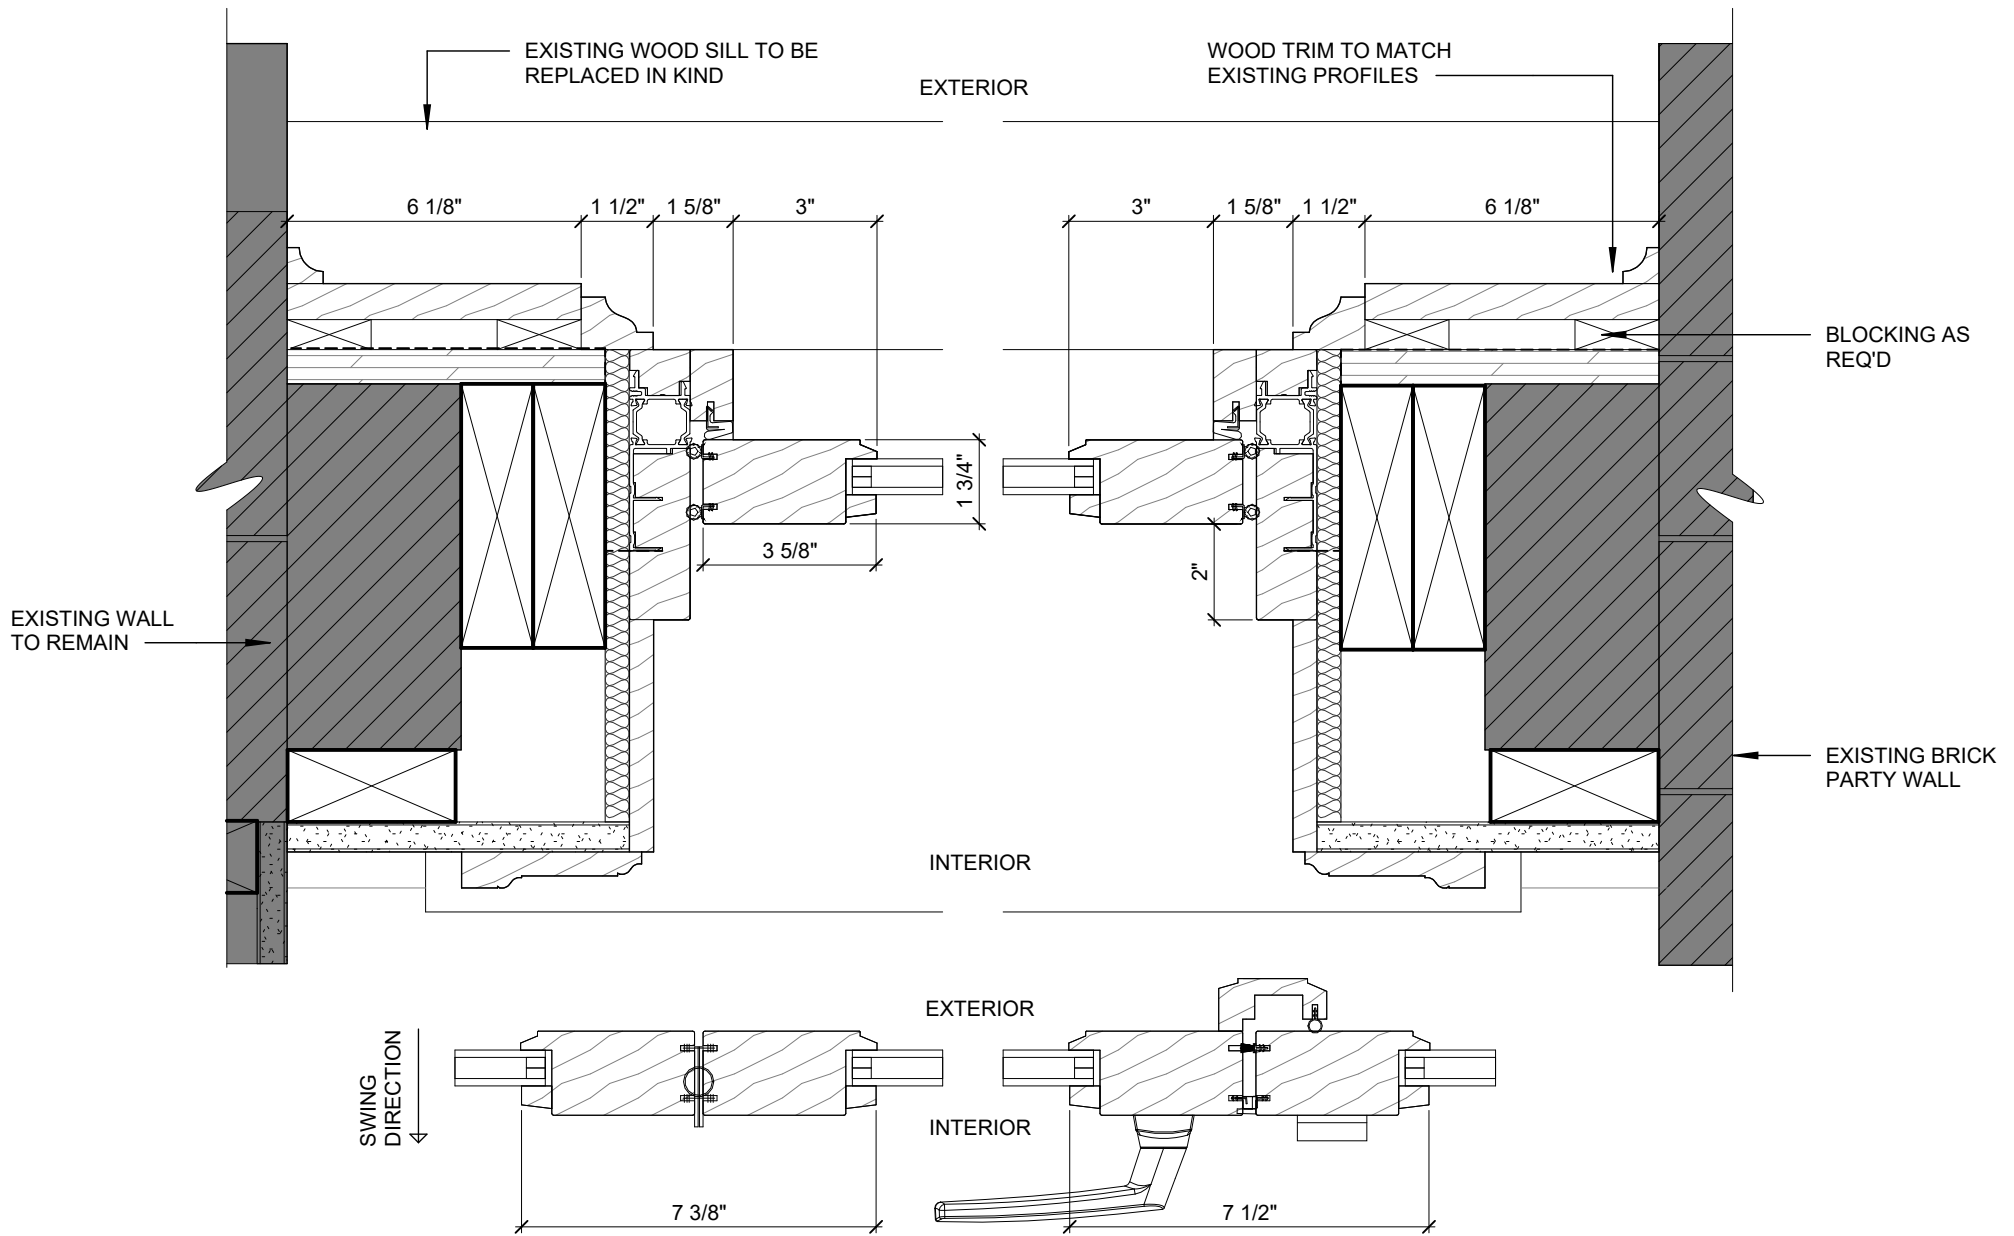
SHEET # 8

WOODEN FOLDING WINDOW SYSTEM DETAILS

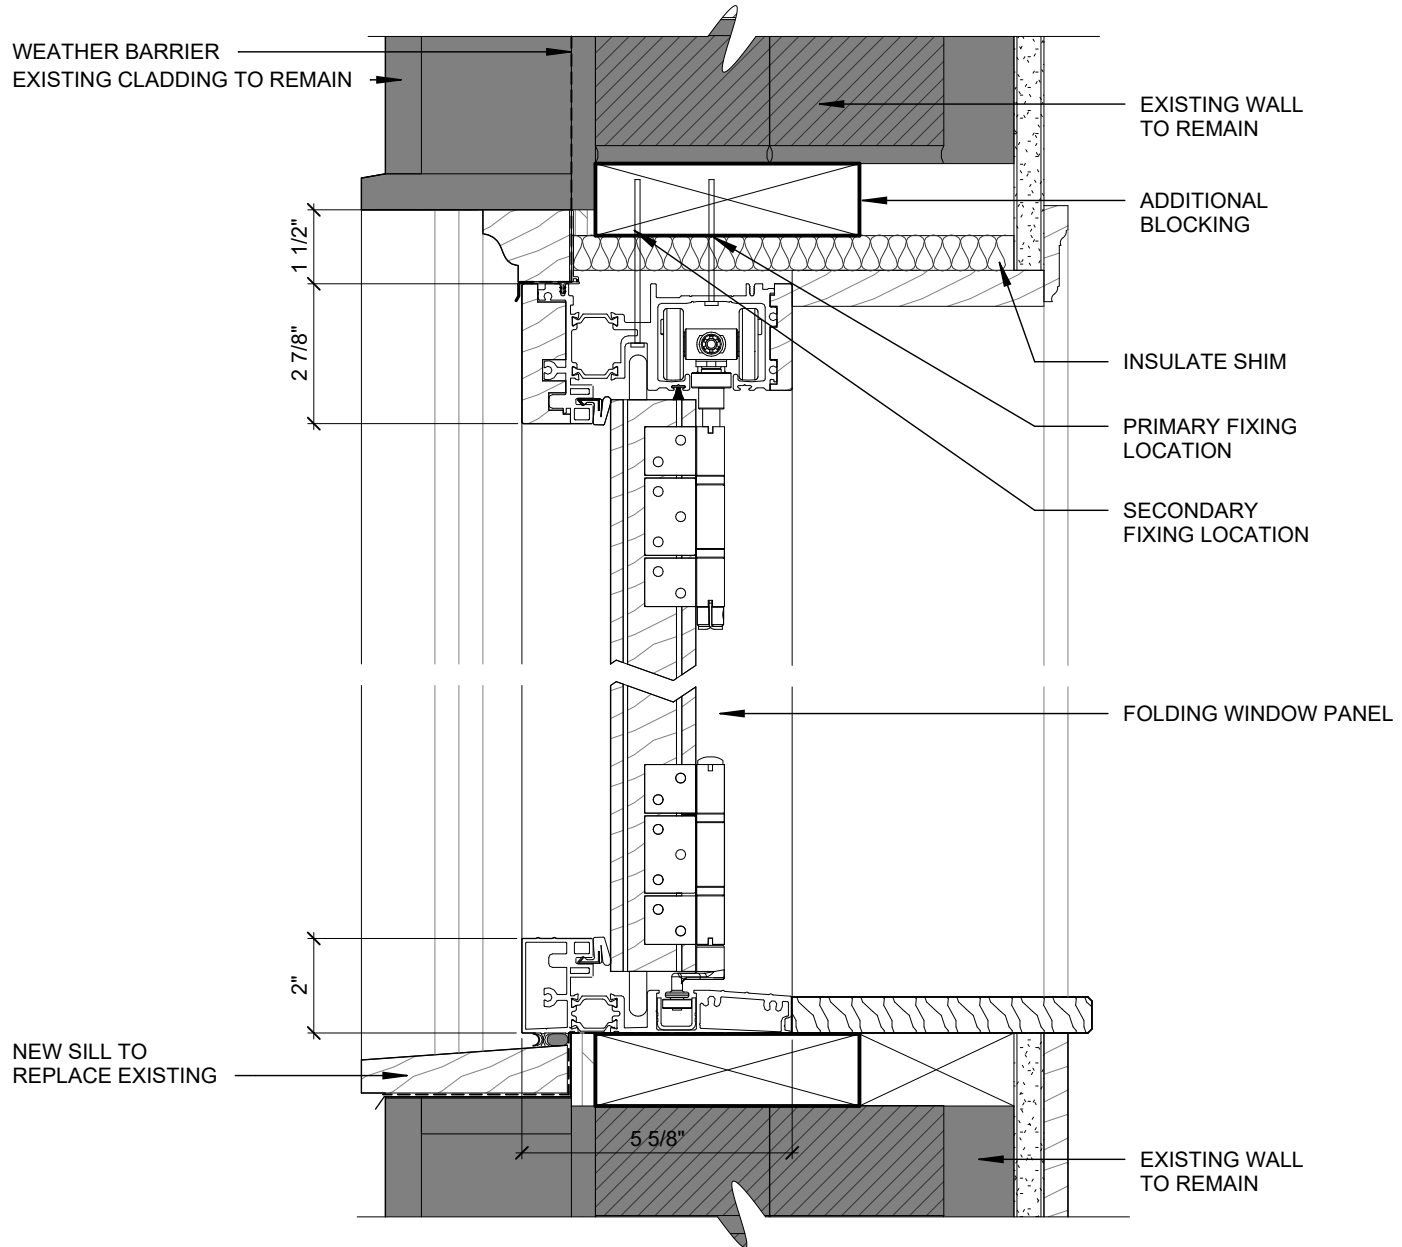
SHEET # 9

WOODEN FOLDING WINDOW SYSTEM DETAILS
3" = 1'-0"
