## CITY OF ANN ARBOR

# GALLUP PARK PATHWAY CULVERT FAILURE AS-BUILT

SHEET 1	-	CULVERT FAILURE LOCATION
SHEET 2	-	CULVERT CONSTRUCTION DETAIL
SHEET 3	-	SINKHOLE REPAIR DETAIL
SHEET 4	-	REPAIR IMAGES

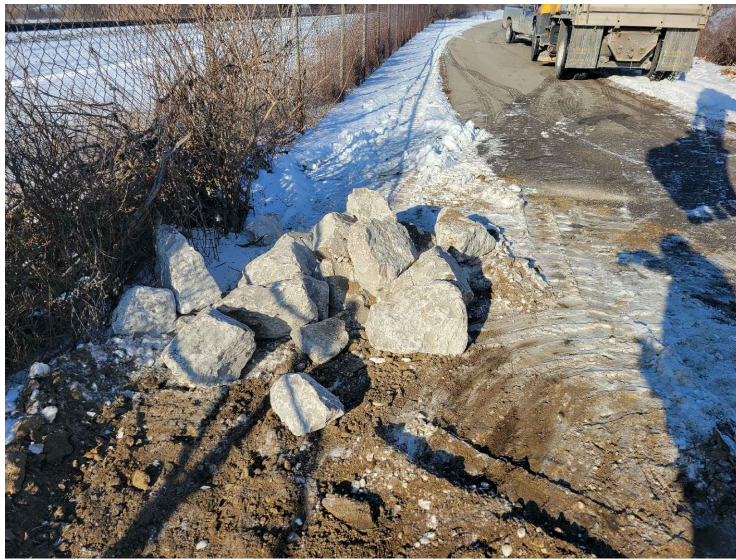
PLAIN RIP-RAP

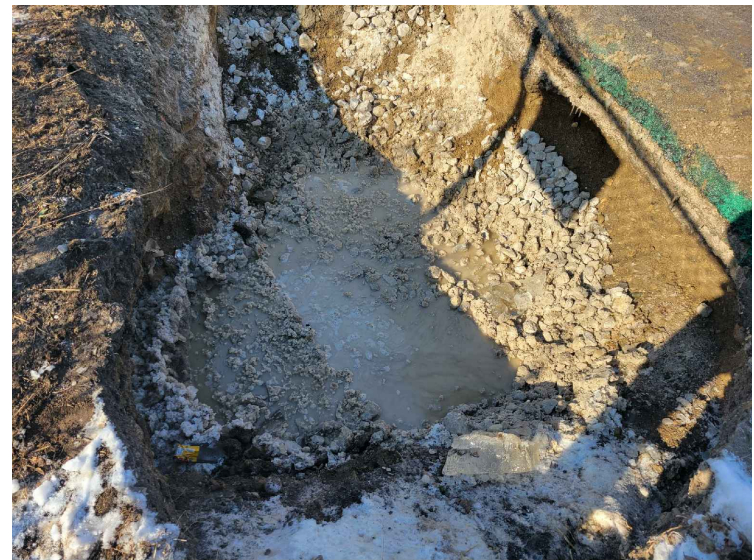
2x3 STONE

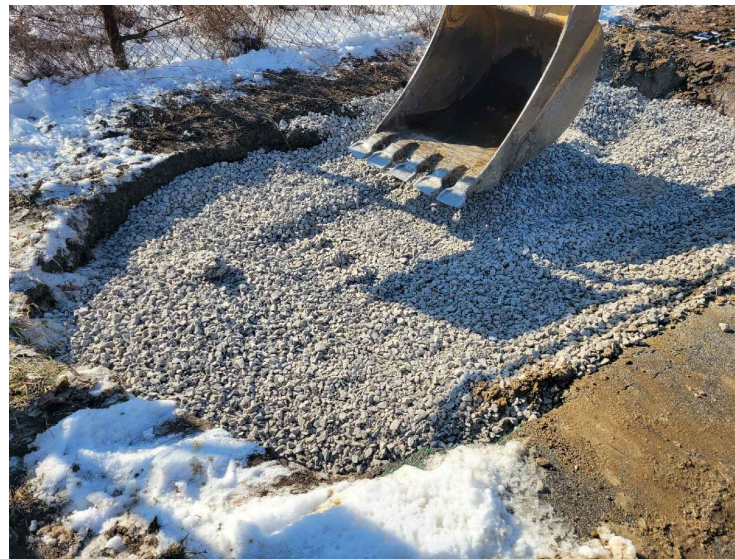
6A STONE
