**From:** [John Redente](#)  
**To:** [Thacher, Jill](#)  
**Cc:** [Kloe Ferriman](#); [Shawn Lenhardt](#)  
**Subject:** Re: 543 Detroit St Siding Replacement  
**Date:** Friday, June 2, 2023 7:50:53 PM

We will be submitting for HDC approval of the removal and reinstallation/replacement of siding at 543 Detroit Street. During the course of our work on the current project we discovered that areas of the siding are failing due to age and condition. Below is the description of what we have found and our plan for replacement and installment.

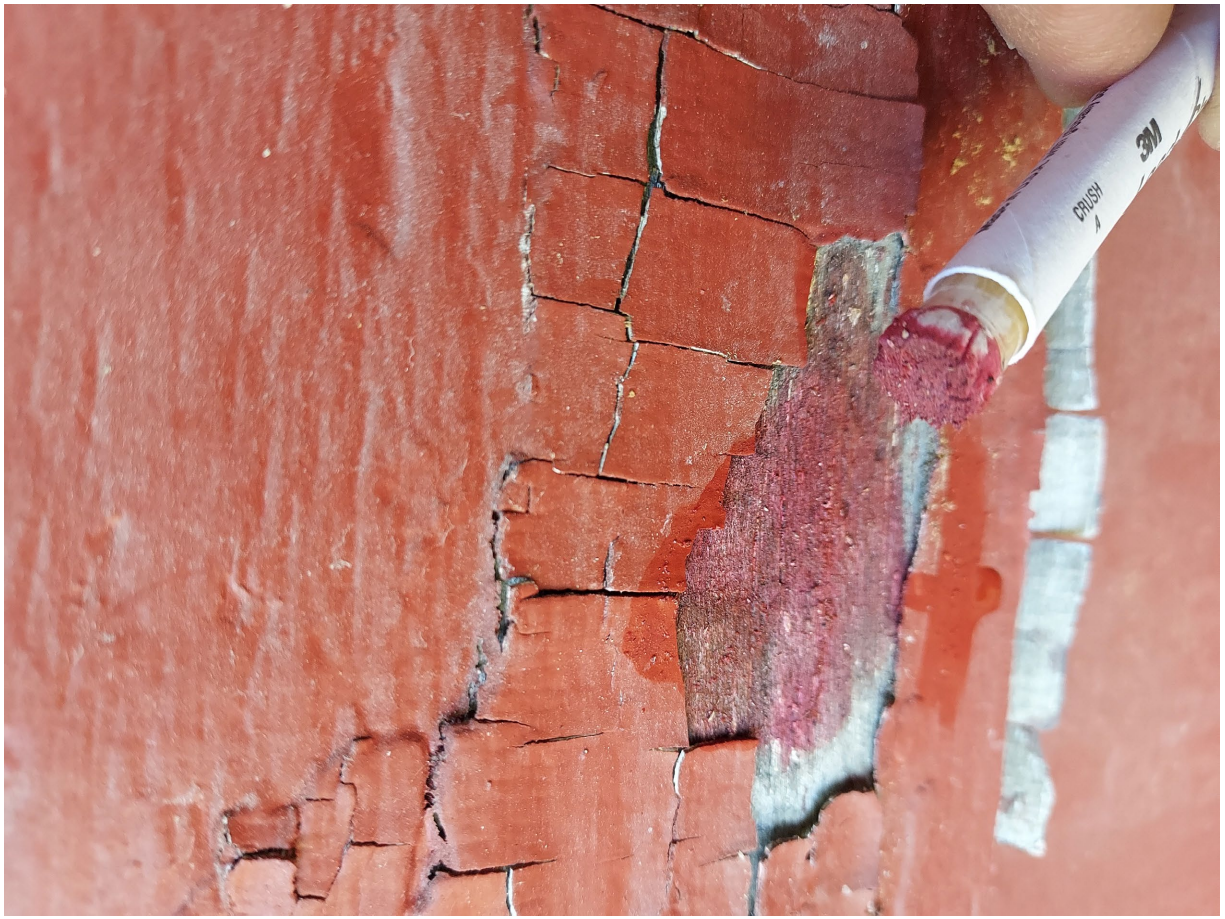
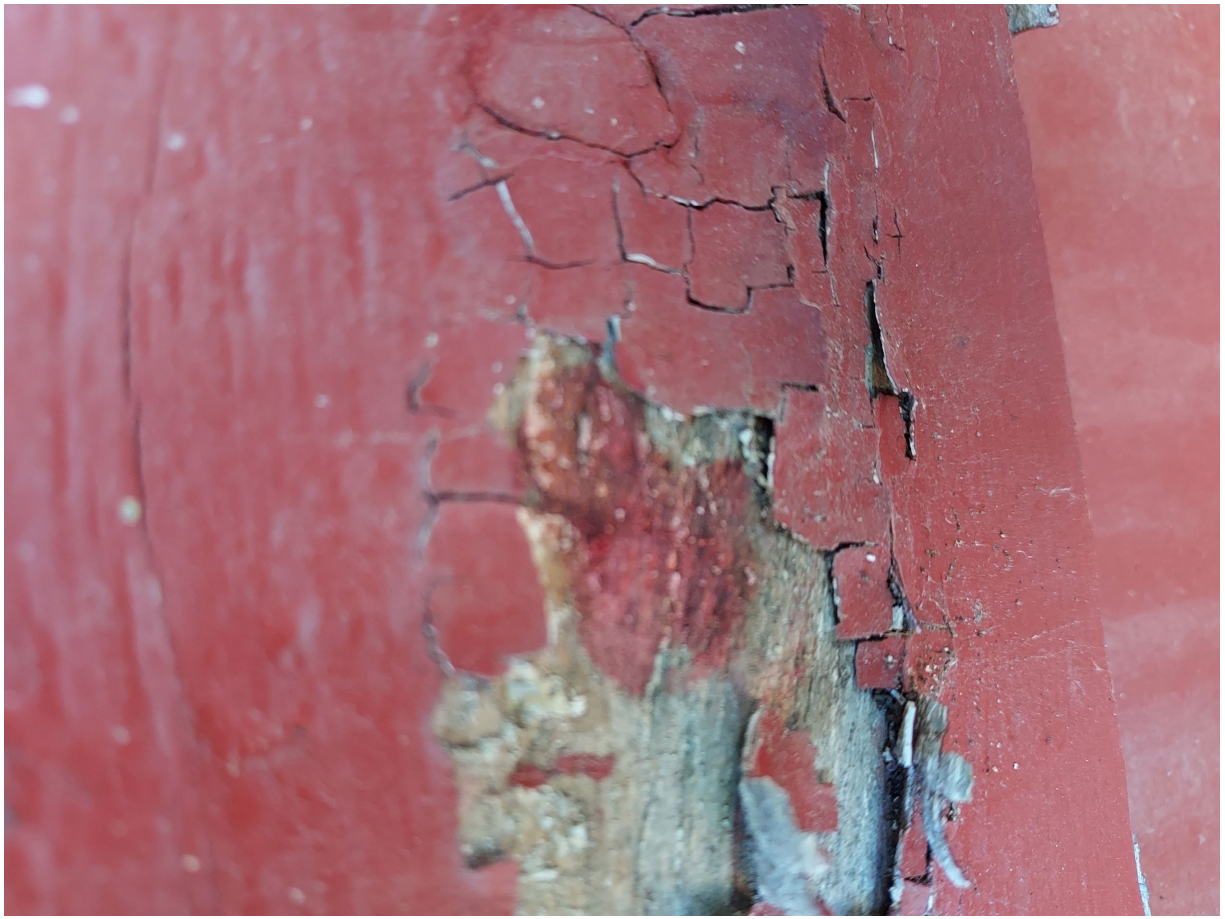
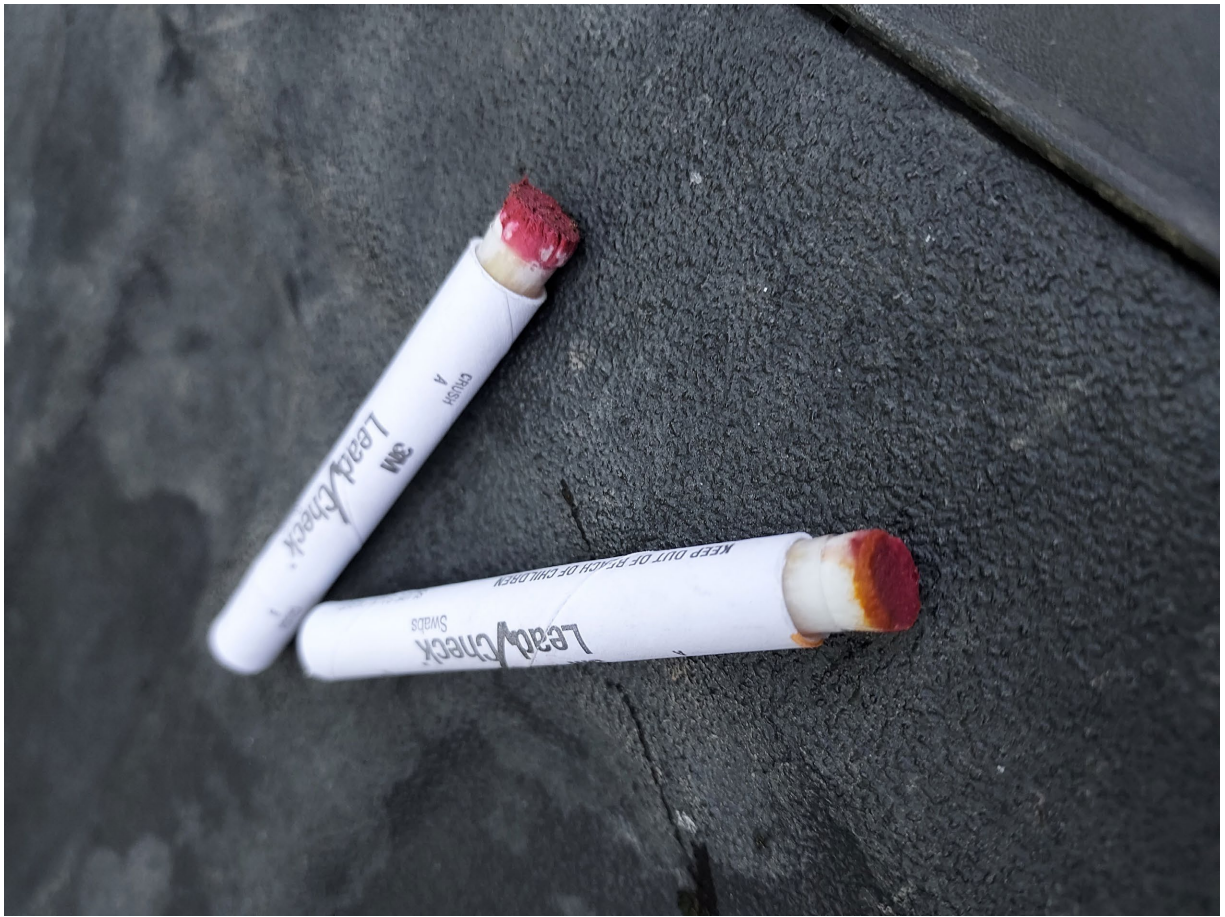
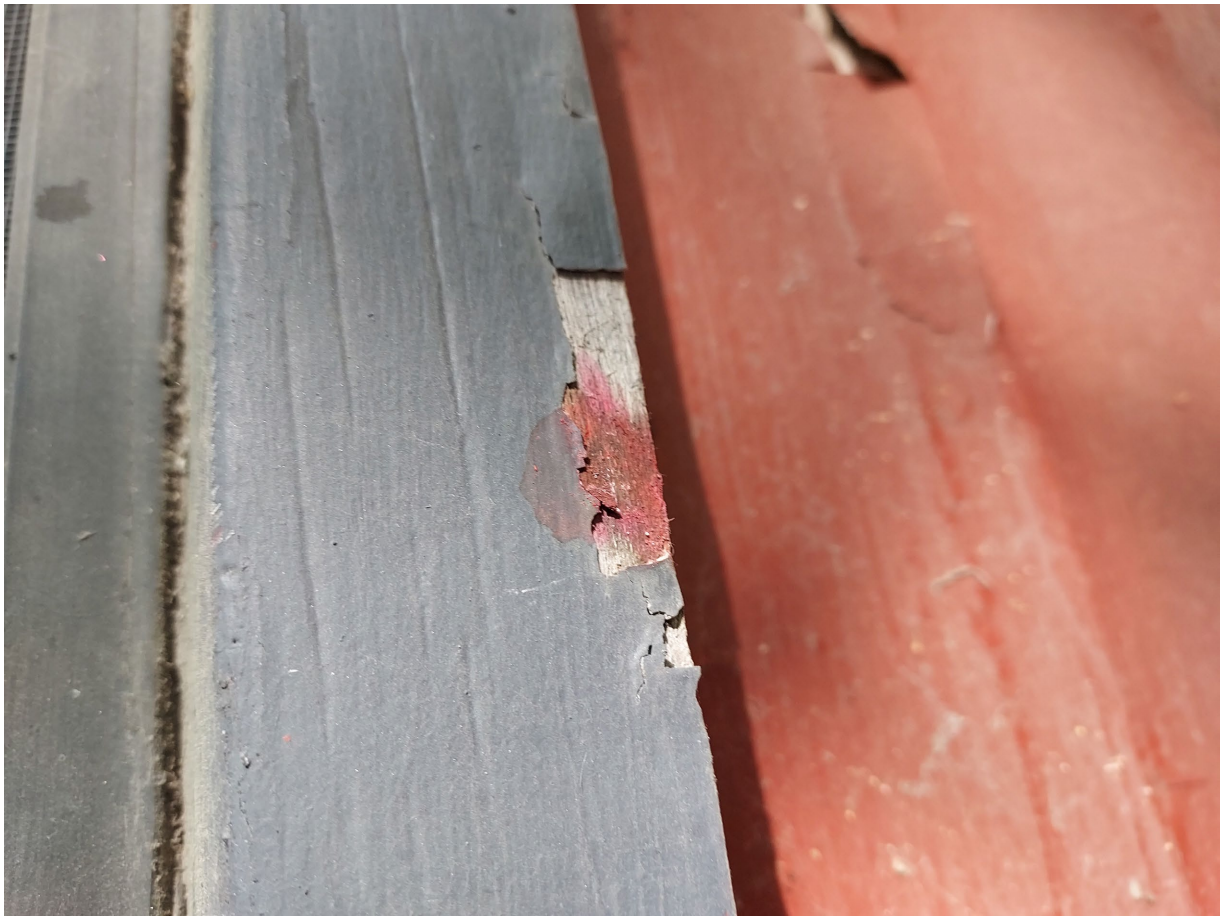
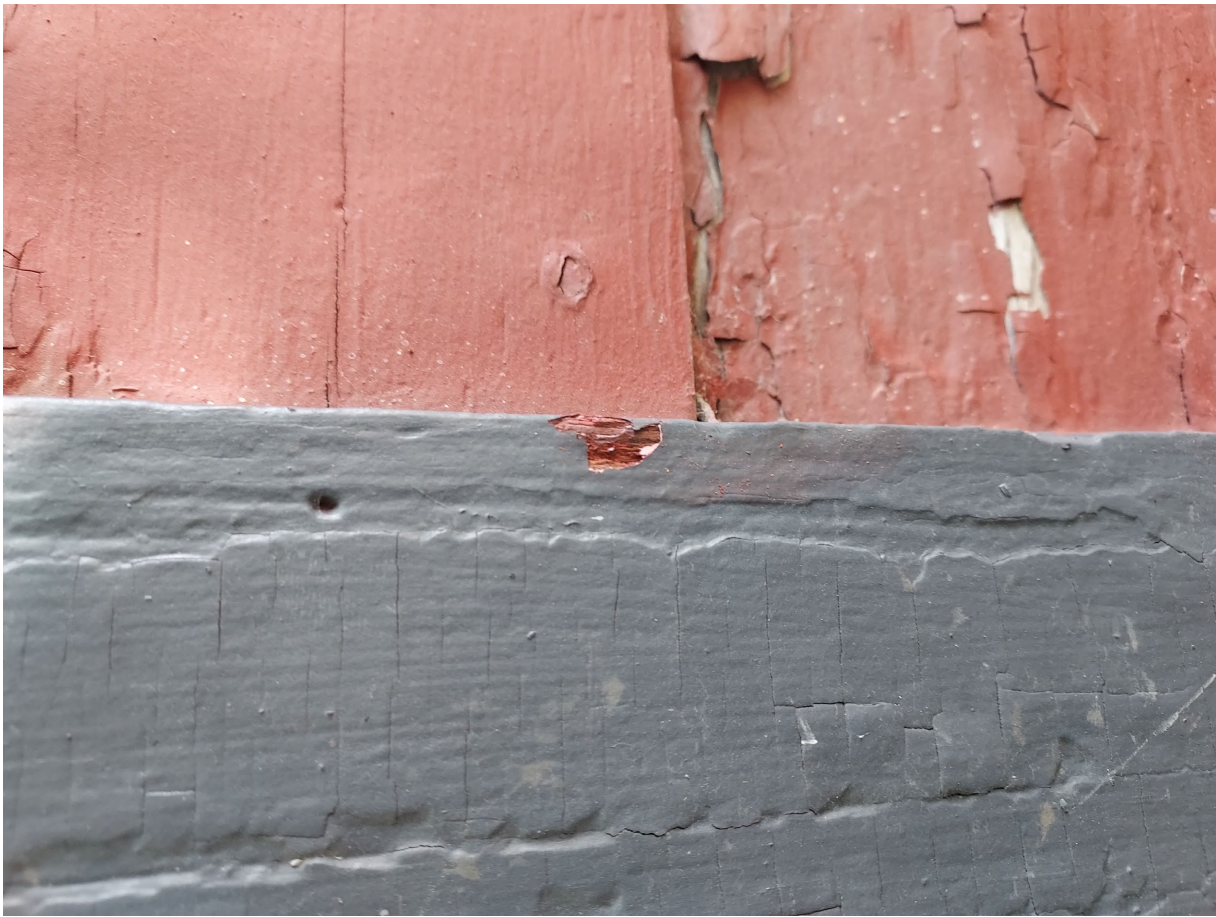
The existing siding is in rough shape and the face of the lap siding has been face nailed; doubling the penetrations and damage. During exploration, six pieces were taken off back of house, only 2 of the pieces could be reused, but would require patching to cover face nail holes.

Additionally all siding and trims on the exterior have Lead Based Paint. Reusing the material will create an even greater expense based on the requirements to abate the LBP. We can confidently say that matching the existing siding and trim details is no problem. In our current plan, we will keep all trim sizes, moldings and reveals the same. We plan to match siding with primed cedar. Basic trims will also be matched with primed cedar. Molded trims will be custom milled from cypress.

We have discovered that there are multiple failures within the current siding material on the home at 543 Detroit St. The best solution is to remove the existing siding and trims and replace as needed. The failure of the siding has allowed water to leak into the wall cavity and soak the framing member and dense packed cellulose insulation.

Our proposed work plan would be to remove all siding and trims on the house, saving whatever material is salvageable. We would then add a layer of exterior sheathing with a rainscreen. Over the rainscreen we would install salvaged materials that are in usable condition, starting on the front face of the house, and continue with matched materials the

rest of the way. We have had a number of pieces of the siding and trims examined and can have custom trims milled to match and existing trims that are not salvageable. We plan to use premium clear cedar bevel siding that will match the 4 1/4" reveal of the existing cladding and custom trims milled out of cypress.
