ANN ARBOR HISTORIC DISTRICT COMMISSION

Staff Report

ADDRESS: 211 East Ann Street, Application Number HDC15-118

DISTRICT: Fourth/Ann Historic District

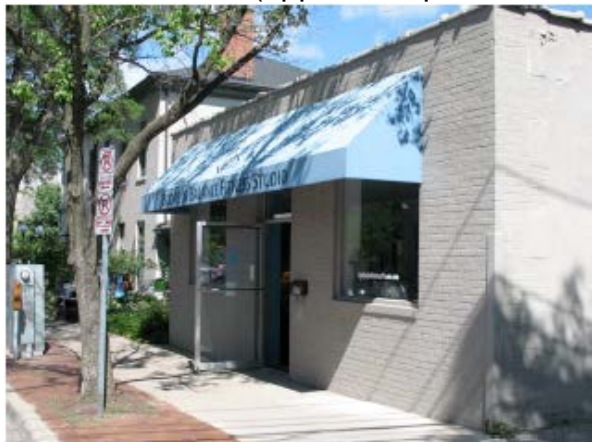
211 E Ann Street (applicant's photo, 2015)

1. The concrete masonry unit building has a brick veneer on the front elevation, and very little other architectural detail. The building appears relatively unchanged from a 1971 file photo. It is a non-contributing structure.
2. The proposed changes to the storefront will provide more light into the building and a code-compliant front door. The design is contemporary, though it uses classical elements. Staff does not believe that it will be mistaken for a historic storefront because of the proportions of the windows and door and the busyness of the design. Building the parapet 1'4" higher will give the building a little more presence on East Ann Street without negatively affecting the historic resources nearby.
3. Drawing SK-4 shows a new door on the west elevation leading to a proposed exterior seating area. Details are not provided, but if the door matches the design of the front
