HDC Application – Old West Side

524 3rd – Norton /Koman Garage

5. Description of Proposed Changes

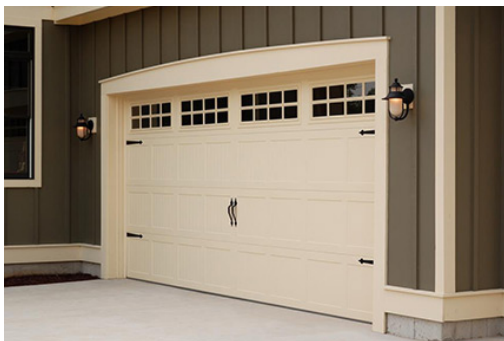
We intend to use a garage door type that looks like the following (without the decorative trim above, again to be more barn-like). These are steel overhead doors designed to look like carriage doors.
