ANN ARBOR HISTORIC DISTRICT COMMISSION

Staff Report

ADDRESS: 526 Detroit Street, Application Number HDC23-0178

DISTRICT: Old Fourth Ward Historic District

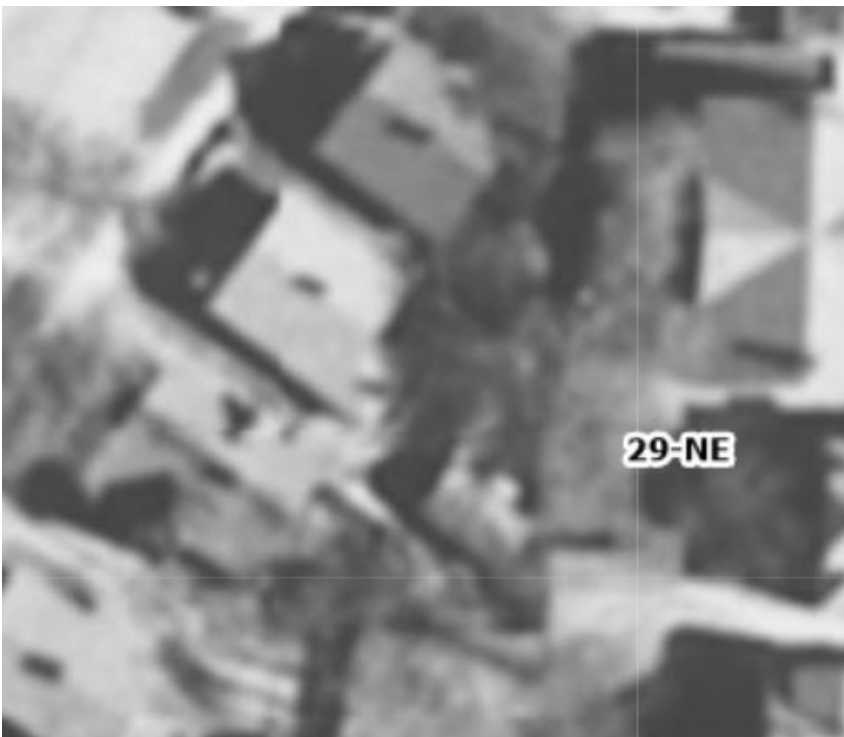
1947 City Aerial Photo (note much smaller single-car garage)

1. The existing house (minus the dormers, which were a later addition) in its current footprint can be seen on 1947 City aerial photos. A much smaller one-car garage is present on 1947 aerial photos; the current garage is not from the period of significance.
2. A composite slat privacy fence is proposed around the rear lot line to form two distinct yard areas: one behind the house's new addition and one behind and to the side of the accessory dwelling unit (ADU). The height of the fence is not indicated; 6' maximum is appropriate per the design guidelines. The HDC will determine whether a composite fence, rather than a wood fence, is appropriate. The fence gives residents privacy in their small spaces; it also has the effect of compartmentalizing a historically open rear yard that is already being shrunk by the rear addition.
