From: [Thacher, Jill](#)
To: [John Redente](#)
Subject: RE: 543 Detroit St Siding Replacement
Date: Wednesday, May 24, 2023 10:22:00 AM

We will be submitting for HDC approval of the removal and reinstallation/replacement of siding at 543 Detroit Street. During the course of our work on the current project we discovered that areas of the siding are failing due to age and condition. Below is the description of what we have found and our plan for replacement and installment.

Siding replacement/Repair.

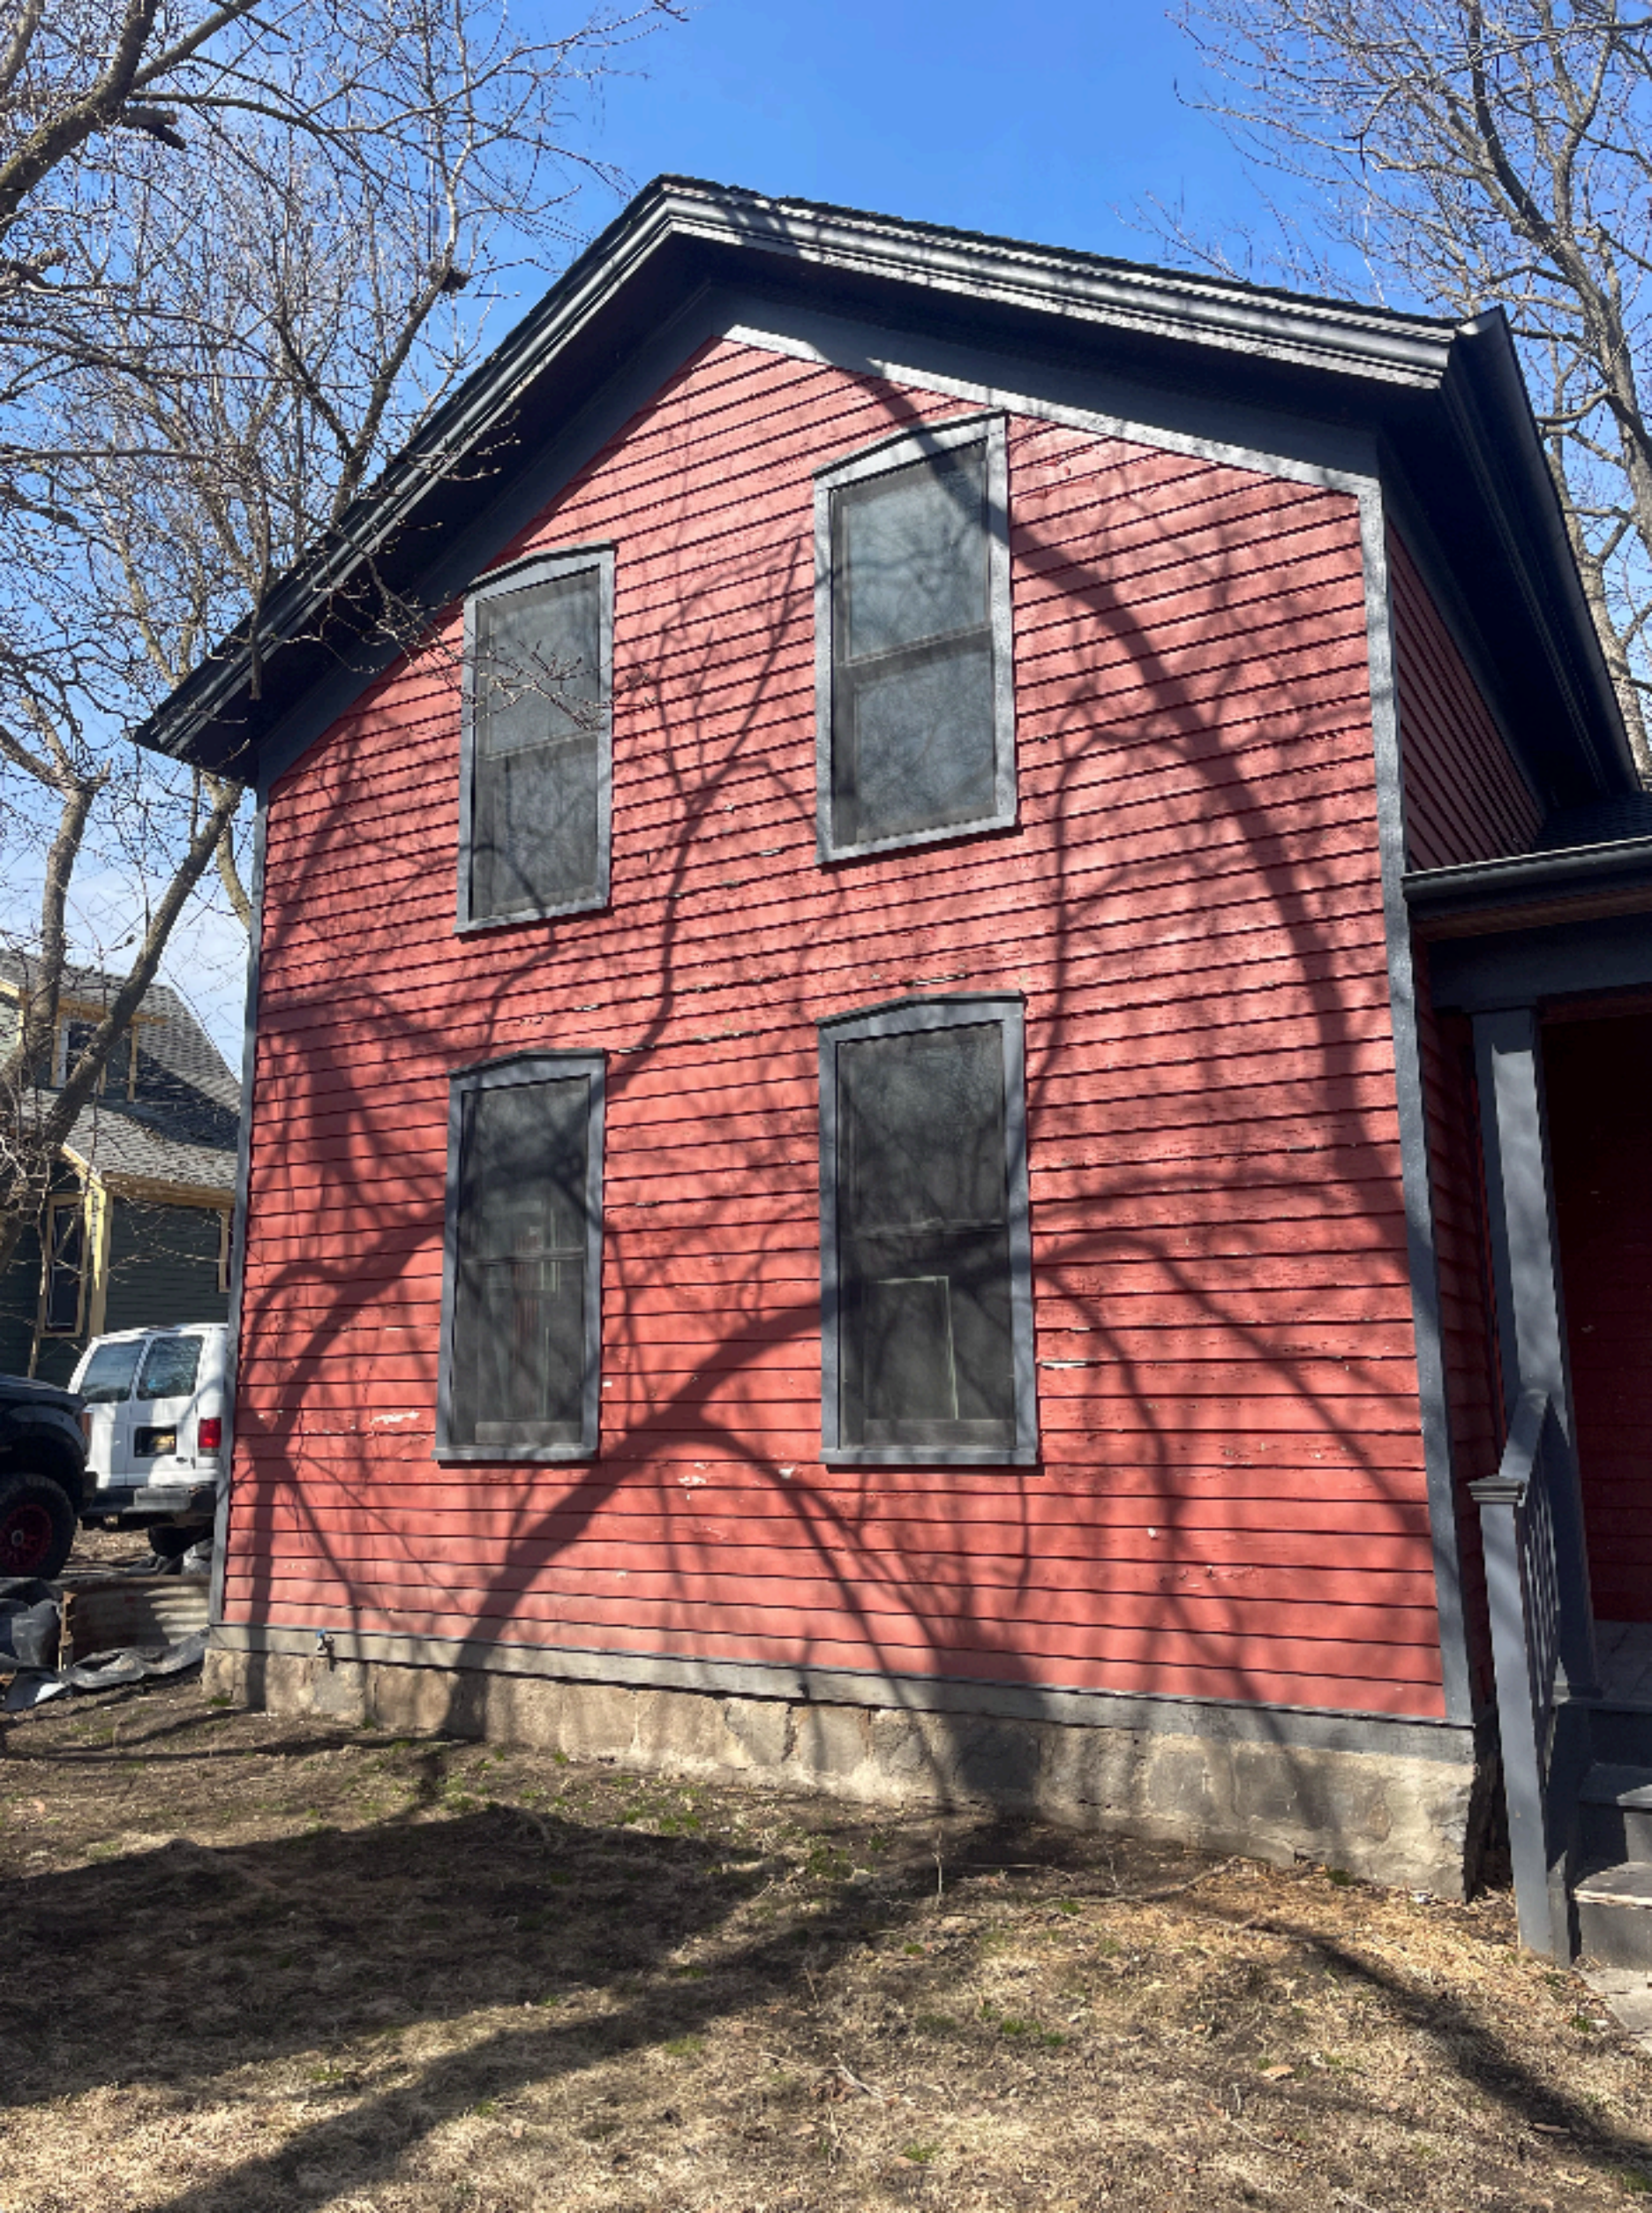
2x4 Wall Framing

Cellulose Insulation

Clapboard Siding

Rainscreen (1/4")

OSB (7/16")

WRB Housewrap

Drip Cap

Water Table Trim

Our proposed work plan would be to remove all siding and trims on the house, saving whatever material is salvageable. We would then add a layer of exterior sheathing with a rainscreen. Over the rainscreen we would install salvaged materials that are in usable condition, starting on the front face of the house, and continue with matched materials the rest of the way. We have had a number of pieces of the siding and trims examined and can have custom trims milled to match and existing trims that are not salvageable. We plan to use premium clear cedar bevel siding that will match the 4 1/4" reveal of the existing cladding and custom trims milled out of cypress.

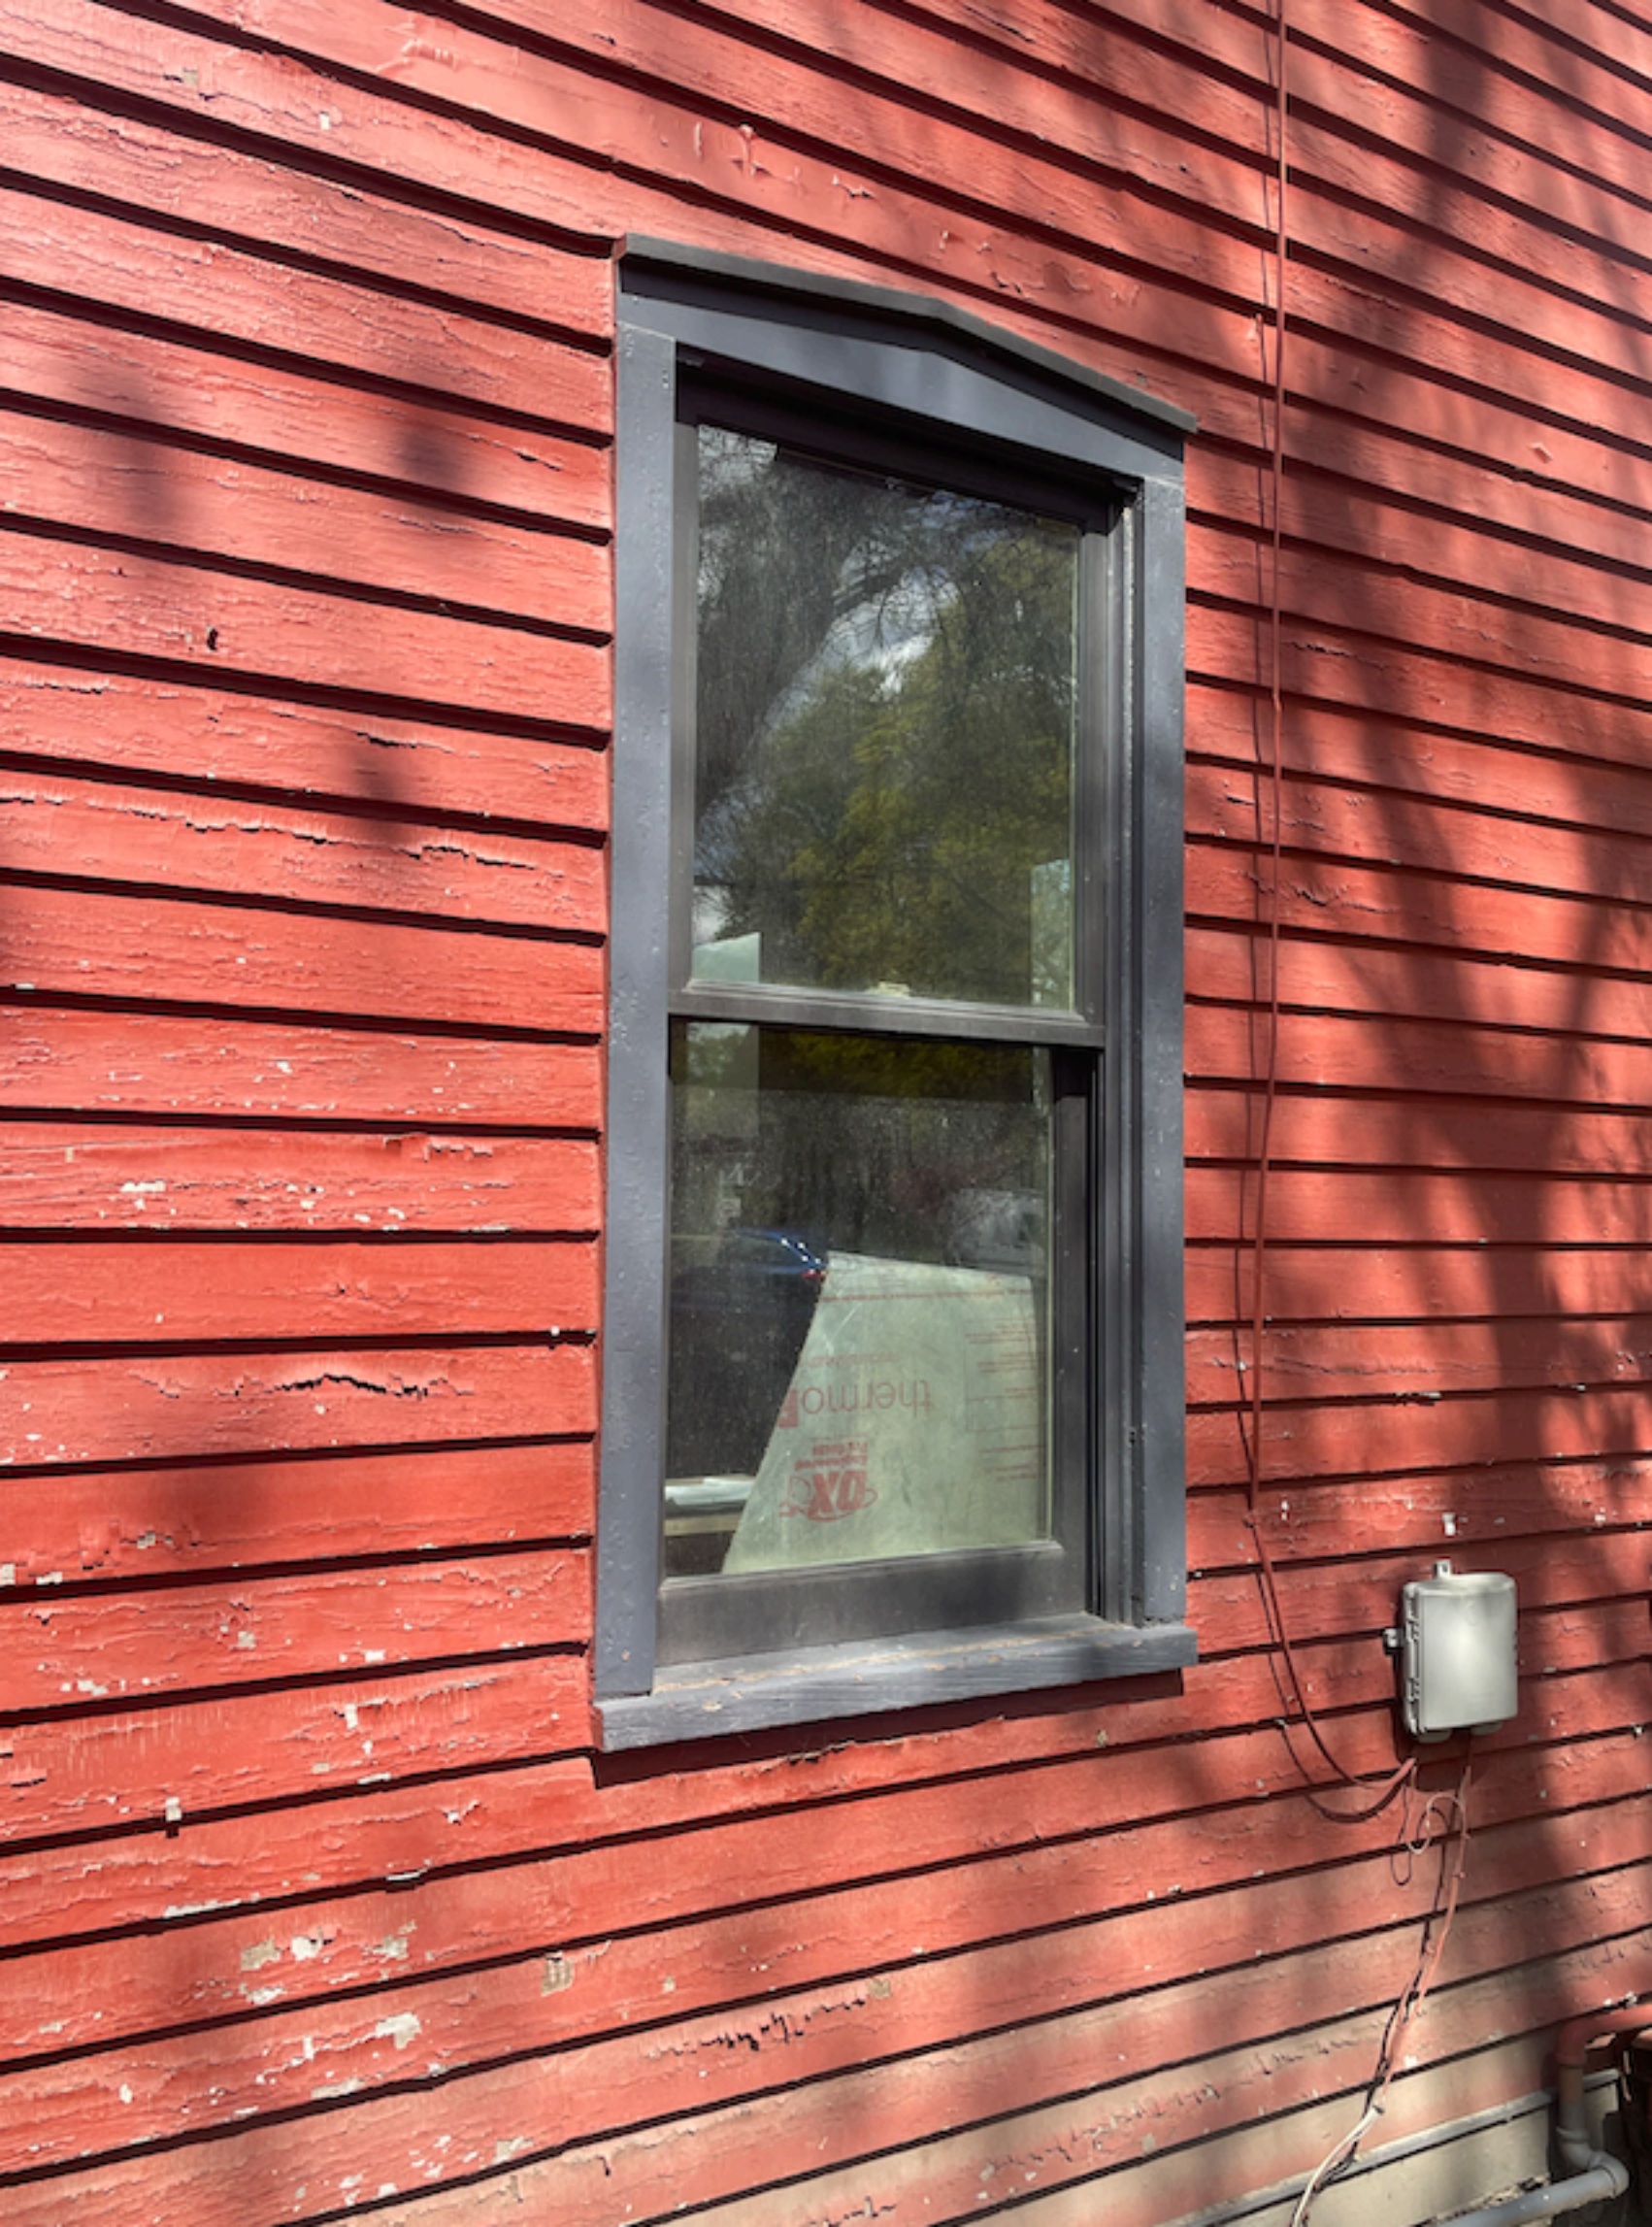
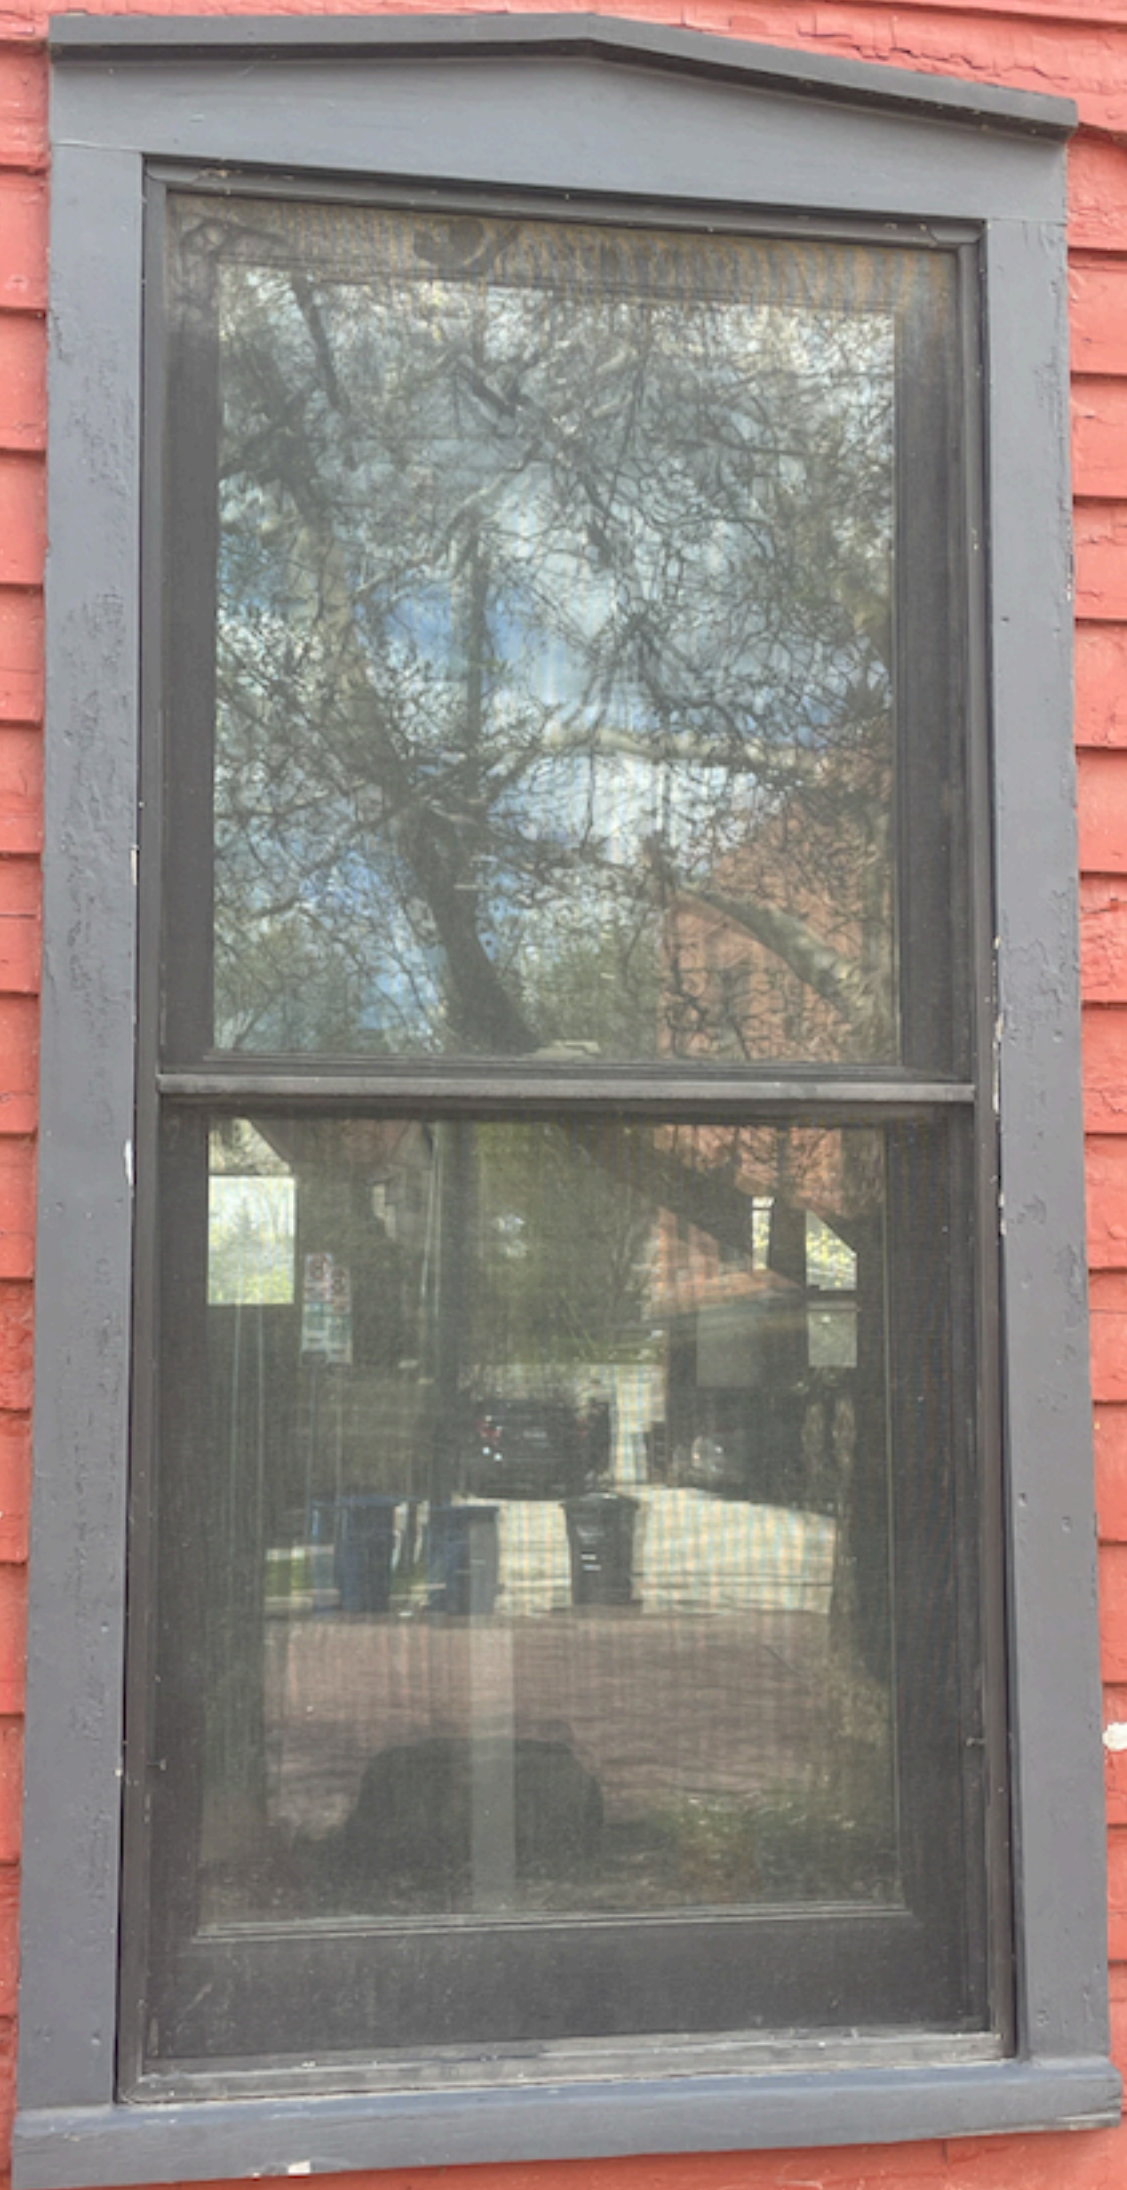
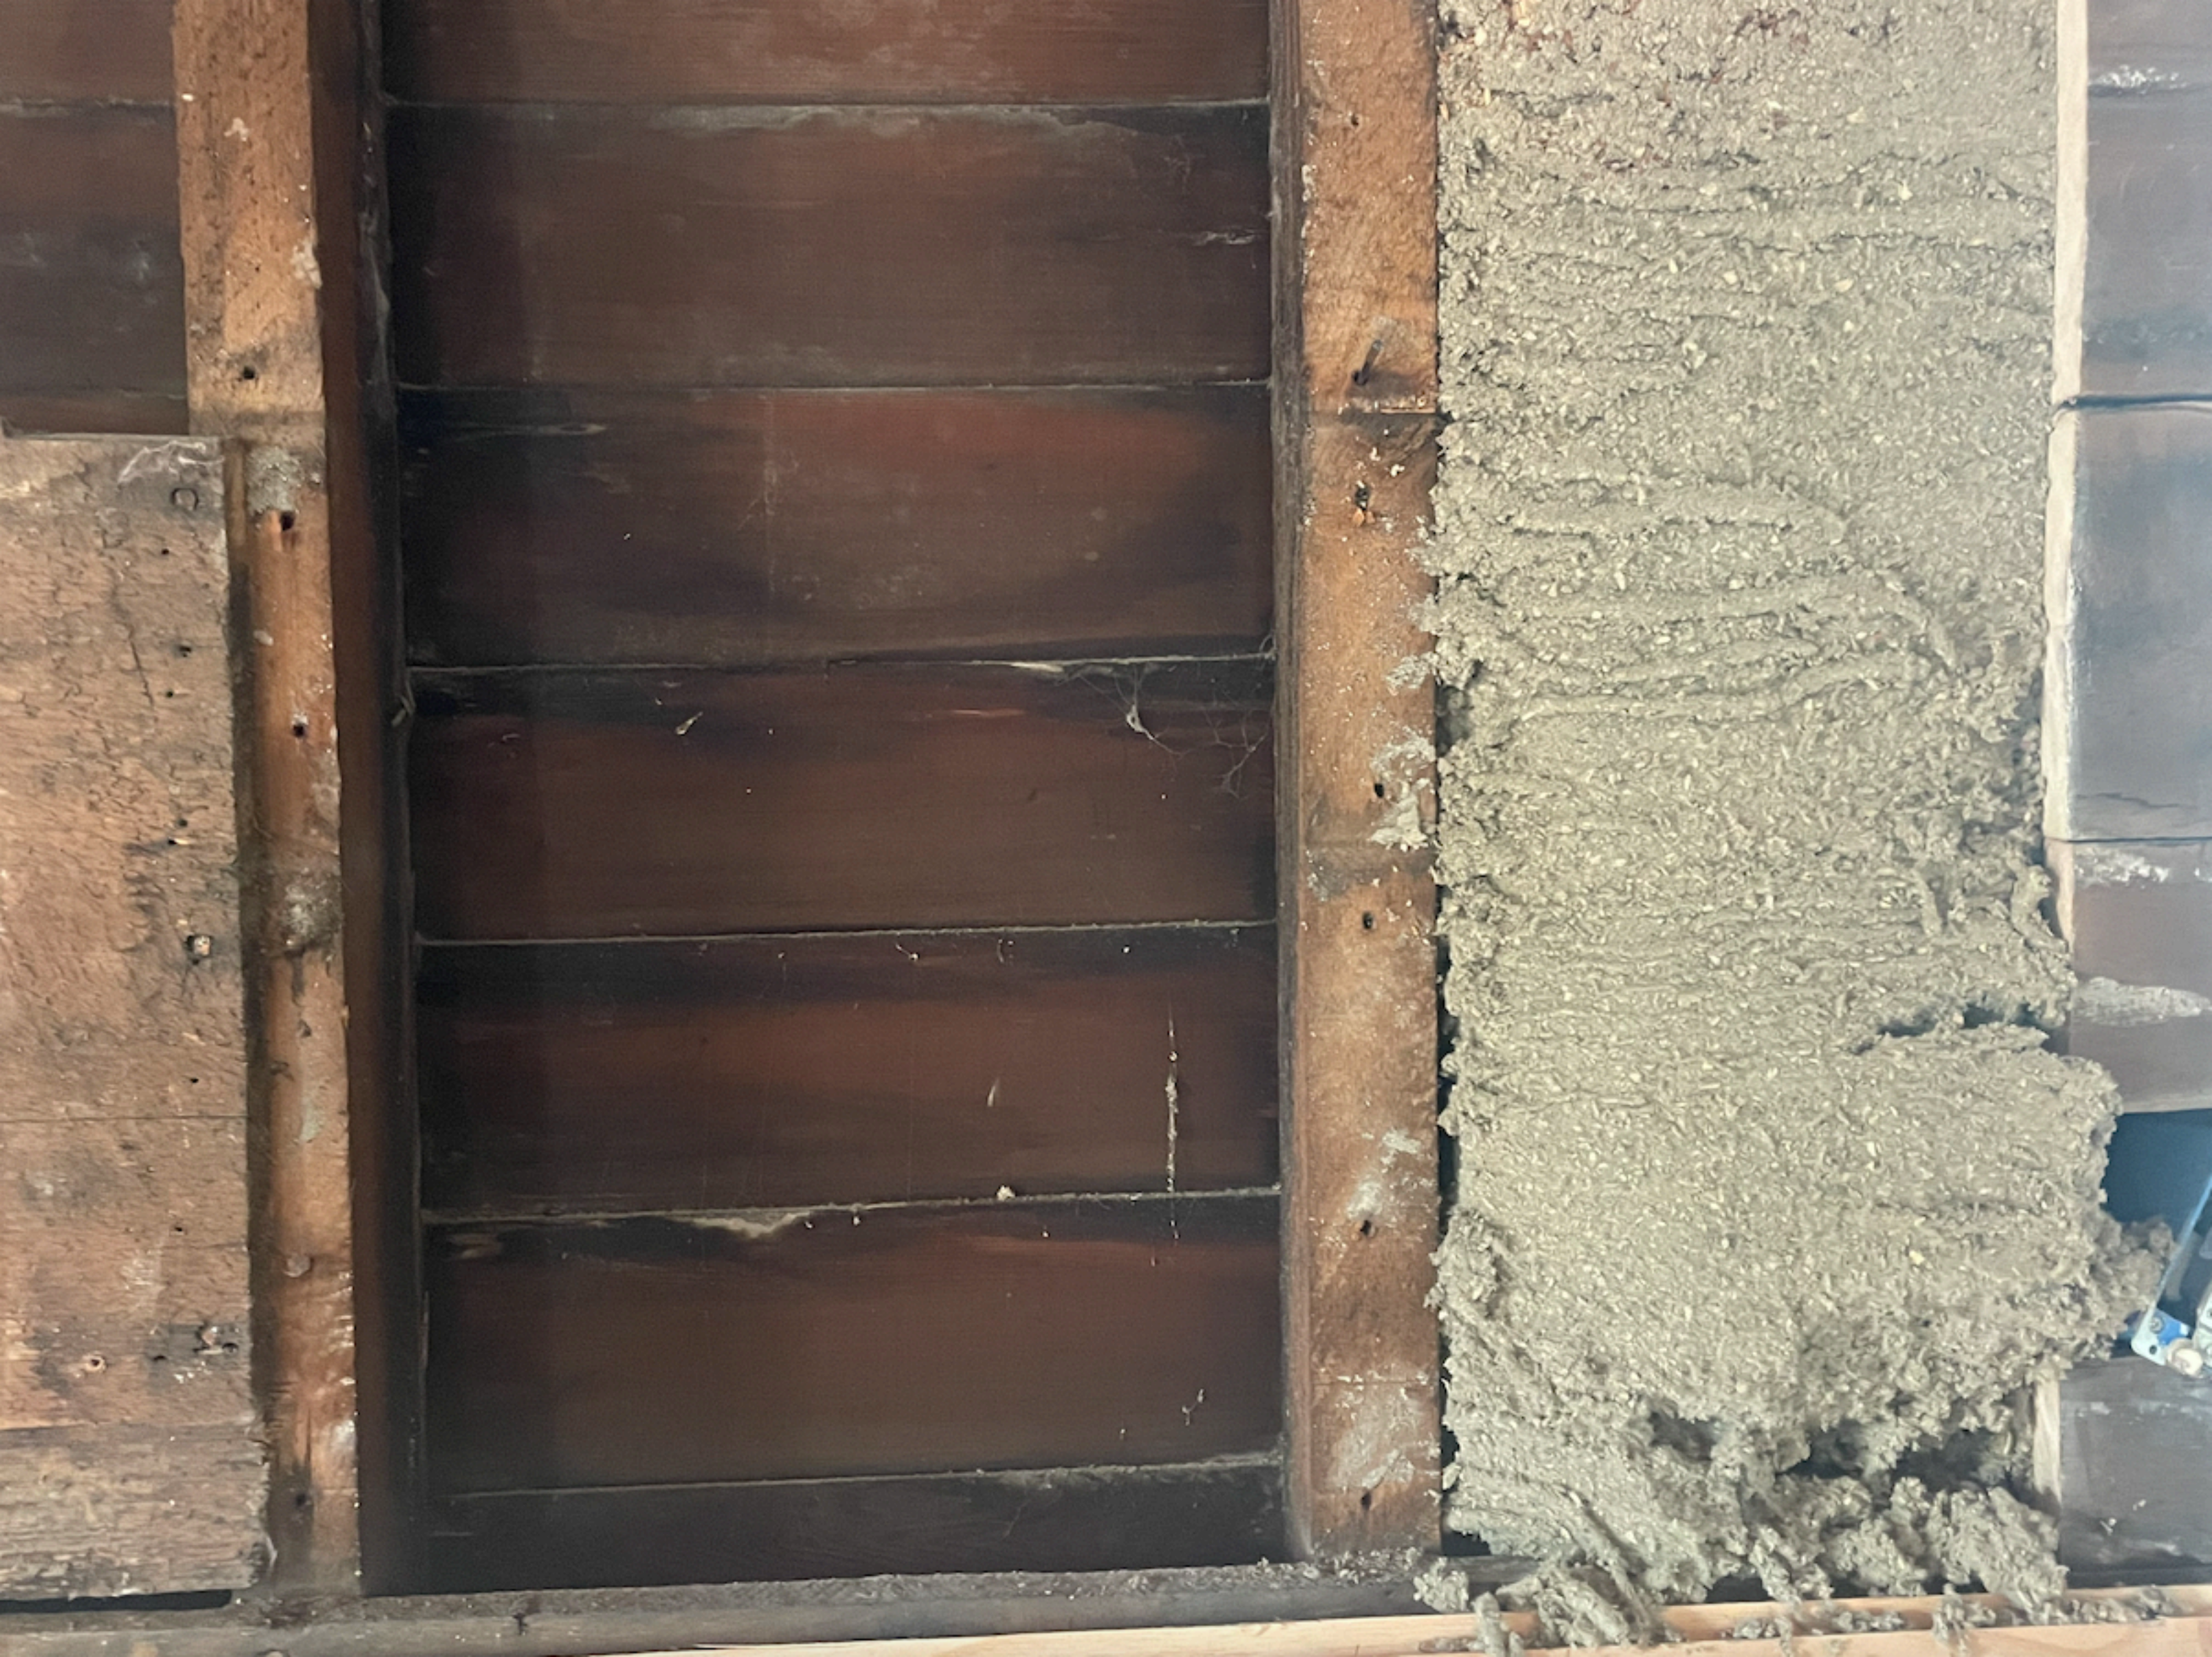
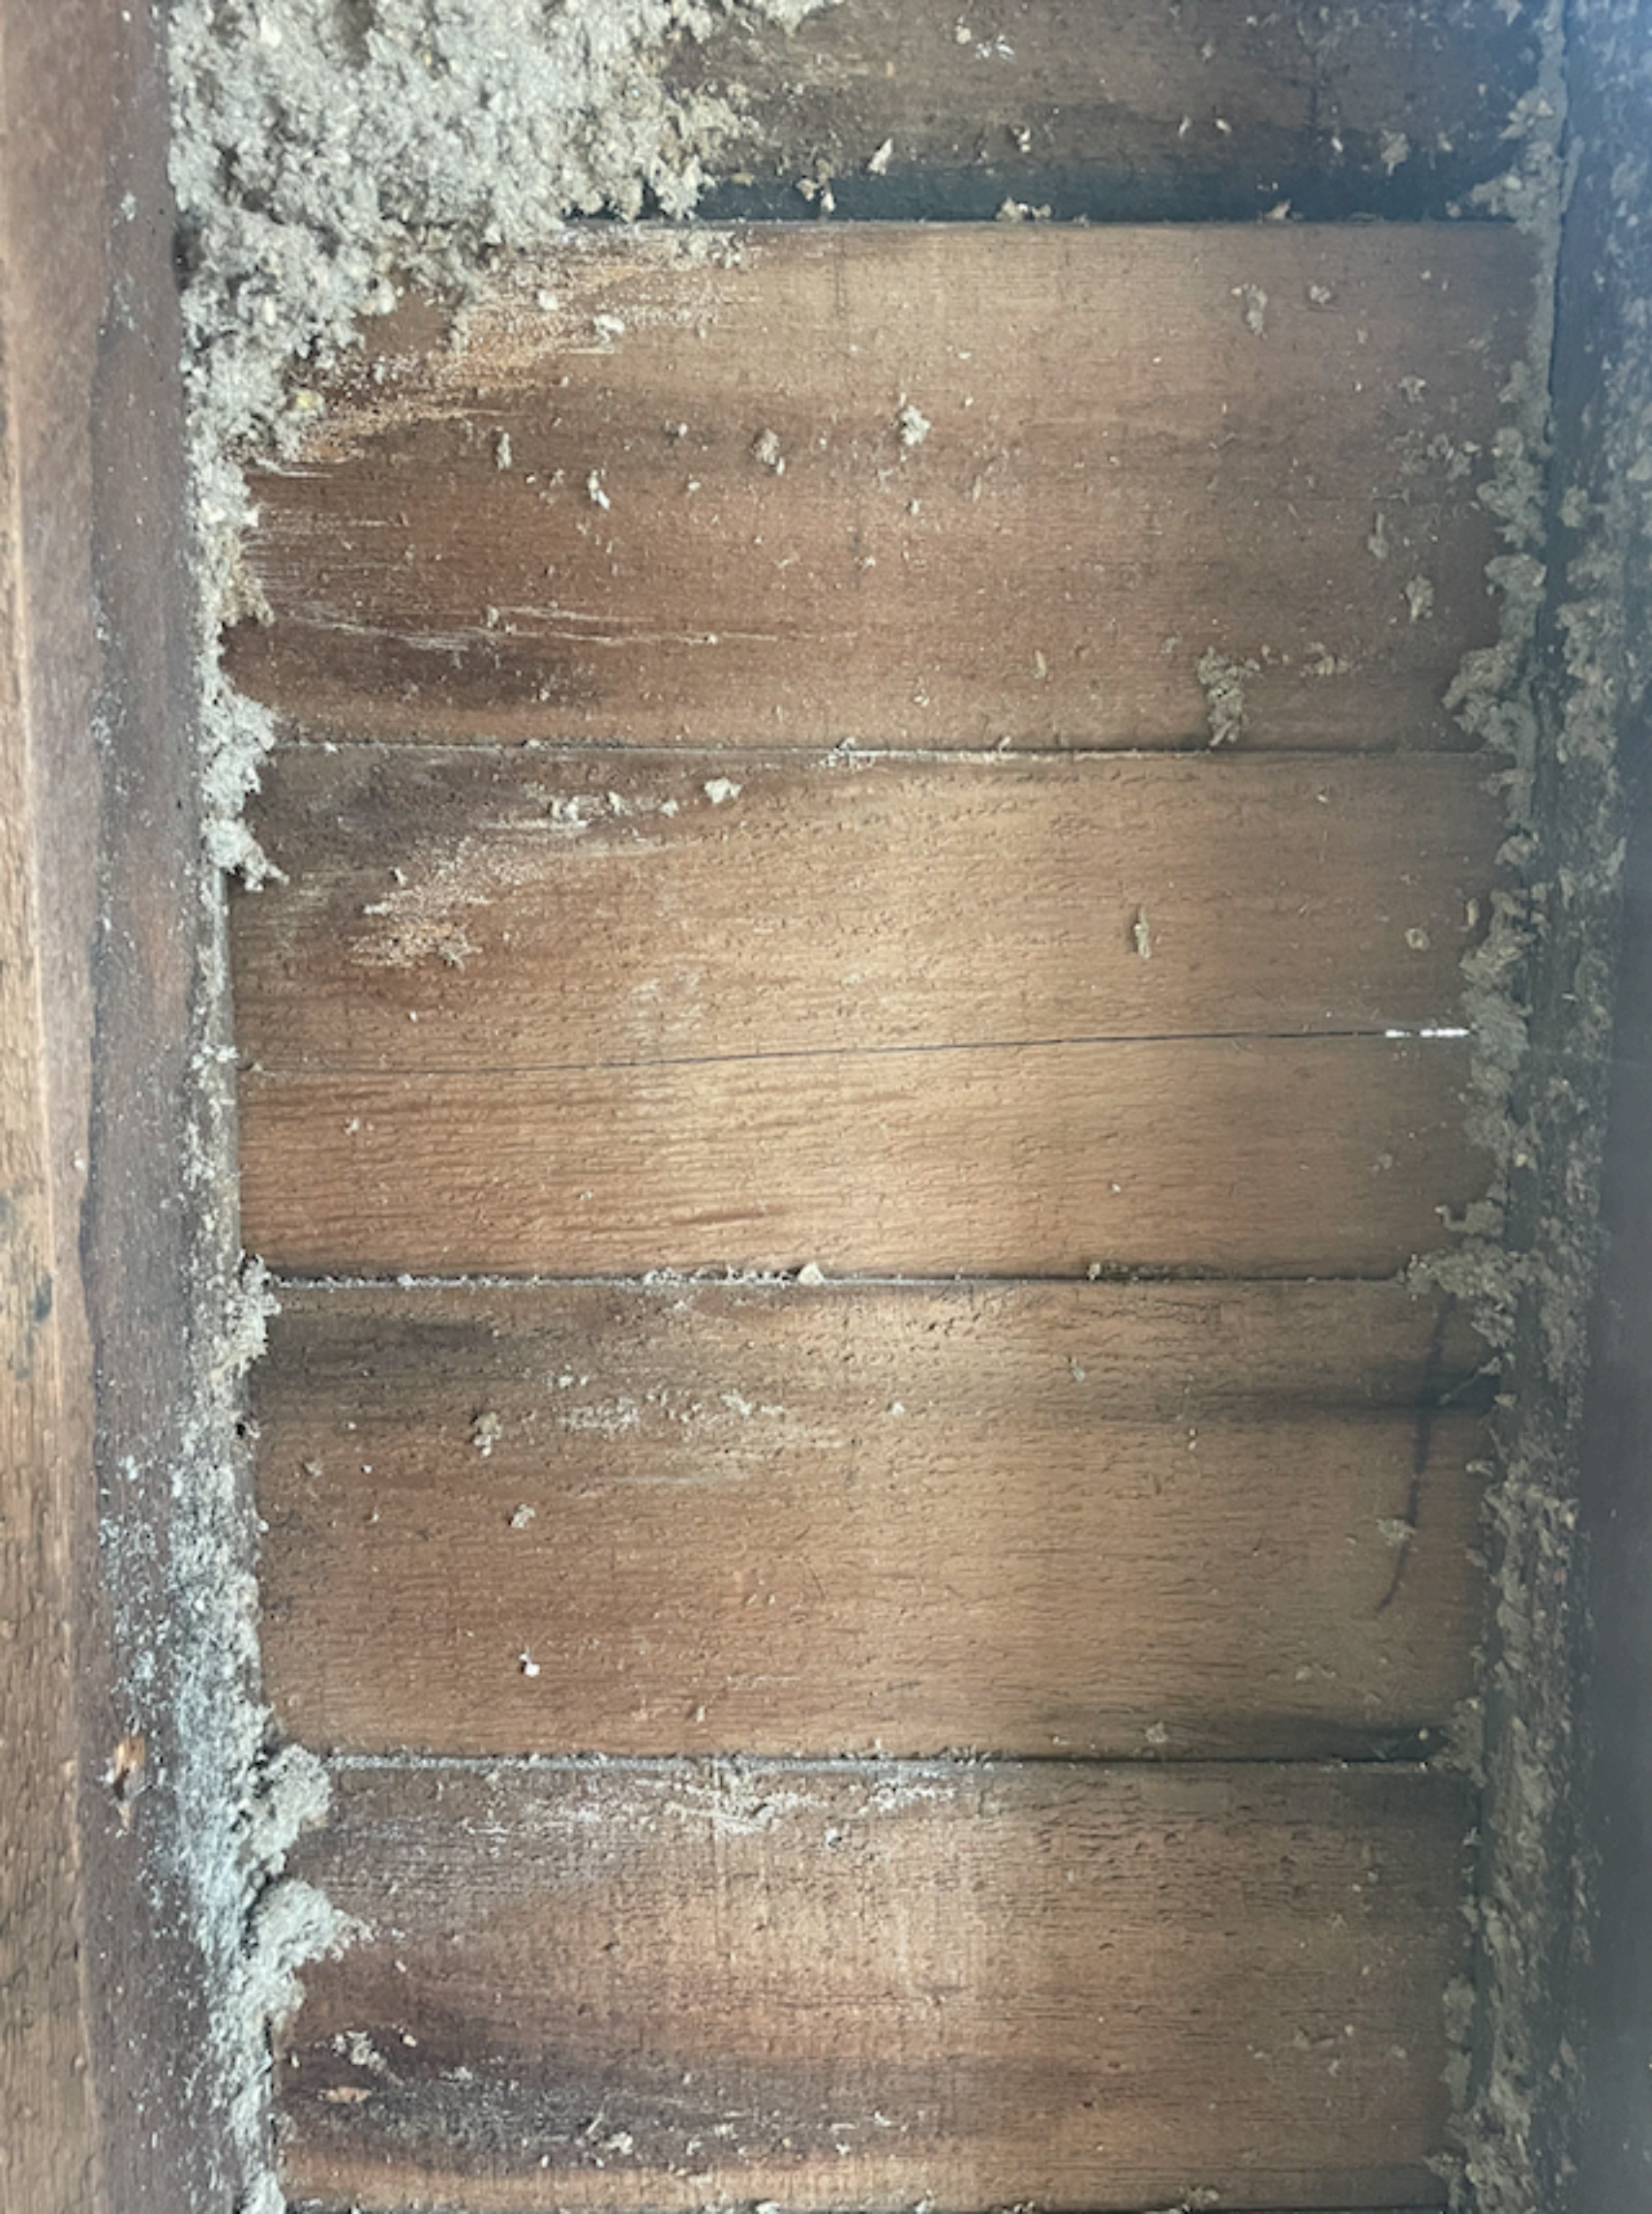
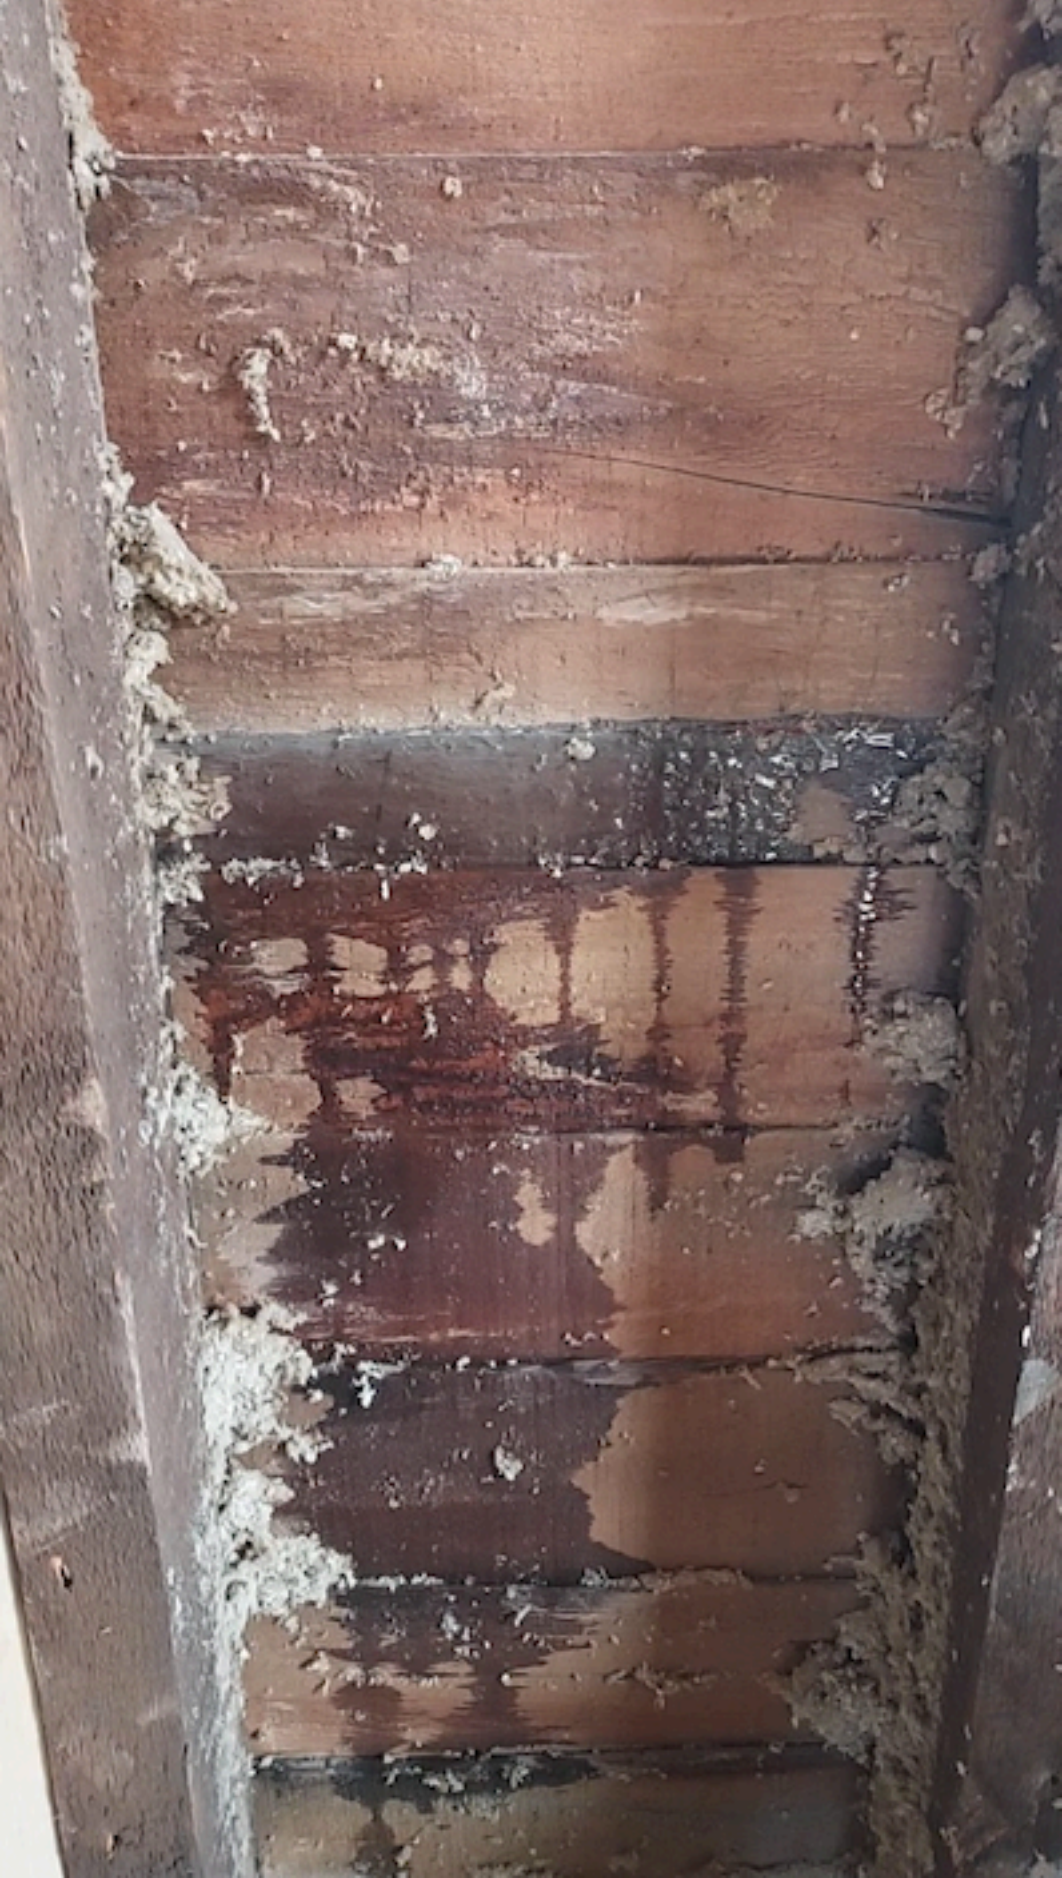
We have discovered that there are multiple failures within the current siding material on the home at 543 Detroit St. The best solution is to remove the existing siding and trims and replace as needed. The failure of the siding has allowed water to leak into the wall cavity and soak the framing member and dense packed cellulose insulation.
